SEALED ENVIRONMENT

Climate Control of Historic House Museums

Golnaz Karimi

Master of Architecture

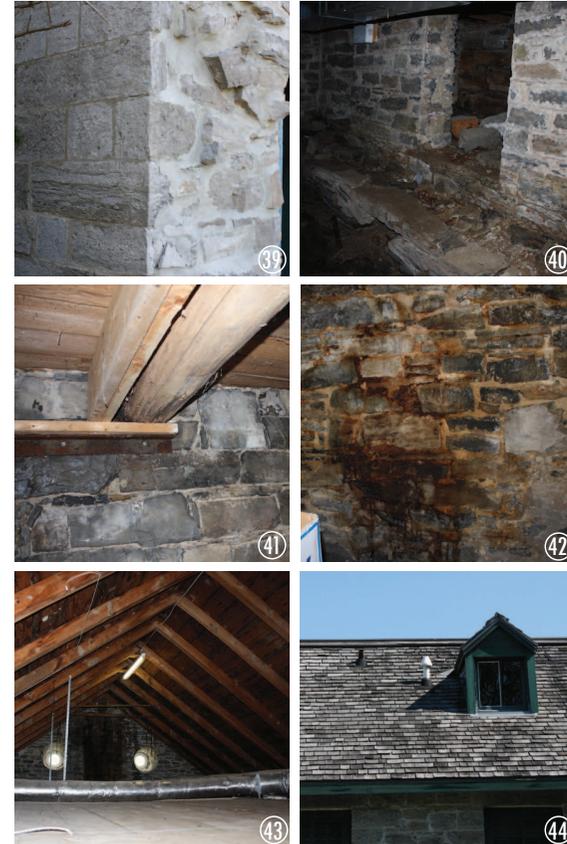
- 39. Ashlar vs. rubble (Karimi, 2015)
- 40. Foundation walls (Karimi, 2015)
- 41. Log beam with additional supports (Karimi, 2015)
- 42. Water penetration (Karimi, 2015)
- 43. Rafters (Karimi, 2015)
- 44. Cedar shingles (Karimi, 2015)

As mentioned above, Horaceville consists of three separate wings connected through wall openings. The exterior walls were constructed of load-bearing stone masonry on stone foundation placed on bedrock. There has been an ongoing passage of groundwater on the surface of the bedrock causing excessive amounts of humidity in the basement (Smith, 1991). The exterior walls are dressed in two different methods: squared ashlar limestone with regular coursing and rubble limestone with irregular coursing (fig. 39). The interior separation walls between each wing are also of stone masonry raised to the underside of the roof. There are signs of water penetration through the upper part of the east and west end walls (fig. 42), requiring immediate remedial measures to avoid further damage to the fabric.

The interior structure (floor, roof and some of the interior partitions) was built with hand-hewn log beams and hand-sawn lumber. The ground floor is supported on log joists, which have gradually suffered from excessive humidity levels in the basement.

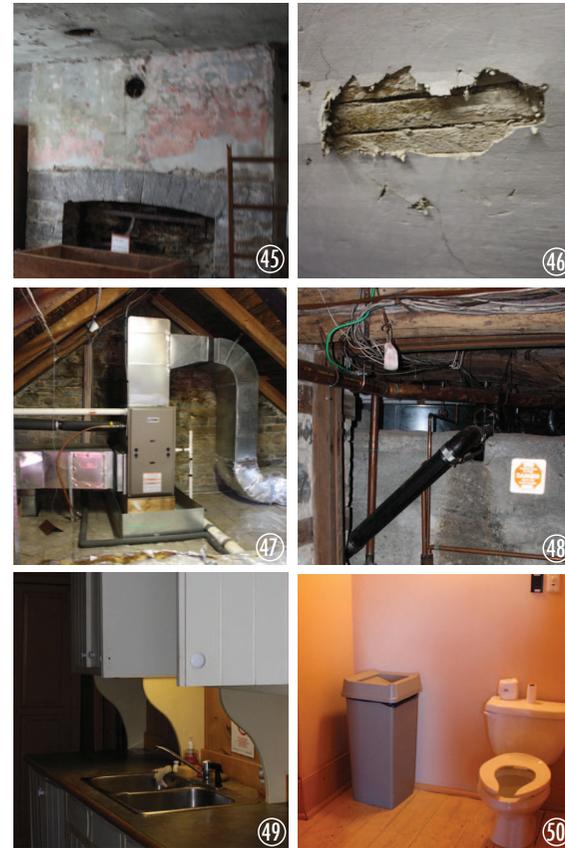
45. **Fireplace** (Karimi, 2015)
46. **Damaged plaster** (Karimi, 2015)
47. **Furnace in attic** (Karimi, 2015)
48. **New plumbing system** (Karimi, 2015)
49. **New kitchen** (Karimi, 2015)
50. **New bathroom** (Karimi, 2015)

The majority of the interior finishes are composed of lath and plaster (fig. 46) with different types of finishes, including plain, painted, wallpapered, and stained. The ceilings are also covered in various finishes and are detailed with plaster cornices. The hardwood floors and interior door surfaces were hand grained. The historic finishes are generally in good condition, but there are some physical signs of thermal and moisture stresses such as cracks and stains on the surface of several walls and ceilings.

The original heating systems included coal and wood operated fireplaces, and wood stoves. The heating systems were connected by a network of flues through wall and floor openings and ventilated via chimneys at the roof level. The major system change was the implementation of a modern mechanical system in the 1990's. The new heating/cooling system is comprised of furnaces in the attics and the basement (fig. 47). Until the 1950's, the house had no electricity, indoor plumbing or running water (Smith, 1991). A plumbing and electrical system, three bathrooms, and a small kitchen were installed during the restoration project of the 1990's (fig. 49).

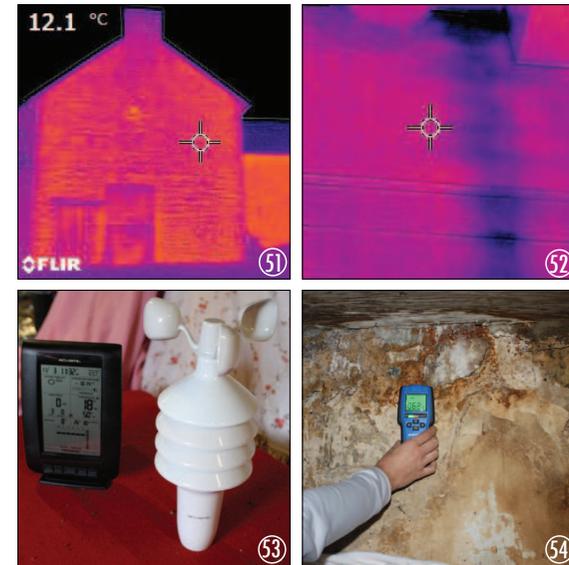
51. Thermal image, exterior (Karimi, 2015)
52. Thermal image, wood floor (Karimi, 2015)
53. Weather station (Karimi, 2015)
54. Moisture metre (Karimi, 2015)

A thermal camera was used to detect moisture on the exterior and interior surfaces of the physical fabric, such as high temperature differentials on wall surfaces and moisture patterns in the floor and ceiling spaces from the mechanical system. Additionally, a weather station was used to measure and monitor the relative humidity and temperature in various rooms. The monitoring began from September and continued through December. A moisture metre was used on various occasions to detect points having high amounts of moisture on the interior side of the building's perimeter walls, such as the bottom of the external walls close to the grade, below window sills, and exterior end walls in the attics.

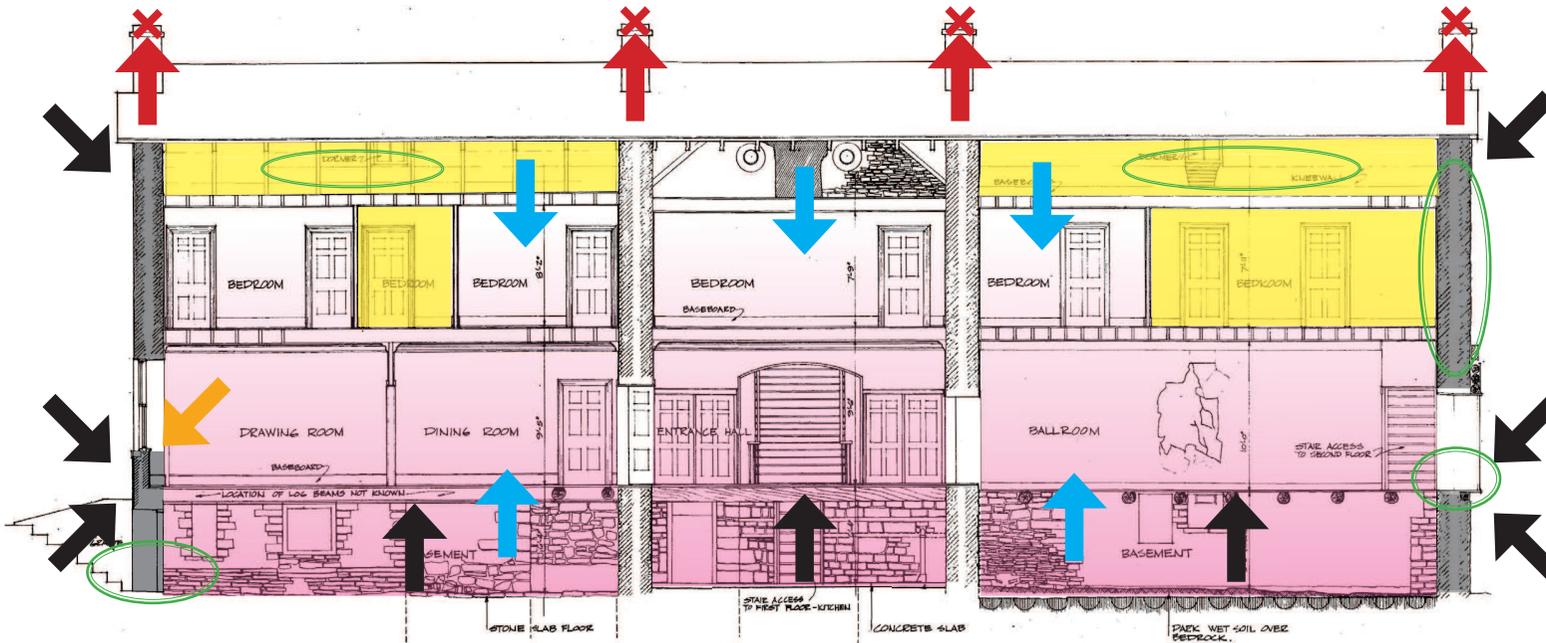
55. Section, performance issues (Smith, add-on: Karimi)

The site investigations and environmental studies identified many noticeable performance issues in the house museum. The main performance issues are highlighted in a sectional diagram of Horaceville (fig. 55). Through independent research and discussions with John Ward, a consultant from the Canadian Conservation Institute, a list of performance issues was prepared and ranked by their level of risk. The detected issues include uncontrolled moisture, high relative humidity, inappropriate artifact storage, poor ventilation, deficiencies with the climate control system, and condensation on windows. The majority of these issues relates to the high levels of moisture in the fabric, which can gradually cause deterioration. Other deficiencies such as fire hazards caused by inappropriate artifact storage can lead to sudden loss of the historic fabric and artifacts. Understanding the performance issues and their associated risks can help to determine preventive conservation measures and maintenance strategies (Karsten, 2002). The performance assessment is also a useful guide for short-term and long-term museum planning. In addition, the general advice and preventive conservation strategies from this case study can be used for other Canadian house museums.

- High risk ↑
- ① Uncontrolled moisture
 - ② High relative humidity
 - ③ Inappropriate artifact storage
 - ④ Poor ventilation
 - ⑤ Issues with climate control system
 - ⑥ Pest infestation
 - ⑦ Condensation on windows
- ↓ Low risk

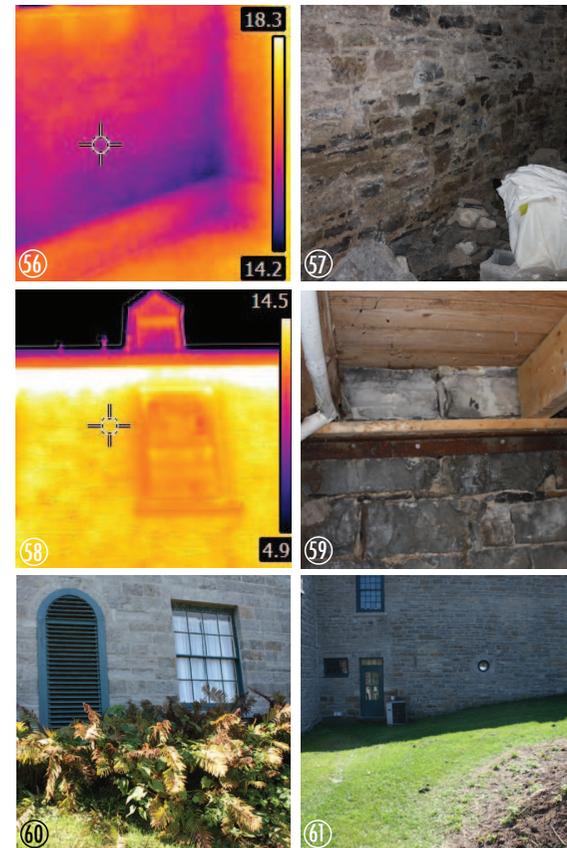
- 56. **Rising damp, ground** (Karimi, 2015)
- 57. **Rising damp, basement** (Karimi, 2015)
- 58. **Missing gutters** (Karimi, 2015)
- 59. **Water penetration** (Karimi, 2015)
- 60. **Exterior vegetation** (Karimi, 2015)
- 61. **Grade drainage toward the house** (Karimi, 2015)

There are currently no gutters and downspout systems for handling surface rain run-off (fig. 58). Controlling the rainwater is one of the most important measures in controlling the unwanted moisture for any historic building. Uncontrolled rainwater saturates the soil around the building and eventually wets the base of the building. The moisture will seep through any cracks in the foundation walls, leading to a damp basement that can increase the level of relative humidity in the entire building (Park, 1996).

The slopes and grading around the foundation walls also contribute to the high moisture levels in the basement. The ground slopes downward at the south elevation (fig. 61)

and directs rain and groundwater toward the building, leading to damp masonry walls in the basement and the south wing's central kitchen at grade (fig. 57). Additionally, rising damp appears at the base of the foundation walls and up to about one-and-a-half metres above ground level in the south wing's kitchen walls. The visual evidence of the rising damp is a band of discolouration or physical damage on the surface of internal walls (Bagg, 2006).

Other factors affecting the damp problem are raised grade and exterior vegetation growing against the masonry walls (fig. 60). Raised ground levels outside the walls increase the moisture levels inside the walls and will not allow the moisture in the soil to evaporate beneath the ground floor. Also, overly raised flowerbeds and vegetation at the north side of the building keep excess moisture levels at the subsurface level, leading to deterioration of the walls and the ground floor log beams.

Deteriorated mortar joints were observed at the base of all exterior walls close to grade. Water and moisture penetrates through deteriorated mortar joints and saturates the masonry walls, leading to a reduction in the thermal performance of the walls. Also, sections of the walls have been repointed over the years with cement-based mortars, which restrict the breathability of the fabric. Traditionally, stone masonry buildings were constructed to breathe in order to accommodate moisture, using materials such as lime mortars and renders (Mitchell, 2007).

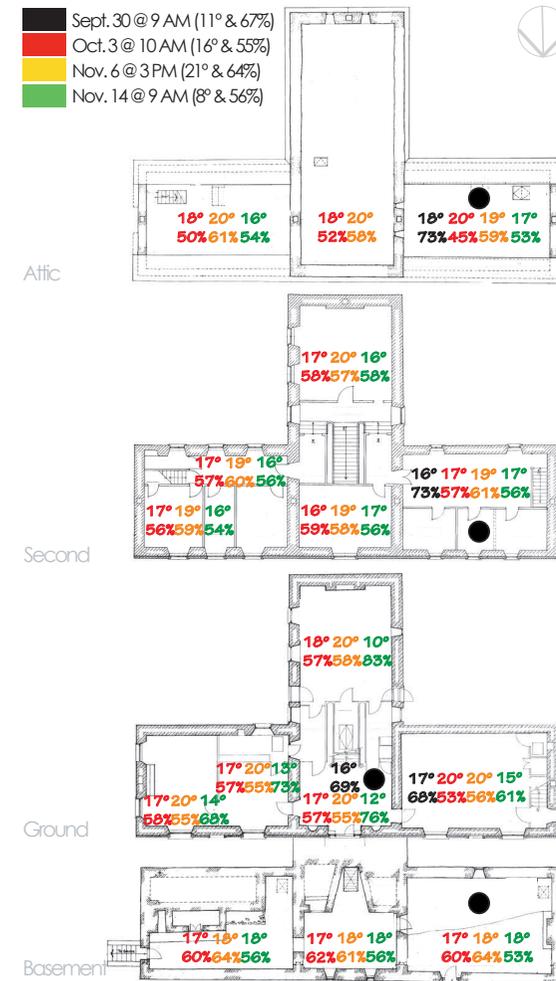
63. Plans, humidity test (Smith, add-on: Karimi)

A single-season monitoring program was undertaken with a weather station to measure the temperature and relative humidity (RH) inside the house museum. The data collection started in September 2015 and was performed once a month for three months in the morning at various rooms of the house (fig. 63). All three levels of the building had consistently high RH levels, predominantly over 50% in all rooms. The basement had the highest RH levels, never going below 60% likely due to damp foundation walls. As discussed in the previous section, moisture can be absorbed by foundation walls from the soil through capillary action and evaporate into the basement, causing damp walls and floors.

RH normally decreases on upper floors due to natural stack ventilation that assists air circulation and moisture dilution throughout the house (Curtis, 2008). Despite the standard decrease of RH above the basement level, the RH at the central wing's south kitchen was once measured at 83%. This level of RH can easily facilitate the growth of mold and other fungi on organic materials such as wood, paint, and paper. Depending on their materials, the collections can have different levels of sensitivity to RH. The outstanding challenge for most house museums is to find an appropriate level of RH for the best preservation of the content as well as the historic structure. RH is not an agent of deterioration, but an incorrect level of RH can threaten the historic structure and the collection.

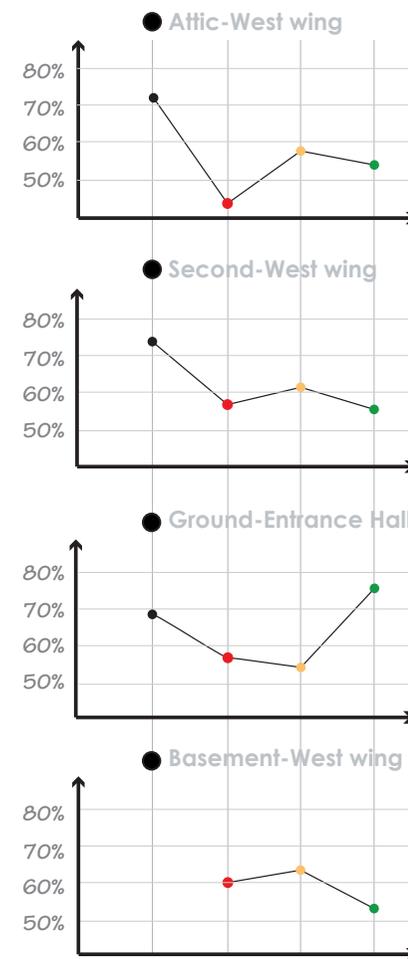
64. Humidity test graphs (Karimi, 2015)

A relatively high level of RH fluctuations was observed within a short period of time during the monitoring season. The RH ranges of one room on each level are presented in the humidity test graph (fig. 64). The RH in the west wing attic space fluctuates between 45% and 73% during the three-month observation period. A rapid change in RH causes the moisture contents of organic materials to change sharply, which in turn causes their size to alter, resulting in cracking of their surfaces (Michalski). Currently, the east and west wing attics are used for artifact storage. These attic spaces are poorly ventilated with high temperatures in cooling seasons and low temperatures in heating seasons. The temperature fluctuations result in high RH fluctuations that can be threatening to the stored historic artifacts. As Michalski points out,

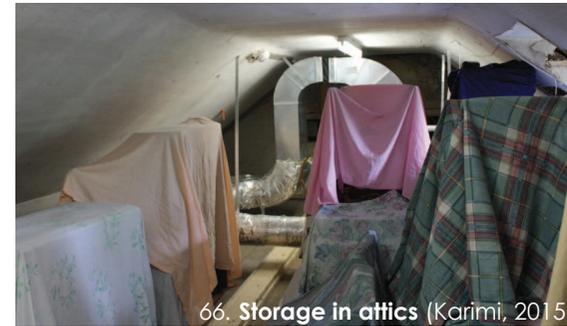
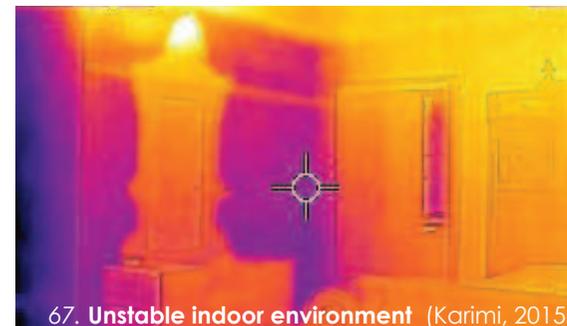
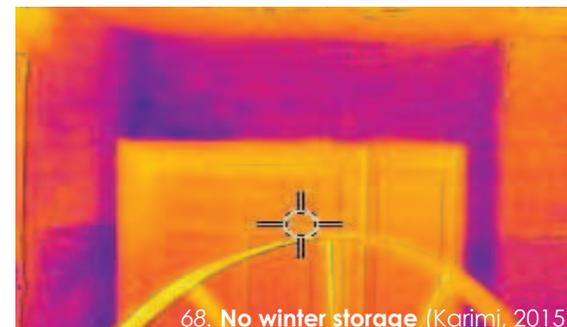
The outcome shows different ranges of colours due to different levels of either temperature or humidity on the wall surfaces (fig. 67 and 68). This can lead to condensation on wall surfaces that are in contact with the artifacts or the wardrobes containing artifacts. Condensation occurs when moisture condenses on a surface with a lower temperature compared to the surrounding air. The colder a surface, the higher the RH is adjacent to that surface (Lstiburek, Carmody, 1993). Currently, paintings are hanging on walls and furniture is positioned near the exterior walls. Based on the thermal images, these surfaces are at risk of forming condensation. Condensation can provide the environment for mold growth, leading to deterioration of the building and objects' materials. These factors can be detrimental to the preservation of the museum fabric and the collection.

Furthermore, storing artifacts in the attics increases the risk of fire hazards (fig. 66). Numerous issues contribute to the occurrence of fire in house museums, including lack of a proper fire protection system, high combustibility ratings of wood structures, lack of building compartmentalization, and storing artifacts in the attics (Baril, 1998). The 1990's restoration project implemented some fire protection measures through the house, but the attic spaces remain unprotected. Currently a large number of combustible wood furniture pieces are stored in the attics, which can potentially catch fire and spread it to the rest of the building.

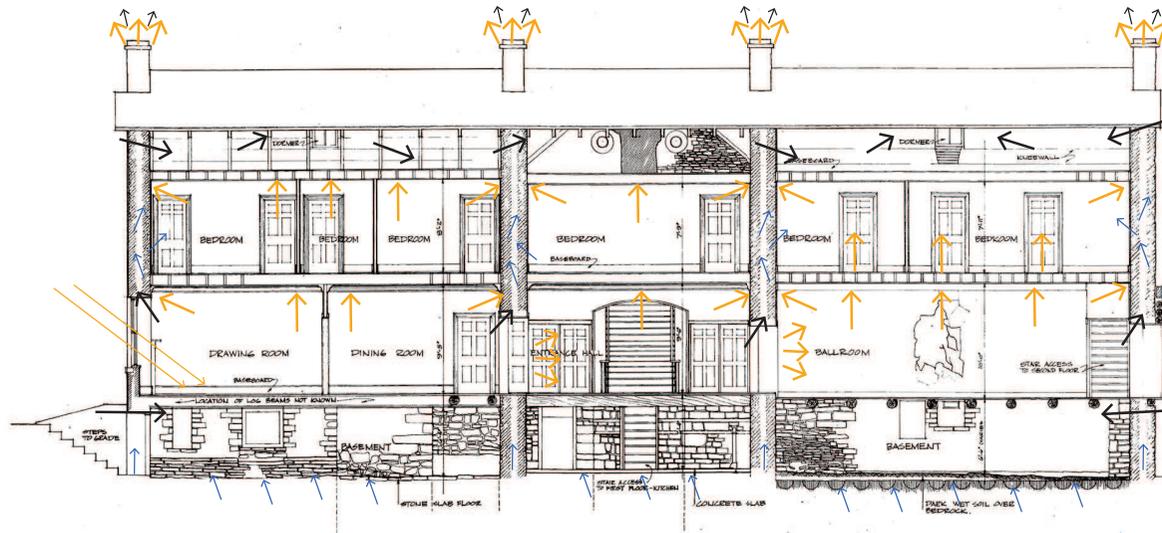
70. Section, 1820's ventilation system (Smith, add-on: Karimi)

The two section diagrams (fig. 70 and 71) show the estimated performance of the 1850's and 1990's ventilation systems. It is safe to say that the original ventilation system allowed free movement of air and moisture through the whole building, in comparison to the modern mechanical system that was designed to control partial areas of the house. Also, the air-conditioned spaces may draw moisture into assemblies from non air-conditioned spaces, which will cause periodic condensation and thermal stress in assemblies.

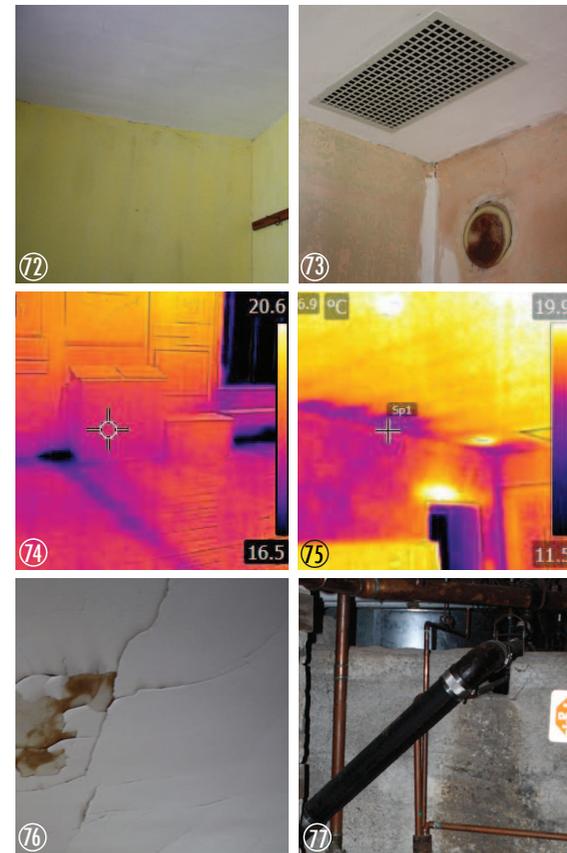
The condition assessment study detected certain moisture-related signs that can be associated with the HVAC systems. Some rooms smell musty due to a lack of ventilation, and some wall surfaces show staining and other signs of moisture damage from condensation (fig. 72) (Park, AIA, 1991). Air conditioning was installed only in a few rooms without a clear planned use of the rooms, leading to periodic condensation and thermal stress on the interior finishes (fig. 76). Also, there are some detected leaks from plumbing in the basement and other concealed areas that can cause deterioration. Some of the mechanical ductworks are lacking insulation, causing periodic condensation on the surface of the ductwork (fig. 74). The condensation can eventually cause decay in the surrounding wood surfaces.

72. **Surface staining** (Karimi, 2015)

73. **Visual damage** (Karimi, 2015)

77. **Leaks from internal plumbing** (Karimi, 2015)

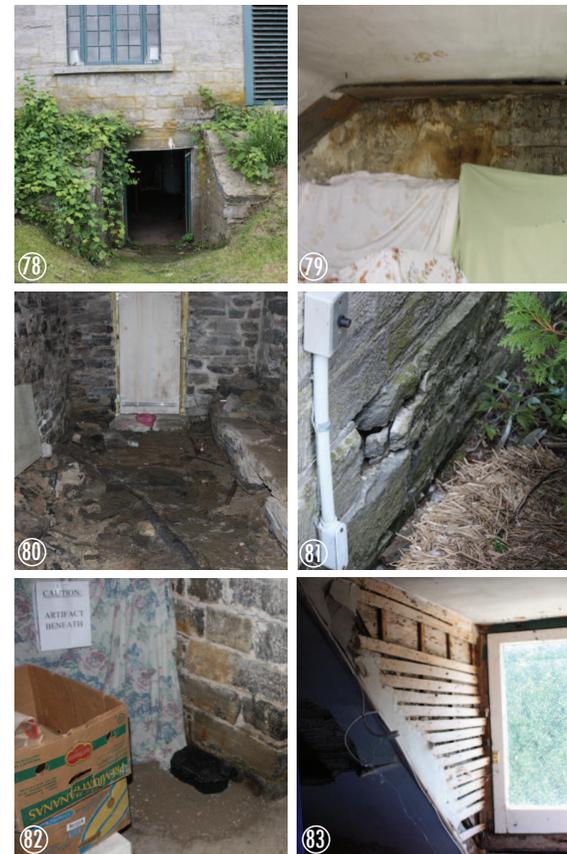
High levels of humidity and lack of air circulation can also cause pest infestation. Dampness provides an ideal environment for fungi and mold growth. The exterior north wall is suffering from adjacent growing vegetation and high garden beds, leading to moisture saturation and growth of fungi on limestone surfaces (fig. 78). The exterior end walls are saturated due to water penetration contributing to the high level of humidity in the attics. The artifacts that have been stored near these saturated walls have increased risk of mold infestation on the surfaces that are in contact with saturated walls (fig. 79).

78. Exterior vegetation and fungi (Karimi, 2015)

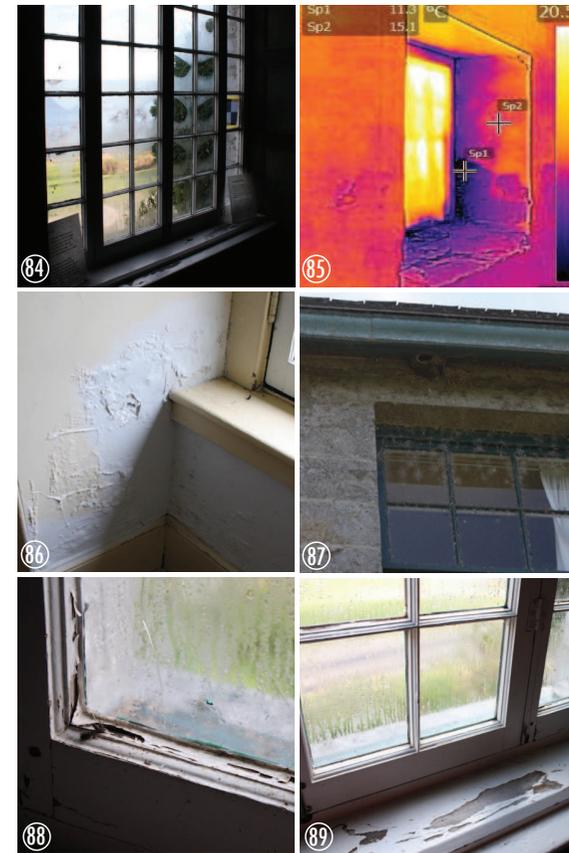
Damp surfaces occur where water in the air inside a building condenses on a cooler surface. This is usually indicative of cold spots in the building. It can also occur where there is poor ventilation or where short intense heating cycles do not allow the walls to fully warm up. This situation allows the heated air to retain more water, which condenses when the temperature drops. Maintaining a steady level of heating inside a building (15-20 degrees centigrade) allows the walls to warm up sufficiently to prevent cyclical condensation on hidden surfaces (Park, 1996). Once the paint and glazing putty are cracked or loosened, they will allow water to saturate the wood. Subsequently the windows' timber parts become vulnerable to decay where paint breaks down and exposes the timber to weather elements. Other conditions, including poor original designs, such as window sills not having drip lines, also contribute to the deterioration of the windows (Myers, 1981).

84. **Condensation on window** (Karimi, 2015)

The condensation on windows is the indication of excessive indoor humidity on cold surfaces (Rose, 1994). The above-mentioned interventions will improve the environmental extremes as well as the condensation problem. Standard window repairs such as replacement of broken glazing and damaged putty should be performed to improve the window performance. Additional thermal improvements can be made using secondary glazing; retrofitting windows with secondary glazing in conjunction with other methods such as blinds and shutters will reduce heat loss by 75% (Jenkins, 2008).

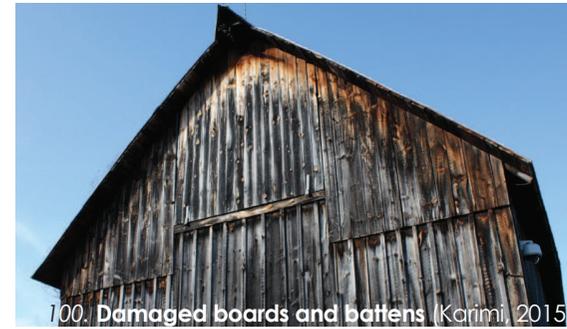
100. Damaged boards and battens (Karimi, 2015)

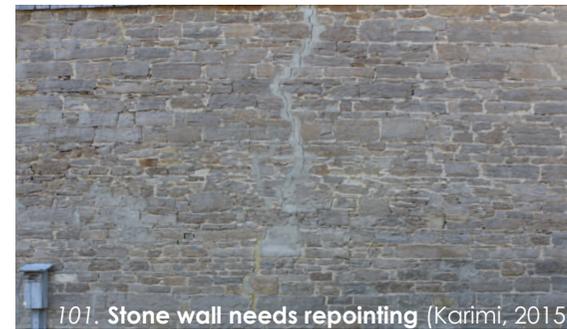
101. Stone wall needs repointing (Karimi, 2015)

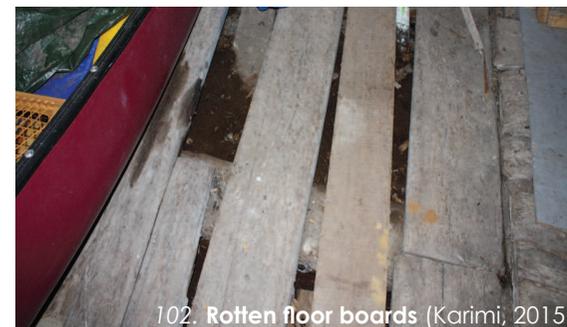
102. Rotten floor boards (Karimi, 2015)
