FAITH IN RUINS:  
CURATED DECAY FOR THE GOTHIC ARCHES  
OF SAINT JOHN

*by*  
Alice C. Fudge

Master of Architecture  
*in*  
Azrieli School of Architecture & Urbanism

Carleton University,  
*Ottawa, Ontario*

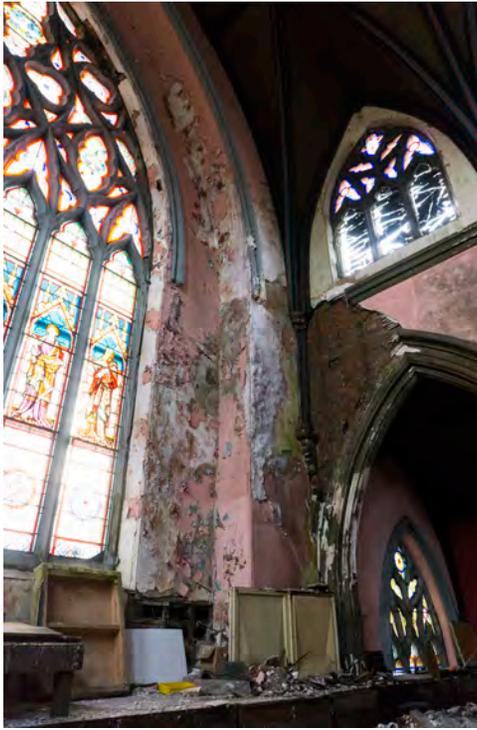
The interior condition was in an unhealthy state as a result of the moisture in the walls and basement. As expected, the vacant building was left unheated for years, and the basement

reportedly filled with water due to undrained frozen pipes<sup>1</sup>. Rot had taken hold of the plaster and decorative wood work throughout the church. Deterioration of the building advanced exponentially during its final years.

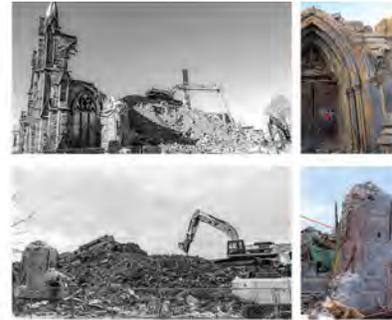
*Demolition Process January 23, 2020*

The demolition activity began the morning of December 11th, 2019 with the first pass of the excavator carving onto the tower on Wentworth Street. Over the following days the pieces of the building were gradually removed from the whole. It stood in silence as the stone, brick and wood structure was reduced to an aggregation of building material. The grand building transformed into large mounds for the machine to climb to reach the heights of the roof apex. Each phase of demolition revealed new perspectives into the interior spaces as well as the layers of material construction within the walls and space hidden by surface finishes. Many truths were revealed through each act of destruction.

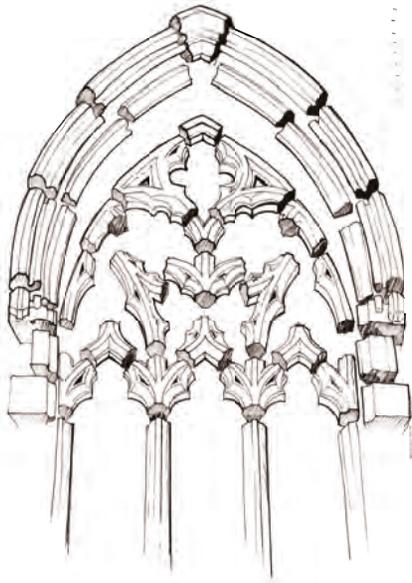
*Exploded diagram of stone tracery  
components, ink on paper  
Source: Author*

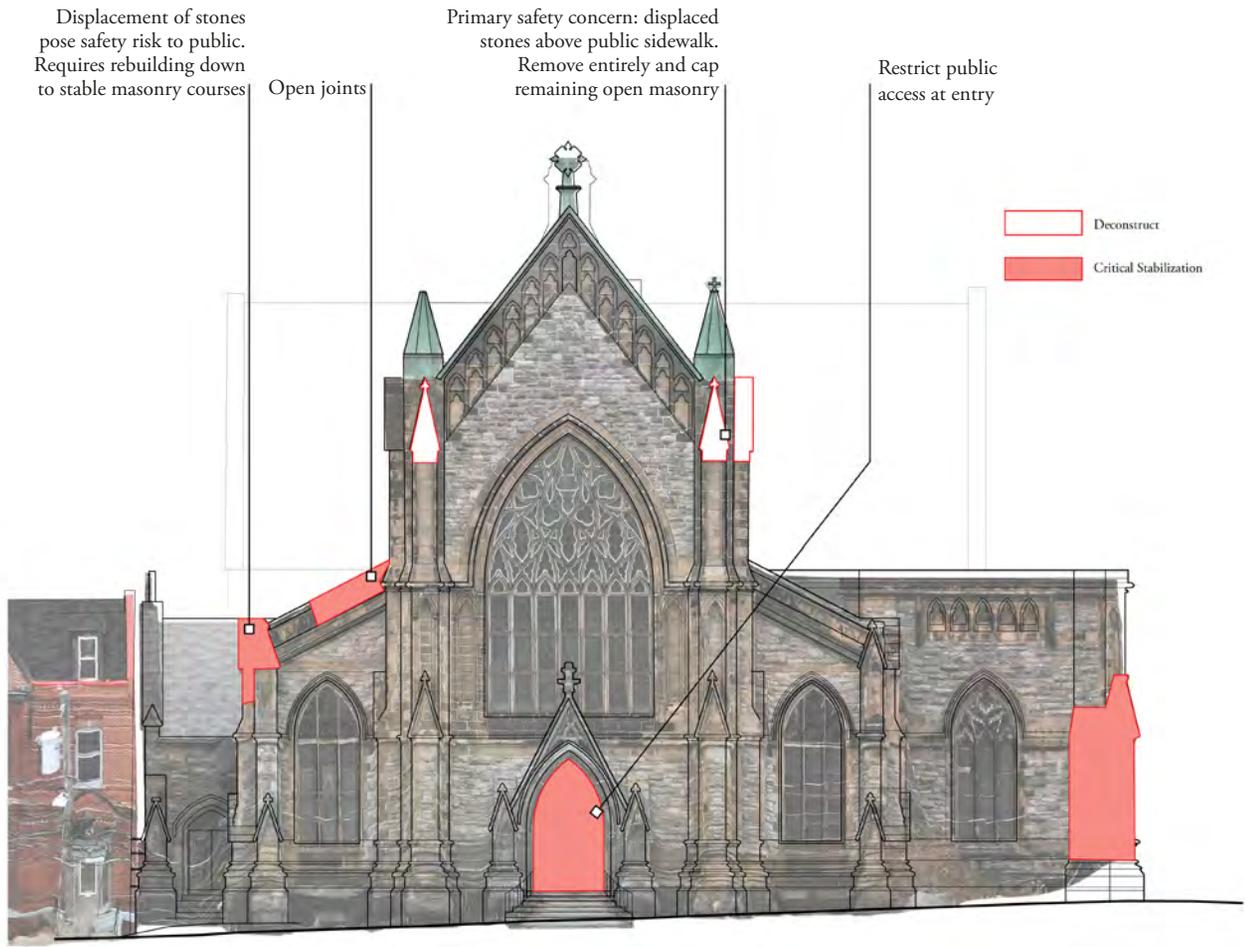
PHASE 2  
SOUTH ELEVATION DECONSTRUCTION

Open joints at Hall gable require repointing and rebuilding in areas. This is critical to reduce further deterioration

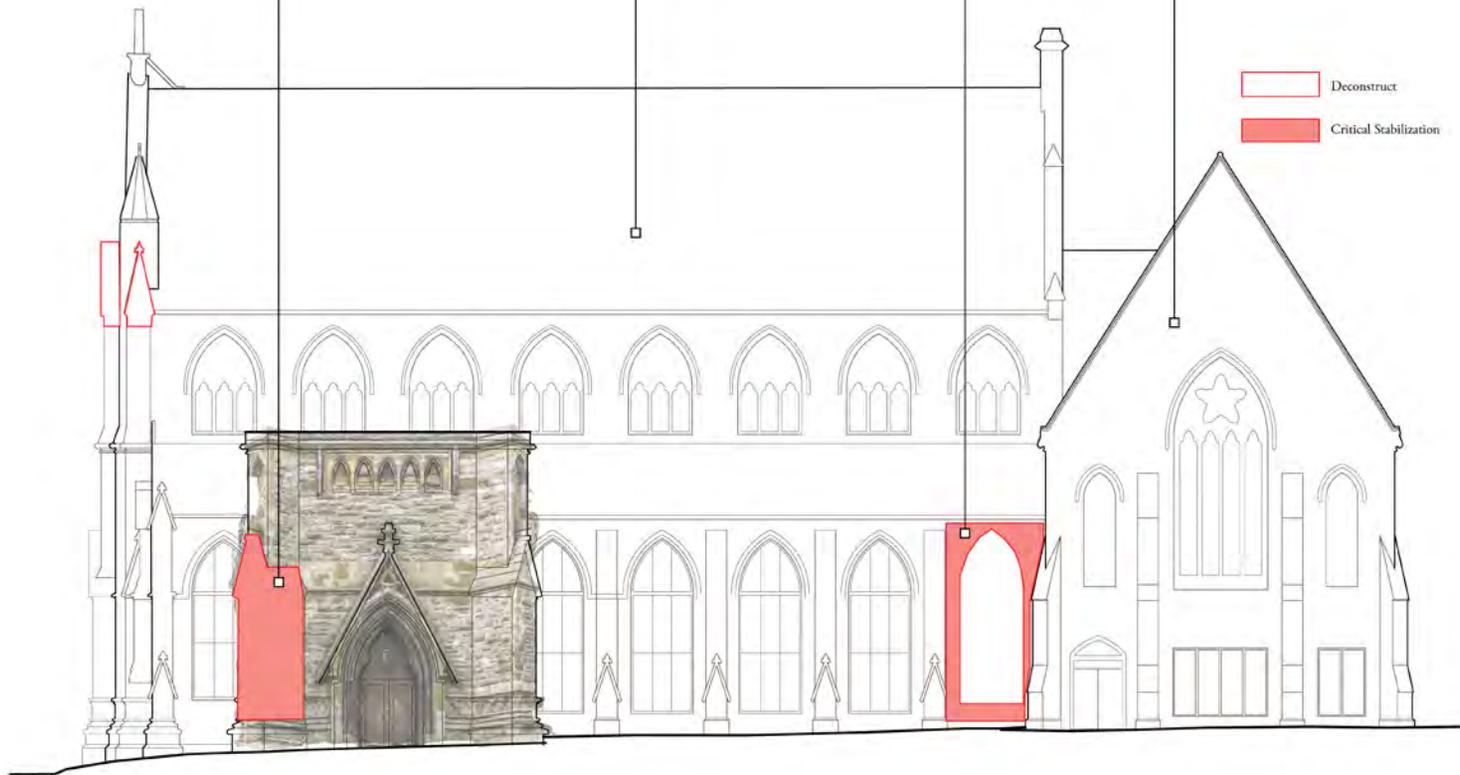
Deconstruct  
Critical Stabilization

All exposed walls will require masonry capping to mediate water ingress to interior wythes

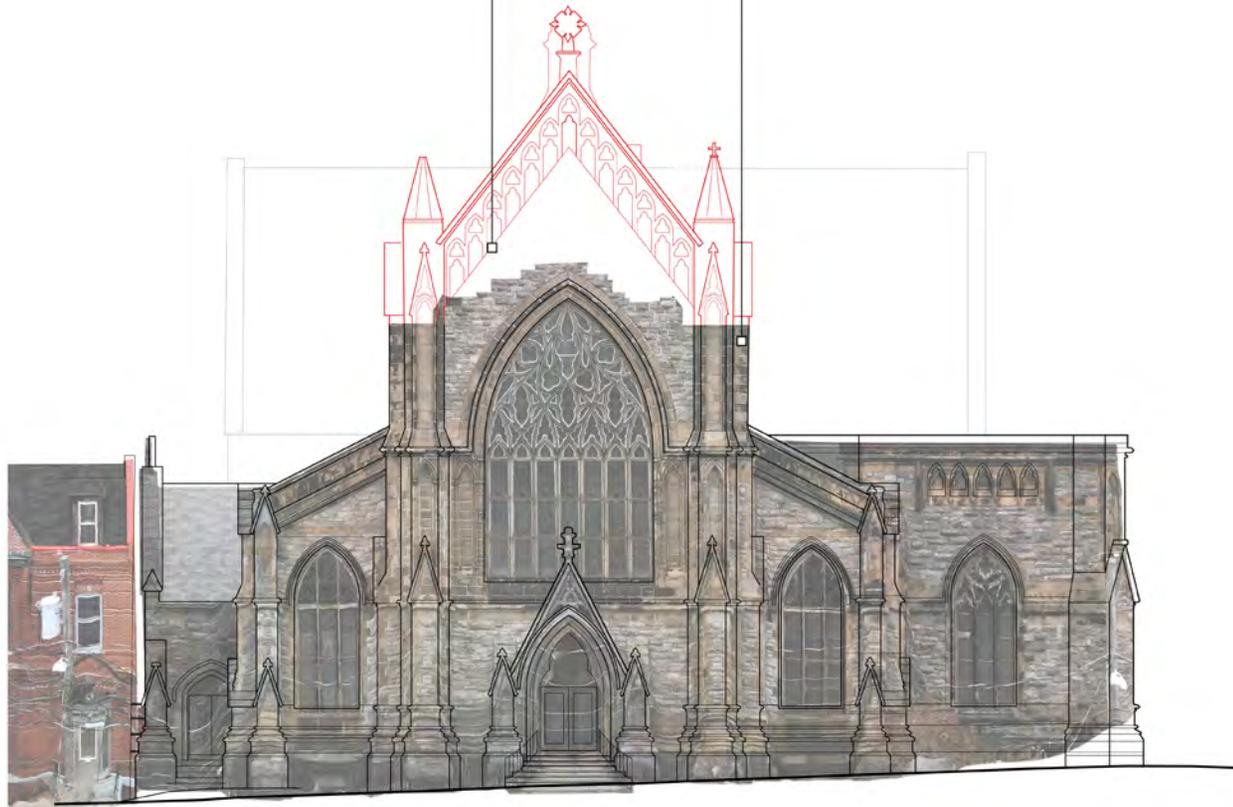
PHASE 3  
SOUTH ELEVATION DECONSTRUCTION

Continued masonry rehabilitation with replacement limestone available from deconstruction. All stone rebuilding will reestablish traditional lime mortar for joints and bedding as well as repointing where cementitious repair mortars are deteriorated.

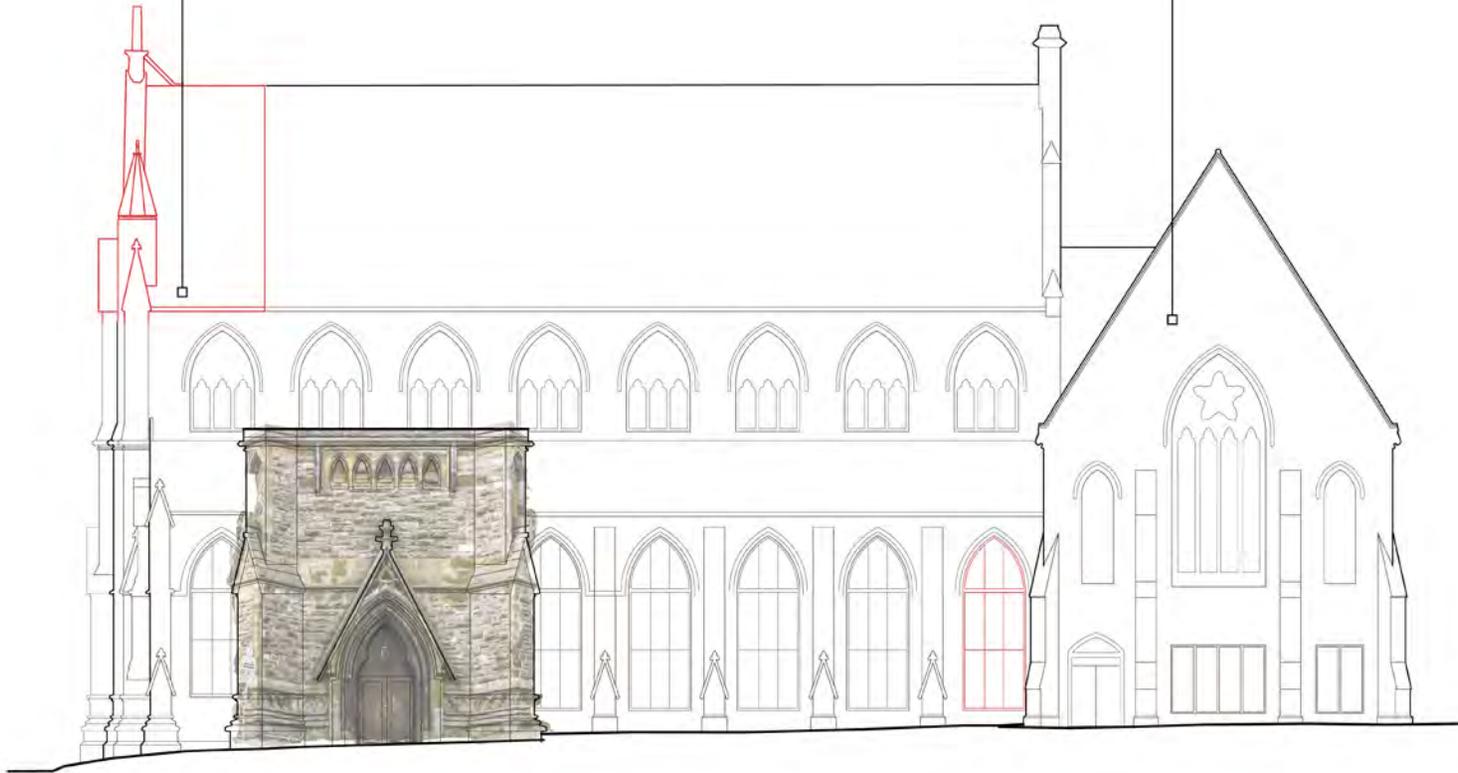
PHASE 3  
EAST ELEVATION DECONSTRUCTION

Remove all glass of primary gothic window: open air window will reduce wind load on tracery and sandstone arch. Cap open masonry.

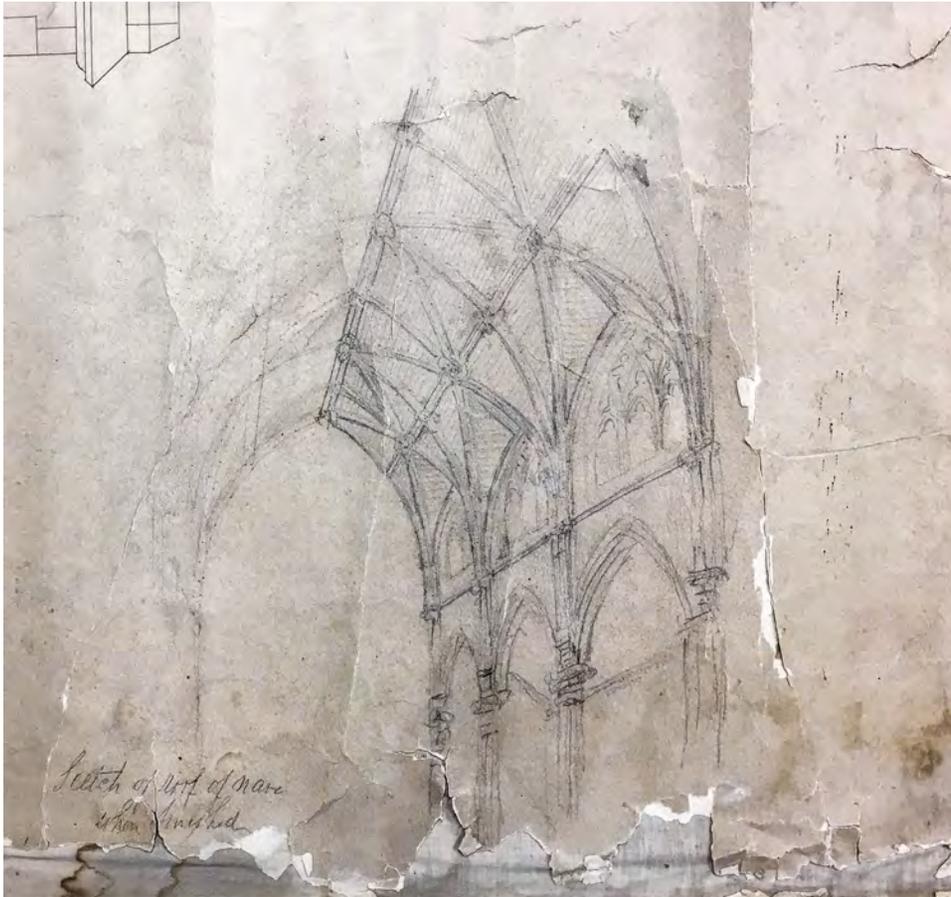
*"Sketch of roof of nave when finished"*

*Small pencil drawing at the top of an original architectural plan by the architect - an imagined finished space.  
Source: United Church of Canada Maritime Conference Archives*

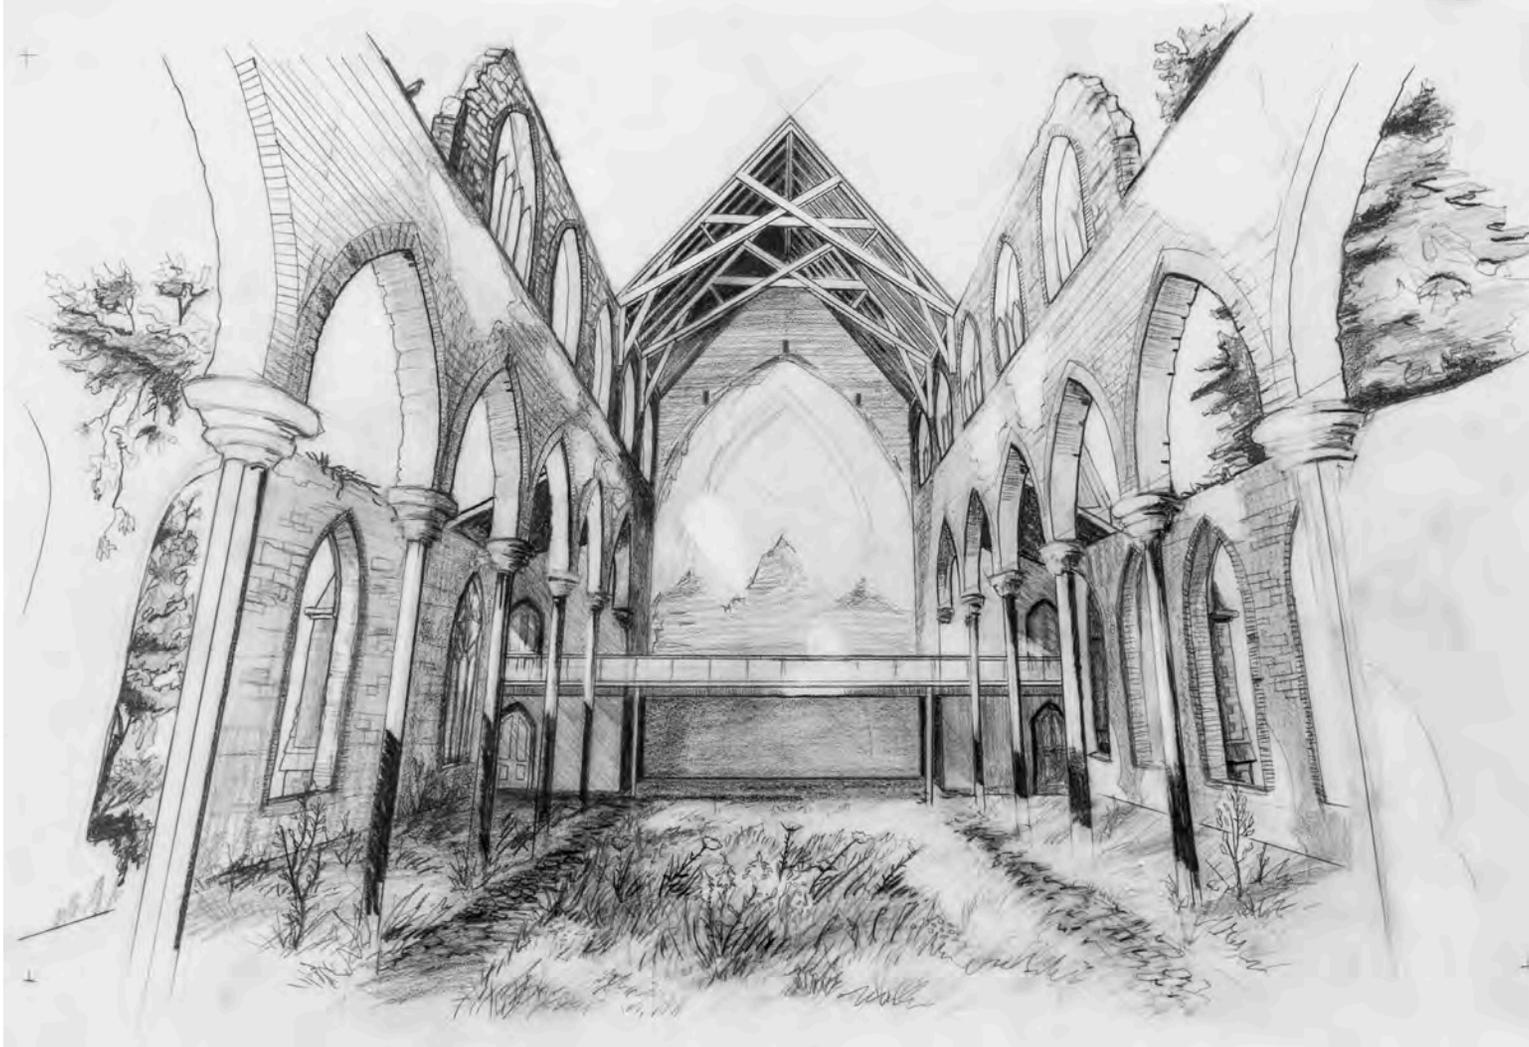
RUIN GARDEN - LOOKING NORTH

**RUIN GARDEN:** A place that is reclaimed for public use and is therefore open for citizens to enjoy. Upon entering from Princess street, through the main entrance, one is immersed in the open-air “sacred” space with a view to the remaining roof apex. There is an elevated walkway which connects the tower stairs to the west stairs for a second level view of the space. This is to be constructed of new material, steel and salvaged wood decking, to provide safe access to the site that is structurally independent of the ruin walls. From the walkway, one can look down at the garden space, which is intended to be “untamed”, which will allow for natural seeding of grasses, wildflower and even trees.

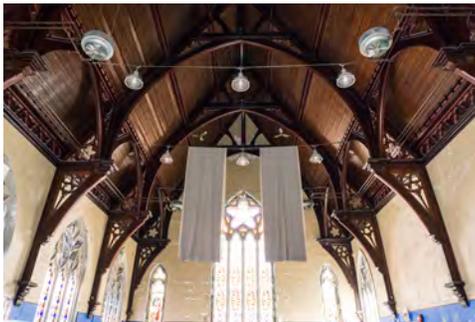
*Hall interior, December 2019*

**CENTENARY HALL:** A community space once again, the building will be rehabilitated to suit multiple purposes and provide flexibility to its users over generations. The main level is lightly renovated in plan which offers four rooms with north facing windows. The upstairs banquet hall is a grand Gothic style room that continues to impress with its hammer beam trusses and wood paneling. This second level is accessed by two stairwells which connect to the ruin. A new Viewing Porch is designed for above the former altar,

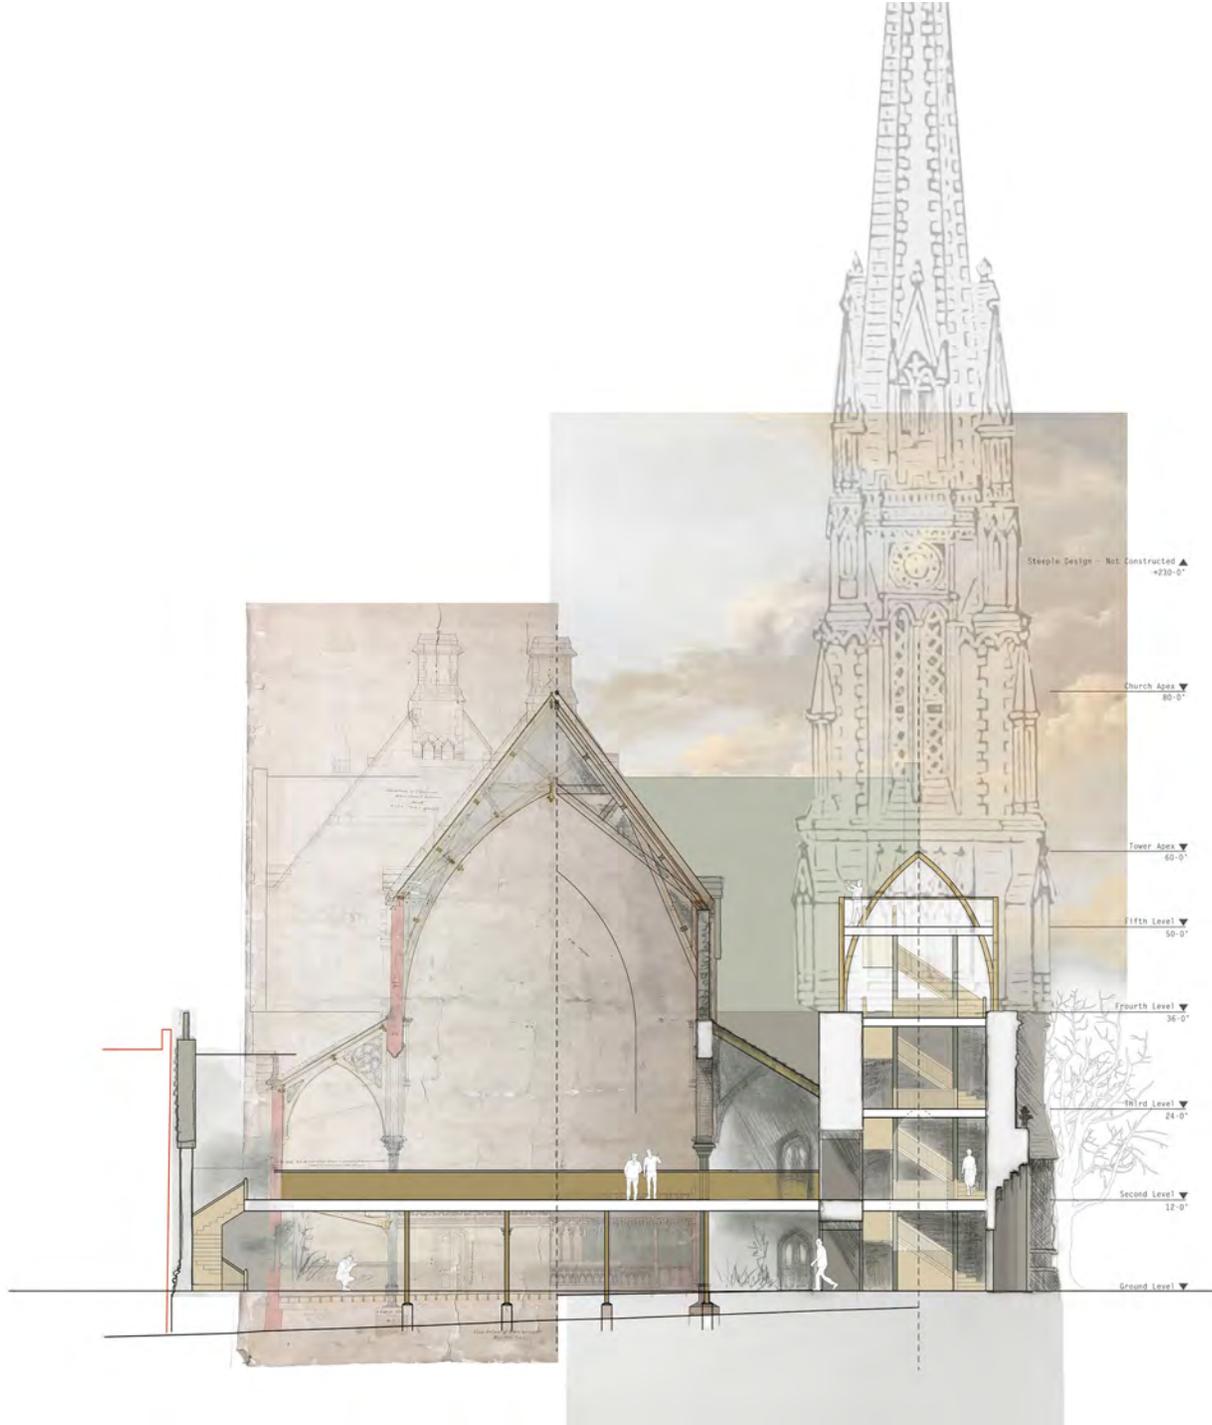
*Section through building,  
imagination and time.*

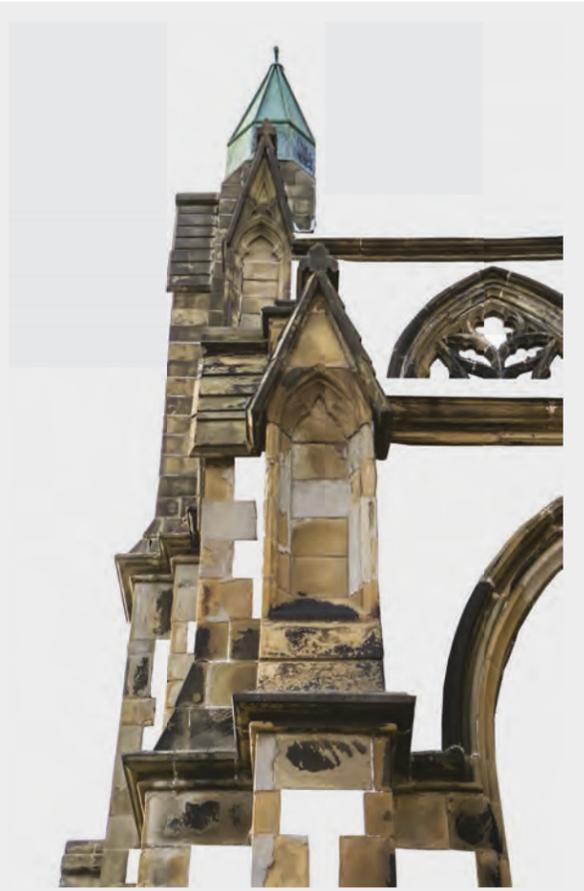
Sandstone is a sedimentary rock, sourced from Westmorland County, New Brunswick. The probable source of this stone is the Budreau quarry, which was very active in supplying fine-grain olive colour sandstone throughout NB as well as the Eastern seaboard of USA. This stone has been identified as being used for other high-gothic churches of Saint John at the same time of construction as the Centenary Methodist Church. Its appearance description is initially an olive colour from the quarry, but as the stone has aged in place, it has turned to a yellowish-buff colour. This is a high quality dimension stone, characterized as such by its lack of impurities, fine sediment grain size and large scale quarry stone.

Right: Edited photo which isolates the sandstone within its larger structural context

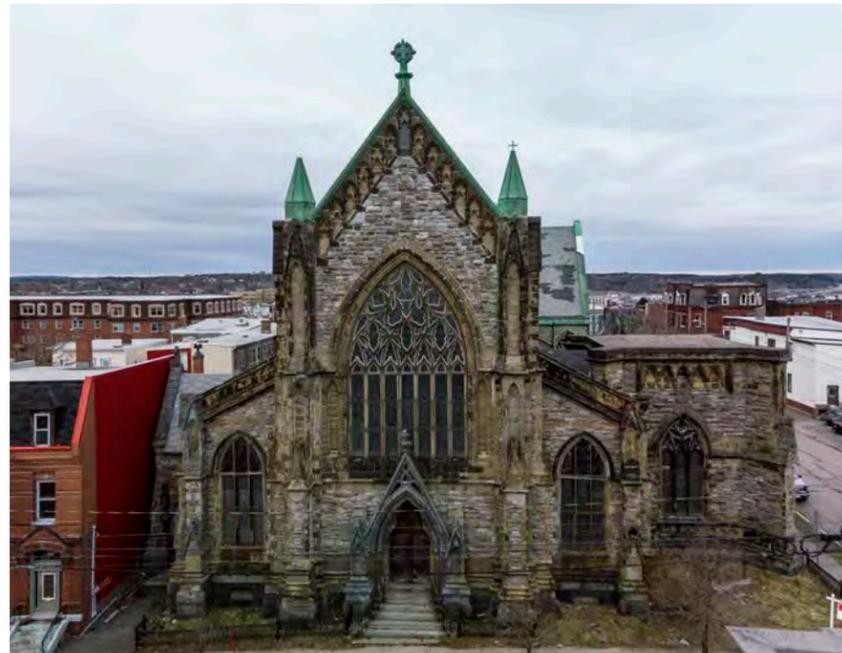
SOUTH ELEVATION

- This elevation receives full sun throughout the mid-day and is unobstructed by trees or buildings.
- Ideal drying conditions.
- The main entrance from Princess Street into the church is centrally located through a gothic arched doorway. A second recessed side entrance is to the left.

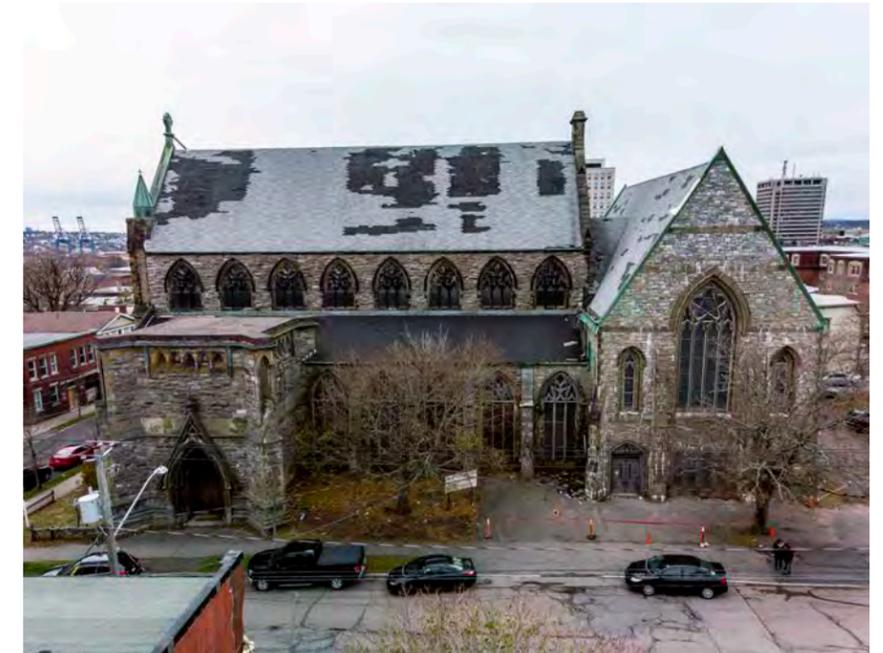
EAST ELEVATION

- This elevation receives eastern sun exposure early in the day and is primarily shaded after noon by the building's own height.
- Two mature deciduous trees located along Wentworth Street provide additional shade and wet conditions for the soil and building.
- Street facing elevation with unobstructed access from public sidewalk.
- Two building entrances; an ancillary entrance into the Sunday School Hall, and an ornate gothic arched entrance into the tower.
- Low-rise residences facing Wentworth street.

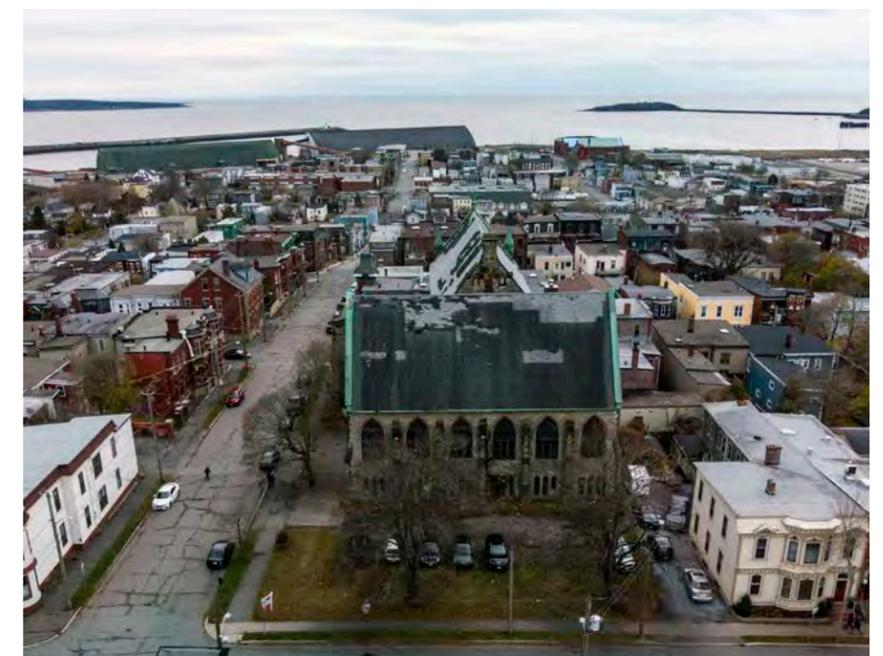
NORTH ELEVATION

- This elevation does not receive direct sunlight and is primarily shaded from height of Sunday School Hall. Commonly wet conditions.
- There are no entrances to the building.
- The open yard is an unpaved vehicle parking lot with a small driveway from Wentworth Street.
- Two mature deciduous trees which line Leinster Street and provide additional shade.

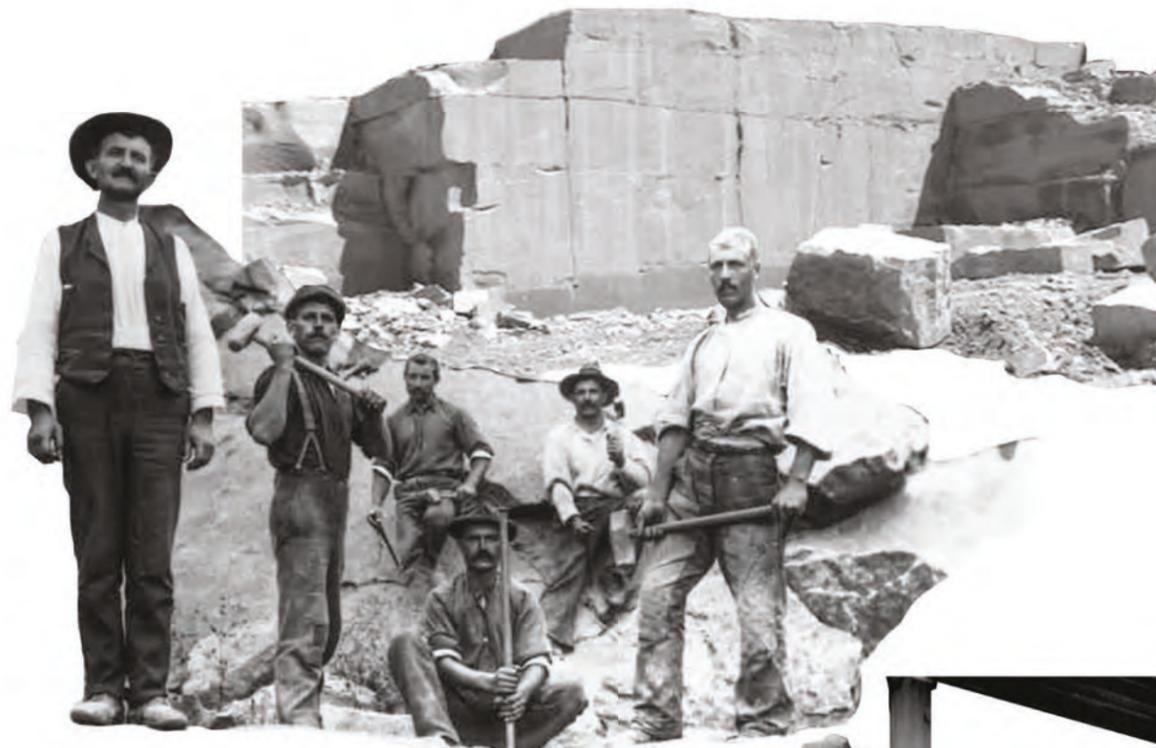
*Stone Extraction from quarry.*

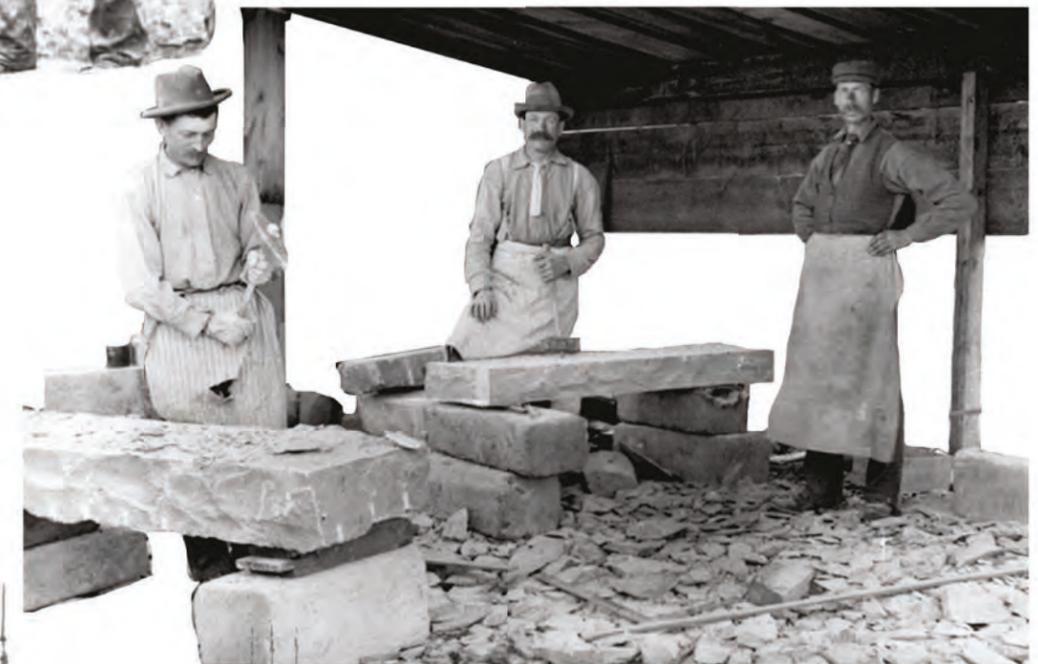
*Building Stone Fabrication.*

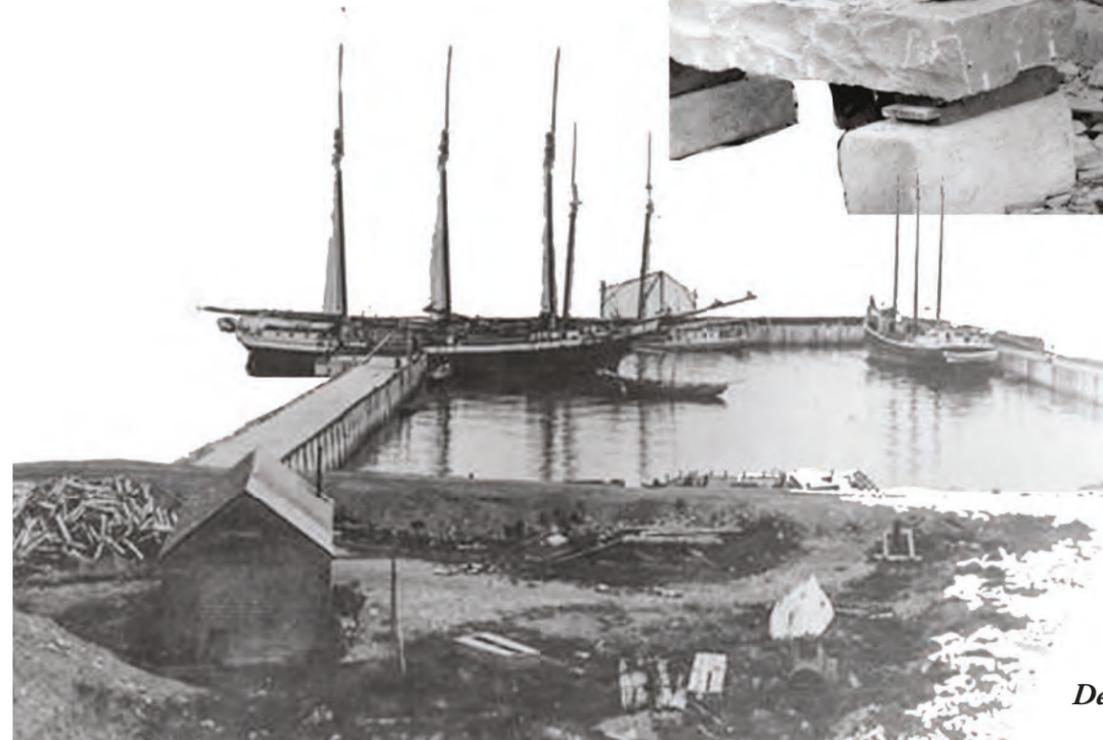
*Delivery by waterways.*

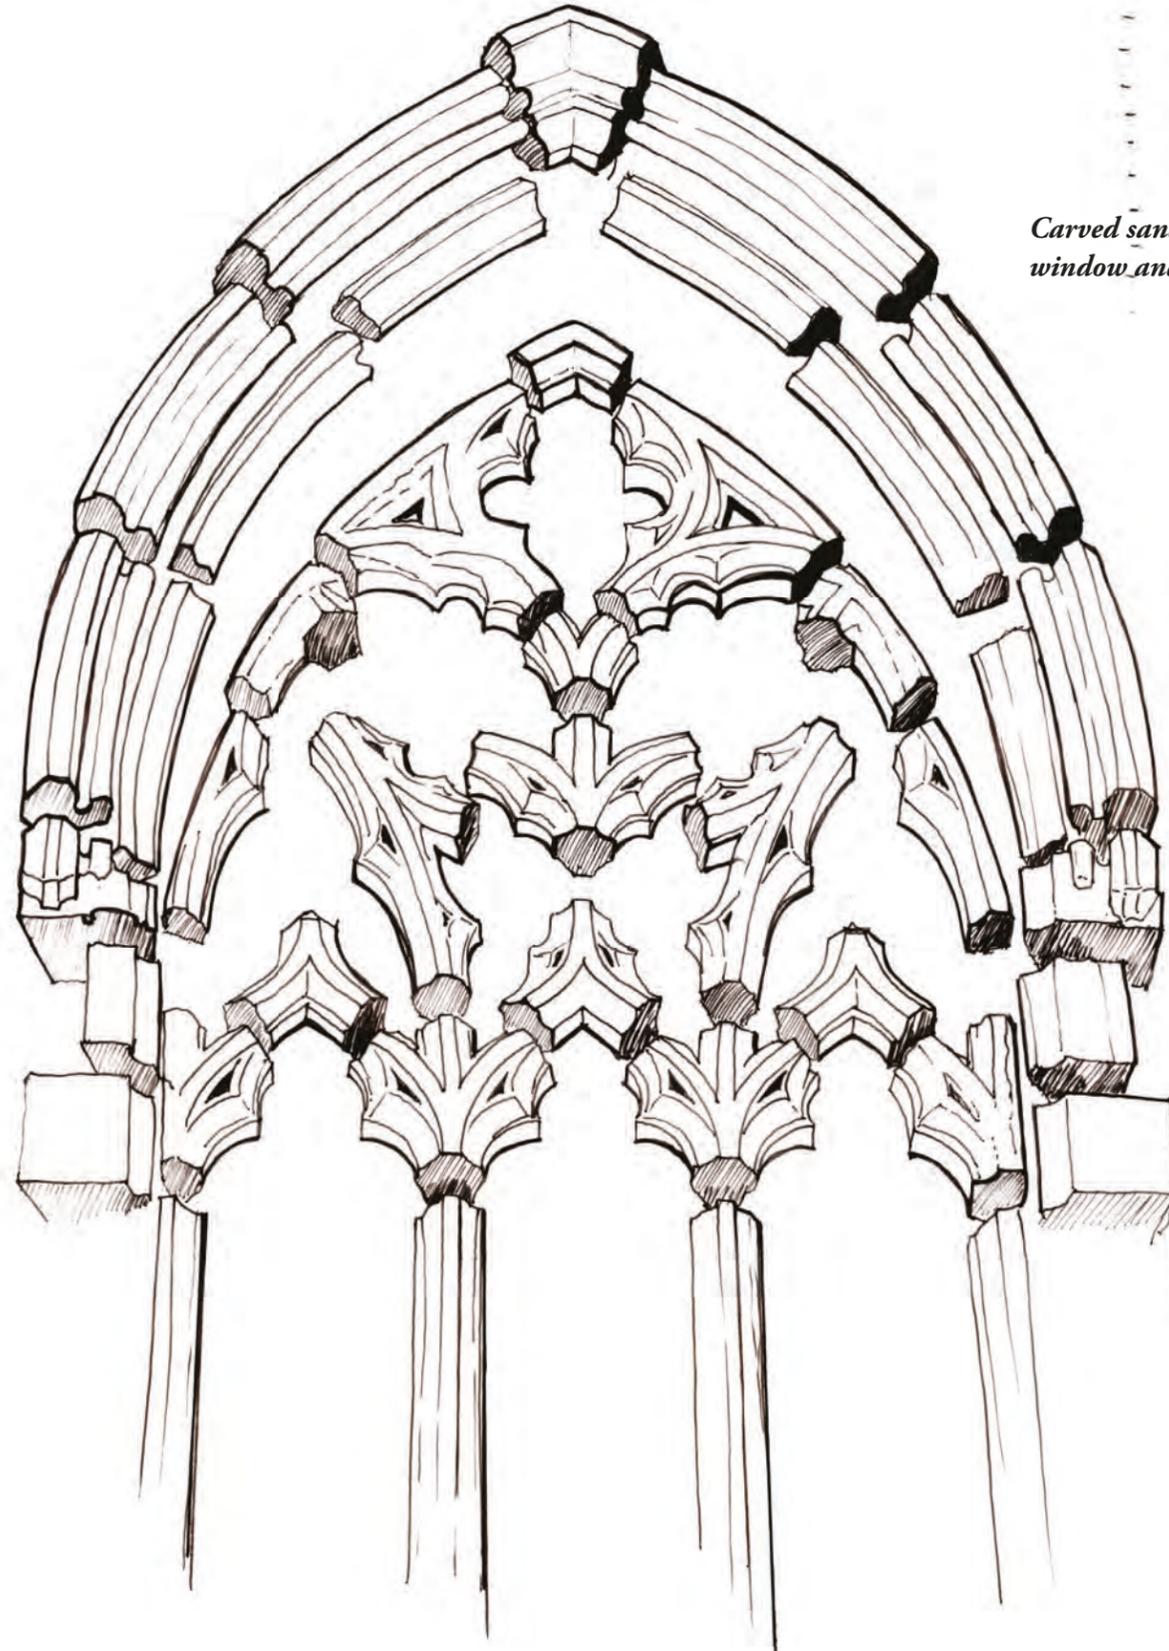
*Carved sandstone assembly of lancet window and ornate tracery*

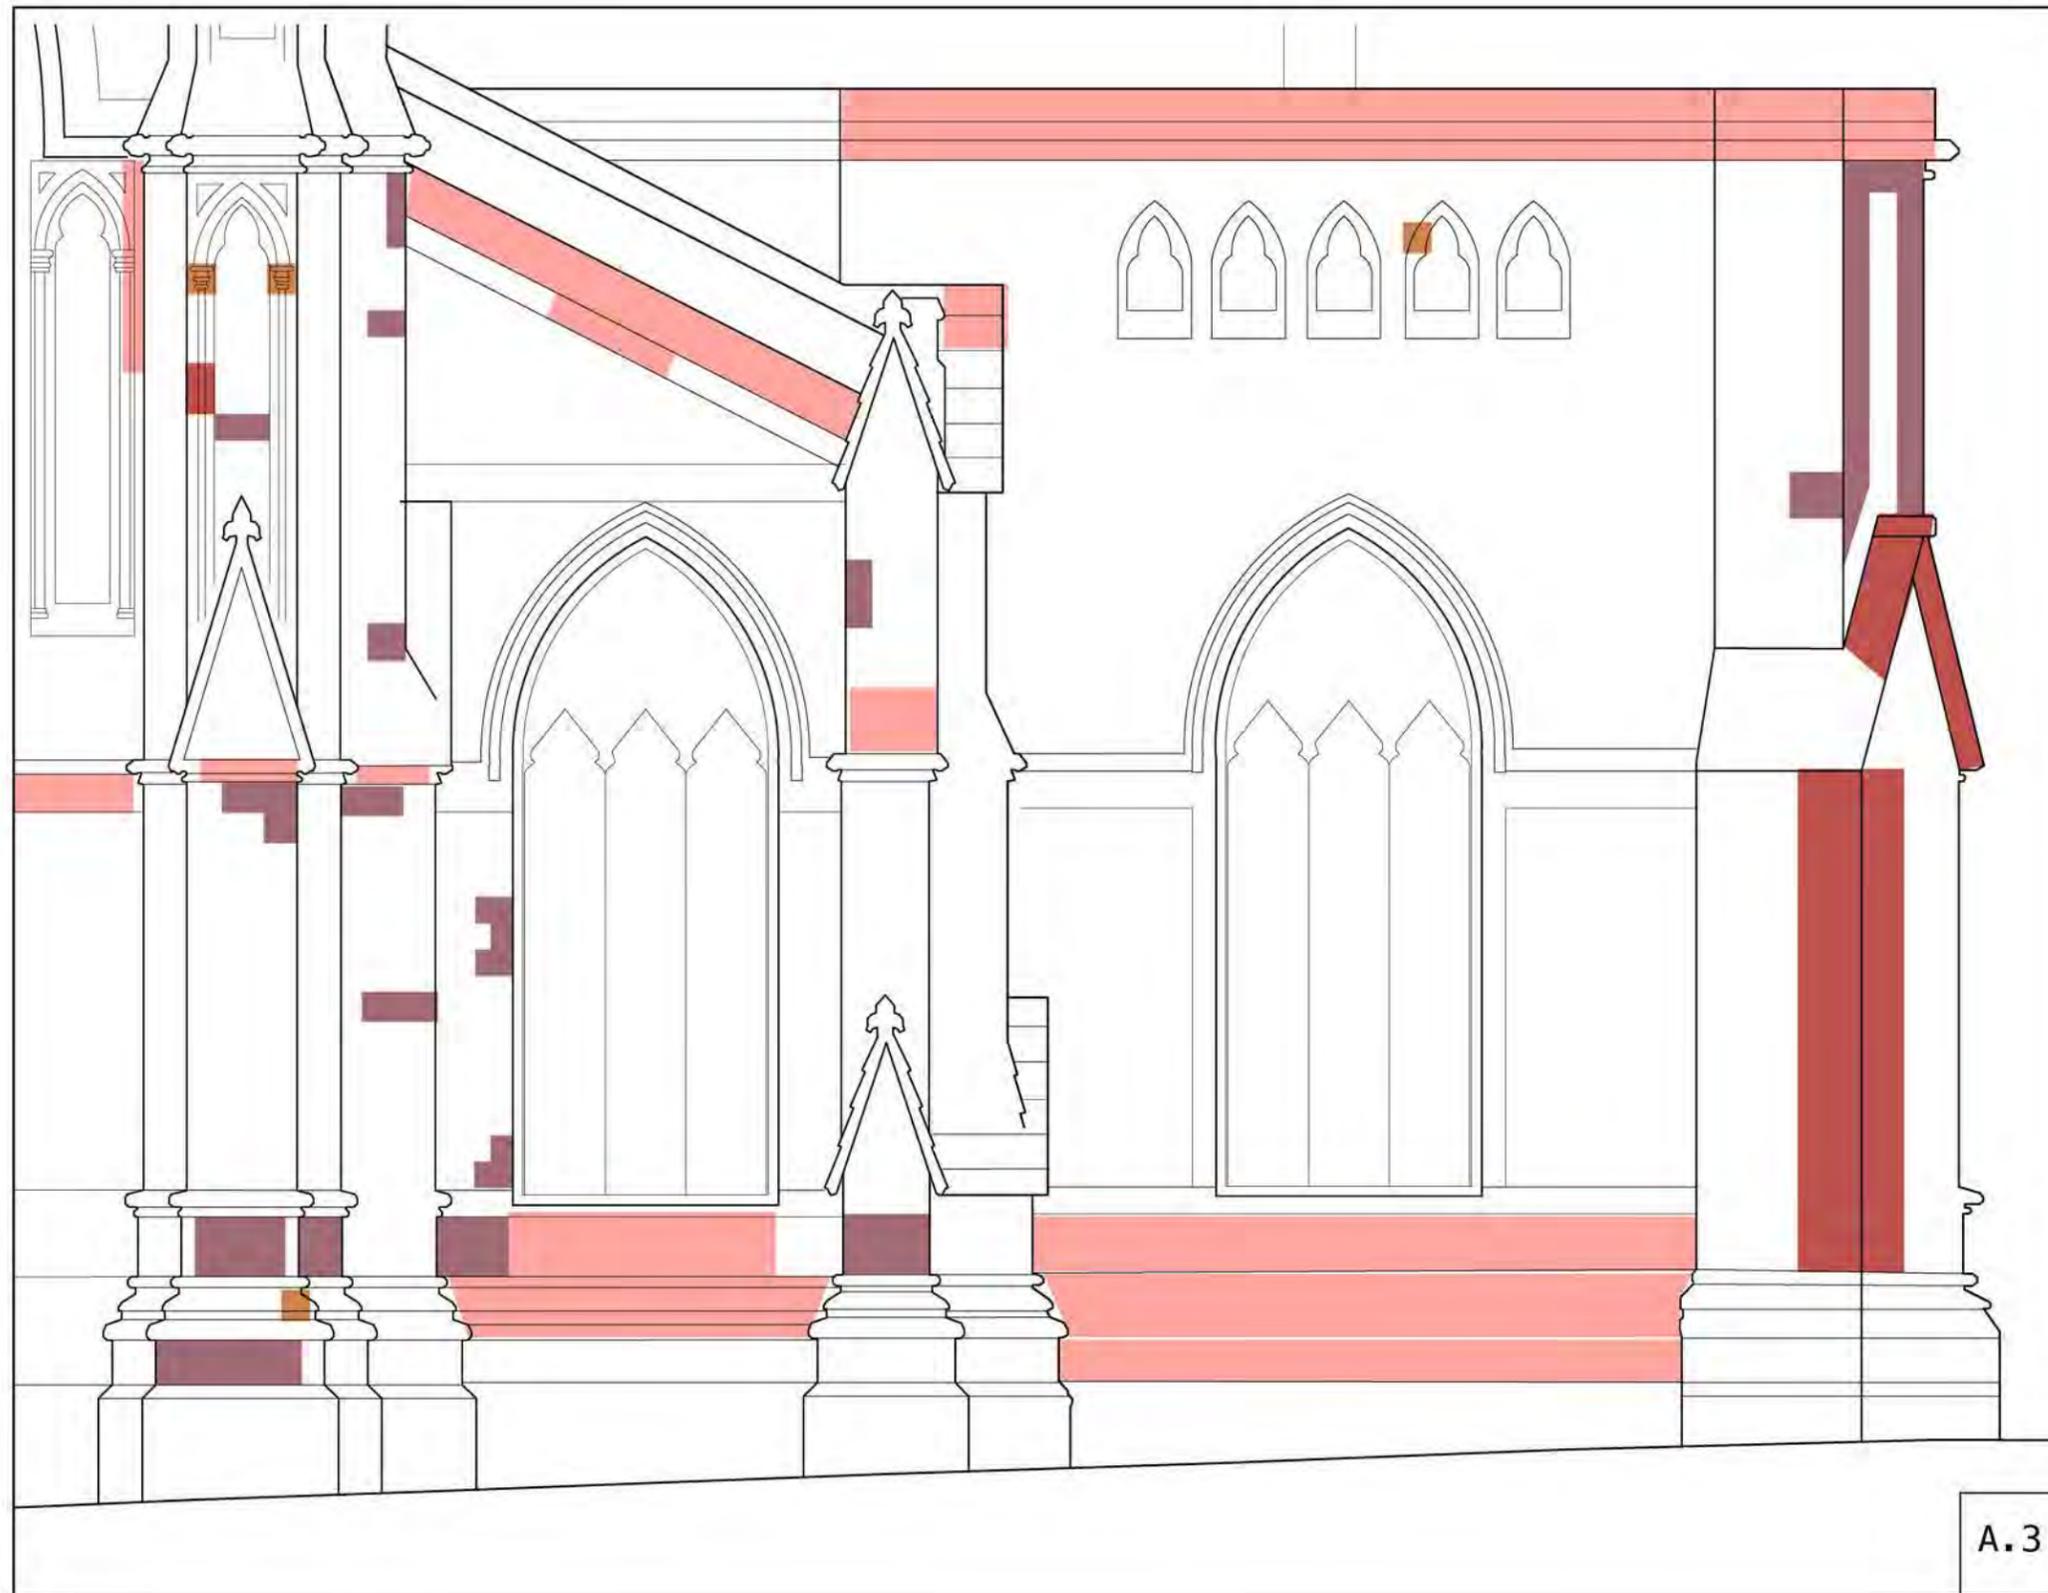
CONDITION MAPPING OF SANDSTONE DEFECTS

Caulking in joint signifies a past intervention where a “quick-fix” was implemented instead of a thorough and sensitive repair. It is likely that the mortar of the fine joints had eroded and was leading to water ingress. The caulking seals the joint however it also seals it from the necessary ability to breathe and dry the surrounding stones.
