FAITH IN RUINS:  
CURATED DECAY FOR THE GOTHIC ARCHES  
OF SAINT JOHN

*by*  
Alice C. Fudge

Master of Architecture  
*in*  
Azrieli School of Architecture & Urbanism

Carleton University,  
*Ottawa, Ontario*

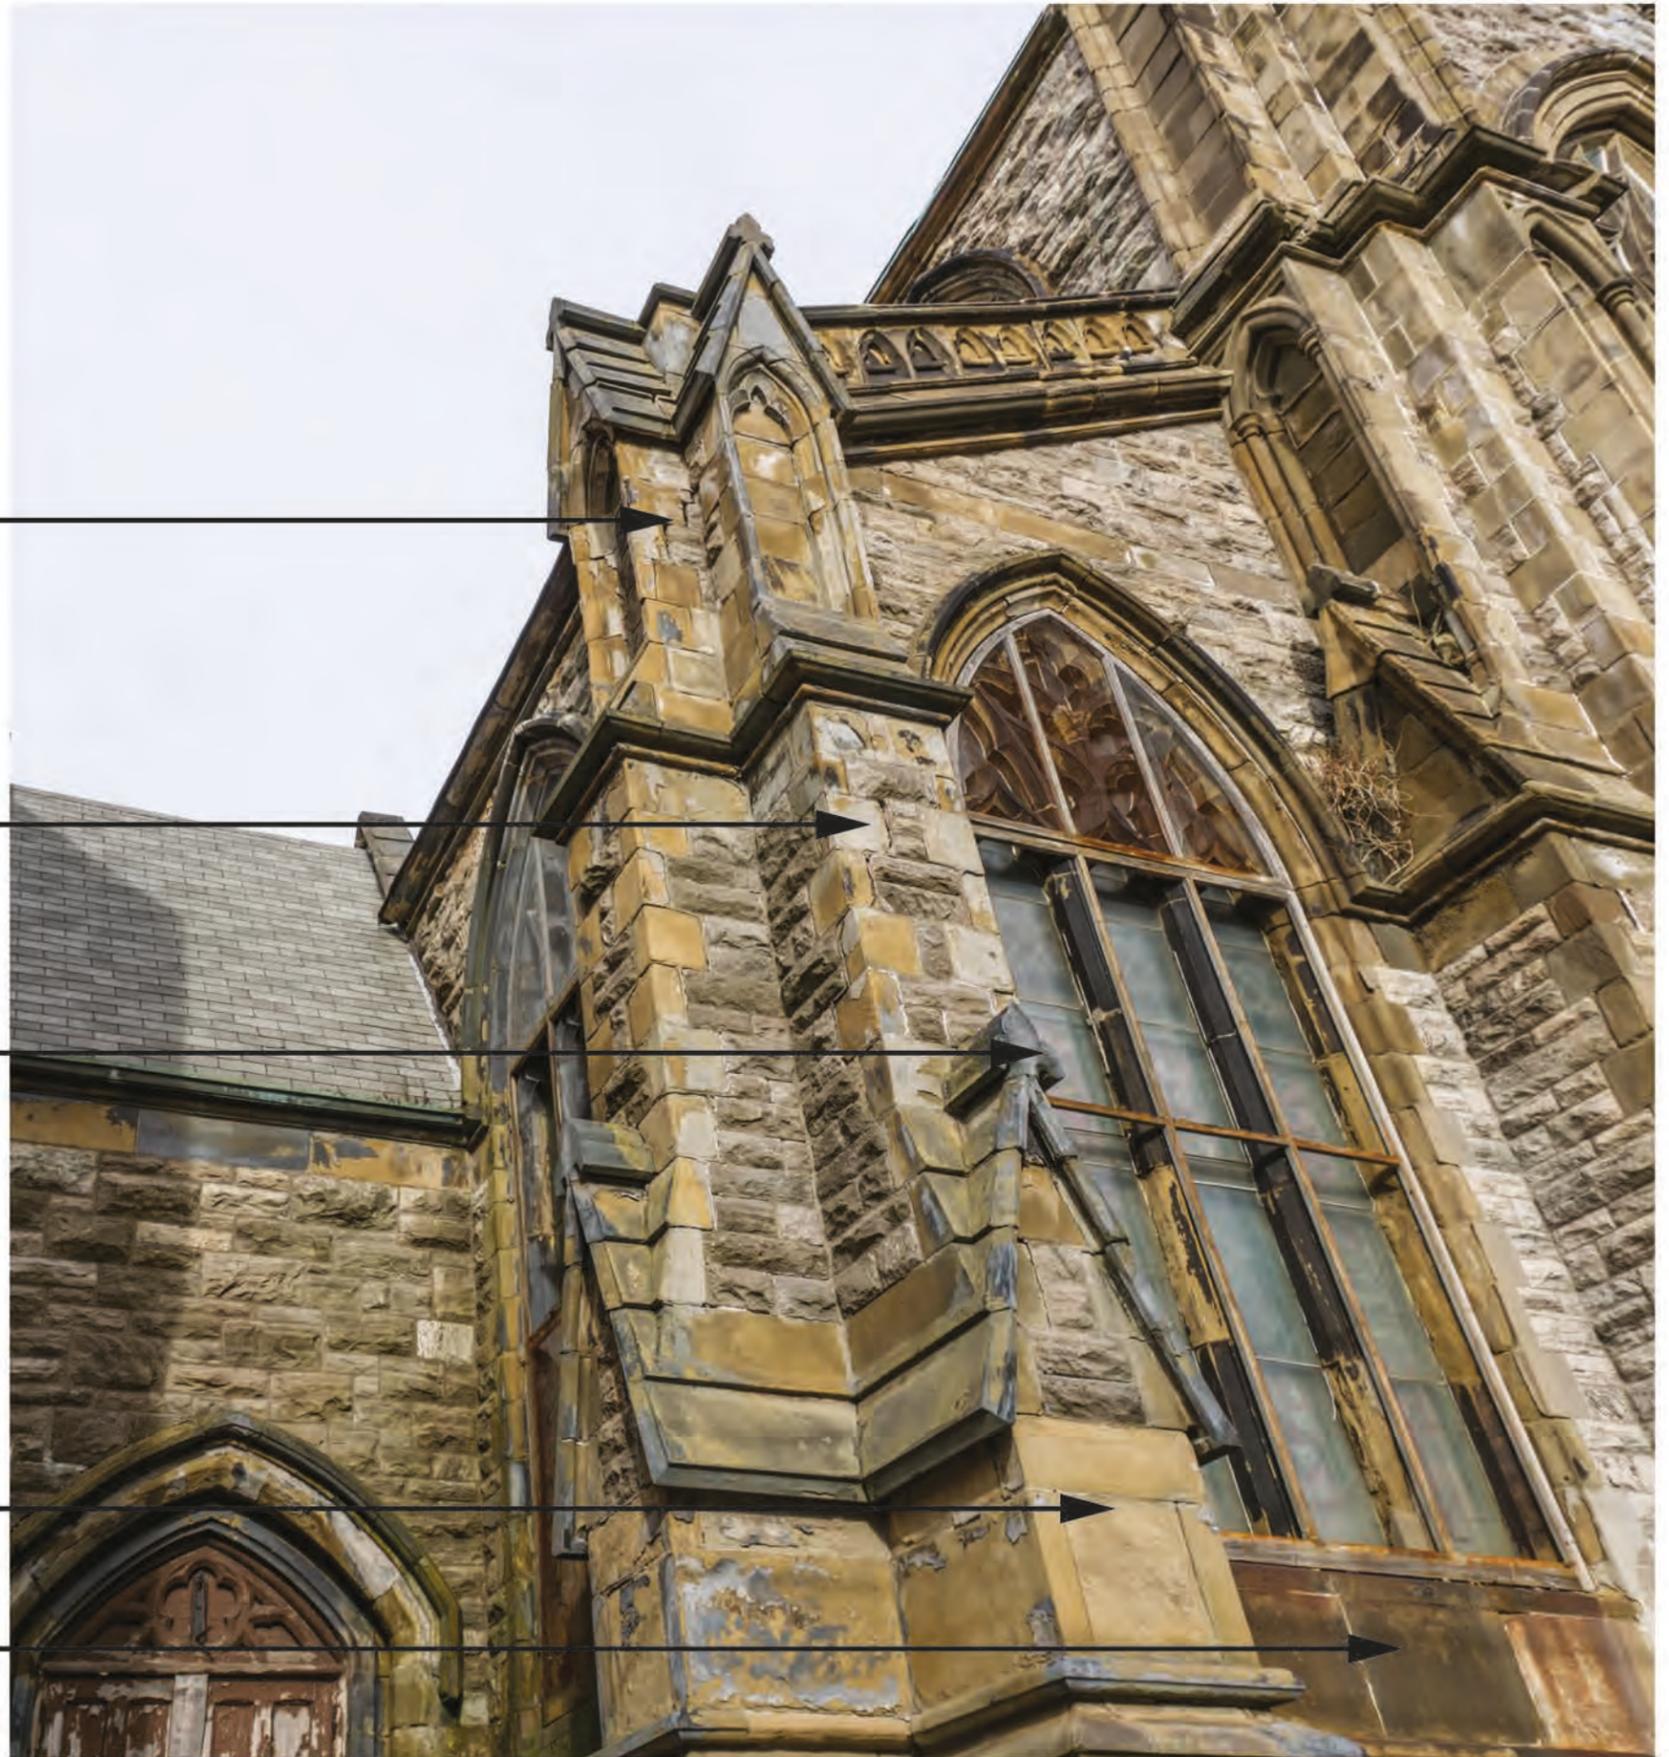
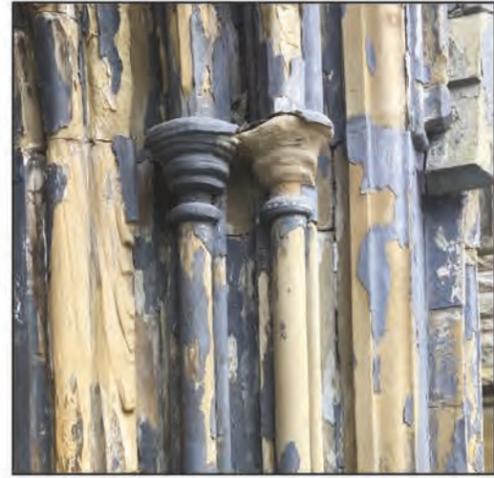
### 3. Sandstone Condition South Entrance Detail

**Paint Coating:** The entire sandstone entrance was painted with a thick coating (blue-grey colour). It is unclear when this intervention occurred, however it effected the majority of sandstone surfaces of the entire building. This coating has accelerated the surface deterioration and overall declined condition of the sandstone. As the coating itself deteriorates, it removes the surface of the stone as well, leaving it susceptible to further erosion.

**Surface Reduction:** Extensive deterioration of the sandstone pilasters. The coating has contributed to the erosion of the surface, to the extent that the form of the carving has been lost. The condition of the sandstone in this area is detrimental.

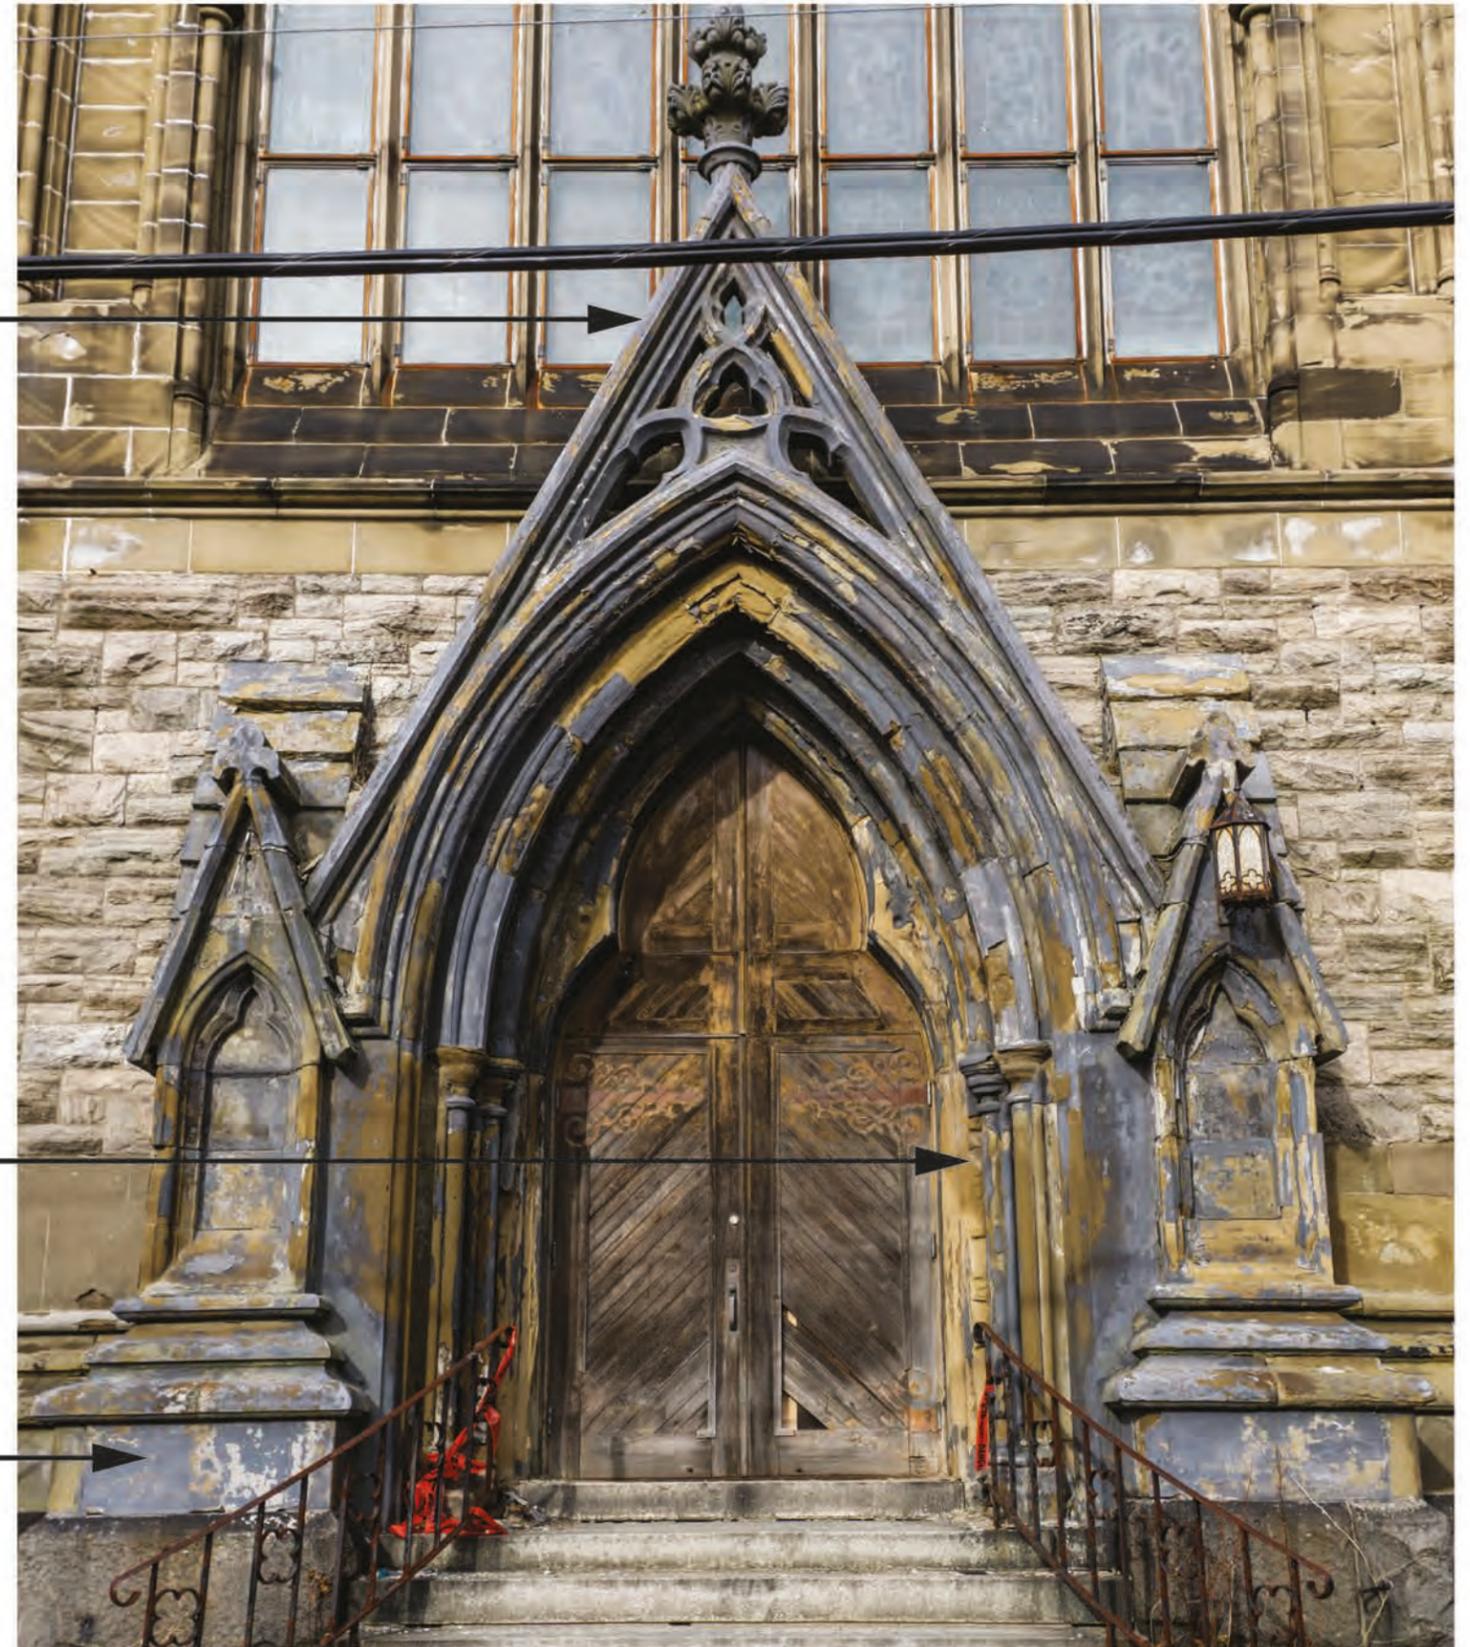
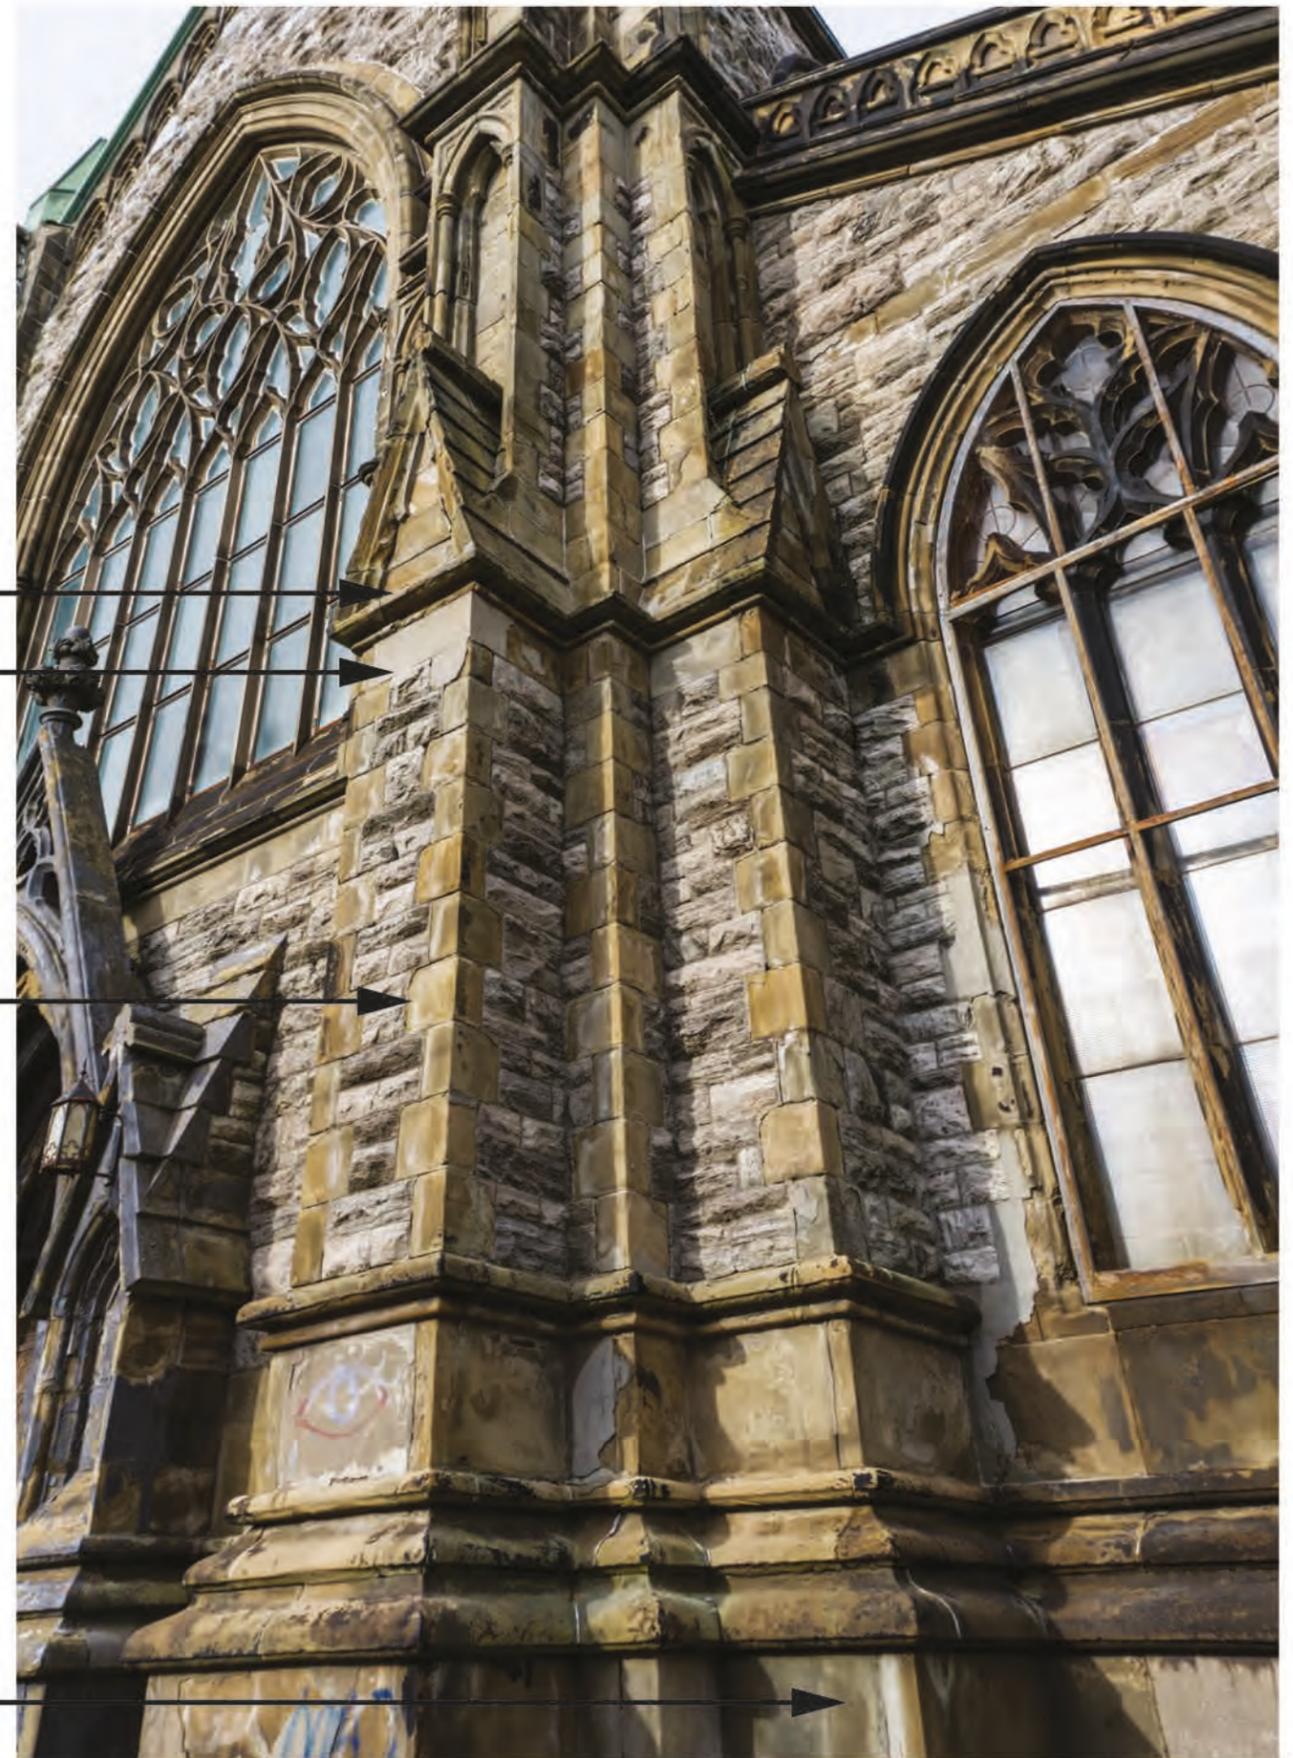
#### 4. Sandstone Condition South-east Buttress Detail

**Efflorescence:** A common condition of stone where water-soluble salts move through the stone and crystallize at the surface which causes the white salty staining.
