FIRE RESISTANCE OF PARTIALLY PROTECTED CROSS-
LAMINATED TIMBER ROOMS

A thesis submitted to the Faculty of Graduate and Postdoctoral Affairs in
partial fulfillment of the requirements for the degree of

Master of Engineering

Civil Engineering

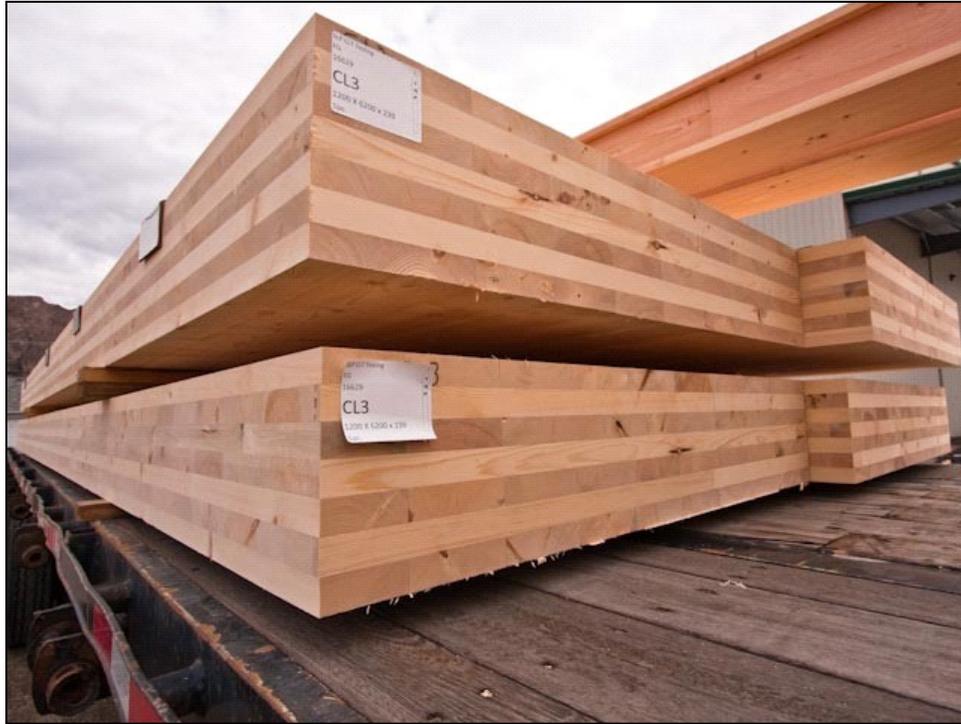
Figure 2-1: Seven-Ply Cross-Laminated Timber Planks [5]

to massive structural elements. Figure 2-1 shows the massive CLT panels that can be manufactured.

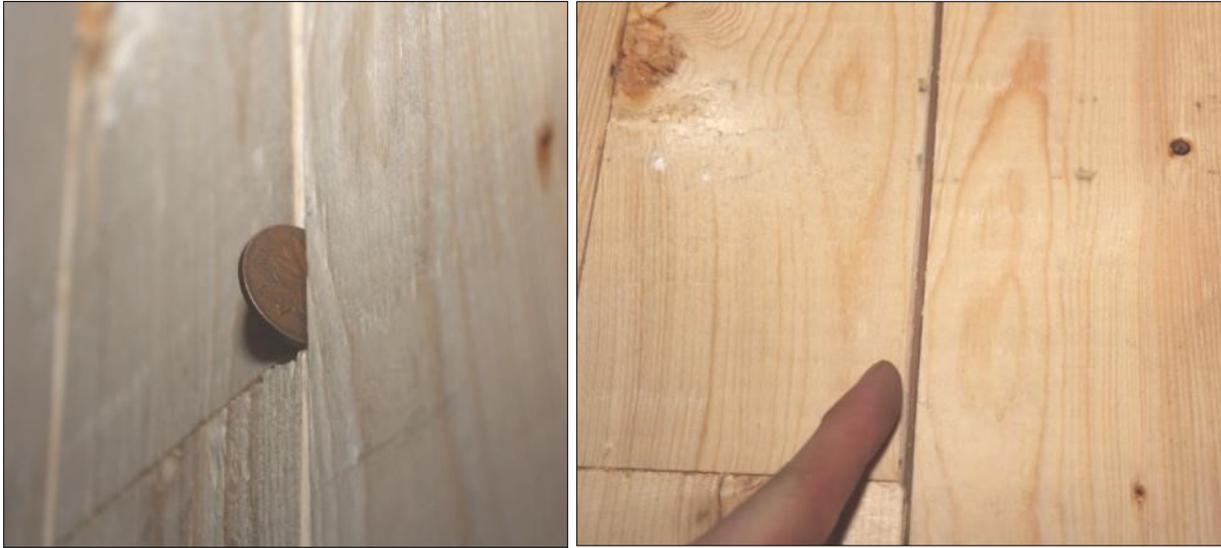
Figure 3-9: Panel imperfections due to uneven drying of the wood

Given the nature of the material, wood is prone to having imperfections such as knots, warps and inconsistencies in the grain. The panels used for the test room had some imperfections such as cracks on the surface of the panels as shown in Figure 3-9. This was mainly due to non-uniform drying of the wood surface due to the low relative humidity present in the lab during the winter months. Other imperfections were due to shipping of the panels to the facility as well as the handling during the construction of the rooms. These minor defects could compromise the integrity of the first CLT ply and contribute to accelerated charring in the gaps and cracks

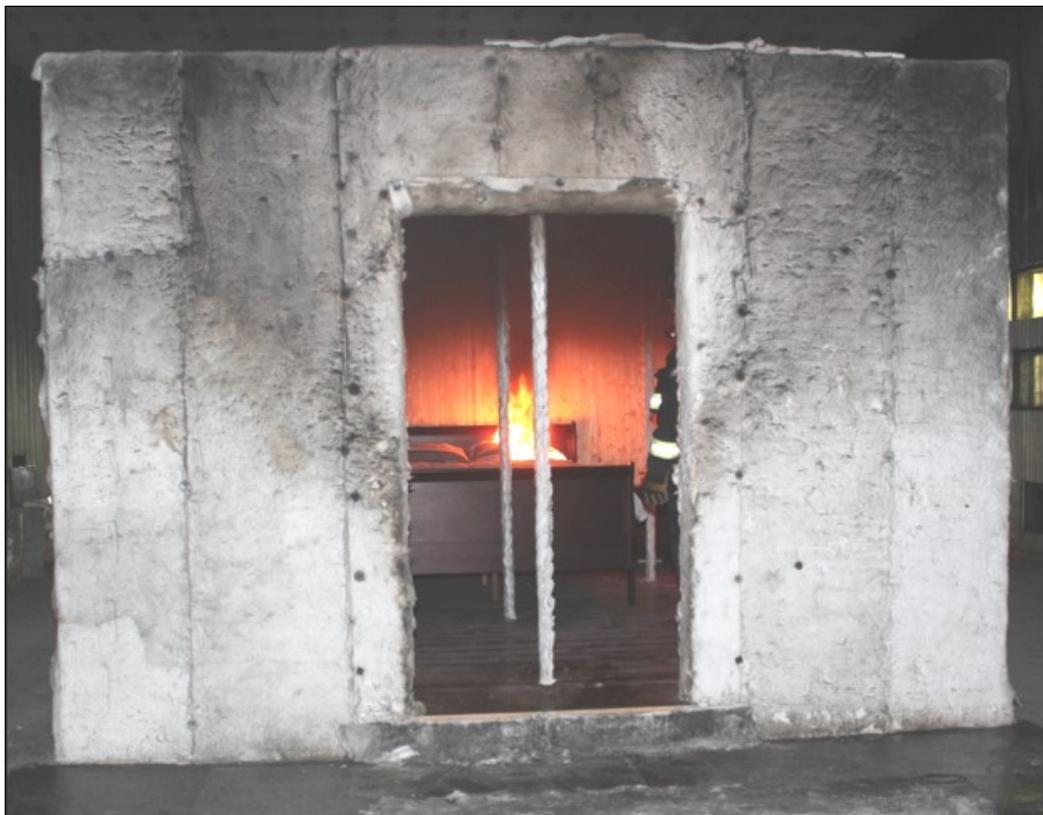
Figure 3-10: Front View Fibrefrax protected façade and thermocouple trees during Test 1

The door opening of the room was also protected, in particular along the top half where flames were expected to exit during the test. Protecting the exterior of the room from burning ensures that the measured Heat Release Rate data is only from the fuel inside the room. Two layers of ½ inch type X gypsum board covered with a layer of 1 inch thick Fibrefrax ceramic insulation were used to cover the door frame as well as the entire exterior façade where the door opening was located. The covered room façade of Test 1 can be seen in Figure 3-10

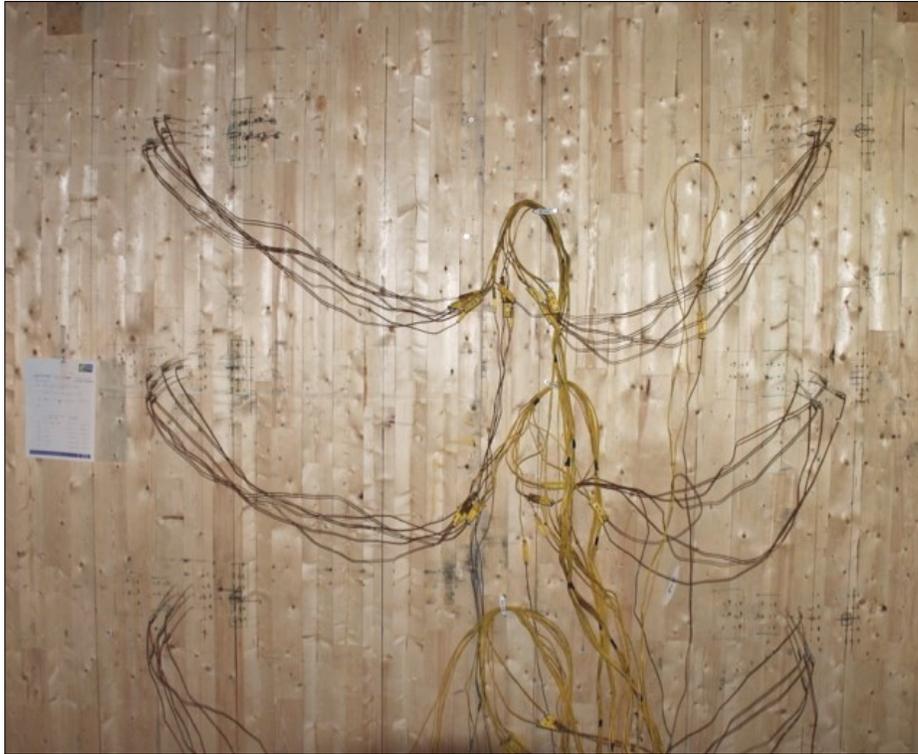
Figure 3-12: Six thermocouple wall groups measuring the internal temperature of an unprotected wall

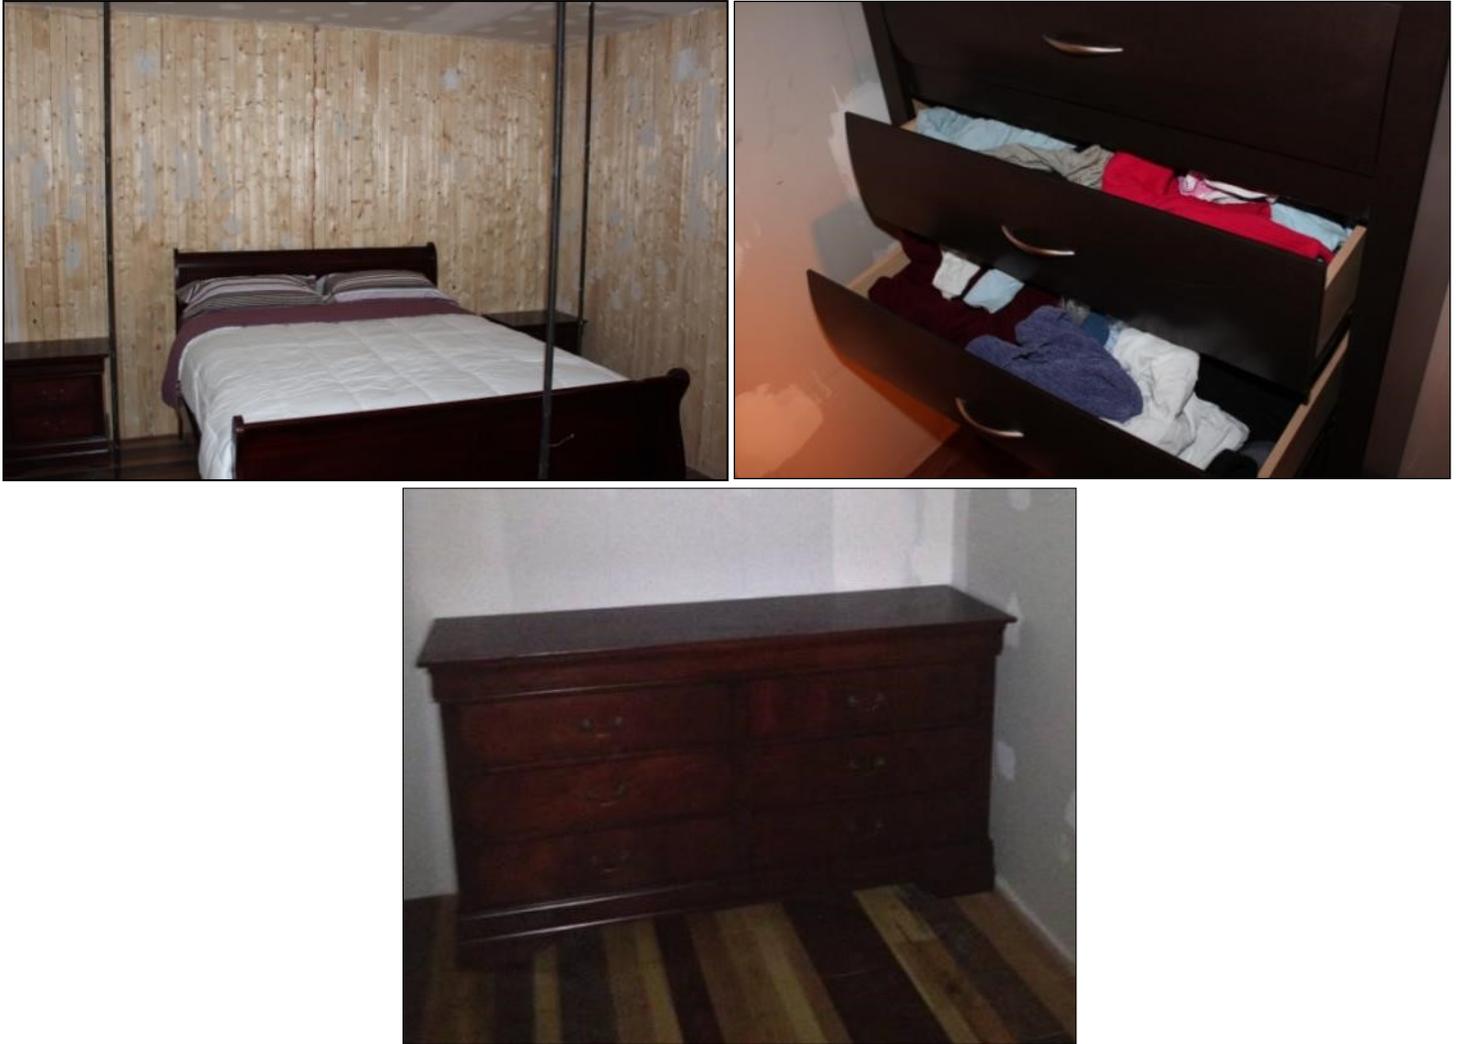
Figure 3-16: Furniture set used in all three room tests.

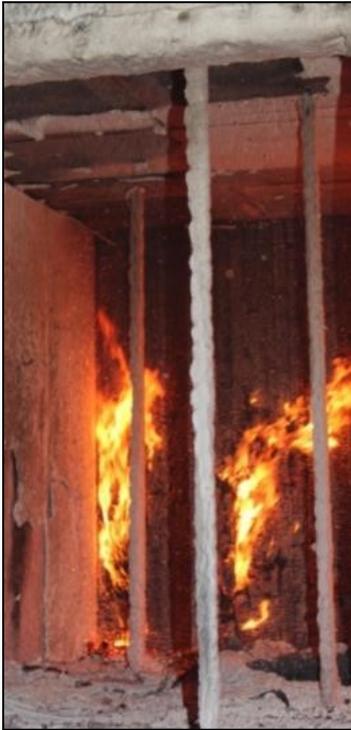
Figure 4-4: Premature delamination leads to some flares

between the back and right-side wall. This was the largest of the three delaminations, exposing lots of fresh wood underneath.

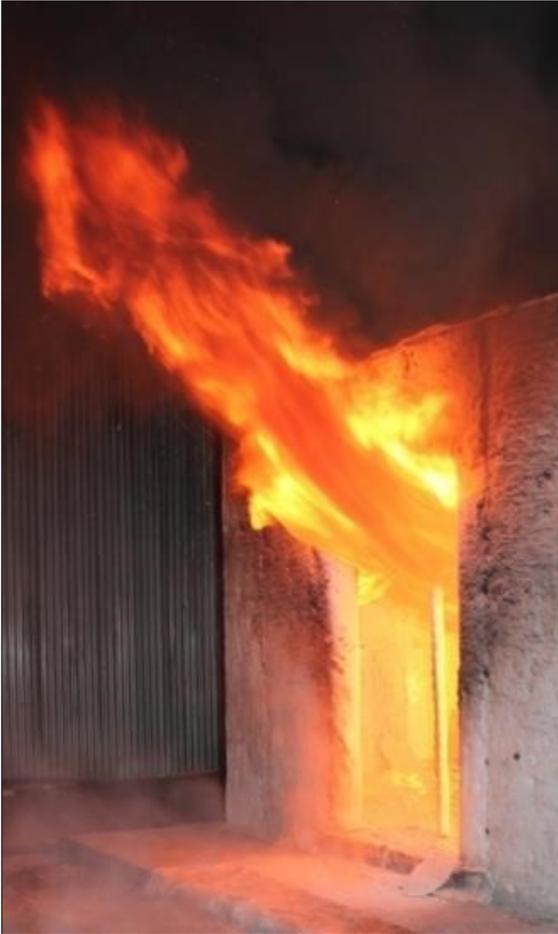
Figure 4-7: A second flashover takes place, this time the CLT walls are fuelling the fire

After the second flashover, room temperatures reached a maximum of 1057°C. Once again the temperature in the room started to fall steadily afterwards.

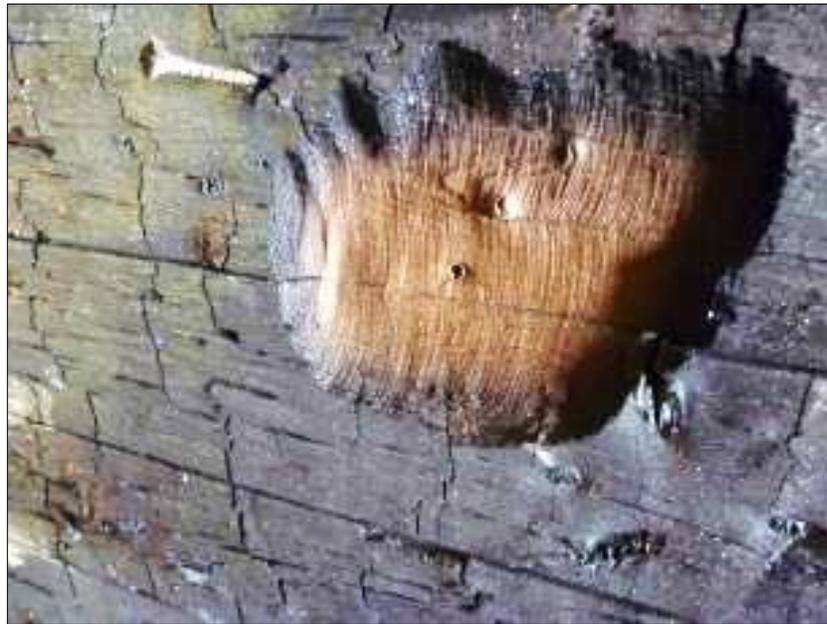
Figure 4-25: Char is removed to measure remaining panel cross-section

until the unaffected wood was reached. The result of the clean surface is showed in Figure 4-25. A small hole was drilled trough the panel and then a digital calliper was introduced to record the measurement of the remaining panel thickness. Figure 4-26 shows the remaining thickness of each panel. The initial cross-sectional thickness of the CLT panels was 105mm therefore the total burned depth can be determined by measuring the remaining cross-section.

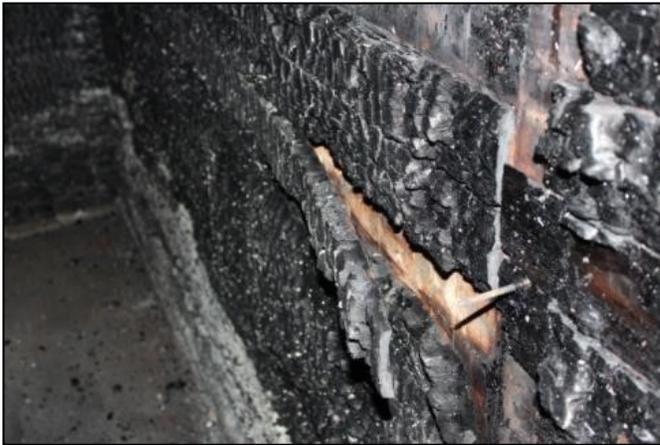
Figure 4-30: Delamination of 2nd ply on the unprotected right wall

The main reason for the re-ignition of the room after it was almost out was delamination of CLT plies before being fully charred. The newly exposed wood served as added fuel causing the HRR and temperature to increase. The polyurethane adhesive used for holding the plies together melts at approximately 200°C which causes the unburnt part of the plies to delaminate before they char. Pictures of the test room taken after the fire was extinguished revealed the delamination of the right wall and ceiling. Figure 4-30 shows the adhesive failure as the second CLT ply is delaminated on the right side wall. Similarly on the ceiling, which was originally protected by two layers of gypsum board, Figure 4-31 shows the failure of the first CLT ceiling ply.

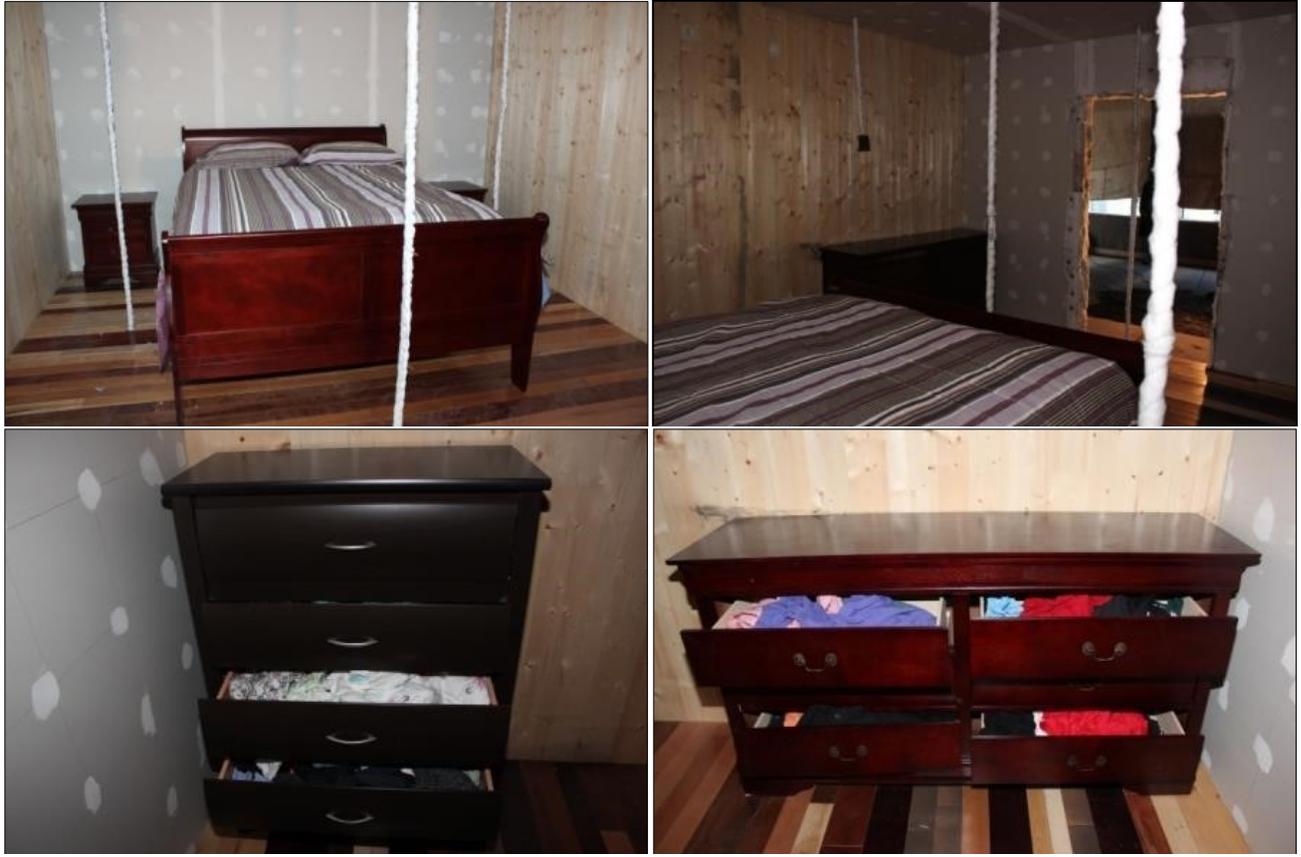
Figure 4-33: Furniture used as fuel for Test 2 including bed, night tables, and dressers

Figure 4-33 shows the fully furnished and instrumented room before the second room fire test.

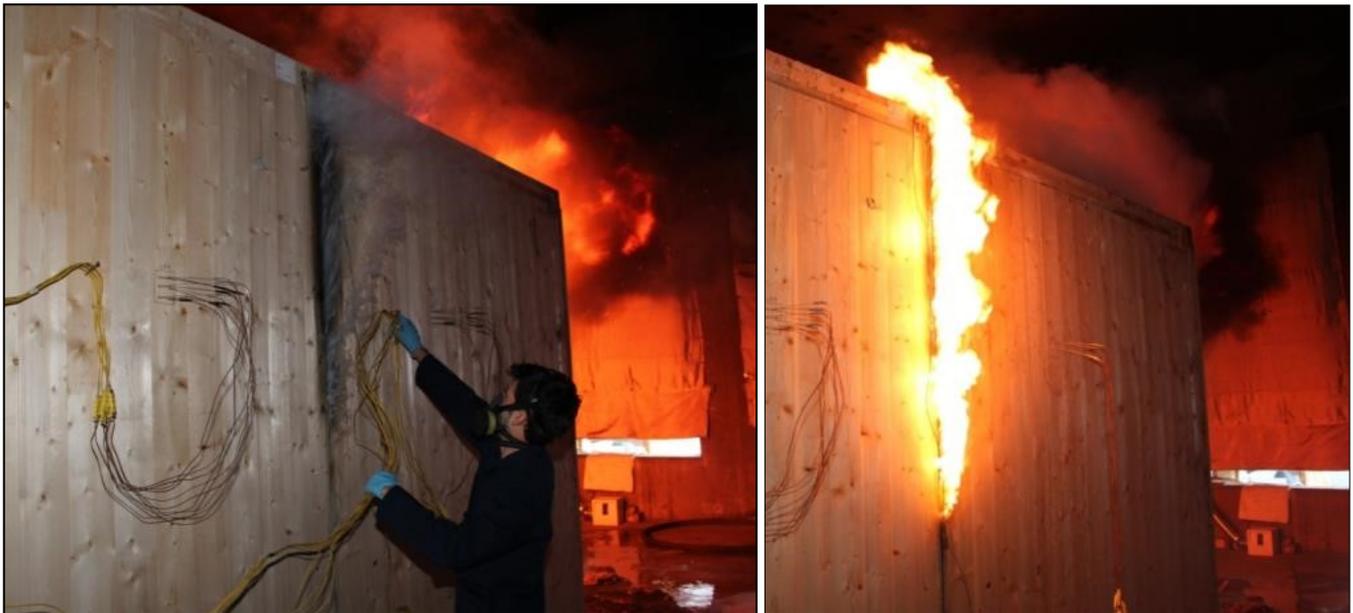
Figure 4-37: Failure of lap joint along the unprotected left wall

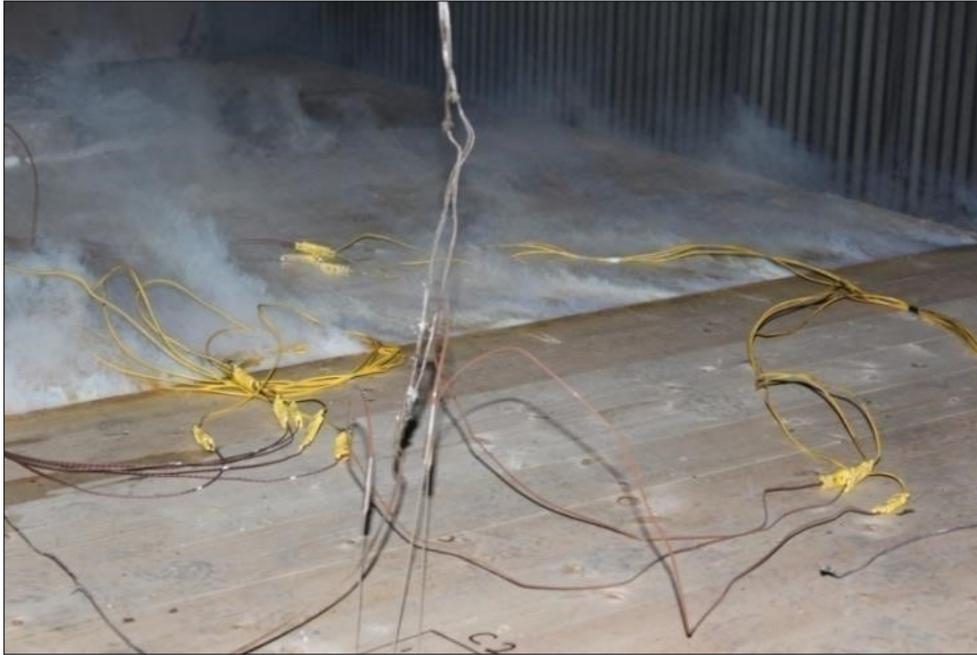
Figure 4-38: Failure of lap joint along the protected ceiling
