**Flexural Response of Corroded Reinforced Concrete Beams at Elevated
Temperatures**

A thesis submitted to
the Faculty of Graduate Studies and Research
in Partial Fulfillment of the requirements for the degree
Master of Applied Science

Gian-Luca Francesco Porcari

January 2011

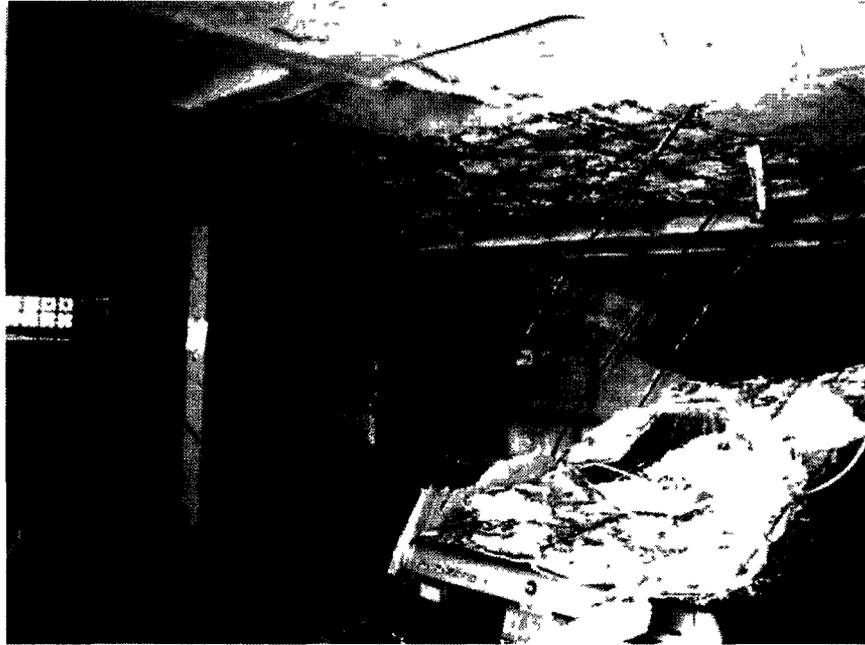
Figure 1-2: A severely damaged reinforced concrete parking structure where the concrete cover has completely delaminated and collapsed. (Cryotech, N.D.).

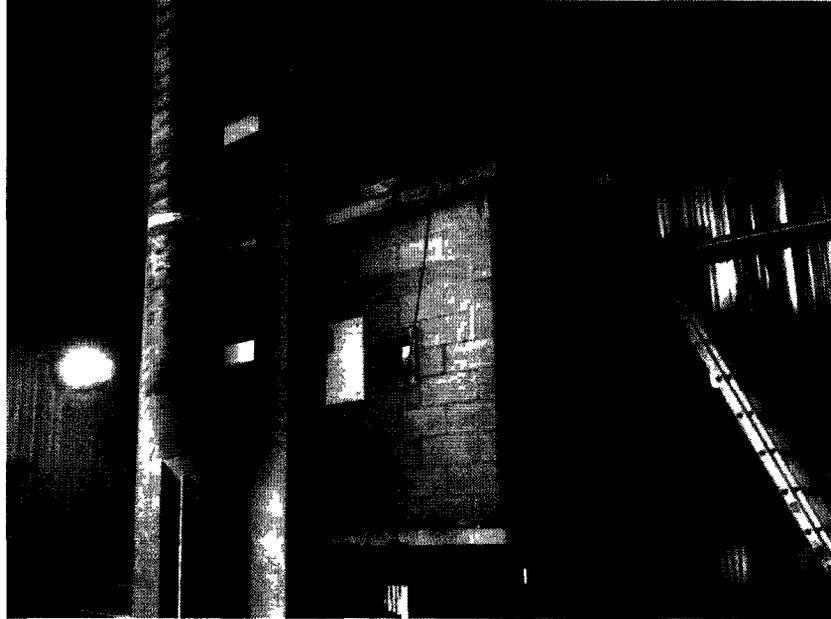
Figure 4-9: The outside view of the testing apparatus, including the burn chamber and the external loading frame.

This section provides details on the combined loading and fire testing apparatus. The apparatus consists of a hydraulic loading frame and a propane fired furnace. This testing apparatus is at Carleton University's Fire Research Facility located in Almonte, Ontario, Canada. After the specimens were corroded to the desired calculated levels, they were transferred to the testing furnace, where they were concurrently heated and loaded. Figures 4-7 and 4-8 show drawings of the test furnace and loading apparatus. Figure 4-9 shows a picture of the outside of the chamber.

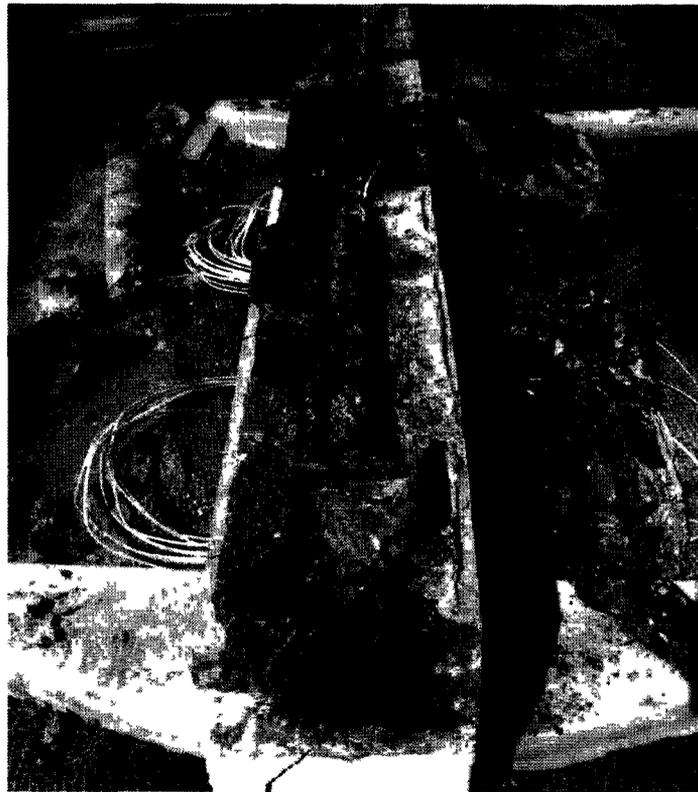
Figure 4-14: The cover being removed from beam D375-C30-C-I.

verified using ASTM G 1 -03 (2003). A mid-range DOC of 3.75% was chosen for the corrosion test beam. The beam, designated, D375-C30-C-I was corroded using the accelerated corrosion technique described in section 4.5.2 at 1 mA/cm^2 for the duration prescribed in Table 4-2. Once complete, the cracking patterns were mapped, and the cover was carefully removed (mechanically) without disturbing the steel re-bar. Once the cover was removed the corroded bars were then removed and carefully cut into pre-determined equal lengths and labelled. Figures 4-14 to 4-16 illustrate this process.

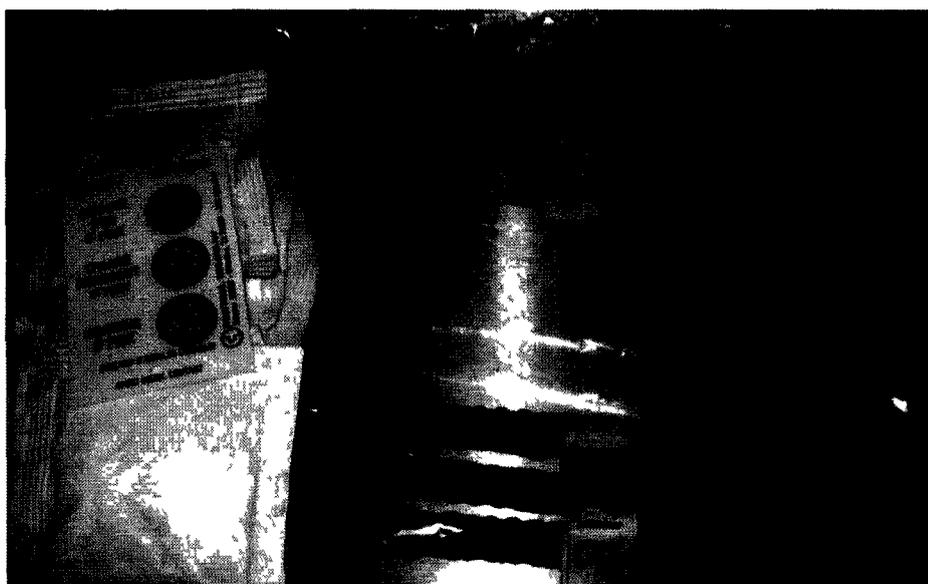
Figure 4-16: The bars from beam D375-C30-C-I cut into 3 equal parts and placed in a sealed bag along with moisture removing minerals.

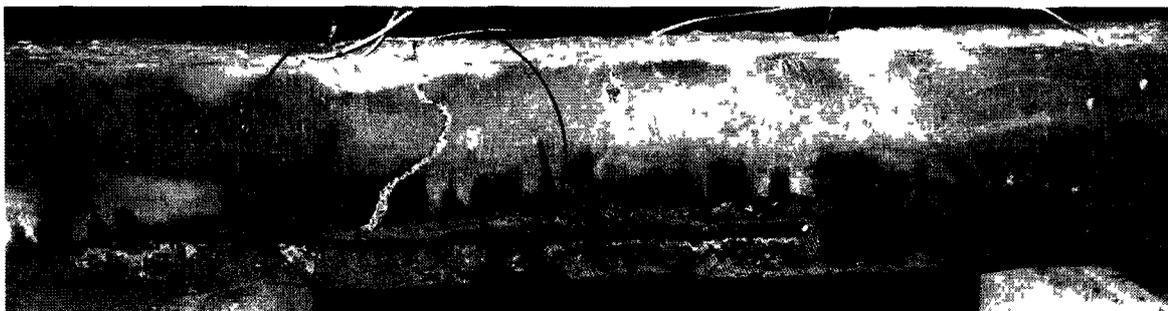
Figure 5-22: Typical bond failure of the beam with 3.75% & 5.25% DOC and no shear reinforcement.

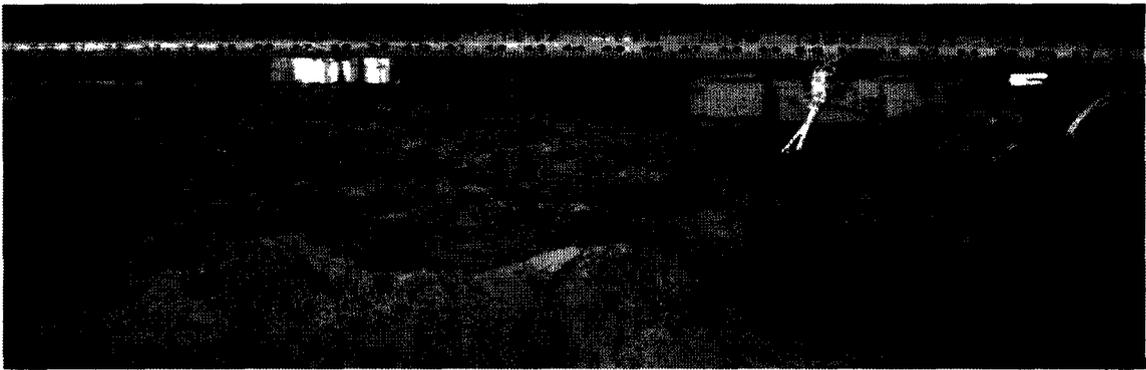
Figure 6-2: The typical flexural failure pattern for un-corroded beams, where multiple cracks extend from the bottom of the beam up to the compression zone throughout the flexural region.
