Durability Characterization of a High Performance Building
Envelope with Vacuum Insulation Panels and Energy Recovery
Ventilation

A thesis submitted to the Faculty of Graduate and Postdoctoral Affairs in
partial fulfillment of the requirements for the degree of

Mechanical Engineering

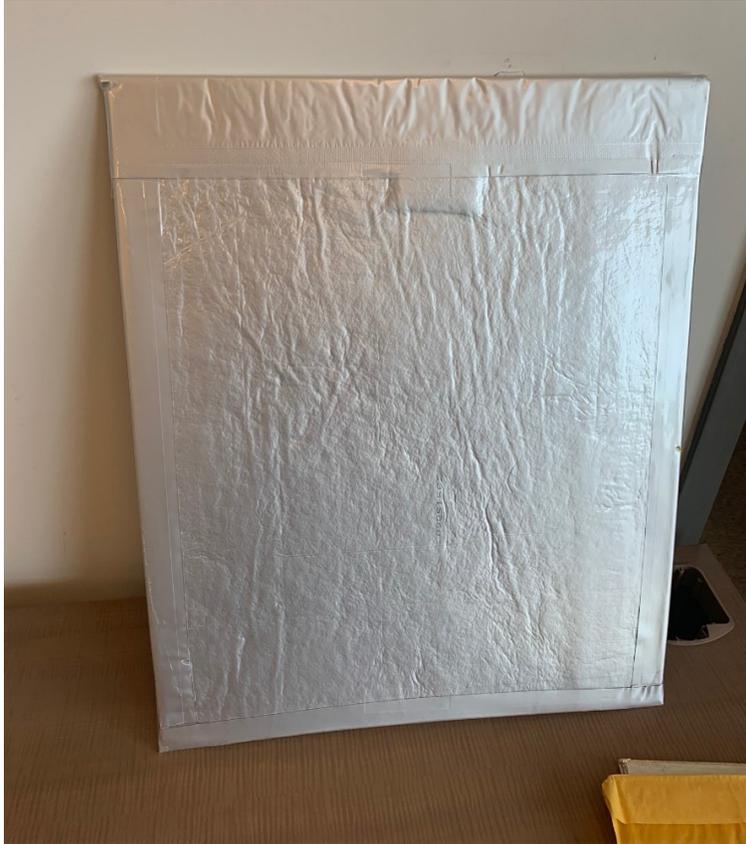
Figure 1-1: A vacuum insulation panel

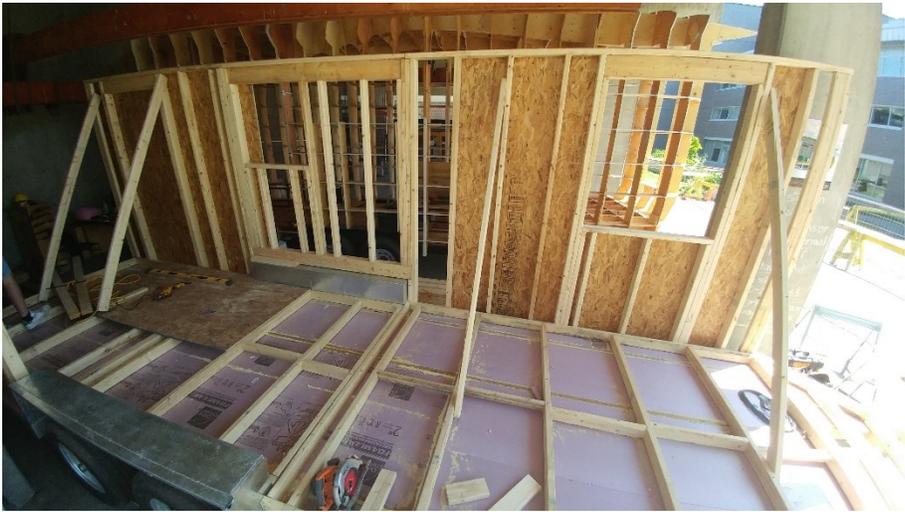
Figure 3-5: floor and wall framing during construction

The walls were built with 2x4 studs and are positioned outside the floor frame and bolted down to the trailer frame. Figure 3-5 shows the framed south wall and floor framing during construction. Painted 16 mm thick tongue-and-groove pine boards were nailed to the inside of the stud walls to create the interior finish over closed cell polyurethane foam applied inside the stud cavities. OSB sheathing (12 mm) was screwed to the outside of the studs and covered with a housewrap to form a vapour-permeable air barrier. XPS (25 mm) was applied to the outside of the

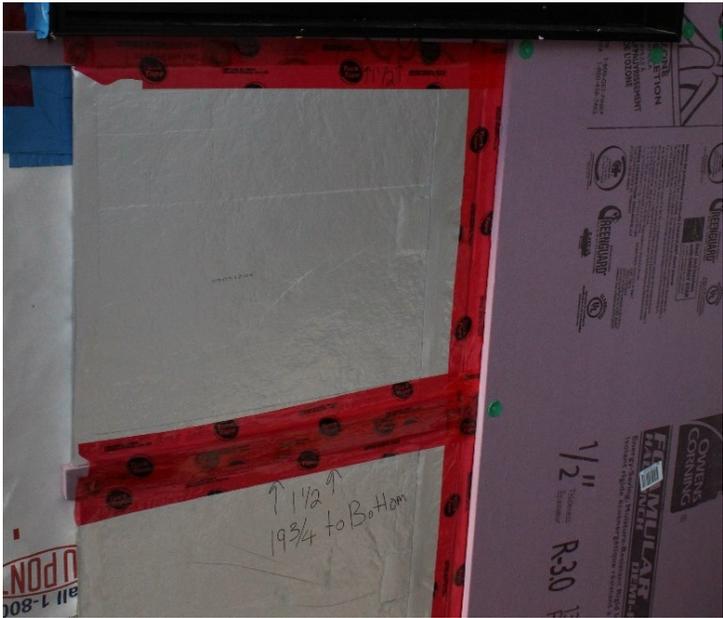
Figure 3-6: VIPs adhered to the air barrier of the south facing wall

walls, except on the south-facing wall which received a layer of 10 mm VIPs and 13 mm of XPS, shown in Figure 3-6. Strips of 13 mm XPS were used between VIPs to provide some regions for fasteners to pass through for securing the 12 mm plywood furring strips and 16 mm charred cedar siding which formed an open chamber rainscreen. The total thickness of the walls is 170 mm (6.75 inches).

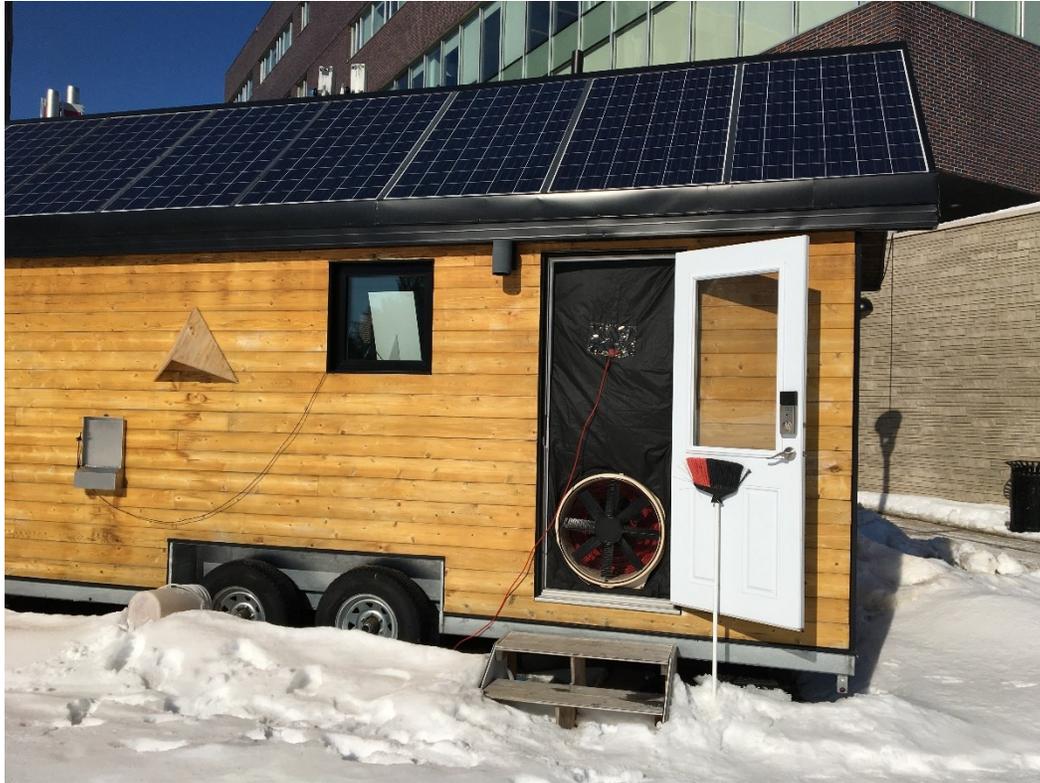
Figure 4-2: Blower door test apparatus, with the red manometer tube end sheltered from wind with a bucket

and were recorded. During testing, the ERV ducts were blocked and water drains were plugged. Ambient temperature and wind speed were not recorded during the blower door tests.

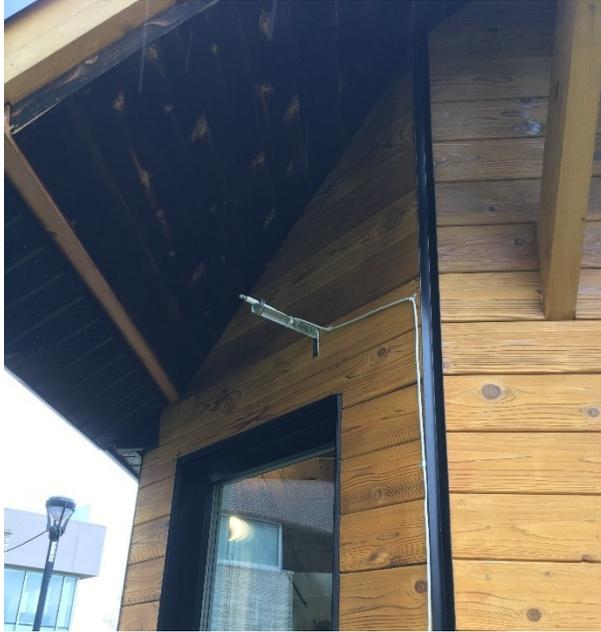
Figure 4-4: Outdoor RH&T sensor

Ambient conditions were measured to provide boundary conditions for nearly all experimental activities. Indoor and outdoor temperatures and relative humidity were measured at

10-minute intervals using HTM2500 sensors positioned near the indoor and outdoor wall surfaces in consistently shaded areas, shown in Figure 4-4 and Figure 4-5.

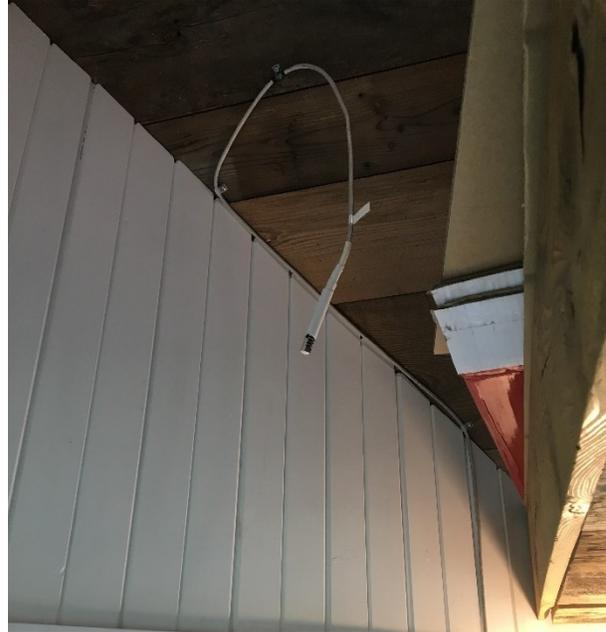
Figure 4-5: Indoor RH&T sensor

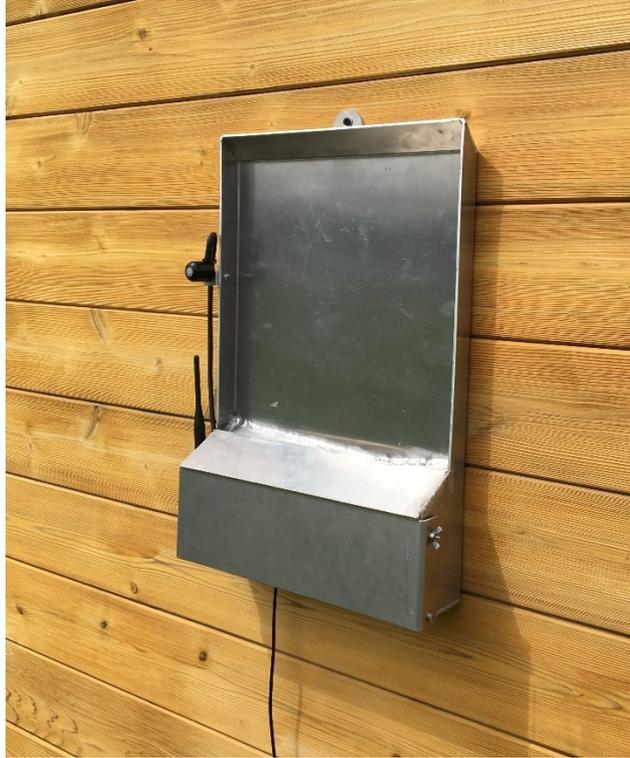
Figure 4-6: Wind driven rain gauge and pyranometer installed on the south façade

Wind driven rain was measured using an SMT driving rain gauge installed on the south facing exterior wall. The gauge works using a 929 cm² catchment area where wind driven rain is collected and funneled down into a tipping bucket with a volume of 5.44 cm³ (Figure 4-6). Each movement of the tipping bucket registers a pulse that is counted by an A2 datalogger, representing 0.059 mm of wind driven rain. Pulses are added up and recorded for each 10-minute sampling interval. A pyranometer was installed on the south façade to measure incident solar radiation normal to the wall at 10-minute intervals.

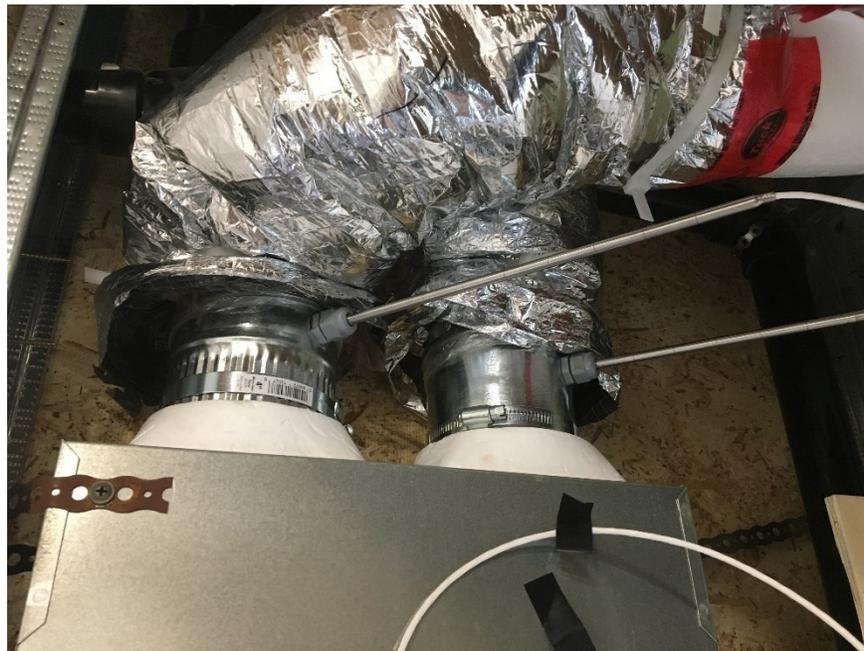
Figure 4-7: Air velocity probes in the exhaust (left) and supply (right) ducts above the ERV

flow speed in the ERV ducts. The nominal flow rate of the ERV on the high flow setting is 68 m³/h and the ducts are 10 cm in diameter, so the highest average air velocity in the ducts was expected to be approximately 2.4 m/s. Air velocity probes with a measurement range of 0-5 m/s were used, accurate within 0.1 m/s. The probes were secured in the ducts by adding a short section of ducting to an existing joint and drilling holes for plastic cable glands that hold the probes. They were positioned such that the measurement point on the probe was in the center of the duct cross section. The installed sensors are shown in Figure 4-7. The sensors transmitted a voltage signal proportional to the air velocity between 0 and 5 V to an SMT A3 datalogger.

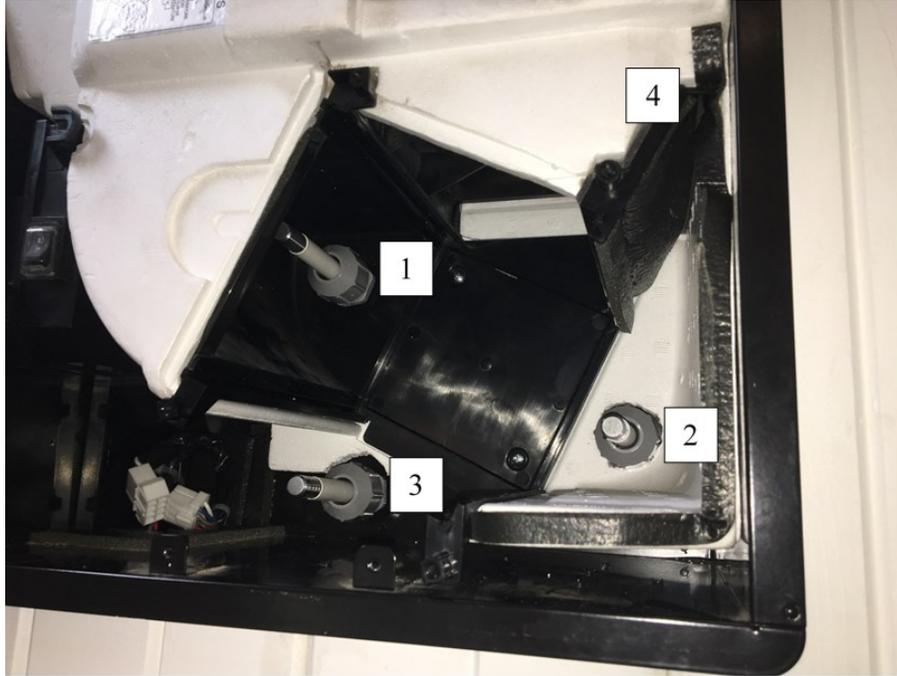
Figure 4-8: RH&T sensors in the ERV measuring conditions at the supply inlet (1), supply outlet (2), exhaust inlet (3) and exhaust outlet (4). The core is removed for clarity.

Temperature and relative humidity were measured at the inlets and outlets of the ERV using four SMT HTM2500 sensors (Figure 4-8) and one A3 datalogger. Measurements began in May 2019 and continued until April 2020 at a sampling interval of 10 minutes. Throughout this period, the ERV was switched between the high and low speed settings and was turned off for some time, providing comparison between different ERV operation modes.

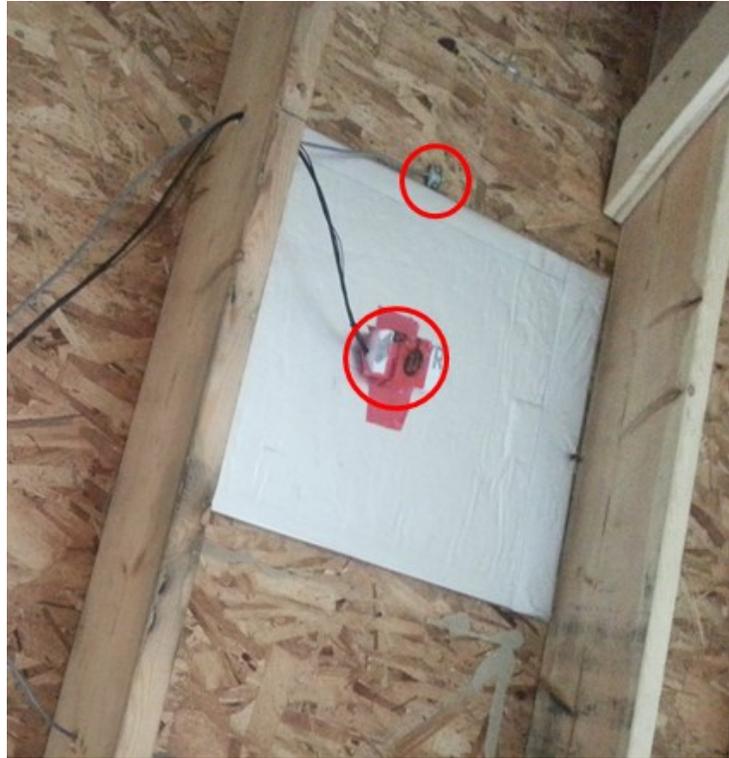
Figure 4-9: Roof VIP with an RH sensor taped to the panel and an MC&T sensor in the sheathing adjacent to the panel

VIPs on the north and south facing roofs. This data is essential for determining the durability of the roof system and the aging of VIPs in different assemblies under different scenarios.

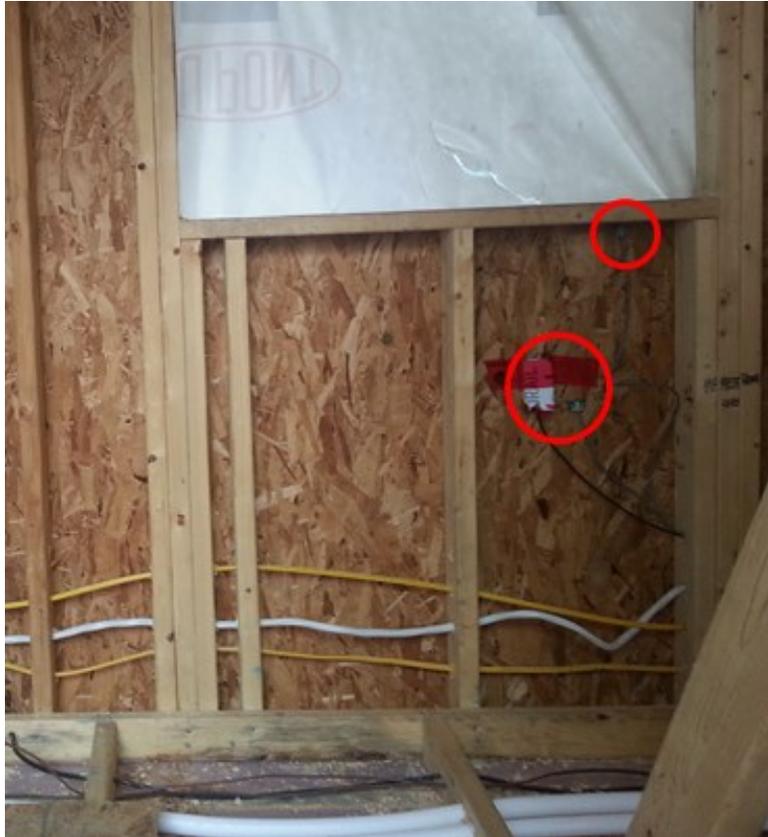
Figure 4-10: RH, MC&T sensors installed in a wall cavity and below a windowsill

sensor, and relative humidity sensor. Sensor locations are symmetrical between the north and south walls.

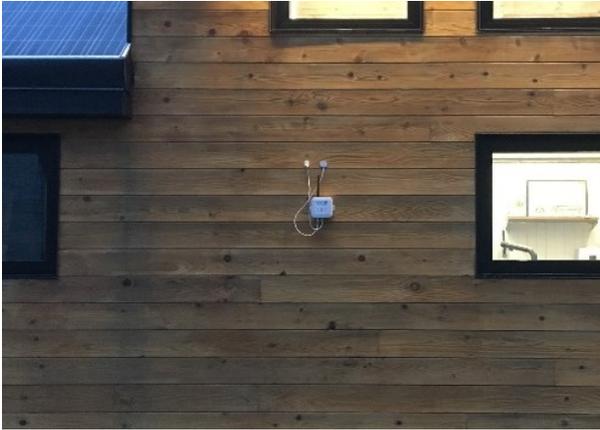
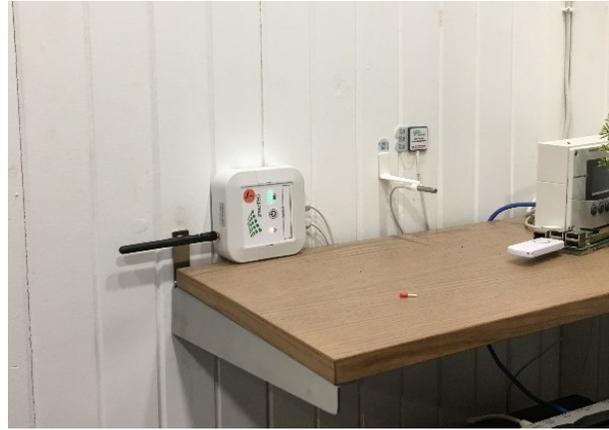
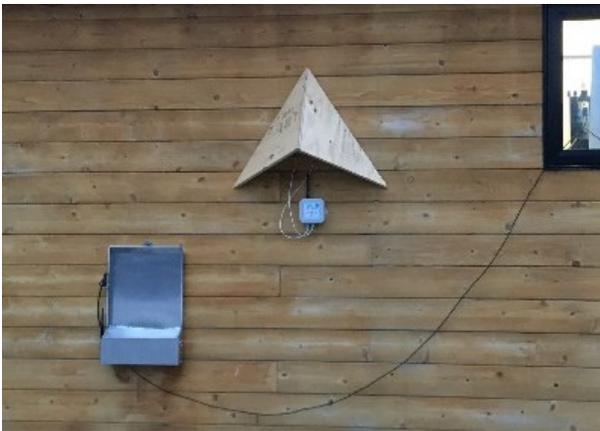
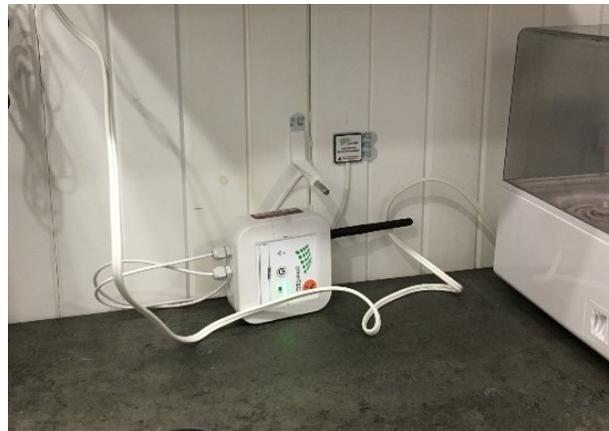
Figure 5-1: Locations of the RSI monitoring equipment: (a) North wall exterior, (b) North wall interior, (c) South wall exterior, (d) South wall interior

Results from the first attempts of RSI measurements indicated that the process needed improvement to conform to ISO 9869 [46]. The outdoor surface temperature sensor took at least one hour to reach the actual surface temperature due to the thermal capacity of the sensor that was moved from indoors to outdoors just before recording. This caused a large variation in RSI measurements and to achieve ISO conformity, the sensors needed to show less deviation at the beginning of the test. Additionally, the battery life of the dataloggers only lasted three days on the first few measurement attempts: the minimum length for an ISO conforming measurement. This limited the tolerance for non-conforming periods of data through the tests, including large deviations in the calculated average RSI over time. To improve measurements, the data loggers were installed and climatized prior to recording data and they were charged from nearby power

outlets as needed during the measurements. This allowed tests to run indefinitely and the first ISO conforming measurements were achieved. However, there were still problems with the results. Upon inspection, the interior surface temperature seemed too low due to nearby infiltration at the battery box, discussed in detail in Section 5.2.1. The lower surface temperature and increased heat flux at that location reduced the calculated RSI of the wall, so the sensor needed to be relocated for accurate measurements to be made. The sensors on the interior of the north wall also needed to be relocated because they were receiving sunlight through the opposing south facing window during the afternoon, causing an elevated surface temperature and reversed heat flux. While the measurement was ISO conforming, it did not accurately reflect the RSI of the wall. As with the exterior sensors, the indoor sensors needed to be sheltered from direct solar radiation. All the sensors were relocated to the kitchen area, as seen in Figure 5-1, and they were carefully positioned to be shaded from sunlight, away from significant sources of airflow, and not on studs or exterior battens. This is where final measurements were made.

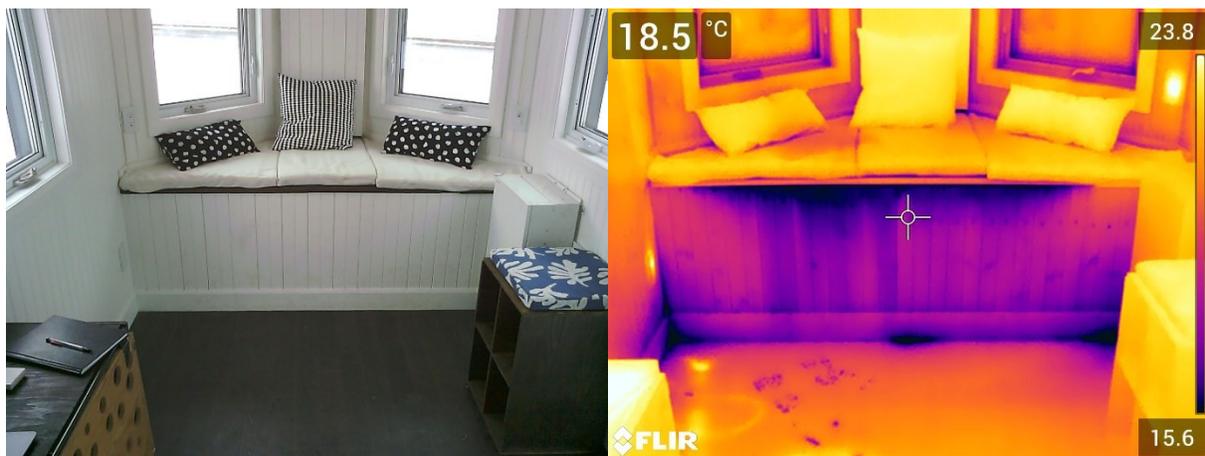
Figure 5-4: Battery box photos: regular (left) and infrared (right) showing significant heat loss

The infrared photos highlighted several cold surfaces inside the Northern Nomad. The air infiltration through the battery box is evident in Figure 5-4, showing surface temperatures as low as 15.6°C while the room temperature was 24°C. According to the infrared photos, the battery box appears to account for a significant portion of the heat loss in the house. This was a result of the vent holes added to the battery box to comply with regulatory standards on the safe usage and storage of lead-acid batteries. In the future, it would be beneficial to thoroughly seal the battery box from the interior space, or switch to lithium-ion batteries that do not require venting.

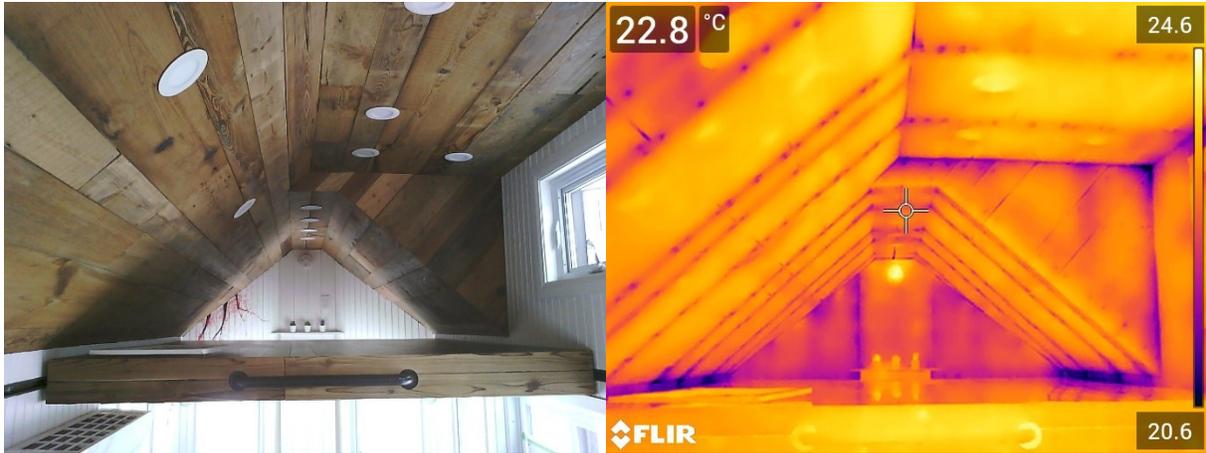
Figure 5-5: Regular (left) and infrared (right) photos of the ceiling showing thermal bridging along rafters
