Re-ornamentation

Robert Pietrzak

Master of Architecture
M. Arch (Professional)

Azrieli School of Architecture and Urbanism
Ottawa, Ontario, Canada
Robert Pietrzak ©2011

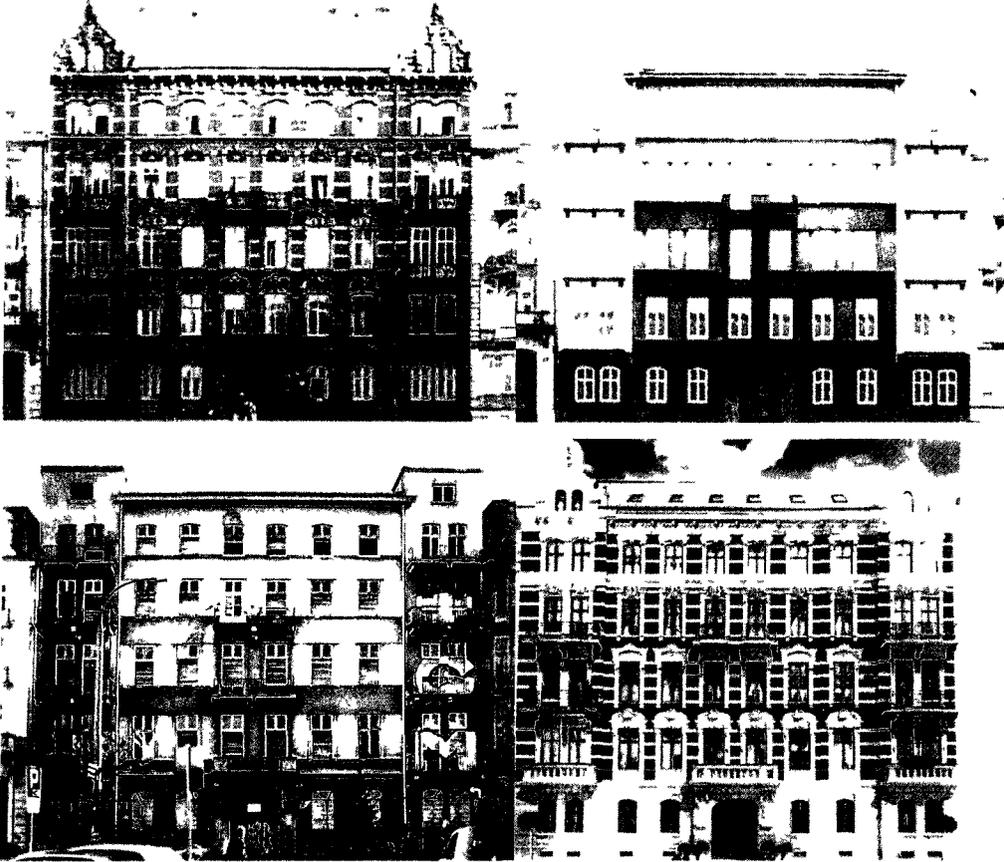
Fig. 5 (Top Left) The façade of 13 Foksal Street in Warsaw, in its original state (ca 1930's) Fig. 6 (Top Right) The façade after being stripped of its ornamentation Fig. 7 (Below Left) The building in its current state (2010) Fig. 8 (Below Right) Architect's rendering for the façade reconstruction (2012).

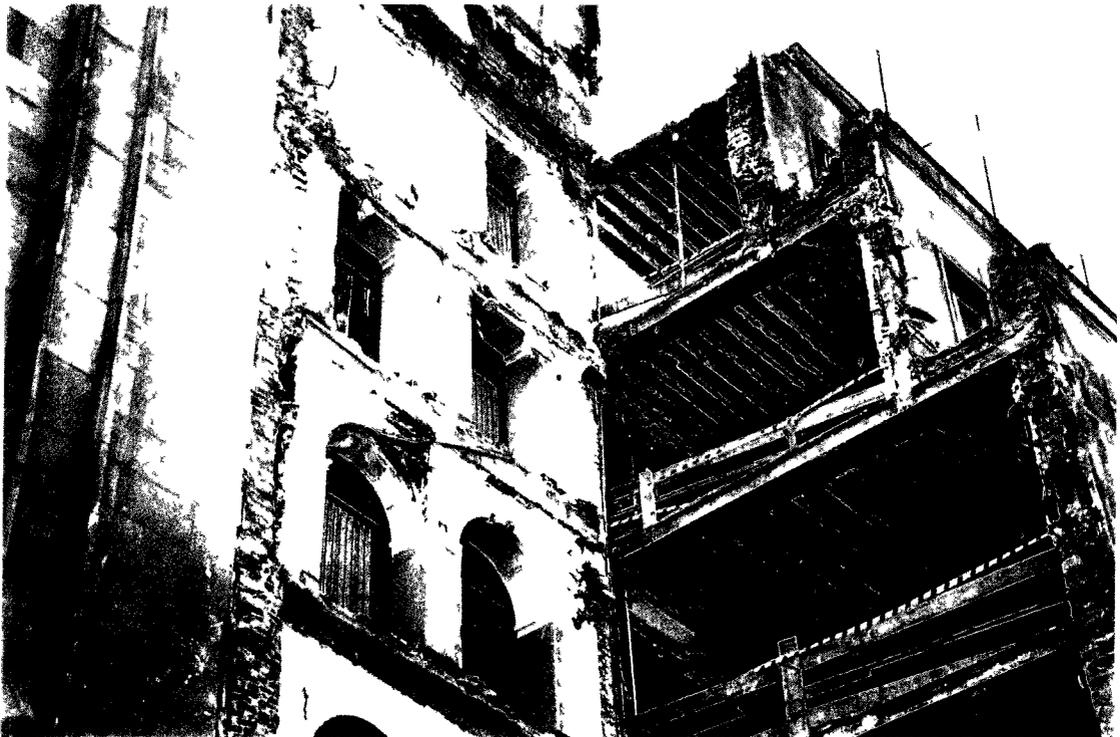
Fig. 9 This image of the *Prudential Building* in Warsaw was *not* taken after the bombings of WWII, but rather during the reconstruction work carried out in 2010 to return to its former Art Deco appearance.

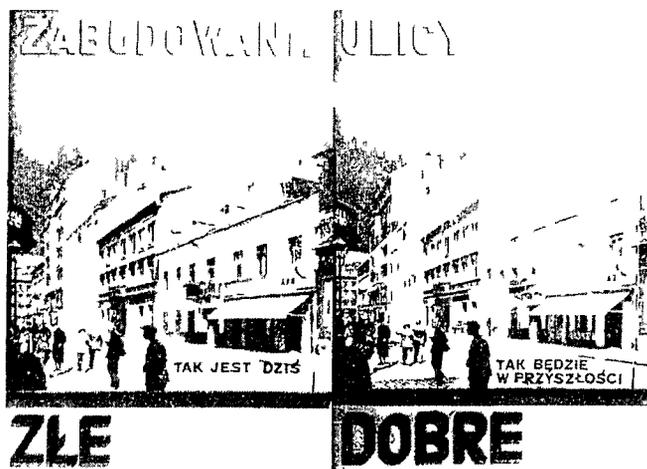
Fig 18 Proposal for the exhibition *Warsaw of the Future*, 1936 showing a 'Bad Streetfront of Today' (Left) and the 'Good Streetfront of the Future' (Right) with re-aligned façades

The city of Warsaw captures a dynamic urban and architectural condition which has been inherited through war and political influence. Like many European cities which developed greatly in the late 19th and early 20th centuries, Warsaw was a dense city and featured many of the typical problems and issues faced by urban centres of the time. The typological urban block consisted of a street-facing residential building with ground-floor retail space (depending on the neighbourhood or street), and apartments above. Usually attached to this front building were two side wings and a back building, connected together to form a rectangular inner courtyard. Depending on the parcel of land, this courtyard-block configuration would be repeated twice or three times under the same address, maximizing the potential of built-up space within one site. Although practical for some, these spaces were decried for their lack of natural light, unsanitary conditions, and generally uncharming quality. The streetscapes of these blocks, on the other hand, were infamous for their non-uniform appearance. This issue had less to do with the ornamentation or variety of façades on a single street than it did with the height and proportion of a building. Critics maligned the lack of planning guidelines in which 7 or 8-storey buildings were erected side by side to those of 2 or 3 storeys, or vice versa. The argument of the pre-war era was that the general disorder of the city was not a positive image as the nation's Capital, much less a liveable or aesthetically pleasing place for its inhabitants.

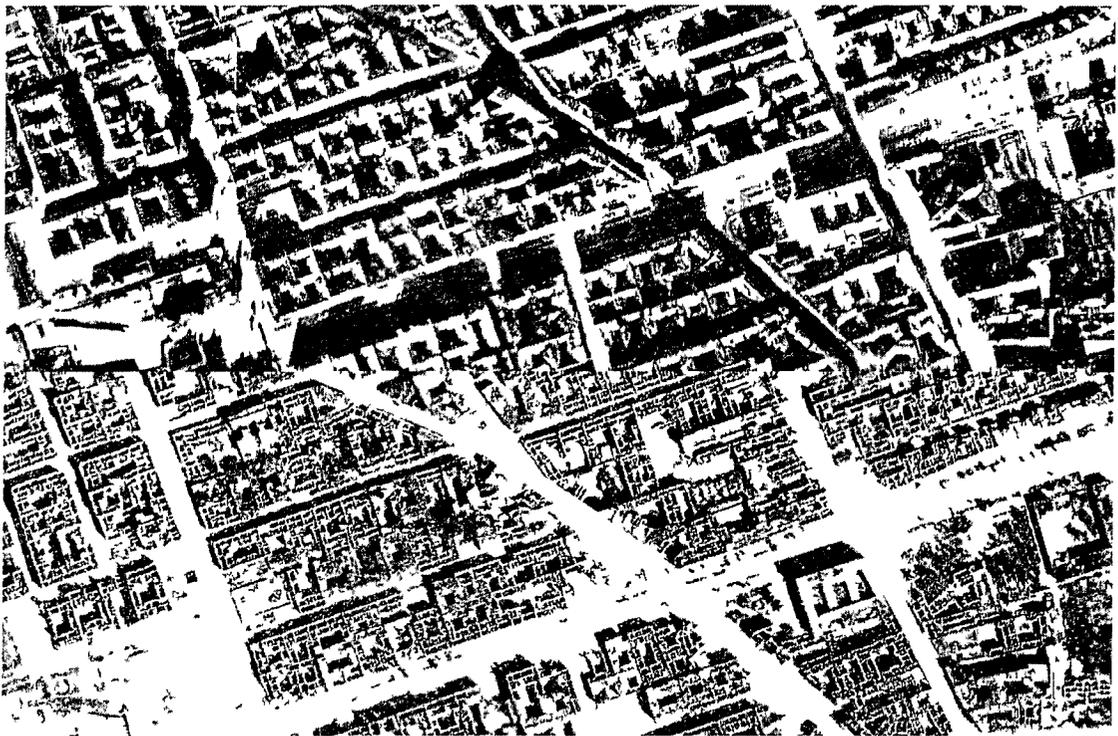
Fig 19 Aerial view of central Warsaw in 1935 (Above) and 1945 (Below), with Central Station in the lower left corner

Much of the city's urban fabric was destroyed during the Second World War, and with it many of the city's historic buildings, landmarks, monuments and entire neighbourhoods, over 80% of the city was reduced to rubble and ruins by the end of 1944. The city lost its decidedly turn-of-the-century character and became a *tabula rasa*. The few buildings of pre-modernist origin which *did* manage to survive, were subsequently stripped of their architectural ornamentation under the policies of the new political system. Not only was ornament no longer *en vogue* in the postwar era (this trend first began to develop in the 1930s with the introduction of modernism in Poland), but the ornamentation of the past had the added connotation of bourgeois symbolism. The strategies which emerged from this growing viewpoint were to either strip façade ornamentation to announce a utilitarian homogeneity, or to refrain from any restorative action with the intention of the building's eventual demolition (this was also favoured due to a typical lack of funding for such endeavours). These activities occurred throughout the country in the early postwar era, however, the purging of ornament was greatest in Warsaw, for the Capital city was meant to represent the new Socialist ideology on a larger scale than in other cities of Poland.

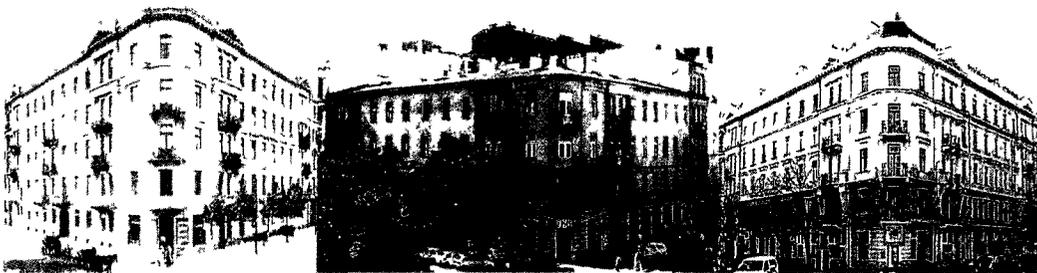
Fig. 20 42 Nowogrodzka Street in 1905 (Left), 1995 (Center), 2004 (Right). During the war the building lost its top floor, and later its façade ornamentation. In 2004 the façade was reconstructed and a glass skylight was added.

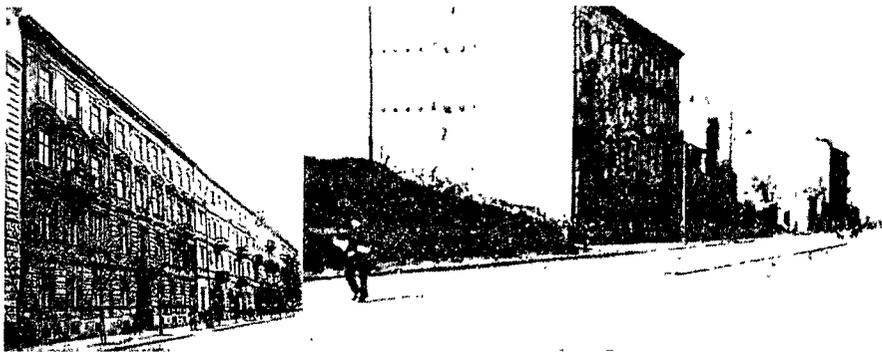
Fig. 23 (Left) 3 Krucza Street in 1938. Fig. 24 (Right) 3 Krucza Street shortly after the war in 1945.

The city centre was a very densely-built area before the war. During the Second World War, this neighbourhood, like the rest of Warsaw, was almost completely destroyed. The site at 3 Krucza was one of few surviving buildings on the street, while only a handful of nearby buildings in the area survived. The building itself was not affected by any major damage. Adjacent and neighbouring buildings were destroyed however, and their ruins were cleared by 1946.

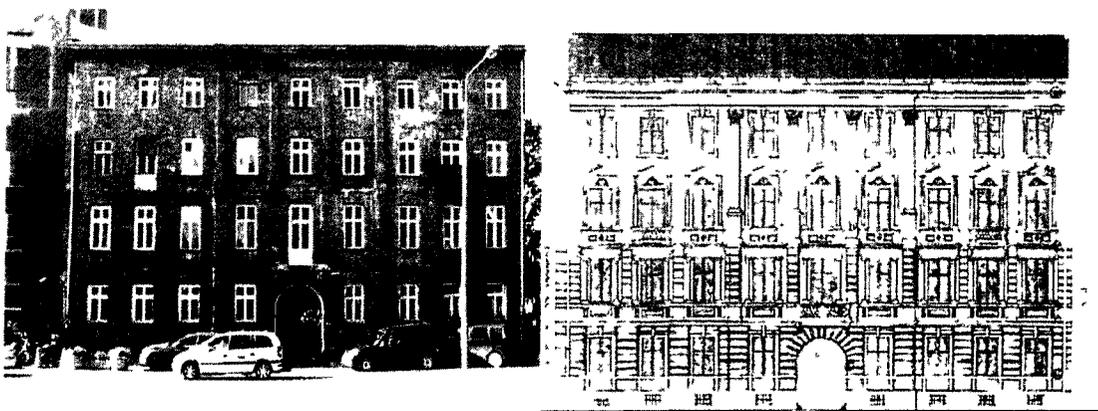
Fig. 25 3 Krucza Street in its present-day state (as of Oct. 2010), Fig. 26 and Anna Rostowska's elevation study (1999).

With no conservation work carried out for decades, a project was drawn up for the reconstruction of the façade and rear elevation in 1999. It was created by Anna Rostowska (M. Arch.) from ProArt studio, commissioned by the Communal Housing Organization of Warsaw City Centre. The drawings were likely based on photographic evidence as well as careful analysis of the remnants and traces of the façade ornamentation. These traces are still visible today, but due to the lack of repairs the building is in grave danger of destruction.

The building is in very poor condition. The façade and courtyard elevations are missing stucco, while fragments of stucco are crumbling and falling off of the exposed wall. The iron balcony platforms are covered in a thick layer of rust and have not been protected from corrosion, balustrades are damaged and cracked, decorations are missing. The walls of the passageway and stairwells are covered in graffiti, damaged, cracked, peeling, and crumbling. The railings of the staircase in the front building are missing several iron balusters. In both wings, the wooden stairs are heavily damaged, uneven, and unstable, several wooden balusters are missing, the stairs in the northern wing are in a comparatively worse condition, with collapsed steps and uneven landings. Door frame mechanisms contain much smaller-scale damage and are covered in thick layers of oil-based paint. Replaced window frames do not correspond to the original window forms, other windows are heavily damaged and are leaky with warped frames.

Three immediate recommendations by the Municipal Office for Historic Monuments in Warsaw include a structural analysis performed by experts, a general renovation, and the reconstruction of all façade ornamentation.

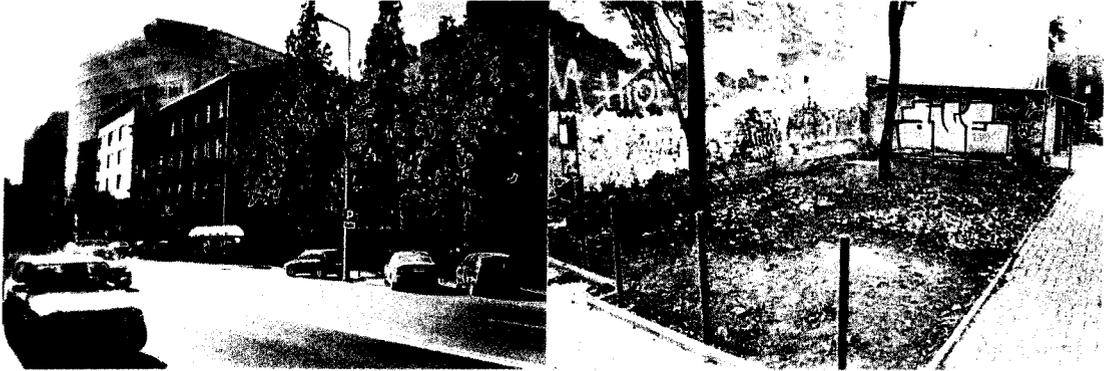
Fig. 27 Perspective of Krucza street. **Fig. 28** Perspective of adjacent lot featuring the exposed wall and parking garage.

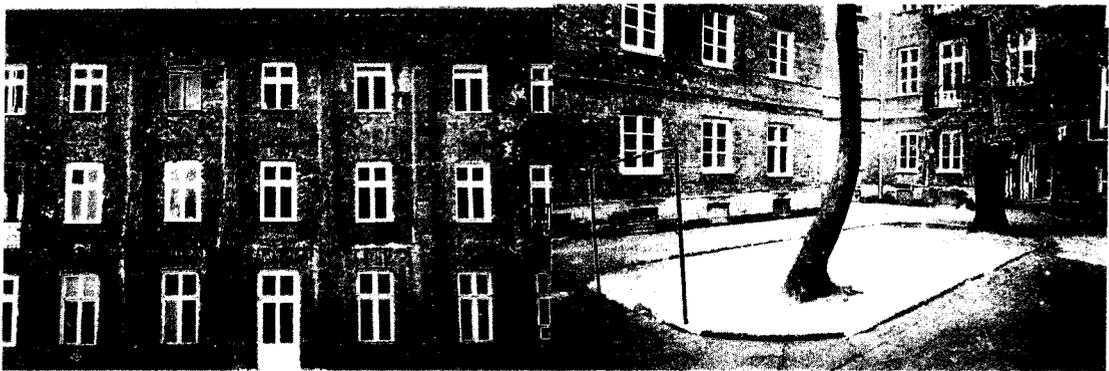
Fig. 29 Façade detail with exposed brick, pilaster traces, steel reinforcements. **Fig. 30** Courtyard perspective.

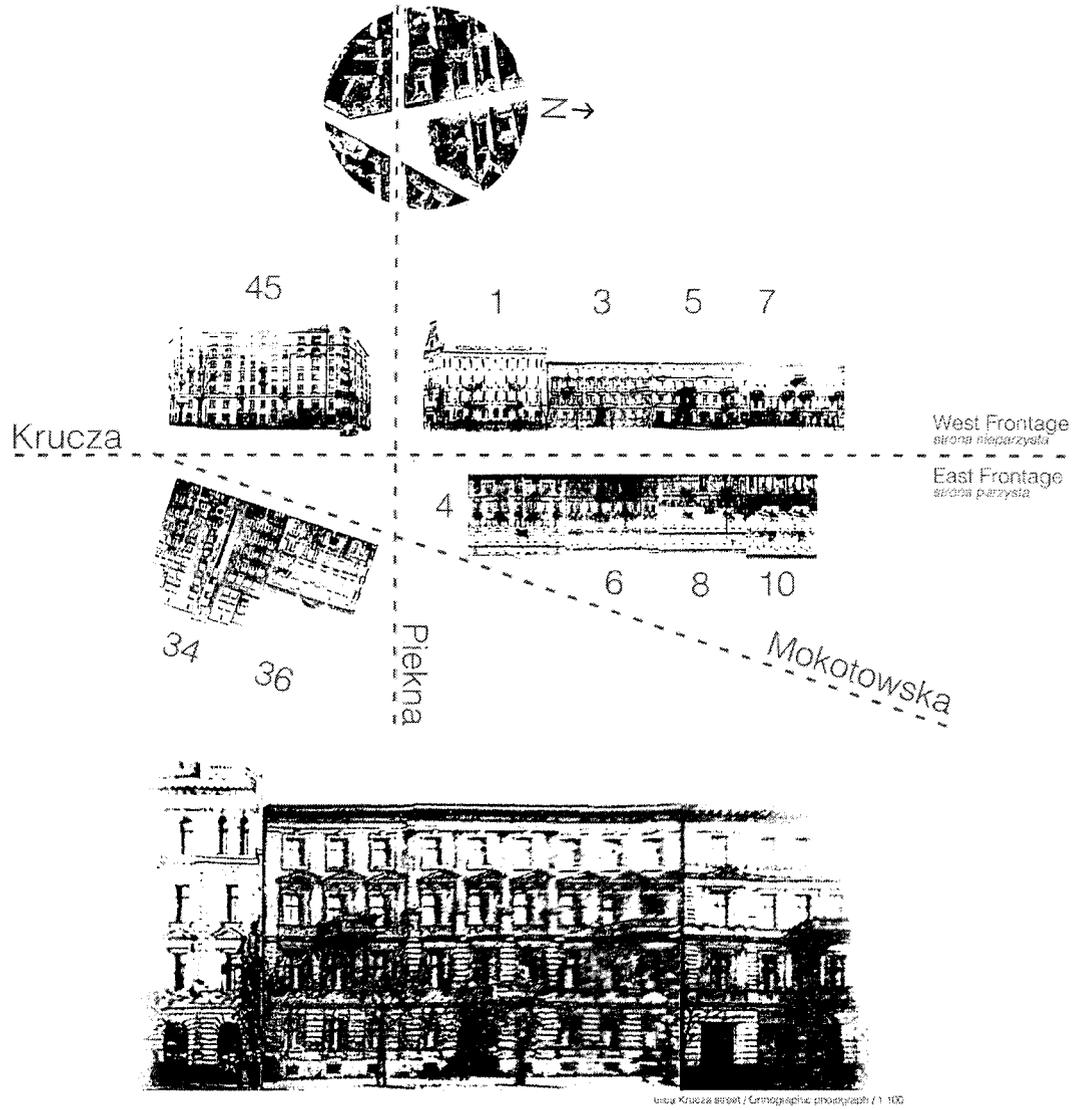
Fig. 34 Historical Situation: Aerial site photograph (1935) and orthographic façade projections from archival photographs.

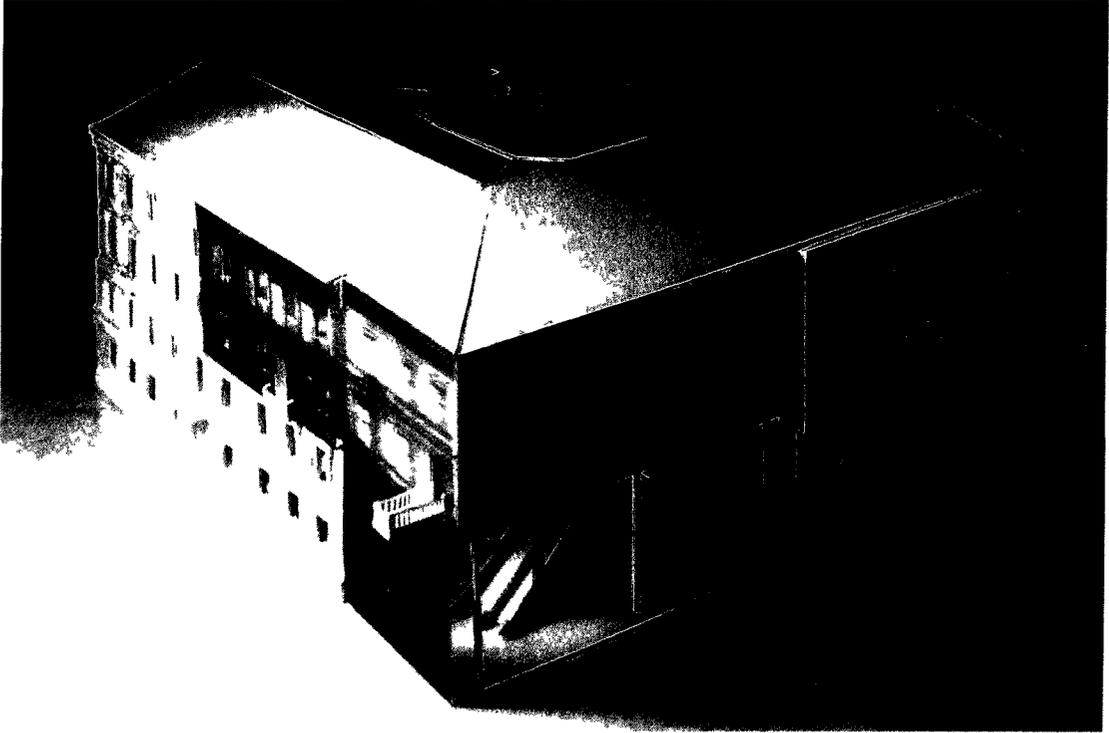
Fig. 37 (Above) View of model showing historic building and new addition **Fig. 38** (Below) Detail view of historic fragment The exposed brick and traces of ornamentation are visible through the printed glass surface

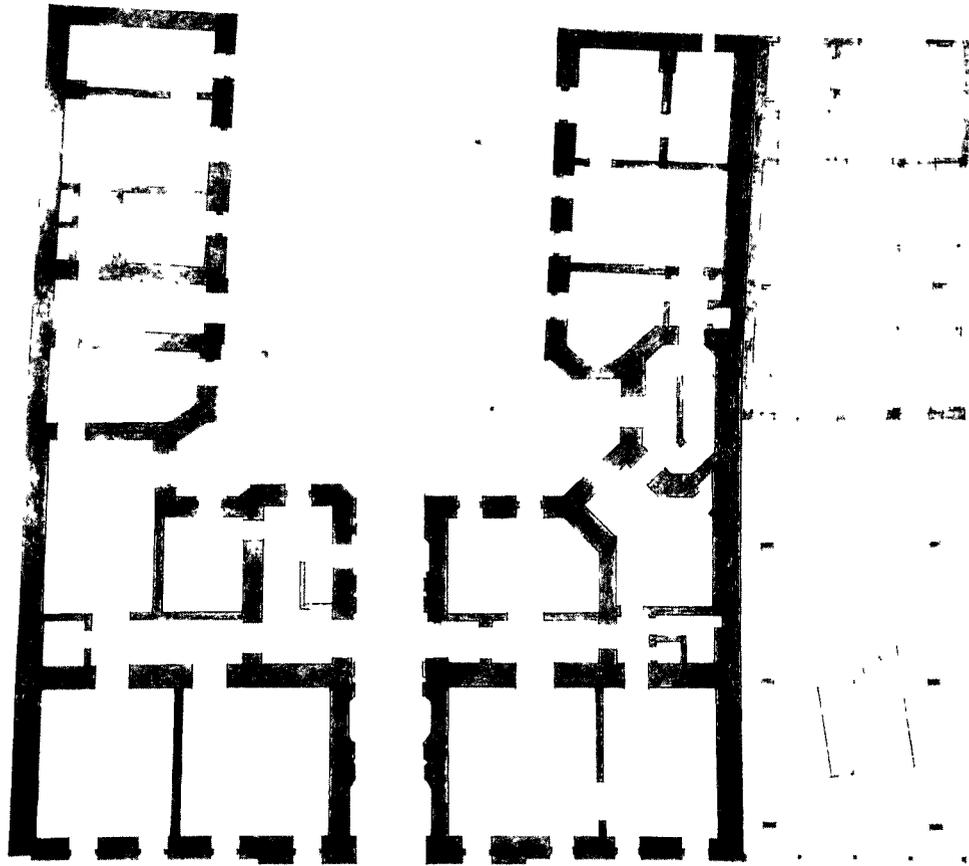
Fig. 41 Ground floor plan and façade study.

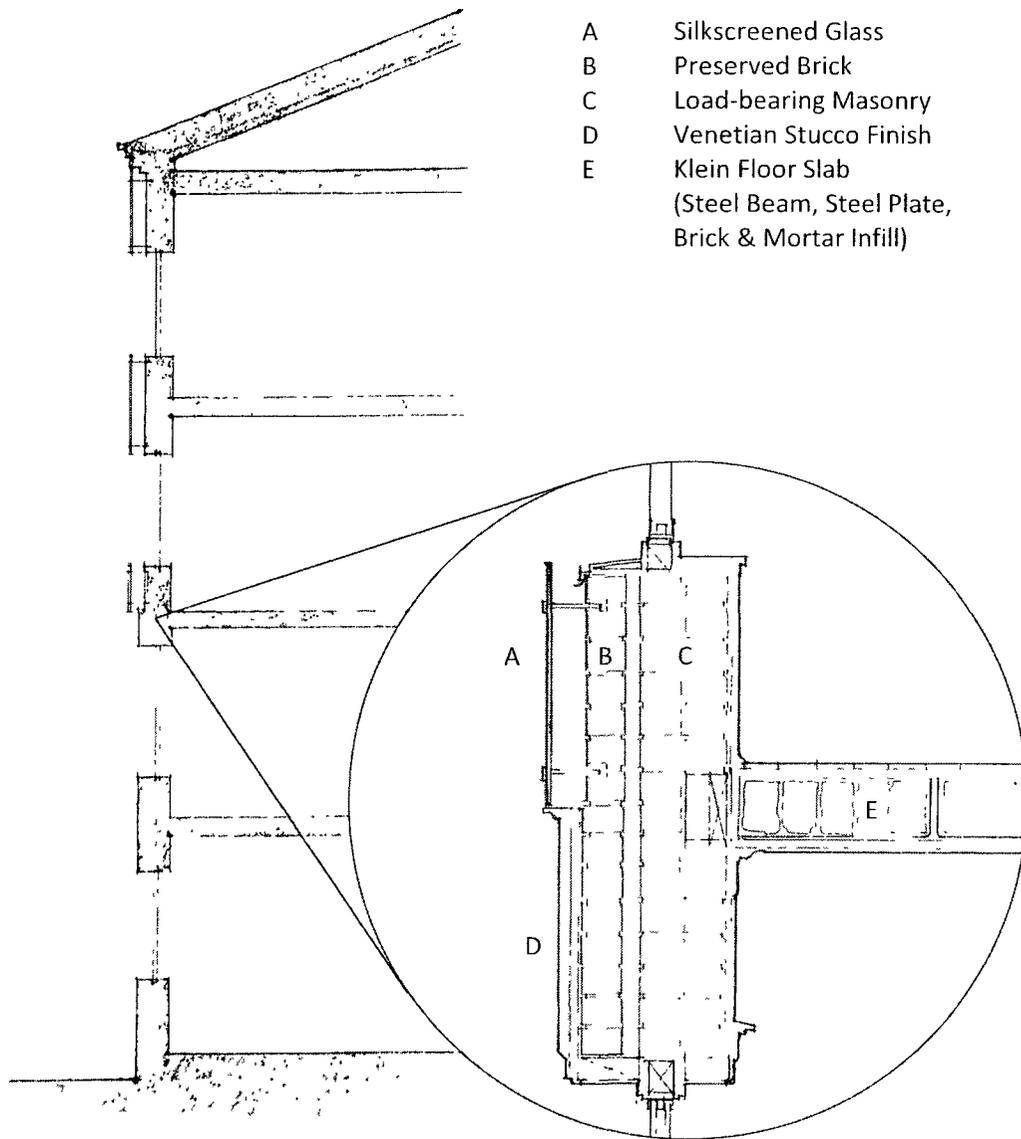
Fig. 42 Wall section and detail of historic façade.

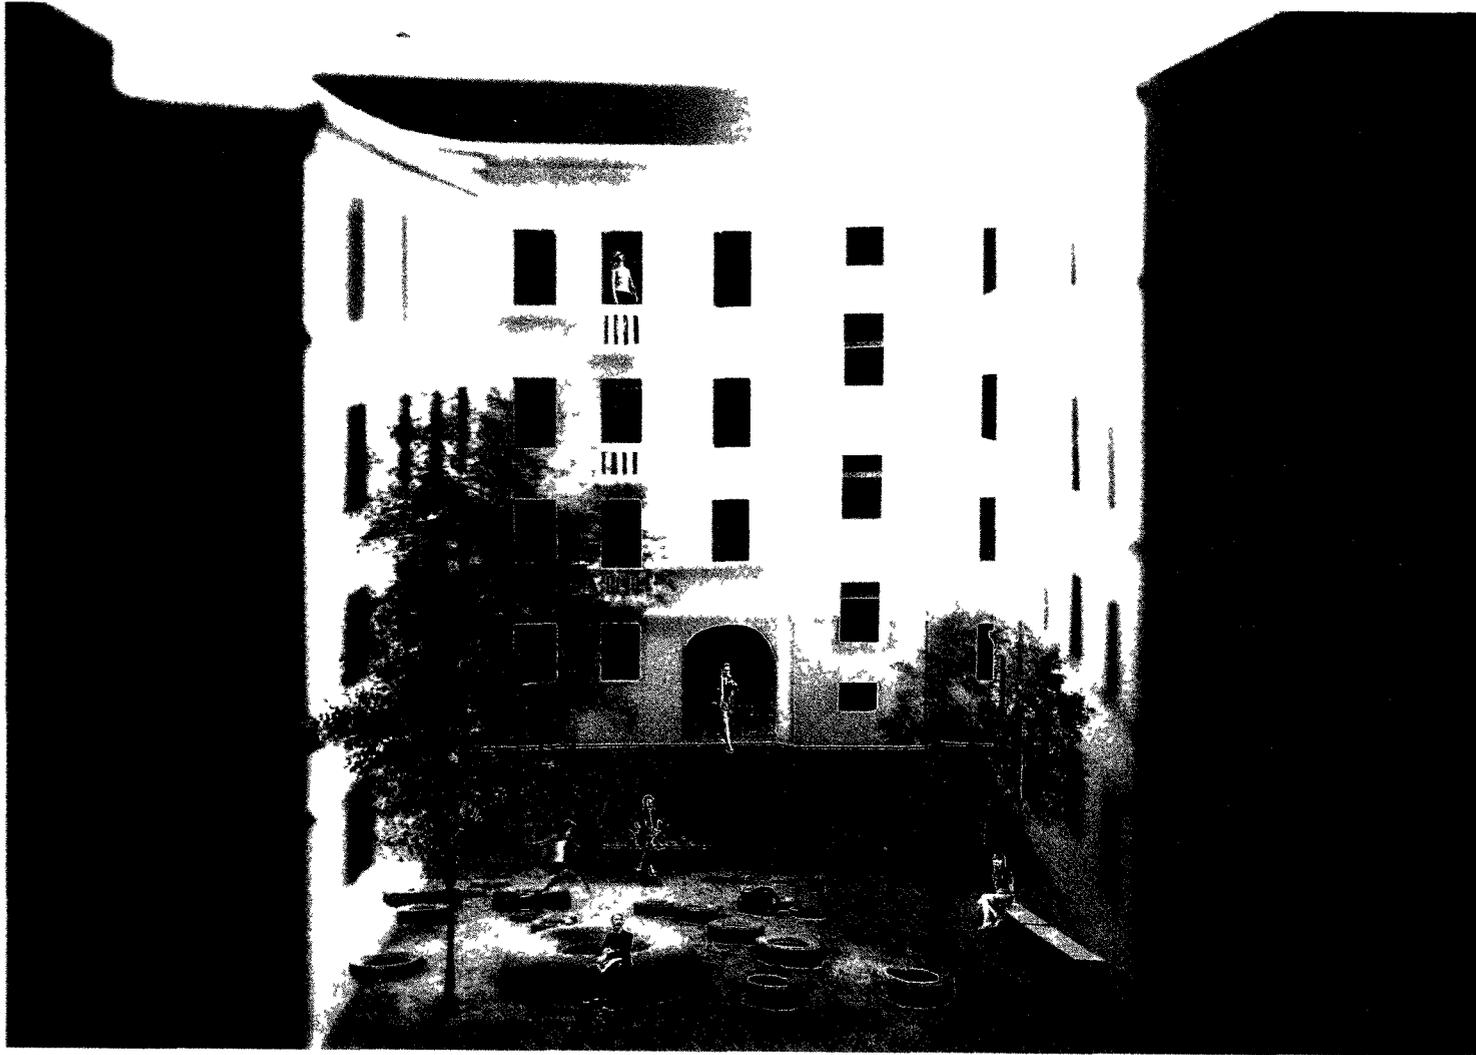
Fig. 46 Courtyard perspective of the historic building, showing the informal landscaping and garden for residents.

It is envisioned that the interior spaces of the tenement apartments will be repaired by updating all services and utilities to modern standards, and a general renovation ensuring structural stability and weather proofing. The courtyard is redesigned to improve the green space with gardens and space for residents to relax, socialize and play.

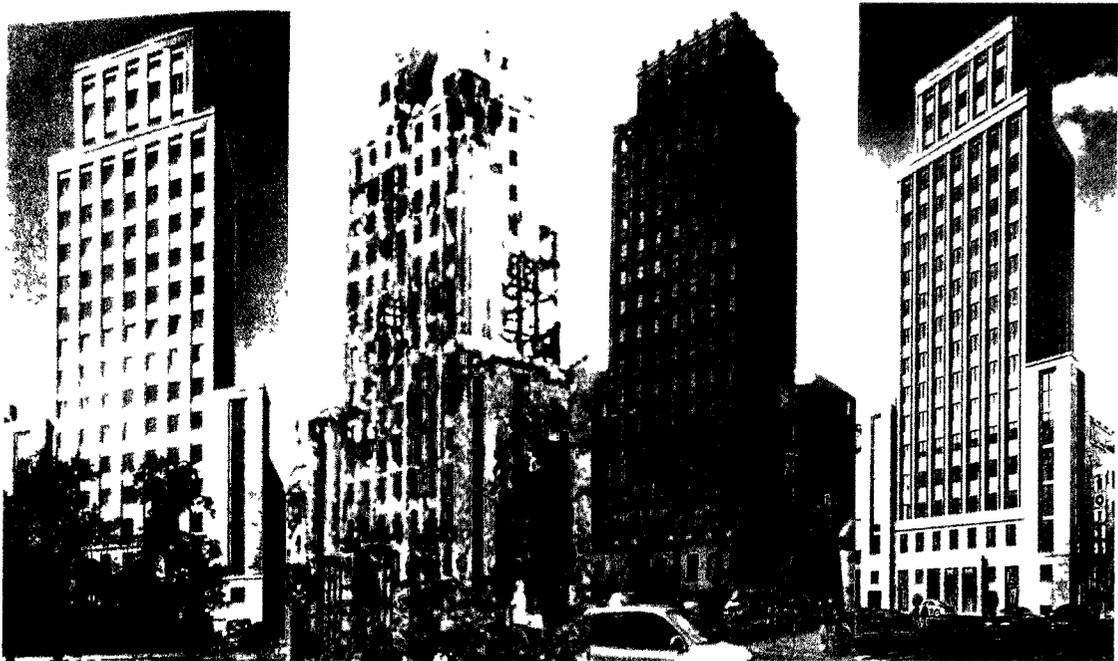
Fig. 47 The Prudential Tower, from left to right: 1934, Fig. 48 1944, Fig. 49 2010. Fig. 50 2012.

The tower faced continuous damage over the course of the war, but its skeleton always remained intact. During the Uprising, heavy artillery damaged the entire building envelope and the interiors were completely burnt by fires, ‘...but the entire building structure was still standing, the steel skeleton towered over the city of ruins and remained a symbol of the heroism of the city’s inhabitants.’²⁴

Because it was costlier to tear down rather than reconstruct, the steel structure was left untouched and for several years it remained a ruin. In 1950 it was decided to reuse the structure and transform the building into a hotel. In 1954 the building reopened and changed its name from Prudential to Hotel Warszawa. Redesigned by the same architect, Marcin Weinfeld, the form of the building was altered in the Socialist Realism style – the official style which was based on Soviet models in Moscow. The tower gained explicit decorative ornamentation with pilasters running the full height of the façades, topped with robust capitals; an open-air colonnaded gallery on the penthouse level; and an interior designed in severe classicism based on the architecture of Moscow’s Stalinist metro stations and public buildings. Ideologically, the tower

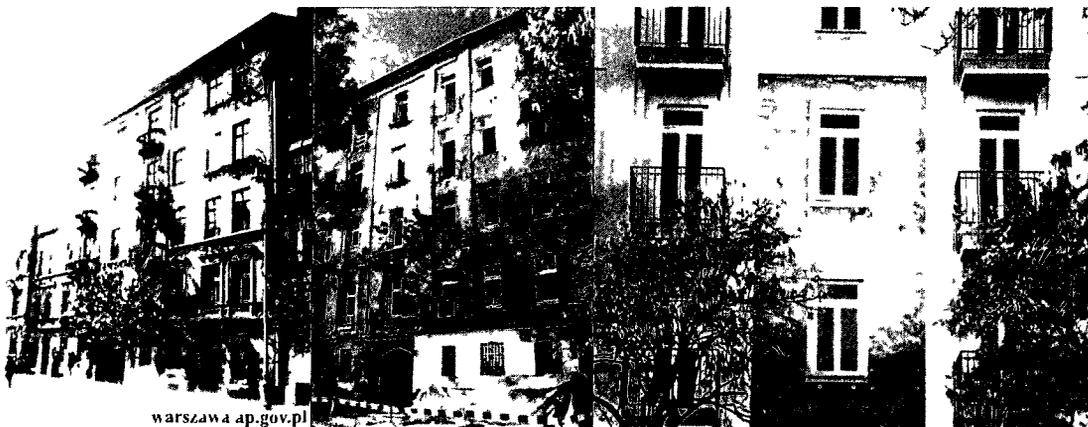
Fig. 53 72 Wilcza Street in 1939 (Left), Fig. 54 before renovation (2009), Fig. 55 and after renovation (2010). The detail on the right shows a fragment of the preserved façade behind glass, while the windows remain operable.

The apartment at 72 Wilcza Street is a typical turn of the XX-century tenement building. It survived WWII with minor but visible damage, and had not been renovated until 2010 after being purchased by an investor in 2009. The renovation successfully restored the façade's ornamentation, while preserving a large central portion in its existing condition in order to display the traces of artillery damage from the war. This surface was carefully preserved to ensure material stability, and encased with transparent glass panels to protect it from the elements. The glass meets the edges of the window frames so that they may continue to be operable. Instead of restoring the entire façade to its original state, the glass surface allows one to be aware of the building's past condition, rejecting notions of false identity and highlighting the historical narrative which is significant in Warsaw.

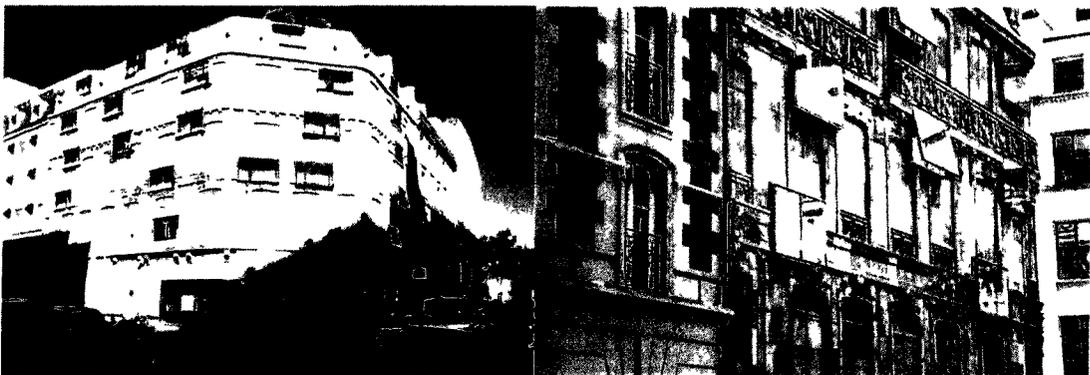
Fig. 58 View of the Hotel. Fig. 59 Façade detail showing seam between historic & new surface.

The façade of the Hotel Fouquet acts as a wallpaper, on which the windows are like picture frames hanging on a wall – the architect pokes fun at the relationship between the interior and exterior by abstracting the surface. This is created with the technique of casting ornament from some of the surrounding buildings and concrete creating moulds for the new façade – which Francois termed *moulé-trouvé*. It is clear that the new openings (windows, garage door, etc.) which randomly break through the surface of the new skin, are being used to allude to the superficial nature of this architectural play. The new building is not a literal reconstruction of a building from former times; instead, the architect reinterprets the typical forms of ornamentation of the direct vicinity, and uses them to refer to historic sensibility and to blend in with the surroundings - but in a completely modern and abstracted way.

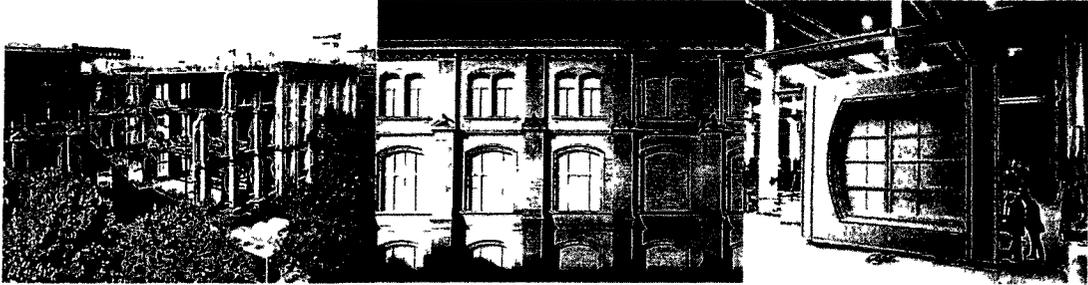
Fig. 62 (Left) The ruined eastern wing. Fig. 63 (Center) Reconstructed fragment.
 Fig. 64 (Right) Concrete façade mould.

In this project, the ruins of the façade (left in this state since the Second World War) were restored, and the gaps of non-existing façades were reconstructed. A new concrete material which mimics the original brick texture was chosen to fill these empty fragments by using a silicone mould which was based on the existing façade. The difference between old and new is subtle but still legible, and the seam between the original yellow brick façade and the new, grey concrete brick façade is noticeable. The act of 'filling in the gaps' with a new material prevents the illusion of a total reconstruction, and instead allows the visitor to witness the seam between old and new.

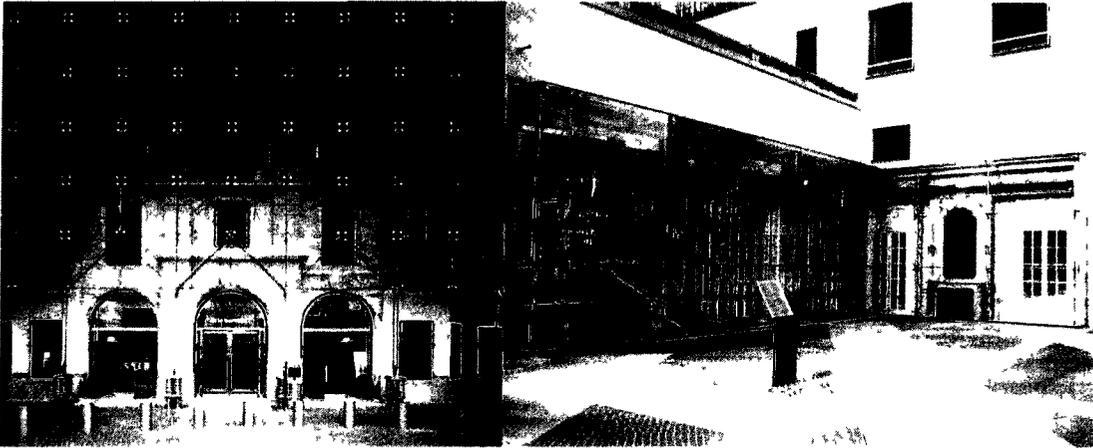
Fig. 65 Surviving façade fragment of the *Esplanade Hotel*, preserved behind glass and incorporated into the *Sony Centre* building. Fig. 66 Interior fragments of the Breakfast Salon now incorporated into the façade of *Café Josty*.

The Frühstückssaal was a breakfast room in the former Esplanade Hotel which was once used by the Prussian royal family and designed in the neo-Rococo style. After the Second World War, only fragments of the original spaces survived, which were then reincorporated into the new Sony Center complex designed by Helmut Jahn. The former interior spaces now form the historic fragments of the exterior façades, reversing the relationship of the interior’s original character. Preserving these 19th century architectural fragments within the surface of a modern building, highlights the historic character of the inherited remnants, and serves to add to Berlin’s interesting architectural narratives.

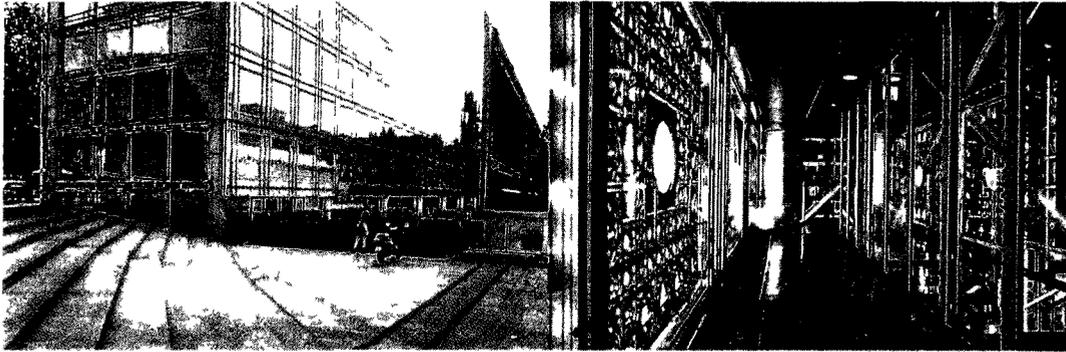
Fig. 75 Exterior view of the Institute Fig. 76 Interior view of the façade system

In this project, the architect uses ornament as a reference to the *jali* screen found in traditional Islamic architecture. At the same time, the ornament is a dynamic mechanism which digitally controls sunlight entering the interior spaces, casting beautiful geometric patterns of shadows. Jean Nouvel has reinterpreted traditional ornament using modern technology, in a way which acknowledges both function and beauty. The ornament is not a literal imitation of historic precedents, rather, it is abstracted and redefined to maintain relevance to our current time.

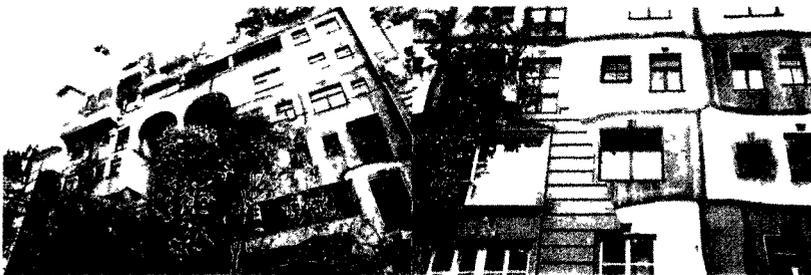
Fig. 77 Renovated façade. Fig. 78 Façade detail, the seam between old and new is visible
