**Experimental and Modeling Studies of Thermal Barrier
Coating Failure under Isothermal Oxidation and Solid
Particle Erosion**

A thesis submitted to the Faculty of Graduate and Postdoctoral Affairs in partial fulfillment of the requirements for the degree of

Doctor of Philosophy in Mechanical Engineering

Carleton University

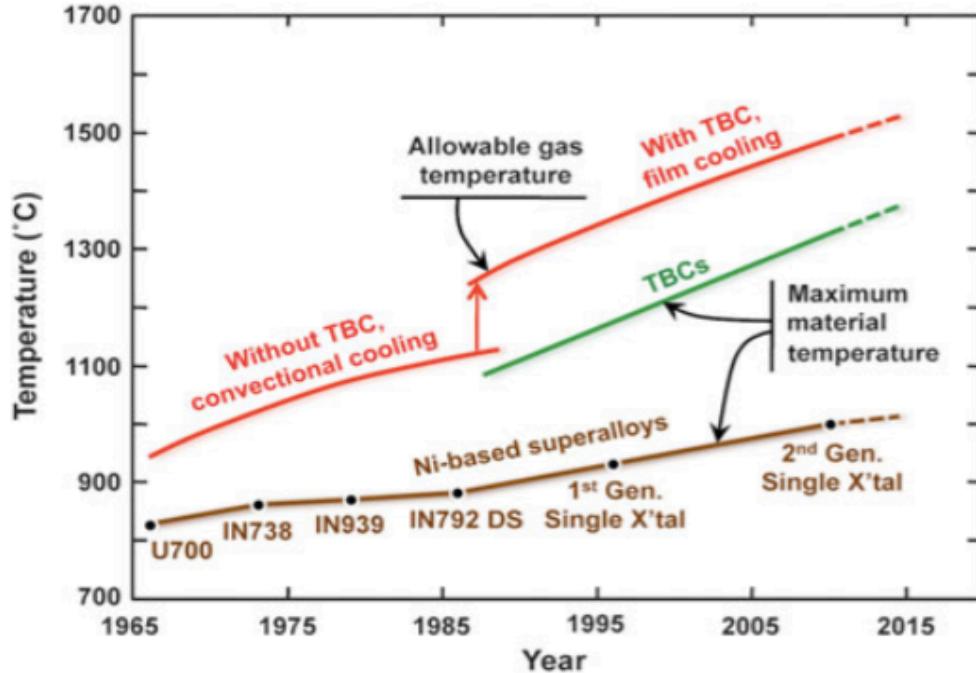
Figure 1.1 Evolution of allowable gas temperature in gas turbines during last 50 years. The red lines show a progression of maximum allowable gas temperature in engines that could be achieved, which is highly increased by employing TBCs [5].

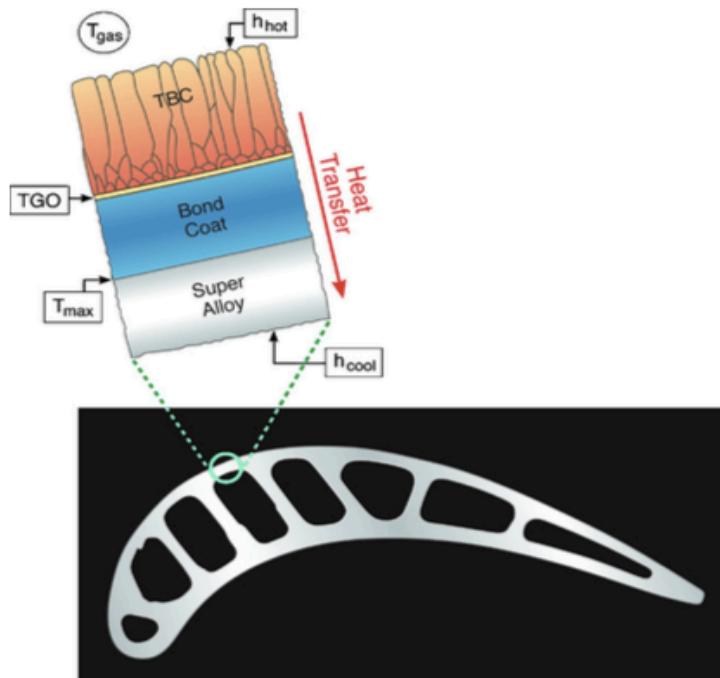
Figure 1.2 An overview of the TBC system on a gas turbine blade [6].

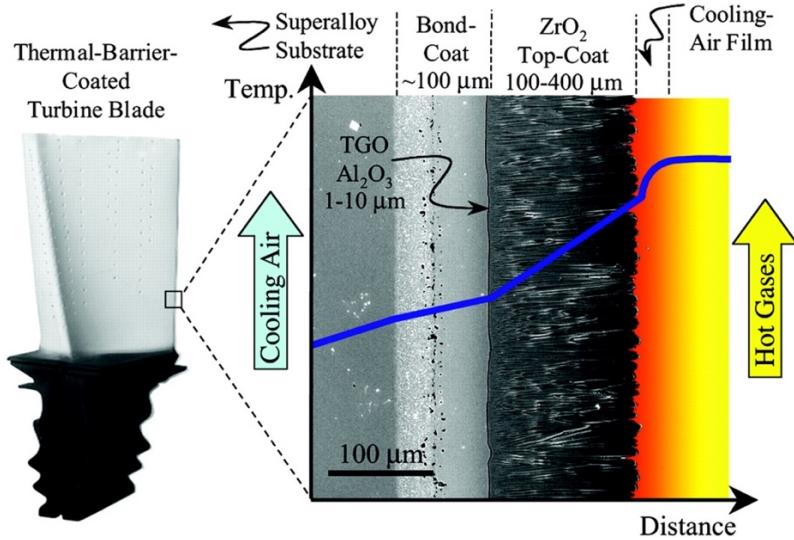
Figure 1.3 Schematic illustration of the TBC structure with coating dimensions shown on a turbine blade [4].

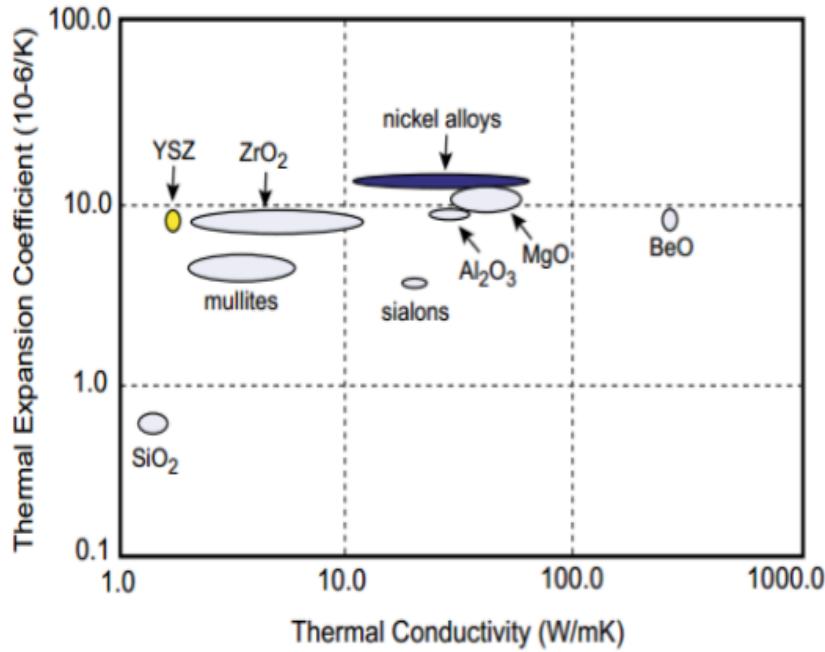
Figure 2.2 Thermal expansion coefficients and thermal conductivity of various materials [11].

coefficients and thermal conductivity properties of different materials [11]. It can be seen that yttria stabilized zirconia has the desired combination of low thermal conductivity and high thermal expansion coefficient.

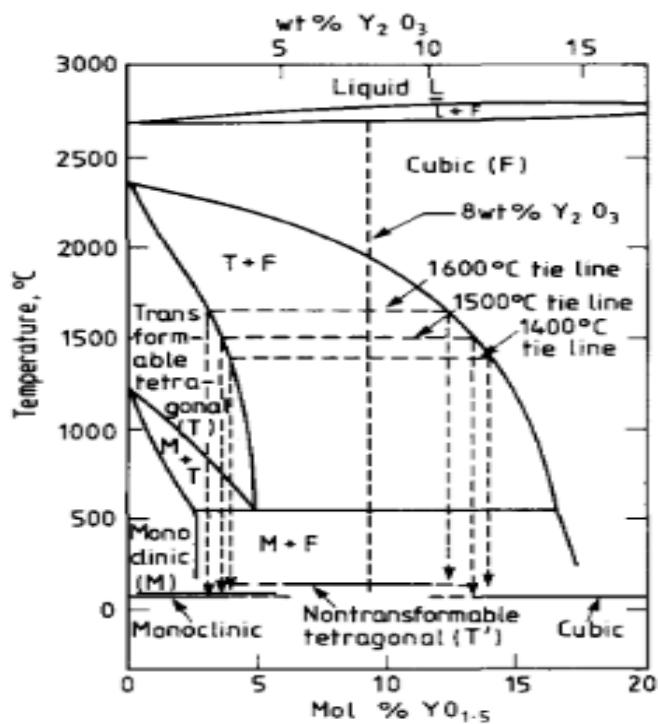
Figure 2.3 Phase diagram of yttria-stabilized zirconia system [13].

required to stabilize the tetragonal phase of zirconia, a high fraction of yttria content can negatively impact the cyclic lifetime of the coating. It has been found that the content of 6 to 8 wt% gives the best compromise in properties [12], [13]. The phase diagram of the zirconia-yttria system in the composition range of interest for TBCs is shown in **Figure 2.3** [12].

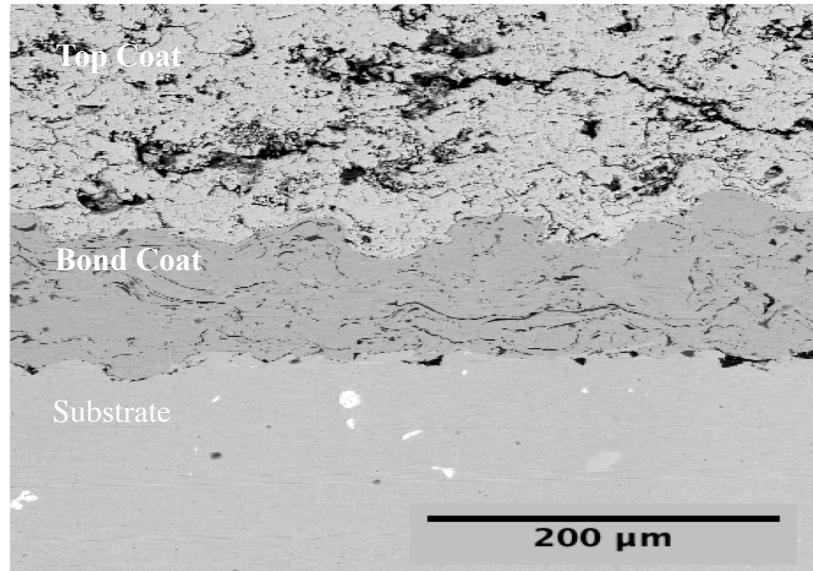
Figure 2.5 SEM microstructure of YSZ coating deposited with APS.

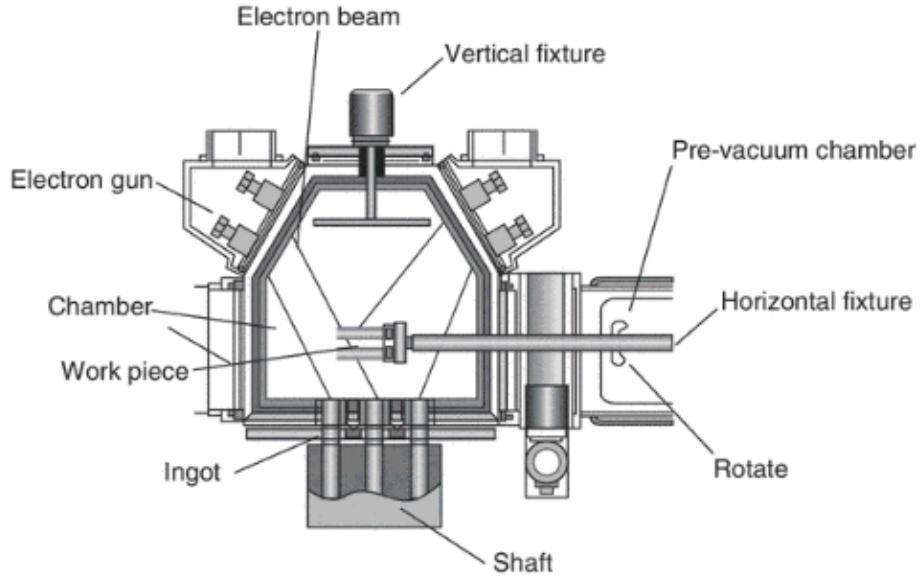
Figure 2.6 Schematic diagram of an electron beam physical vapor deposition (EB-PVD) system [14].

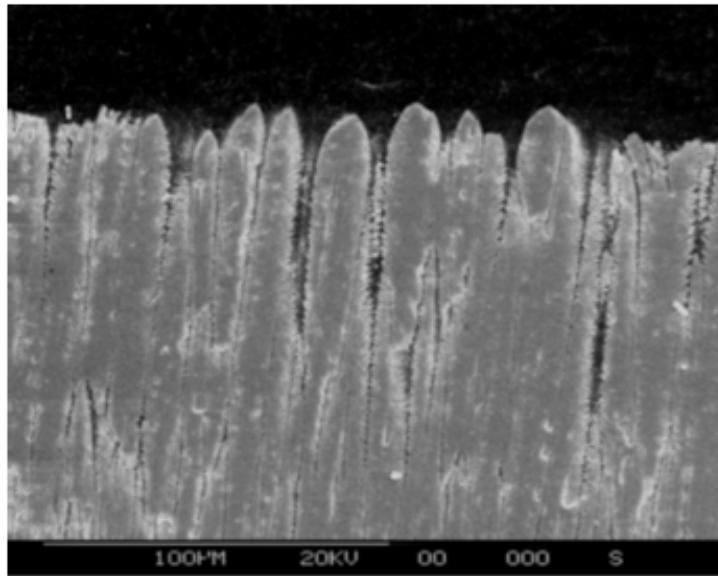
Figure 2.7 SEM microstructure of YSZ coating deposited with EB-PVD [18].

deposited by APS, EB-PVD TBCs have a columnar microstructure with nanometer-scale porosity and channels separating the columnar grains [16], as shown in *Figure 2.7*. The disconnected columns provide excellent strain tolerance and reduce thermal conductivity. Compared to APS TBCs described above, EB-PDV TBCs generally have longer thermal-cycling lives, but they are more expensive in production. As a result, EB-PVD TBCs are suitable for applications in aircraft engines, such as turbine blades [4], [17].

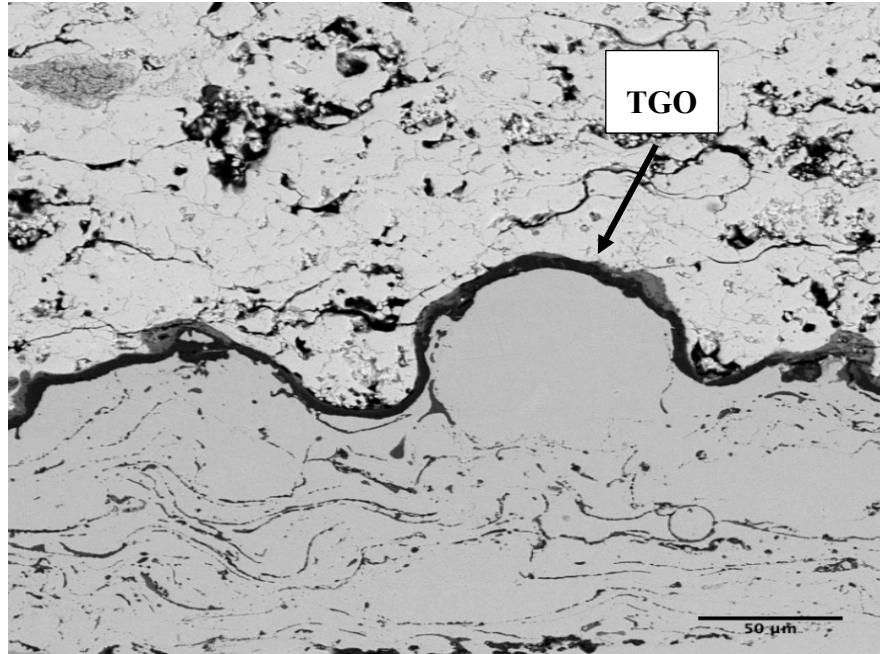
Figure 2.10 SEM microstructure in cross-section of a TBC system showing bond coat oxidation with developed TGO.

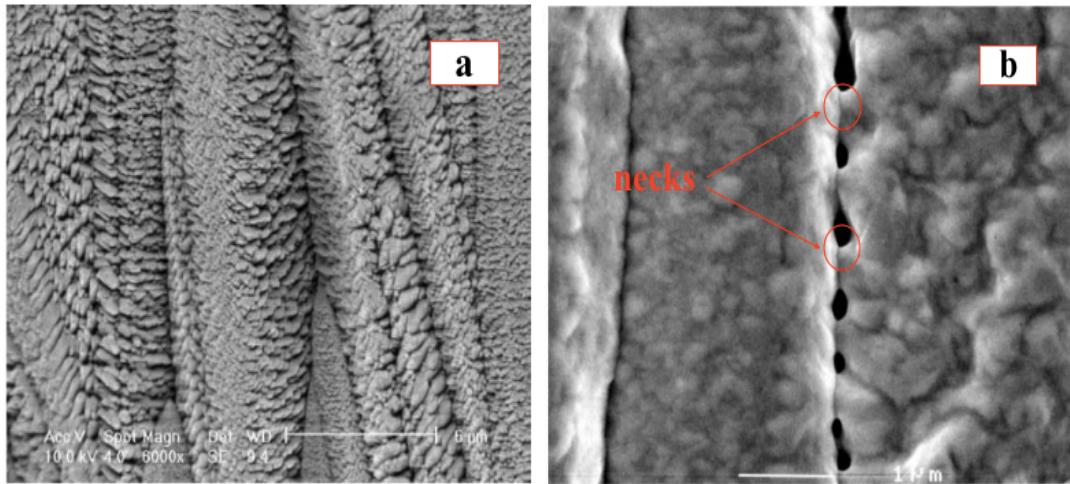
Figure 2.11 Microstructure of EB-PVD top coat: (a) feathery shape of columns and (b) formation of necks [61].

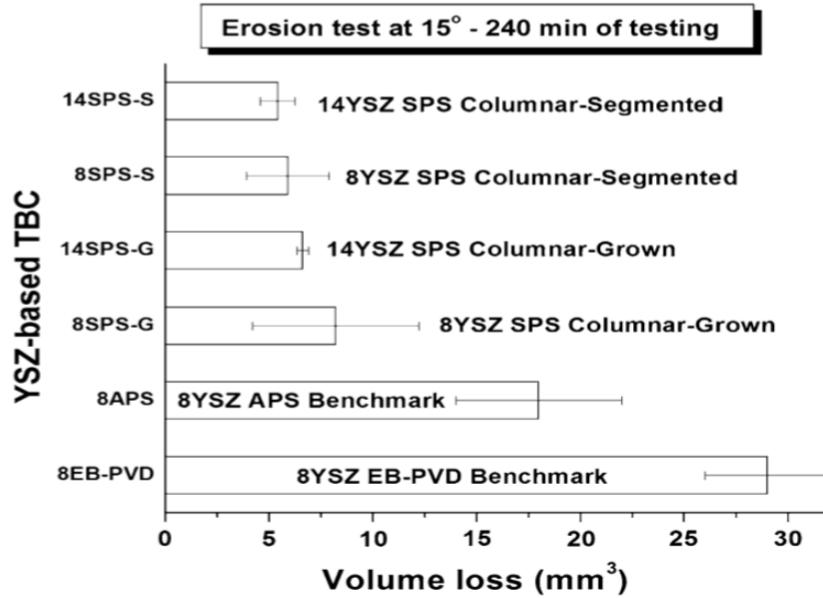
Figure 2.15 Comparison of solid-particle erosion loss between different TBCs [79].

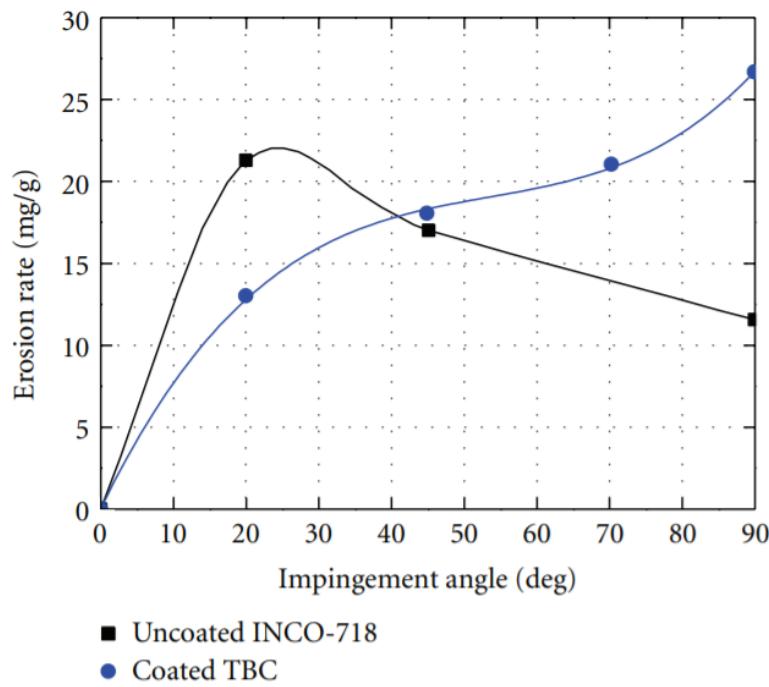
Figure 2.17 Comparison of erosion rate of Inconel 718 with or without TBC under impact with $26 \mu\text{m}$ alumina particles at 1093°C and 365.8 m/s [80].

erosion performance, as shown in *Figure 2.17*, the latter had a turning point on the erosion rate curve (about 20 degrees impingement angle) where the erosion rate started to decrease with impingement angle. This was attributed to the ductile feature of Inconel 718 alloy, which made the erosion mechanism change at the critical impingement angle [80].

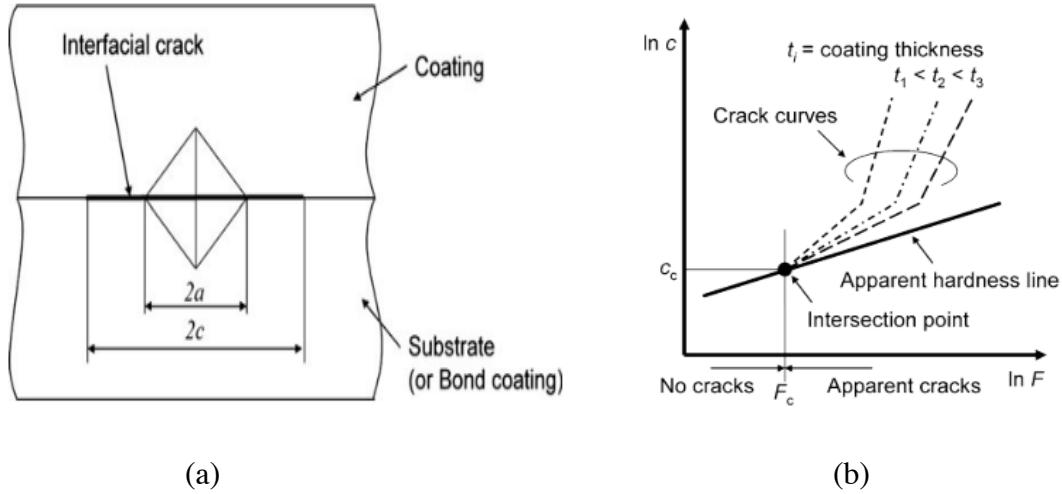
Figure 2.19 Interfacial crack in a TBC system under indentation: (a) geometry of interfacial crack and (b) schematic illustration of crack length [91].

of the radial crack which starts at the corner of the indentation mark or impression, as indicated in **Figure 2.19 a**. When the crack length is plotted as a function of the applied load in a bi-logarithmic scale, a linear relationship (called the crack curve) is achieved for a given substrate and coating thickness [91]. Similarly, the relationship between the half diagonal length of the impression, and the applied force is linear, as shown in **Figure 2.19 b**. The intersection between the line of the half of the diagonal and the line of the crack length is the critical point for failure, as indicated in **Figure 2.19 b**. The coordinates of the points are the critical load F_c and the corresponding critical crack length c . The apparent interfacial fracture toughness is calculated by using these coordinates of the critical point [91], [92].

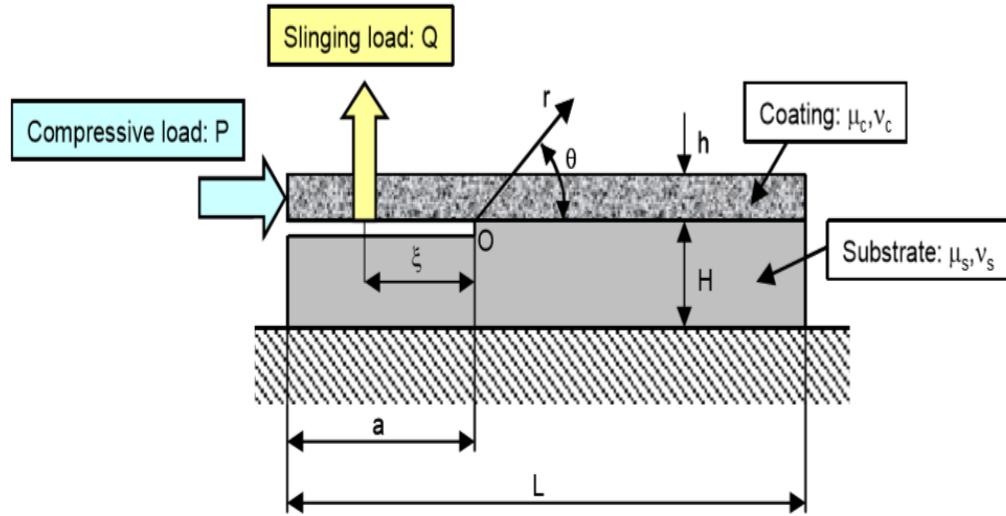
Figure 2.20 Mixed-mode interfacial fracture testing method [87].

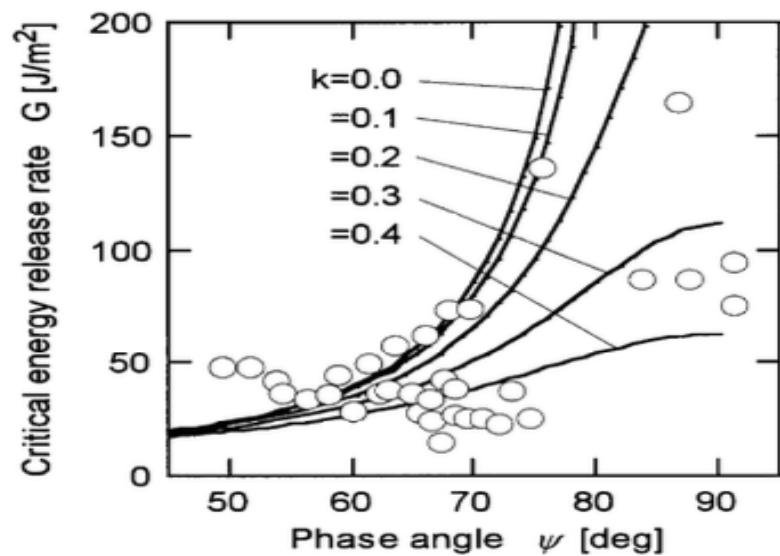
Figure 2.21 Critical energy release rate varying with loading phase angle and interfacial crack roughness k value [94].

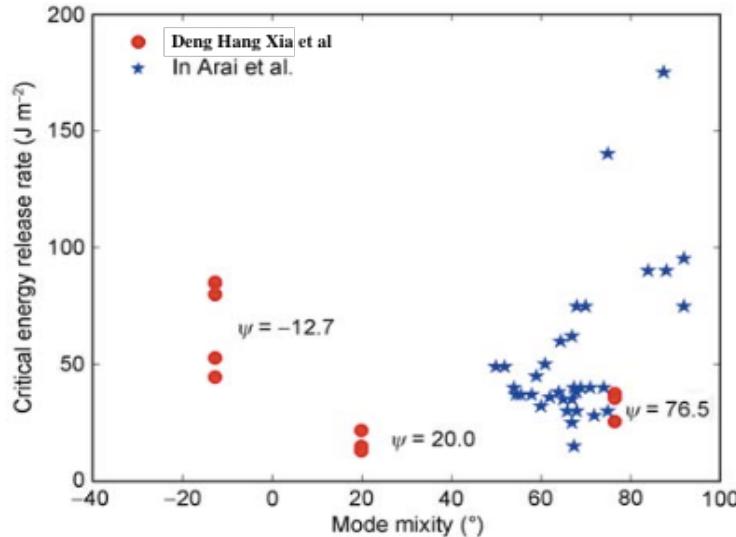
Figure 2.22 Critical energy release rate varying with mode mixity [95].

Deng et al. [95] developed a mixed-mode test method to evaluate the interfacial fracture toughness of TBCs over a wide range of mode mixity. Their results shown in **Figure 2.22** reveal the dependence of the critical energy release rate on mode mixity. The measured critical energy release rate in their work varies from 13 to 85 J.m⁻² with mode mixity range $-12.7^\circ < \psi < 76.5^\circ$. The differences in critical energy release rates between these tests may be attributed to many factors such as the difference in properties of each layer and the interface, the difference in surface roughness and stress at the interface, etc.

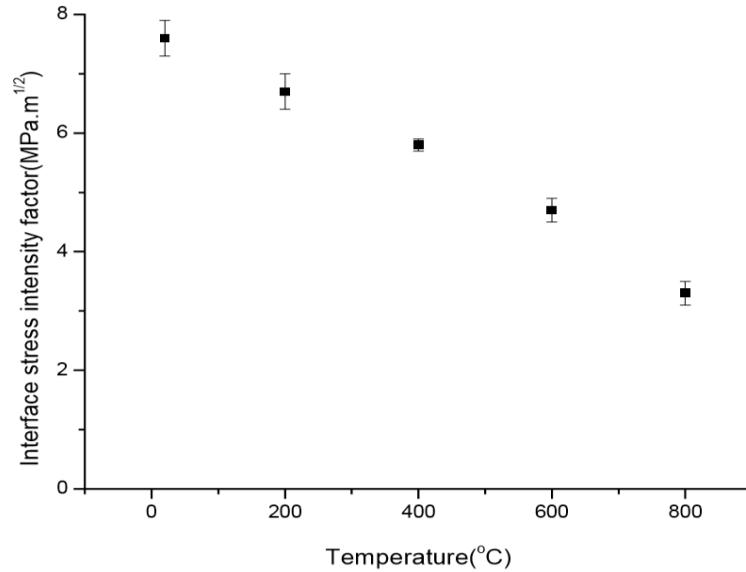
Figure 2.24 Variation of interface stress intensity factor of TBCs with temperature [97].

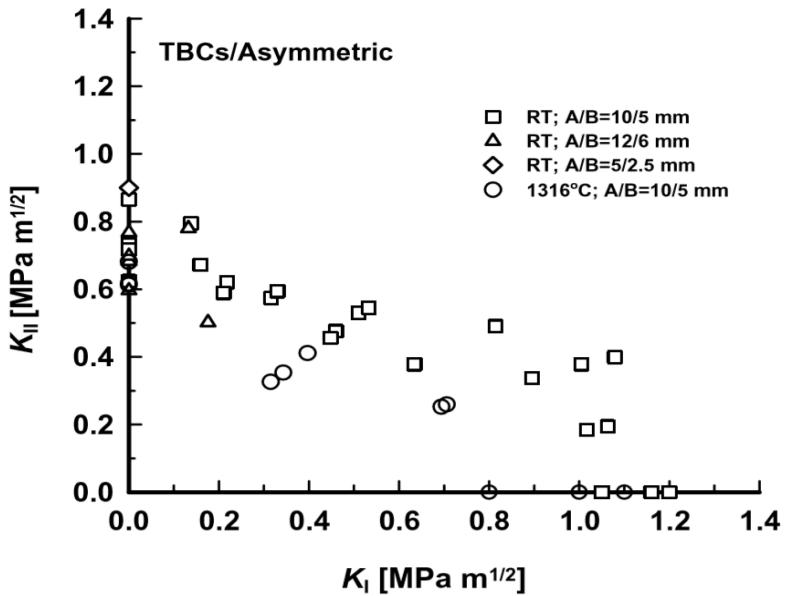
Figure 2.25 A summary of K_I versus K_{II} for mode I, mode II, and mixed mode fracture of plasma-sprayed ceramic TBC at 25 °C and 1316°C in air , A and B distances from a load point [98].

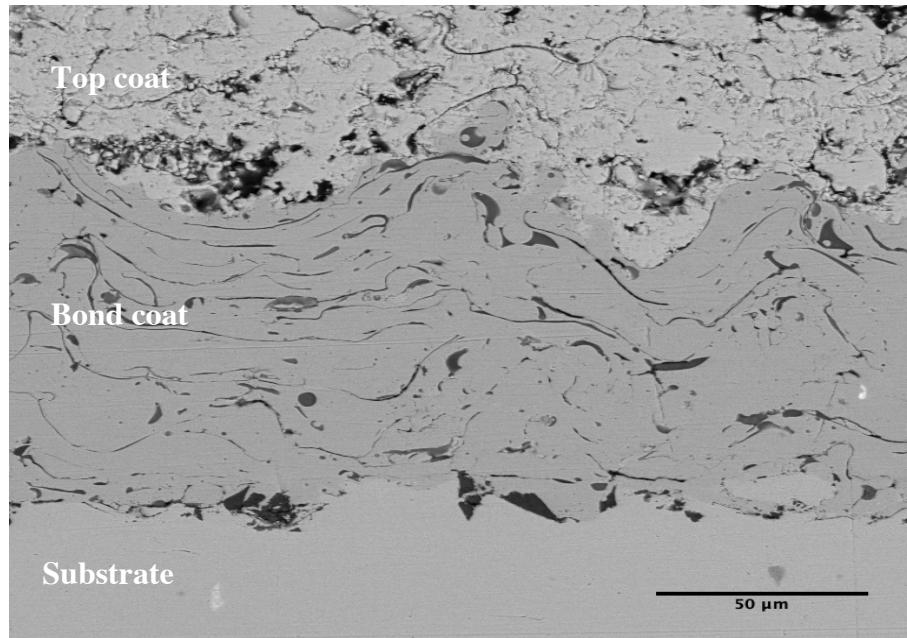
Figure 3.3 shows the typical microstructure of the TBC system in the as-deposited condition. The cross-section microscopic image displays the three layers, substrate, bond coat, and top coat. The APS top coat layer is about $254 \pm 5.9 \mu\text{m}$ thick. The thickness of the bond coat is approximately $111.70 \pm 3.9 \mu\text{m}$.

Figure 3.3 SEM image in cross-section of the TBC specimen in as-deposited state.

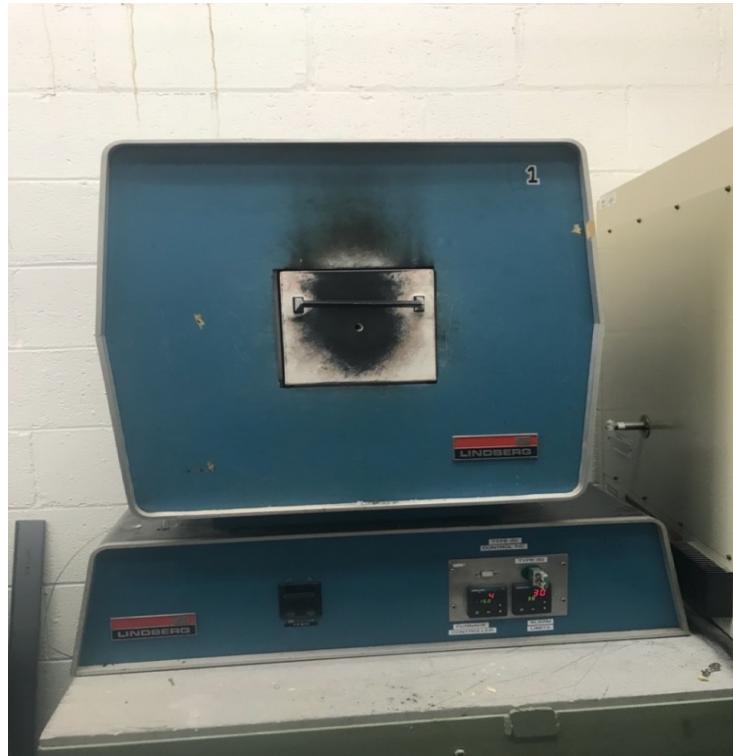
Figure 3.4 Lindberg Type (s) Box Furnace.

The tests were performed using a Lindberg type (s) box furnace, shown in *Figure 3.4*. The furnace was preheated to the set temperature before the TBC specimens were inserted. The detailed test plan is given in *Table 3.2*. For each test, after the set test time, or after the failure had occurred, the specimens were removed from the furnace and allowed to cool in laboratory air to room temperature before being prepared for examinations to compare their oxidation kinetics and damage to the coatings caused during the oxidation process.

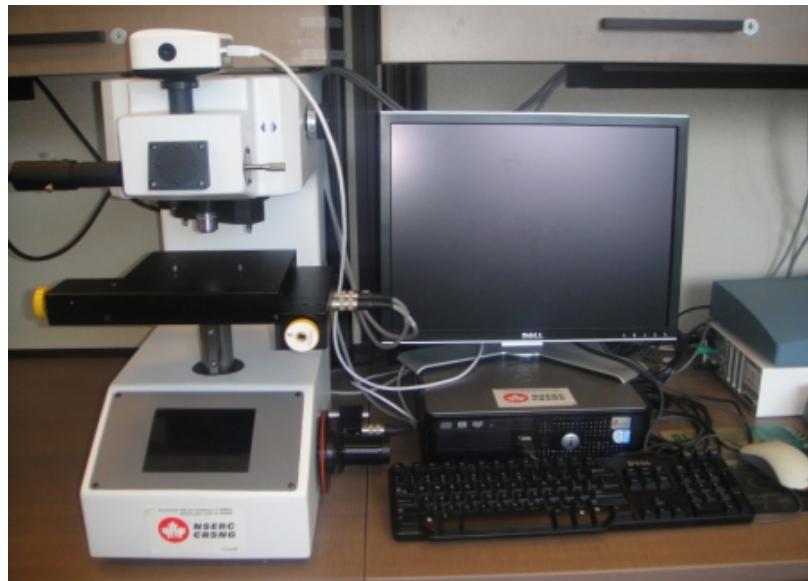
Figure 3.5 Microhardness Tester Unit, Model SMT-X7 Dual Indenter.

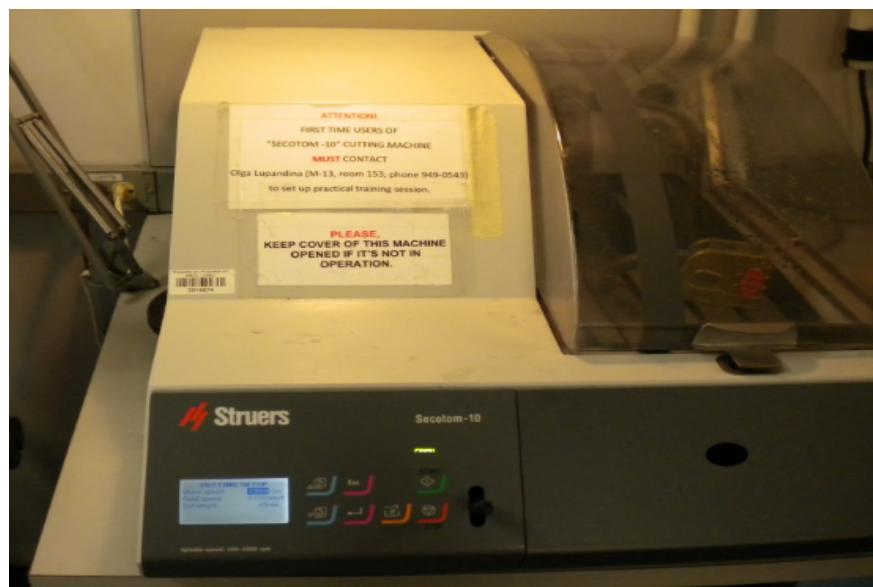
Figure 3.8 Secotom-10 Cutting Machine (Courtesy of Struers Co.).

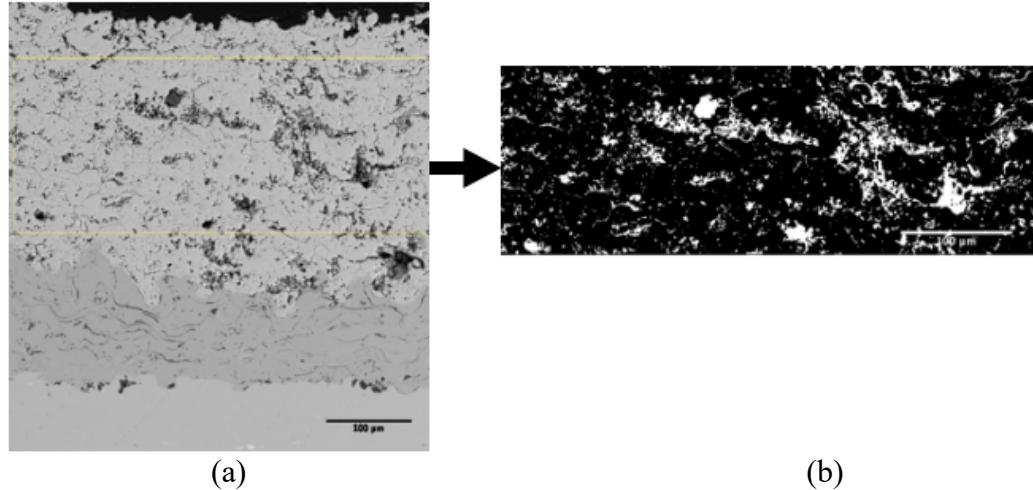
Figure 3.13 Cross-section microscopic images of the TBC sample for porosity analysis using Image J software: (a) SEM microstructure and (b) processed binary image showing pores.

black pixel, and the pores were converted into white pixels, as shown in **Figure 3.13**. The process of selecting the appropriate range of white pixels was done to ensure that only voids were sampled. The analysis was repeated at least three times for each image to ensure accurate.

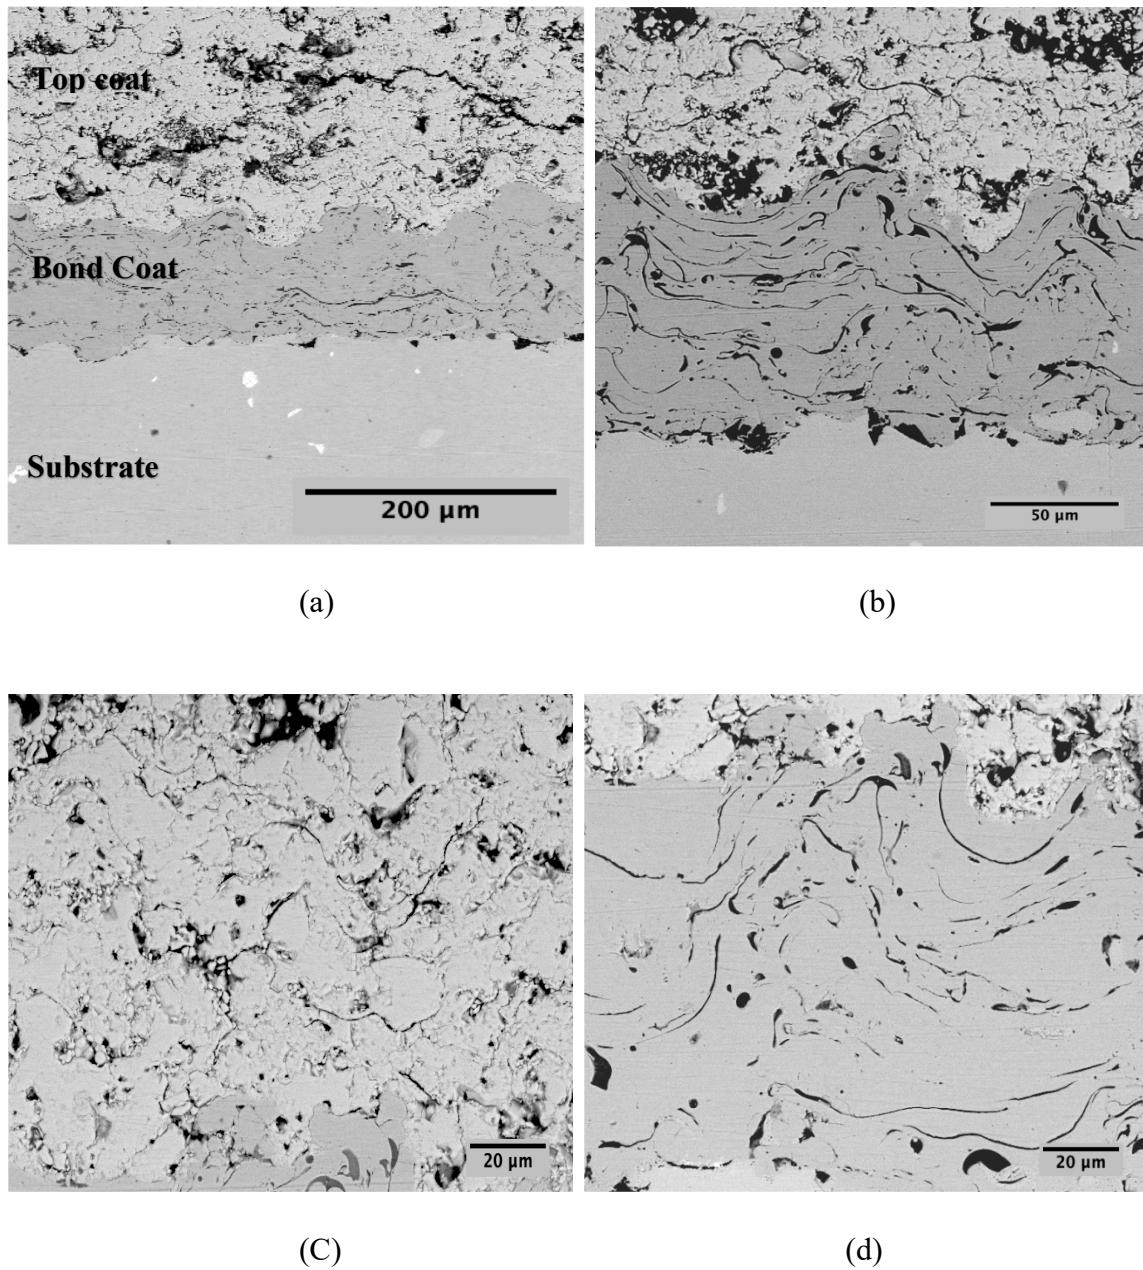
Figure 4.1 SEM microstructure of the TBC specimen for isothermal oxidation test in as-deposited state: (a) cross-section image at low magnification, (b) cross-section image at high magnification, (c) top coat and (d) bond coat.

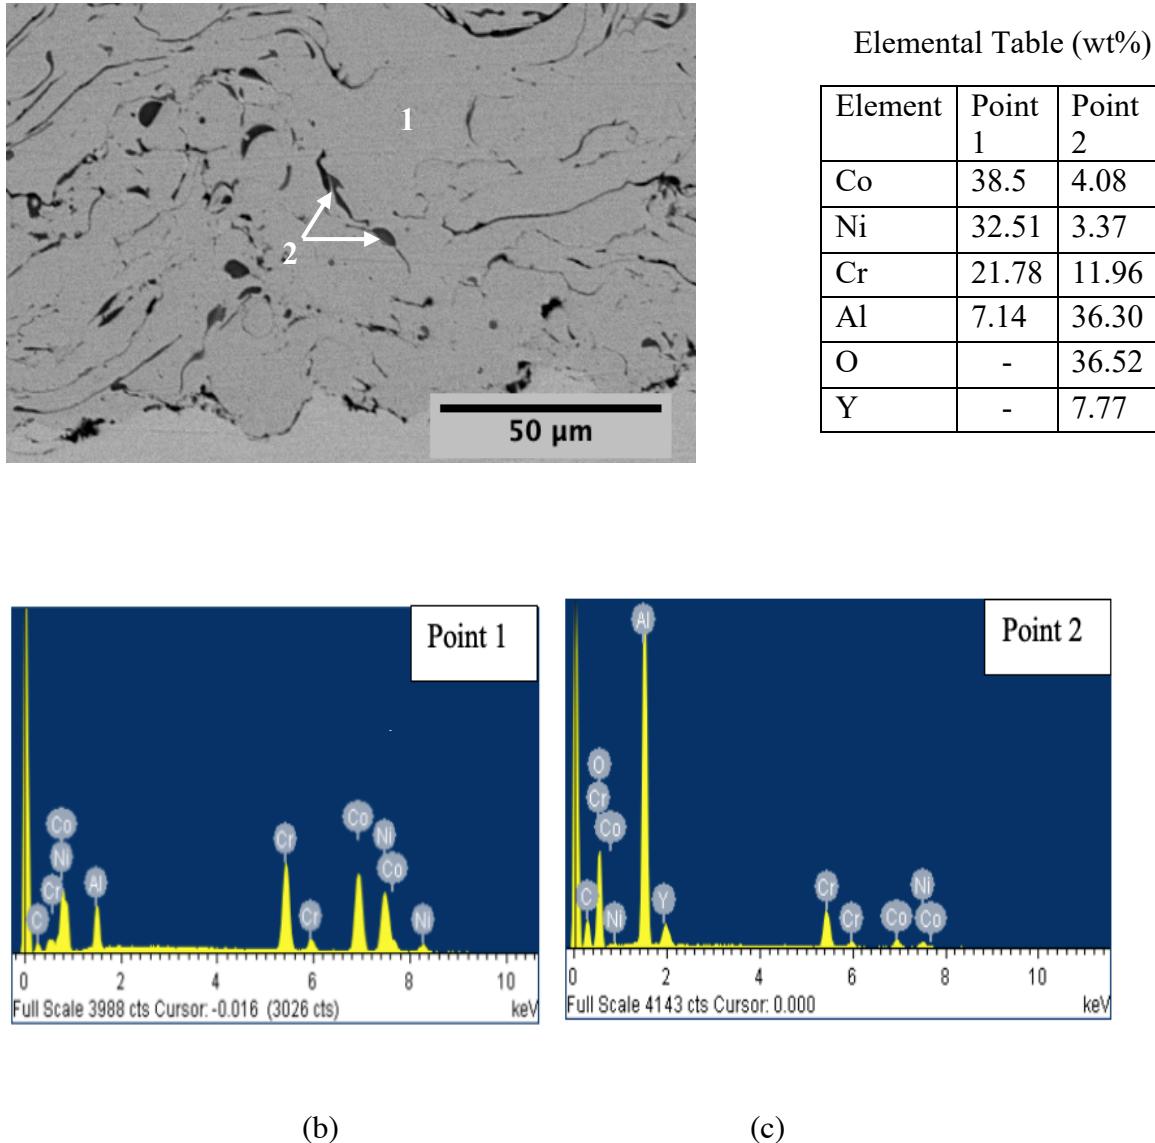
Figure 4.2 EDS analyses of CoNiCrAlY bond coat: SEM microstructure with selected points indicated, (b) EDS spectrum of alloy matrix (point 1) and (c) EDS spectrum of oxide particle (point 2).

is known from chapter 2 that element Y is usually added to the bond coat of TBCs to enhance the alumina scale adherence. The absence of this element in the metallic matrix of the bond coat of the as-deposited TBC specimen could be attributed to the oxidation Y in the coating deposition process, which had limited its positive effect in the bond coat.

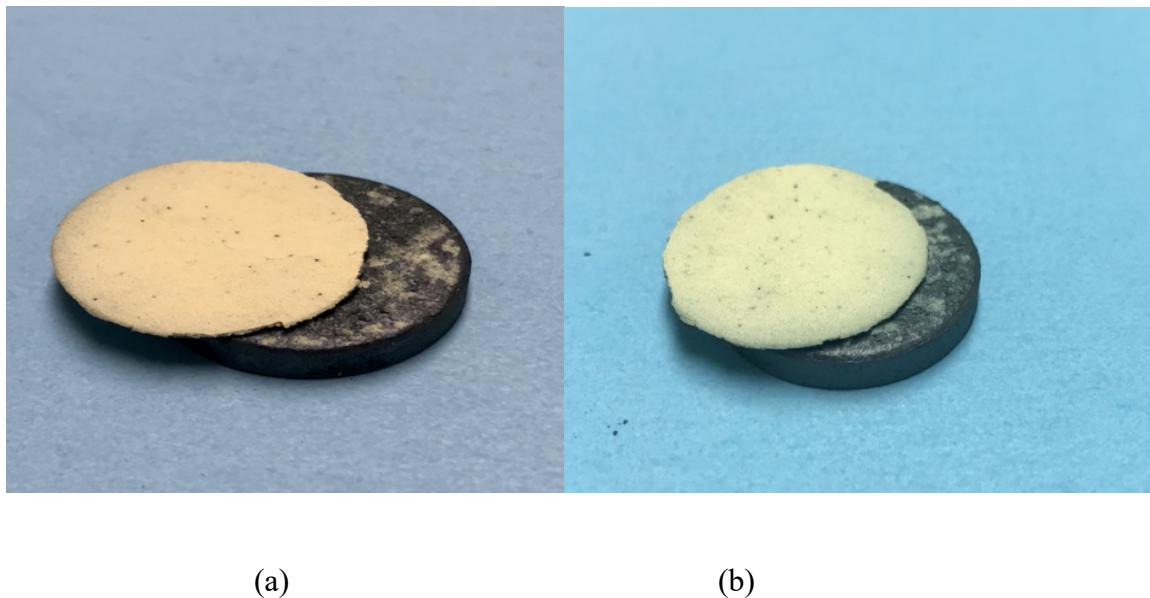
Complete spallation had also occurred when the TBC specimen was oxidized at 1150°C for 360 h and then cooled down to ambient temperature. The specimen did not show any sign of macroscopic or complete spallation initially as soon as it was cooled down, but after a short time at room temperature, the YSZ top coat layer had completely spalled off. Generally, the exposure time at a high temperature until failure decreased with increasing the exposure temperature.

Figure 4.4 Macrograph of failed TBC specimen (a) after 1500 h at 1100°C and (b) after 360 h at 1150°C isothermal test showing top coat spallation.

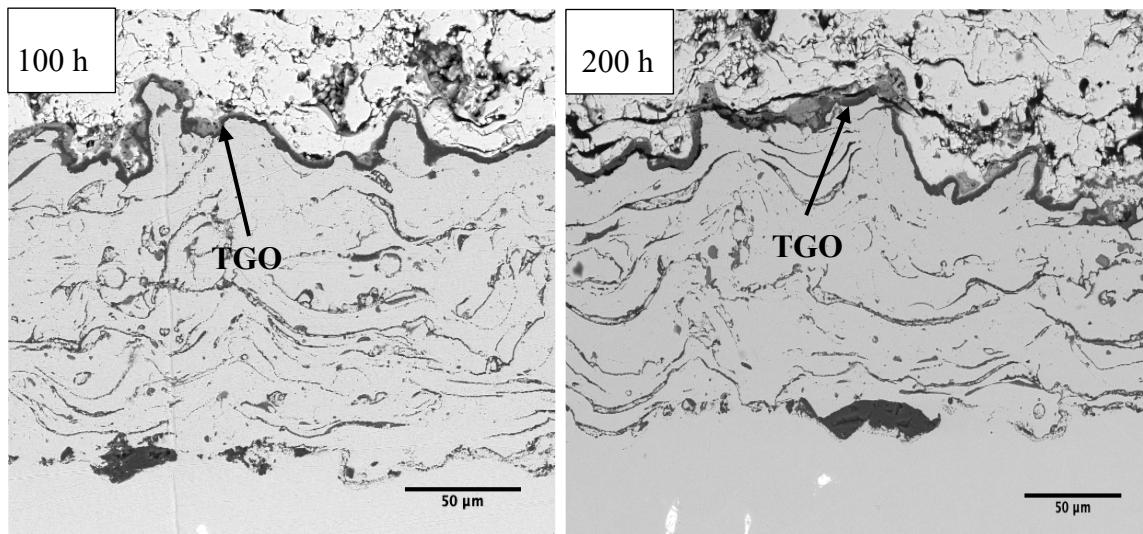
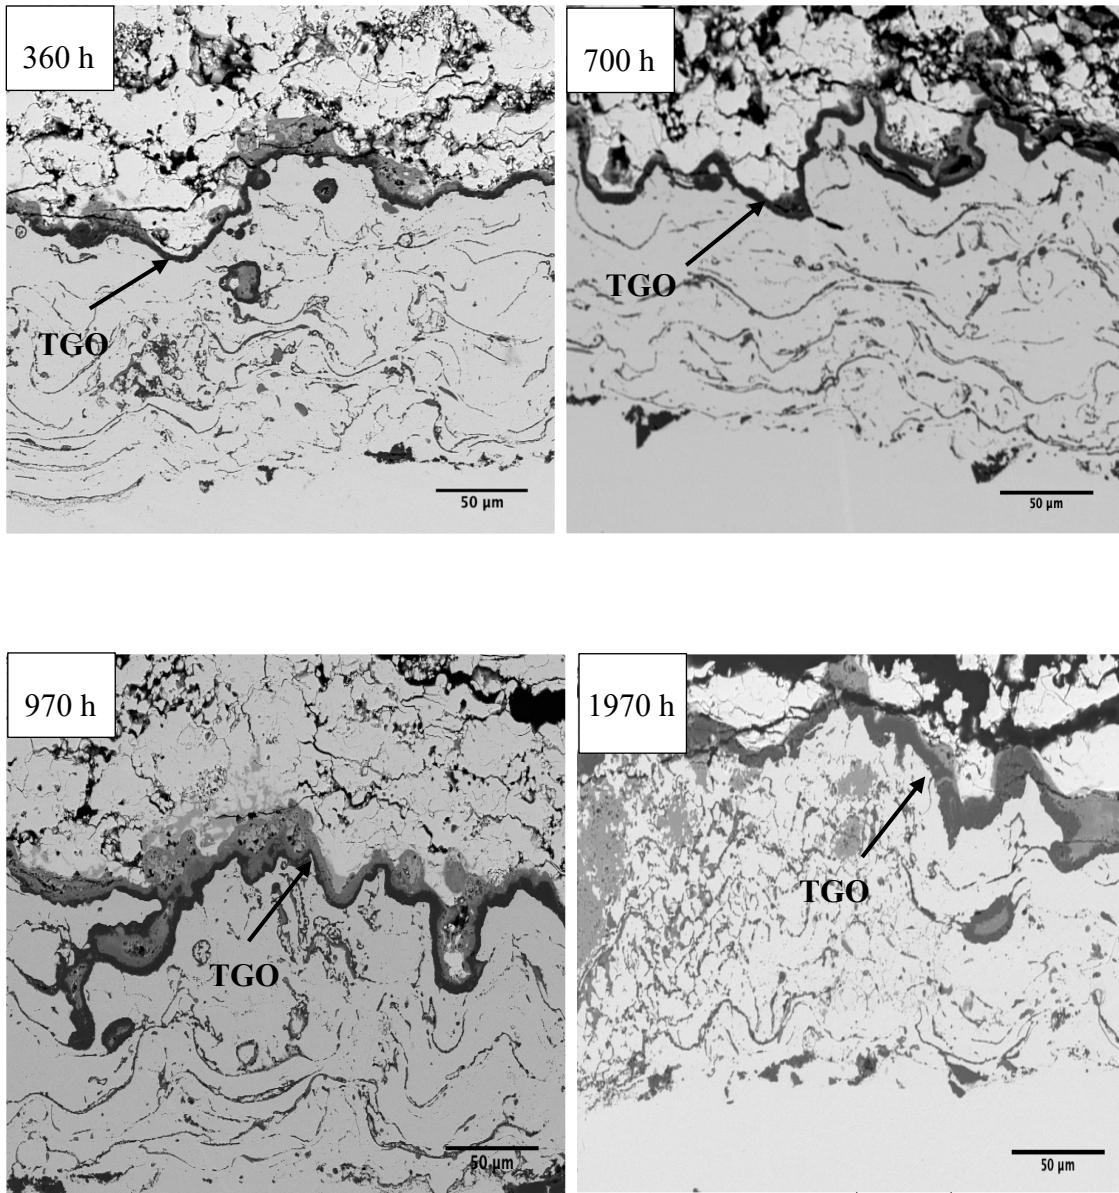
Figure 4.5 SEM image of the oxidized TBC specimen showing a TGO formed at 1050°C for different exposure times.

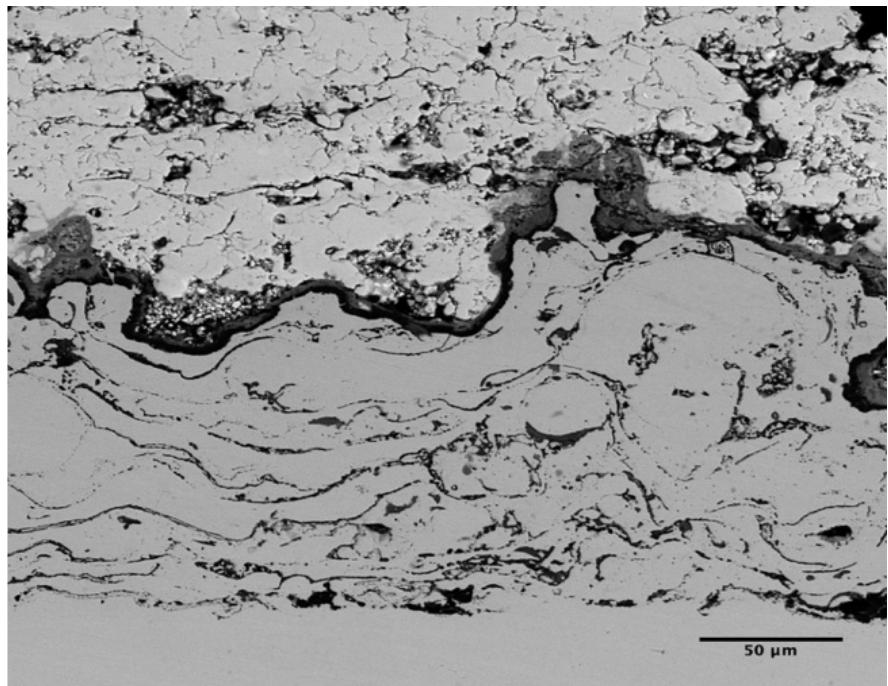
(a)

The interface SEM microstructures of the oxidized specimens after 200 h of exposure at 1100°C and 1150°C are shown in **Figure 4.7**. The oxidation behavior of the TBC specimens oxidized at 1100°C and 1150°C was similar to that at 1050°C, but the TGO layer was obviously thicker and the rate of oxide formation was higher at these temperatures. The TGO scales showed an obvious double-layer structure with the outer layer consisting of mixed oxides and the inner layer containing mainly Al₂O₃, as revealed by the EDS analysis. The thickness of the TGO at 1100°C after 200 h exposure increased and reached 6.11 μm and 9.45 μm at 1150°C, compared to 3.77 μm at 1050°C.

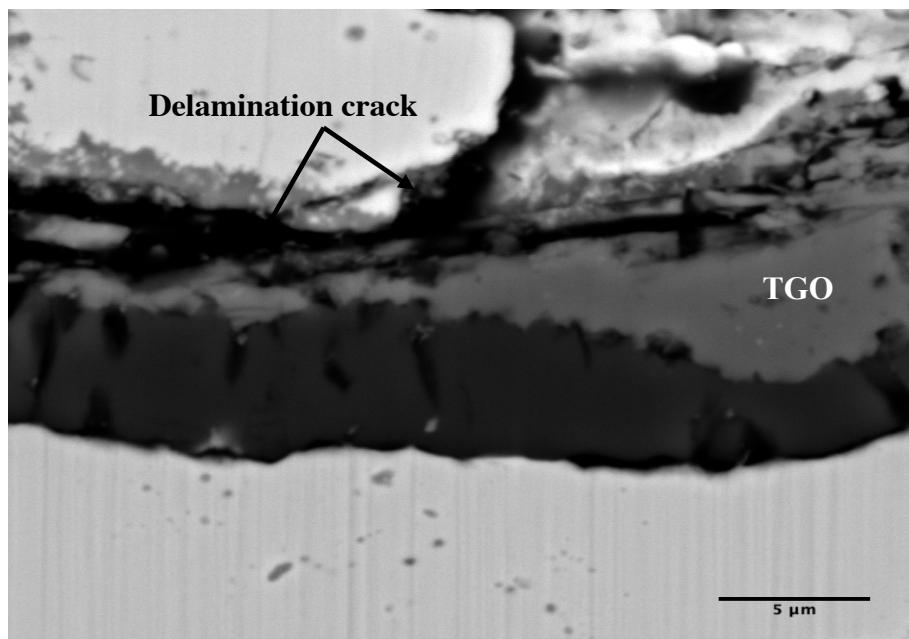
The formation of the TGO layer and subsequent thickening of the oxide layer resulted in the development of out-of-plane stresses at the interface, which promoted cracking within the vicinity of the interface. With increasing the time of exposure, these stresses increased as the TGO became thicker, thus led to the propagation of microcracks and subsequent the failure of the coating. **Figure 4.8** shows the delaminated top coat/TGO interface in the TBC specimen oxidized at 1150°C for 200 h.

Figure 4.8 SEM micrograph of developed TGO layer containing cracks after 200 h of exposure at 1150°C.

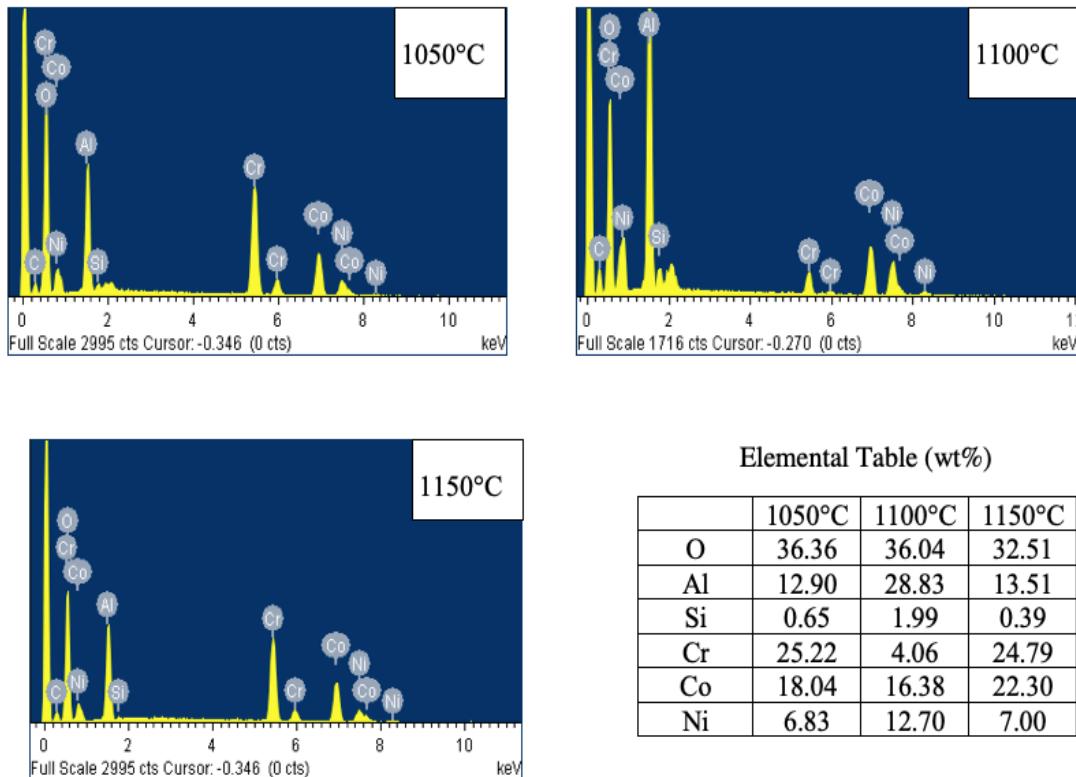
Figure 4.9 EDS spectra of the TGO in the specimens oxidized at different temperatures for 200 h.

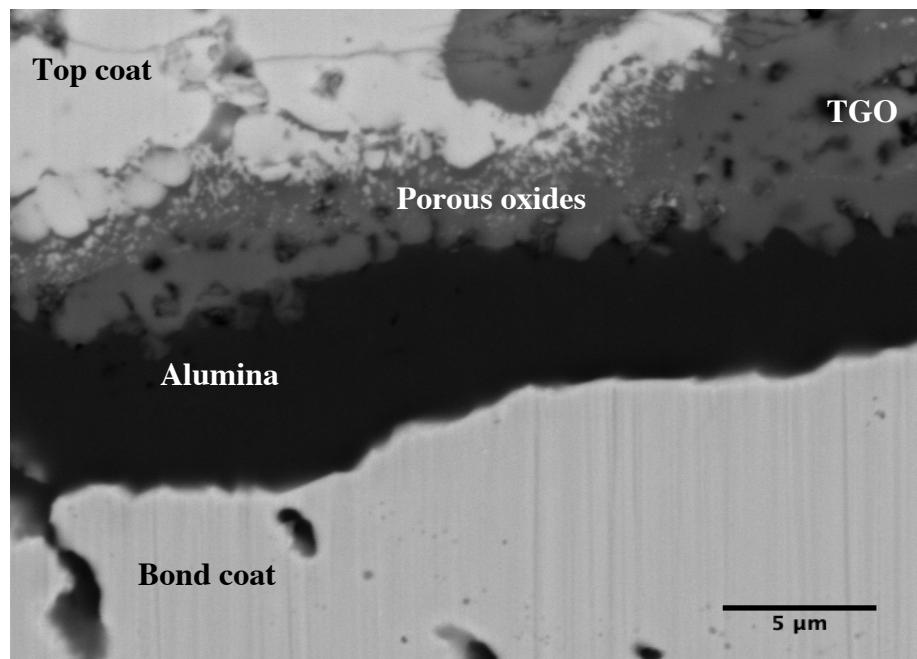
Figure 4.10 SEM micrograph of the oxidized specimen showing porous and non-uniform TGO when oxides rather than alumina are present.

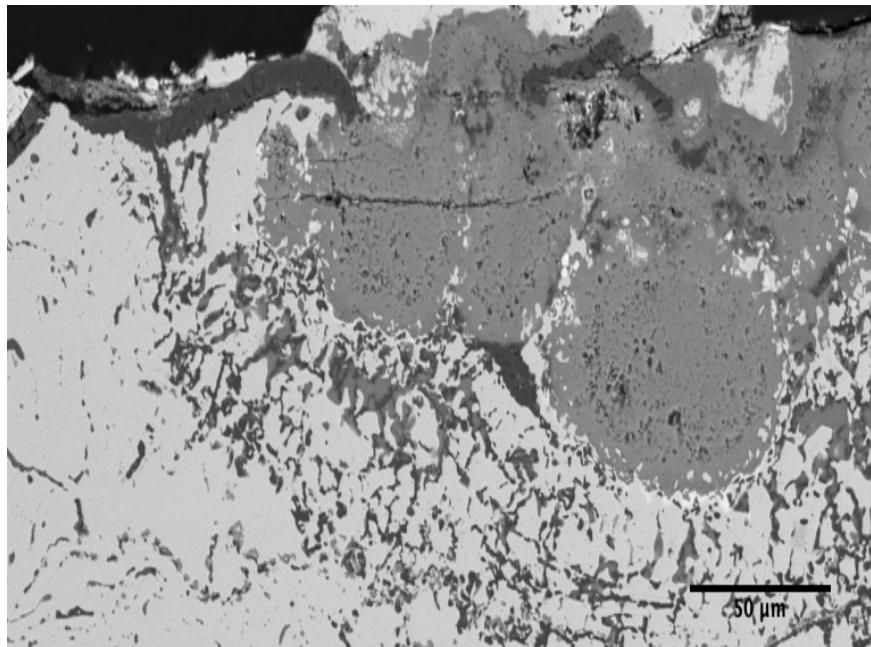
Figure 4.15 SEM micrograph of internal oxides in the bond coat of the TBC specimen oxidized at 1150°C for 360 h.
