**Experimental and Modeling Studies of Thermal Barrier
Coating Failure under Isothermal Oxidation and Solid
Particle Erosion**

A thesis submitted to the Faculty of Graduate and Postdoctoral Affairs in partial fulfillment of the requirements for the degree of

Doctor of Philosophy in Mechanical Engineering

Carleton University

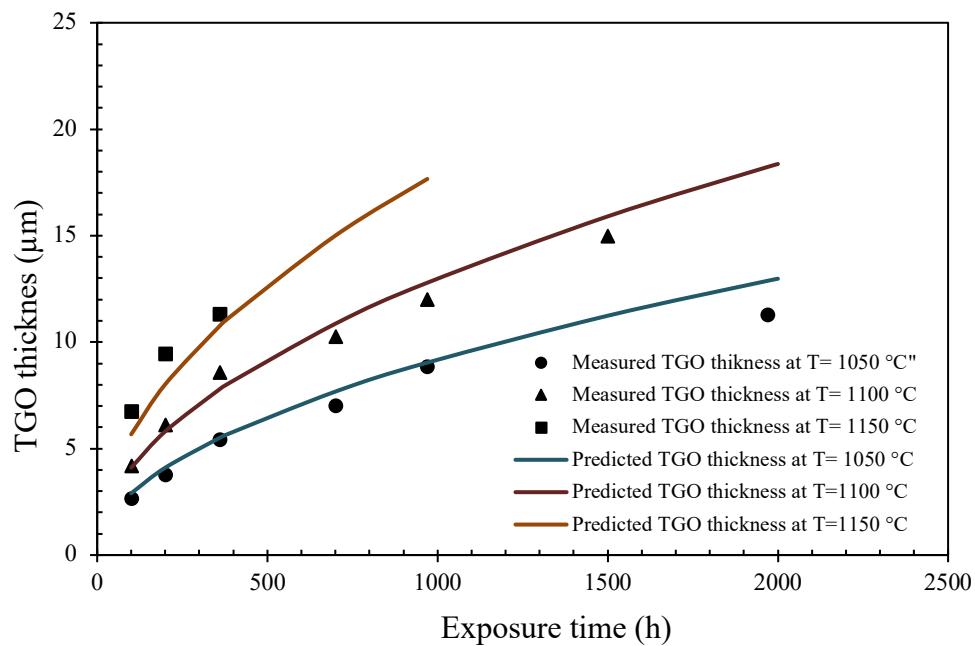
Figure 4.20 Comparison in TGO thickness growing with exposure time at different oxidation temperatures between theoretically predicted values and experimentally measured data.

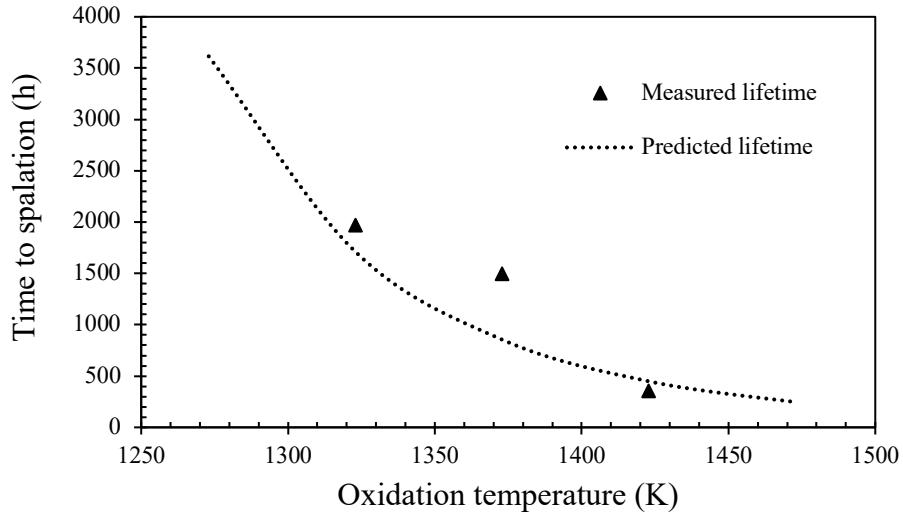
Figure 4.21 Comparison of TBC failure times between theoretical prediction and experimental data.

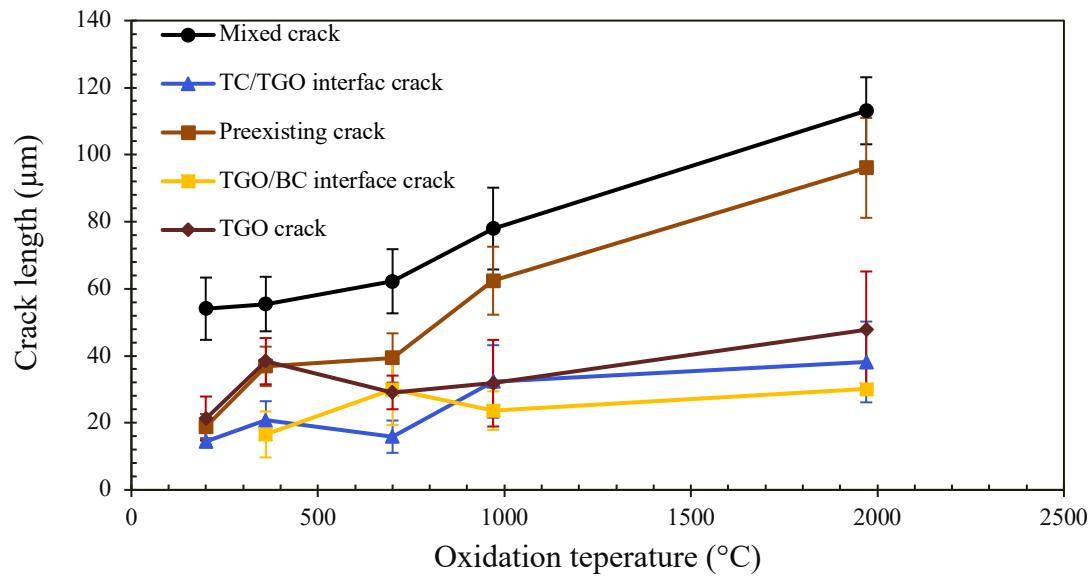
Figure 4.25 Crack sizes versus exposure time for the TBC specimen oxidized at 1050°C.

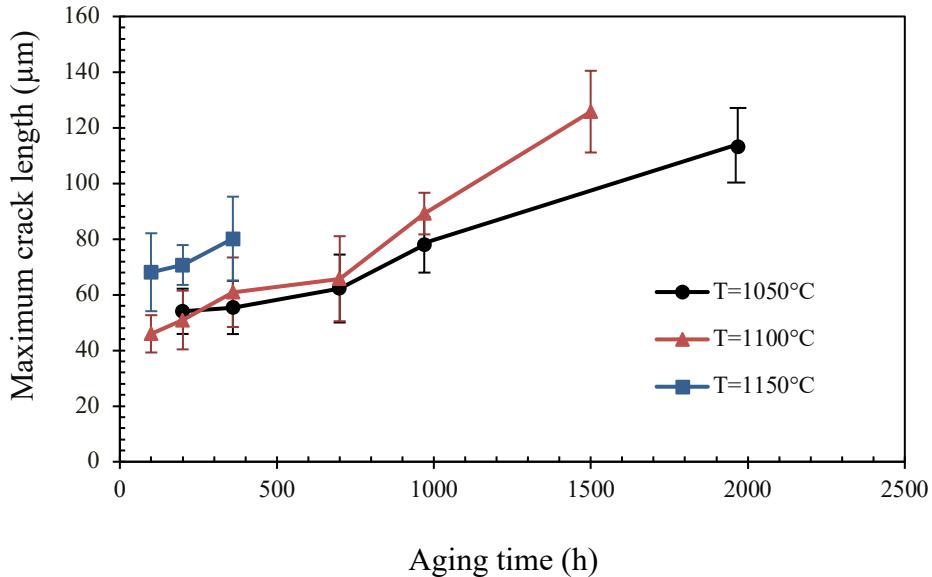
Figure 4.26 Kinetic performance of the maximum crack length of the mixed crack during the TBC oxidation at different temperatures.

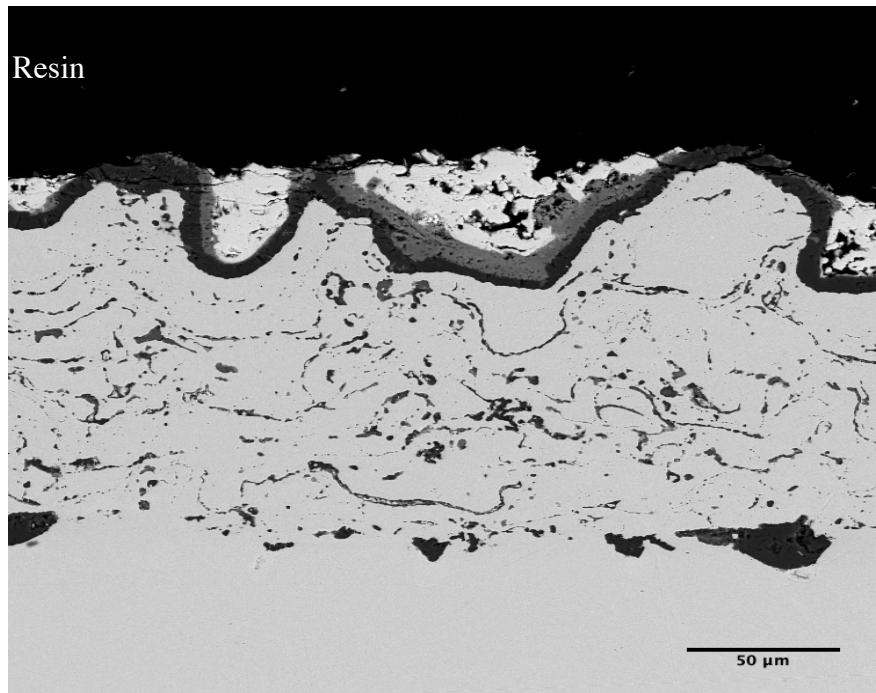
Figure 4.30 SEM micrograph of the TBC specimen after oxidation at 1150°C showing spallation of the top coat.

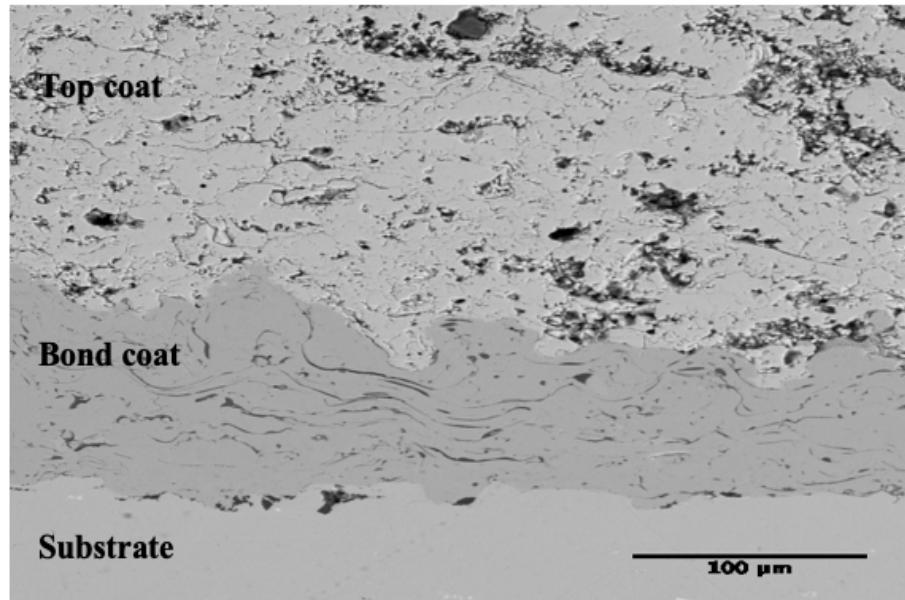
Figure 5.1 SEM micrograph in cross-section of the as-deposited specimen for solid particle erosion test.

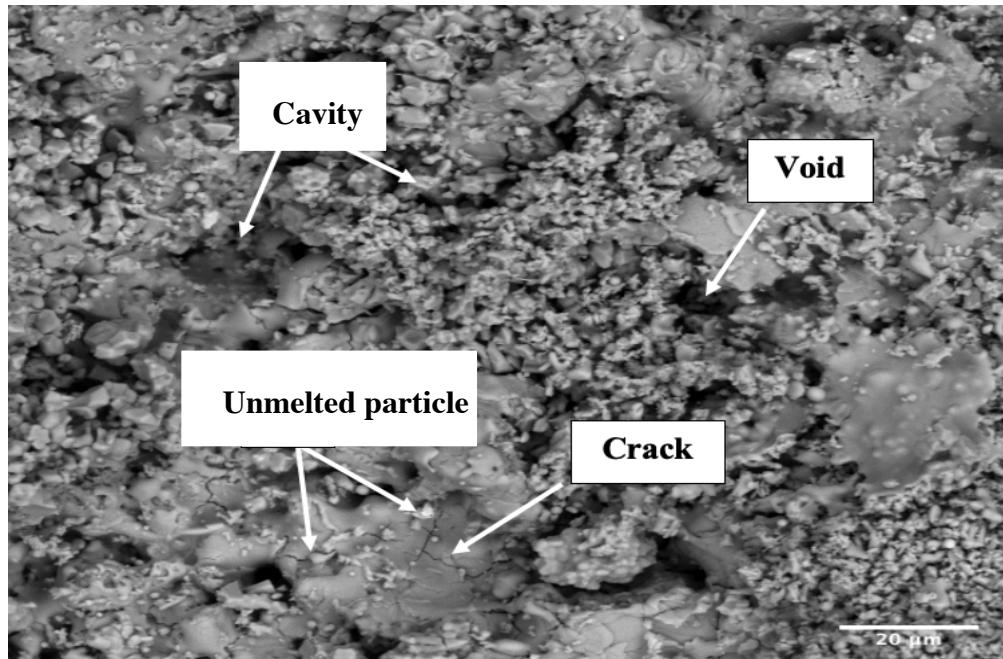
Figure 5.2 SEM surface morphology of the top coat in as-deposited state.

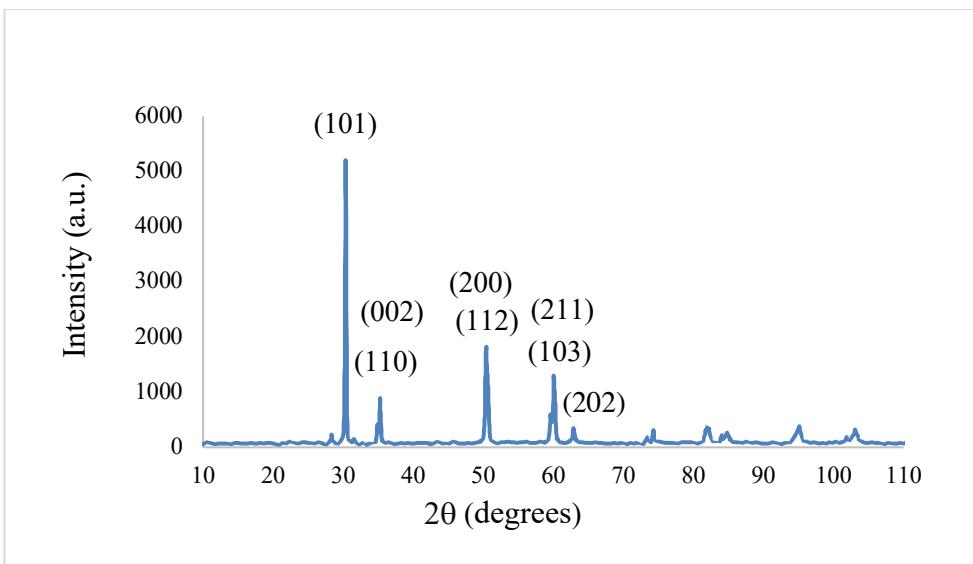
Figure 5.3 XRD diffraction pattern of the top coat in as-deposited condition.

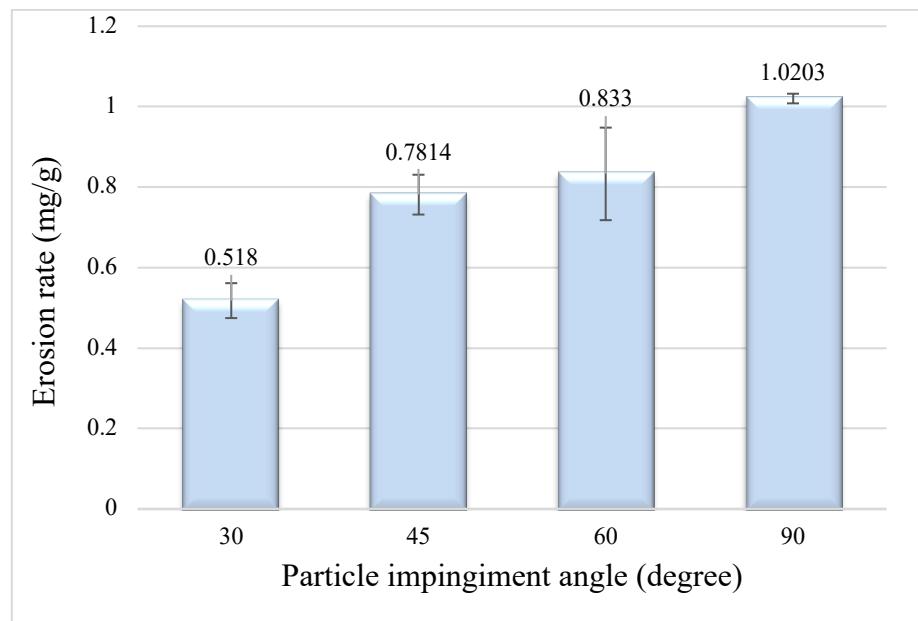
Figure 5.5 Erosion rates of as-deposited TBC specimen tested with particle impact velocity 84 m/s at different particle impingement angles.

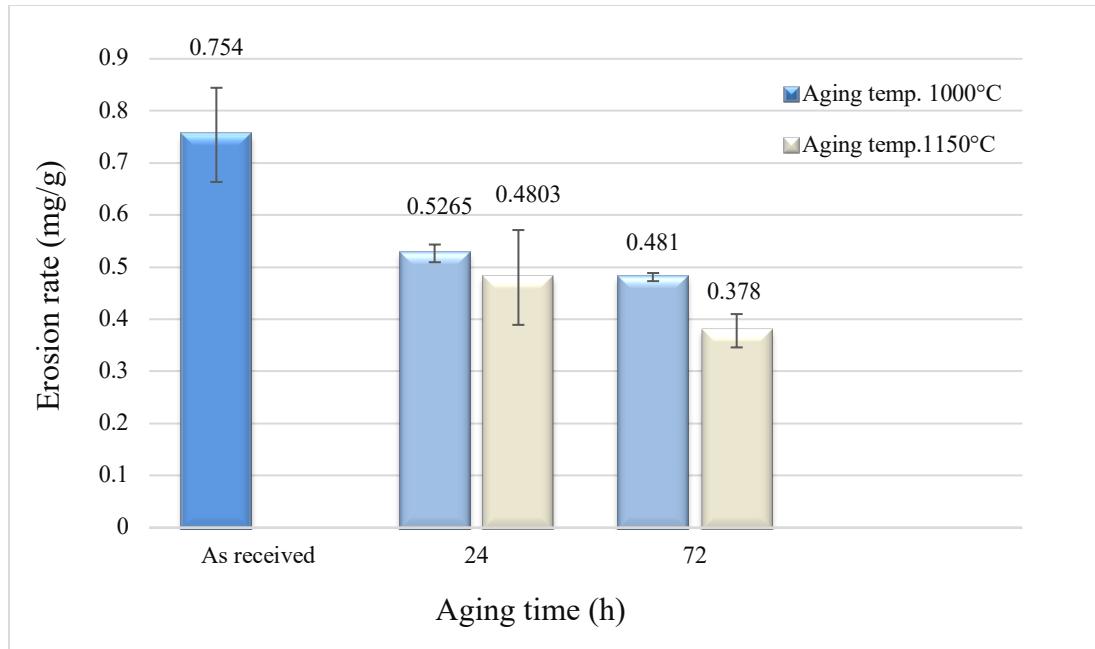
Figure 5.10 Comparison in erosion rate of the TBC specimens aged at different temperatures for different times.

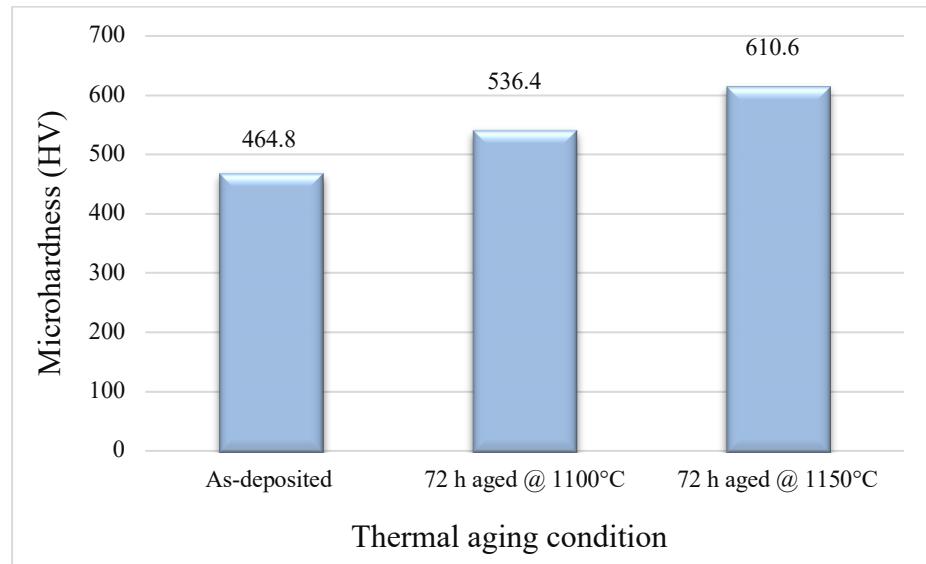
Figure 5.12 Microhardness of the top coat in the TBC specimens.

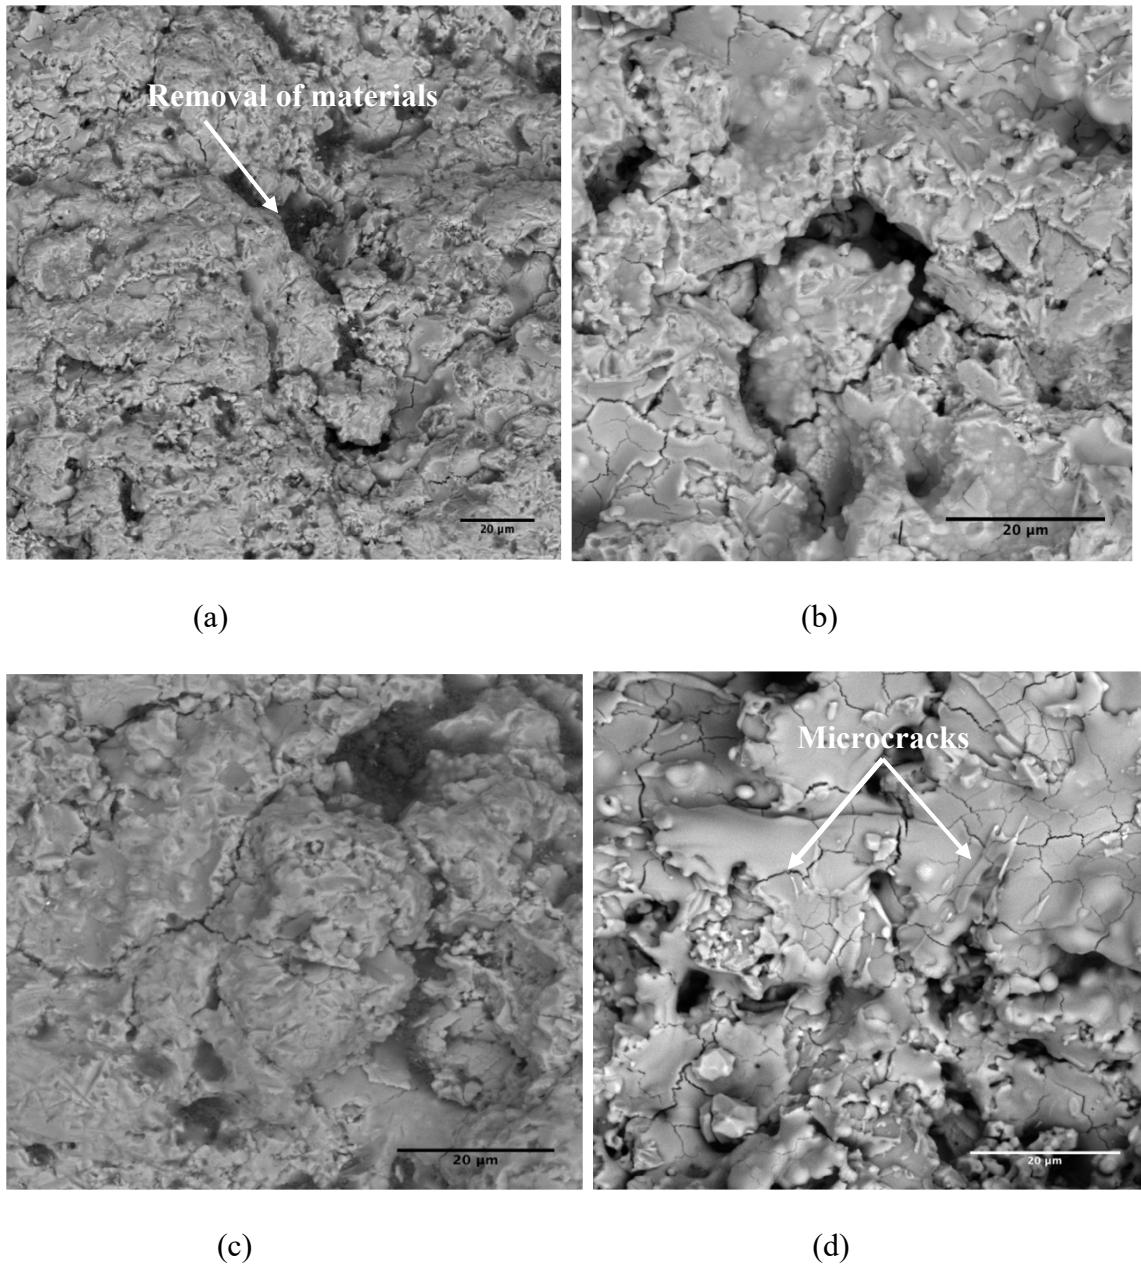
Figure 5.14 SEM eroded surface morphology of the top coat under solid particle erosion at impact angle of (a) 30°, (b) 45°, (c) 60°, and (d) 90°.

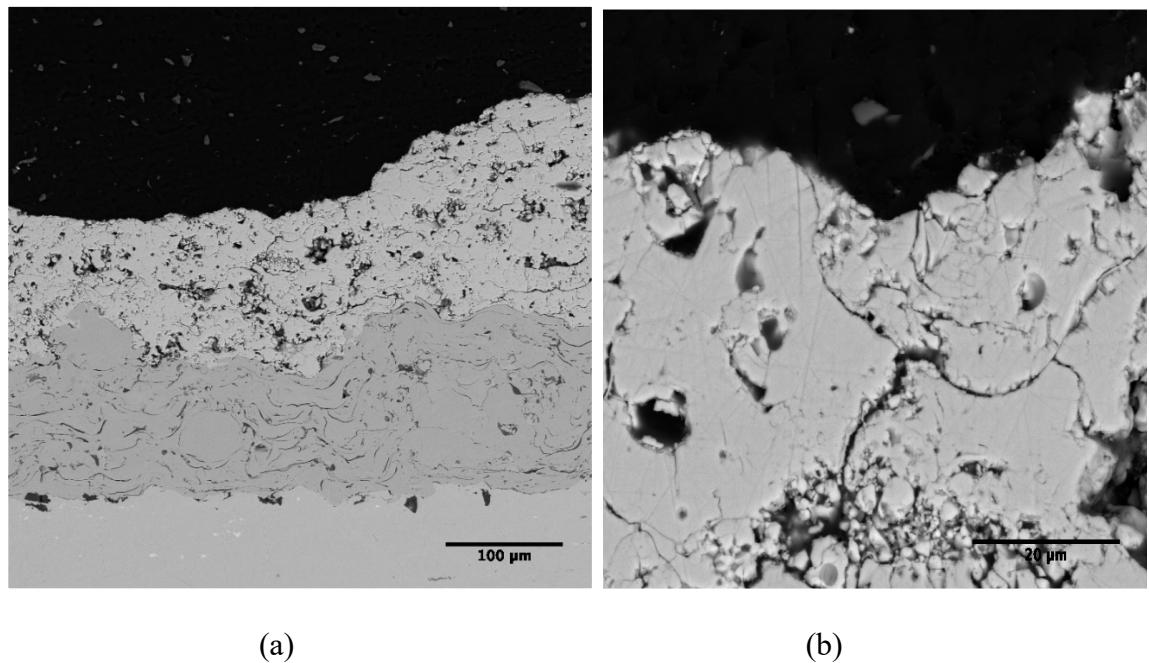
Figure 5.18 Cross-section microscopic images of as-deposited TBC specimen eroded at particle impact angle 90°: (a) at low magnification and (b) at high magnification.

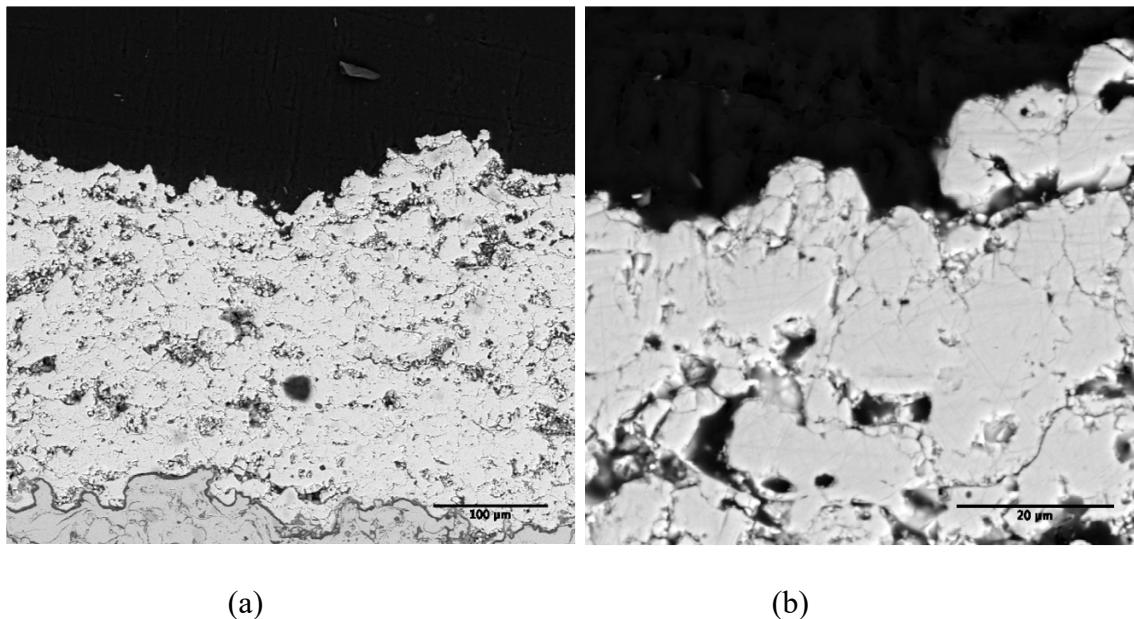
Figure 5.19 Cross-section microscopic images of eroded TBC specimen at impingement angle 30° and particle velocity 100 m/s : (a) at low magnification, (b) at high magnification. The specimen was previously heat-treated for 72 h at 1000°C .

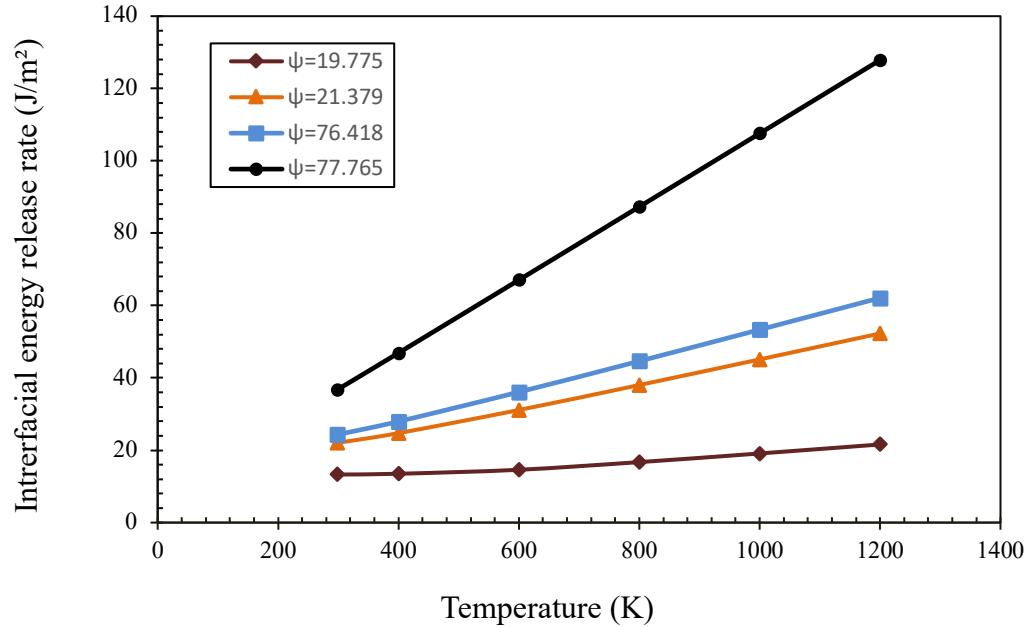
Figure 6.1 Variations of interfacial energy release rate with temperature for different mode mixites.

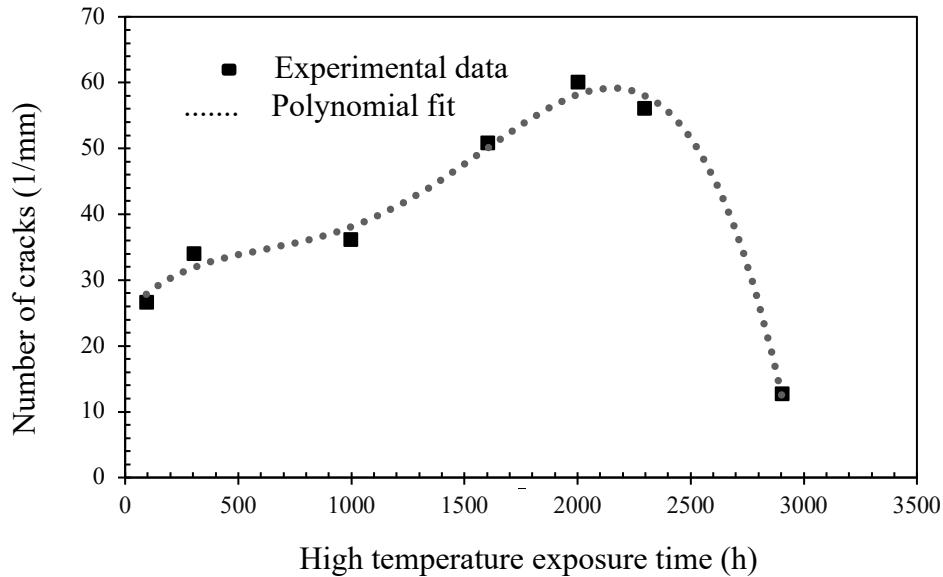
Figure 6.2 Variation of crack density vs isothermal exposure time at 1050°C.

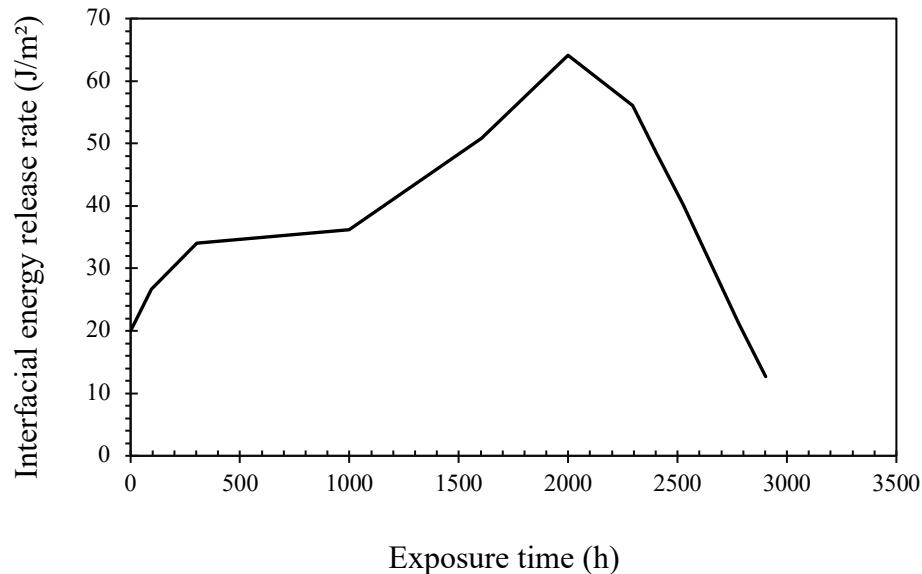
Figure 6.3 Variation of the interfacial energy release rate with exposure time at 1050°C.
