Evaluation of Organic Barrier Coatings for Wastewater Digesters Using Electrochemical Impedance Spectroscopy

A thesis submitted to
the Faculty of Graduate Studies and Research
in Partial Fulfillment of the requirements for the degree

Department of Civil and Environmental Engineering
Carleton University

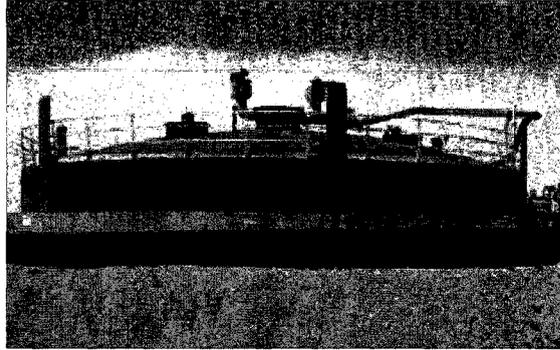
(a) Anaerobic digester of the water treatment plant of the City of Sante Fe. [Taken from the webpage of the City of Sante Fe, USA]
