Conservation of Historic Timber Trusses with Case Study
of the Governor General's Pavilion Roof, East Block of
Parliament, Ottawa.

A thesis submitted to the Faculty of Graduate and Postdoctoral
Affairs in partial fulfillment of the requirements for the degree of

Civil Engineering

Carleton University
Ottawa, Ontario

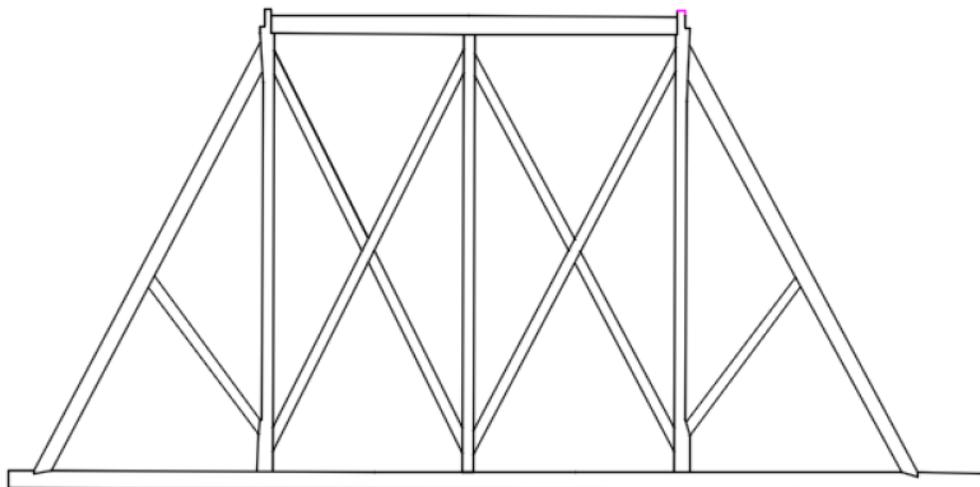
Figure 1-1: Double Queen Post Truss [adapted from [1]]

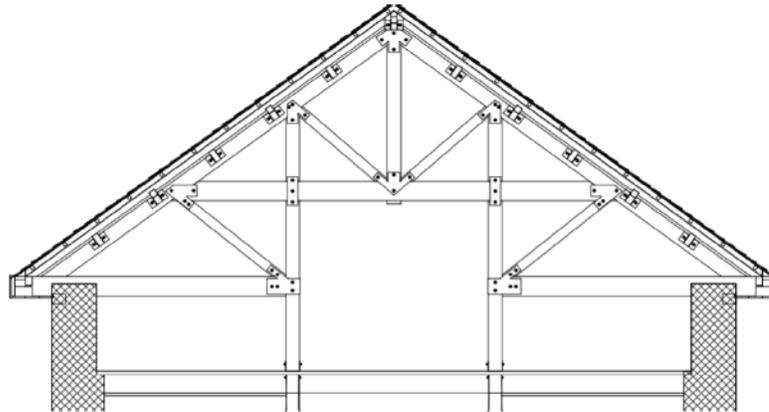
Figure 2-3: Roof Truss of Commissariat Building (Bytown Museum) [adapted from [23]]

The Commissariat Building (Bytown Museum) in Ottawa is a local example a masonry building with heavy timber roof trusses. The federal heritage building was constructed in 1827. The roof structure makes use of a variation of king post and queen post trusses (Figure 2-3). [23]

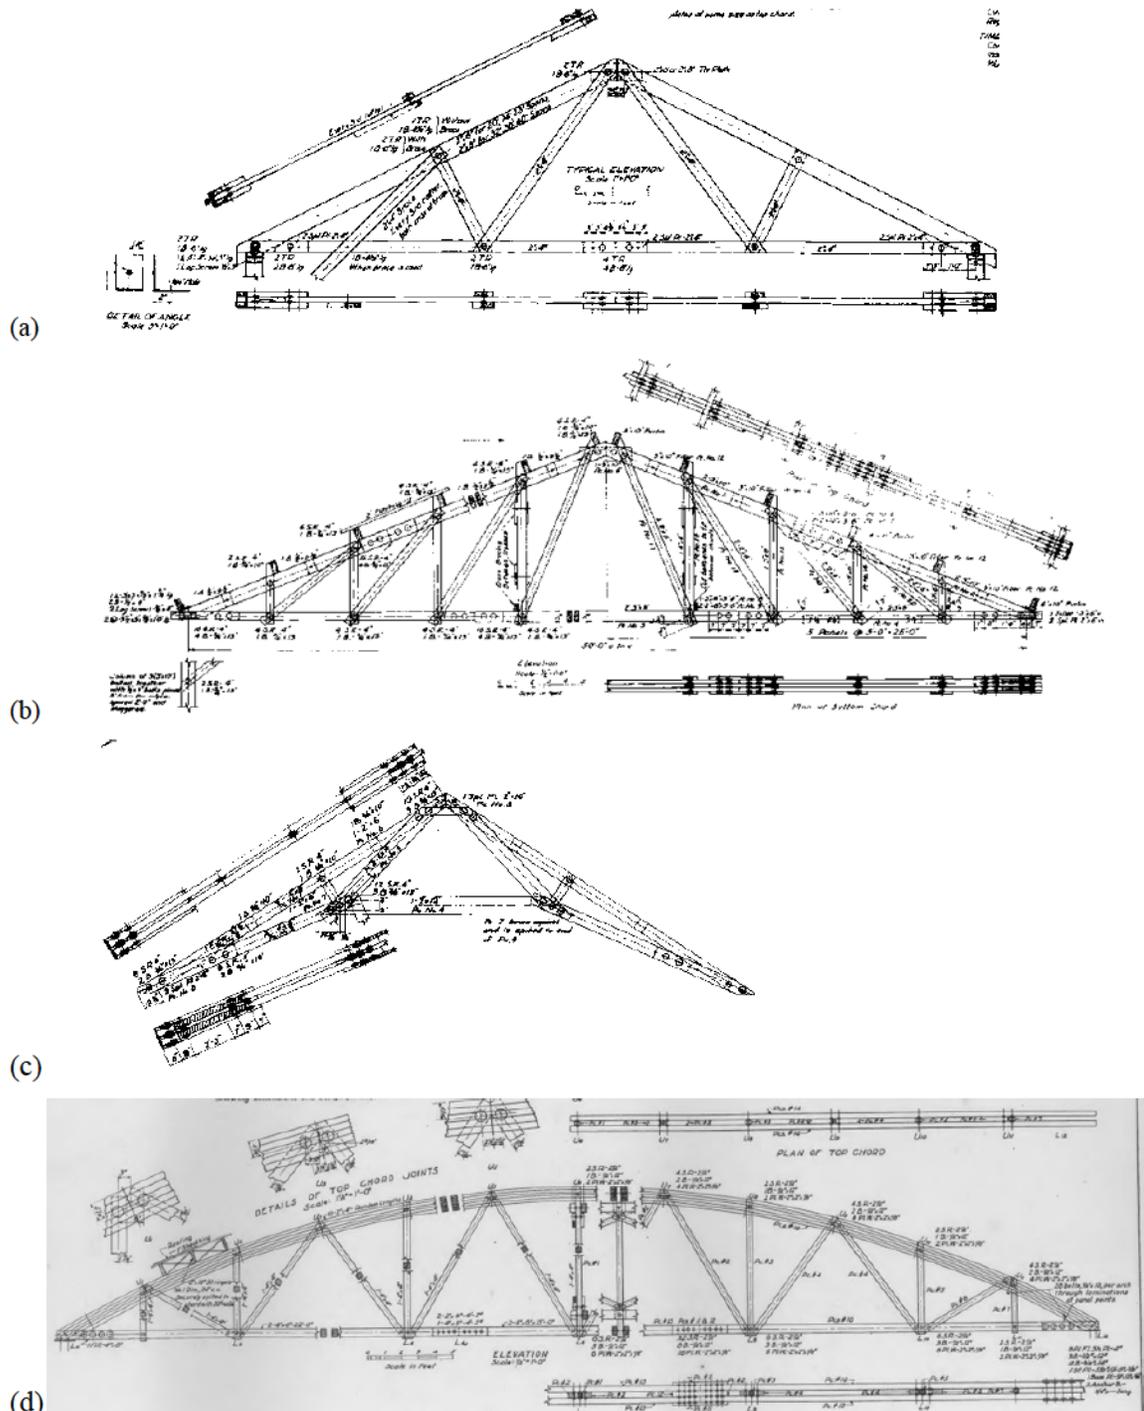
Figure 2-4: Type of trusses; (a) Fink Truss; (b) Pratt Truss; (c) Scissor Truss; (d) Bow String Truss [adapted from [24]]

The 1930 document includes drawings and specifics on a number of truss types including Fink, Pratt, Scissor and Bowstring (Figure 2-4). [24] Recommended spans and uses are included for the various truss types and include member sizes and required fasteners for assembly. The development of the different truss types was based on structural and material efficiency. [24] These documents are examples of useful

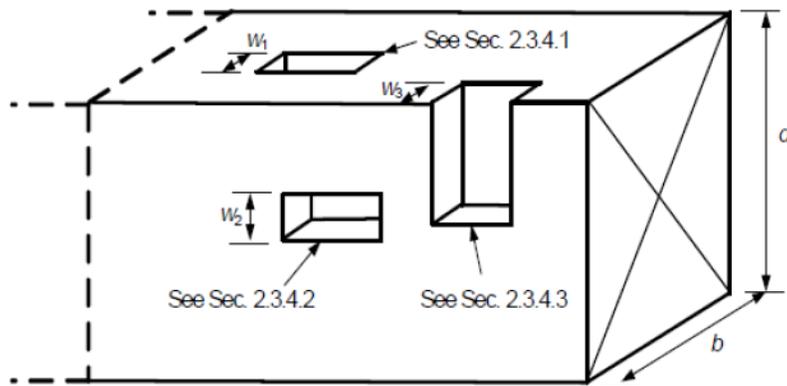
Figure 2-9 Notching Diagram [33]

The *Timber Frame Engineering Council: Technical Activities Committee (TFEC)* offers some guidance on evaluation of timber members with notches [33], (Figure 2-9).

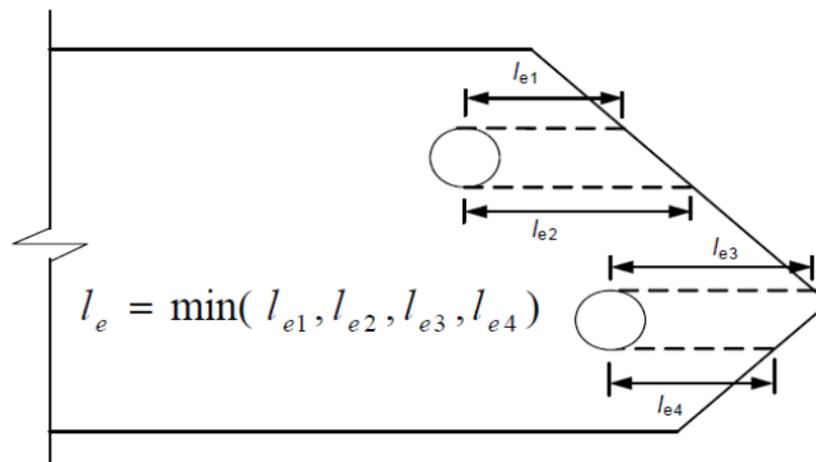
Figure 2-10: TFEC Spacing requirements for tapered members [33]

For tapered end members, Figure 2-10 illustrates how to measure end distance, l_e .

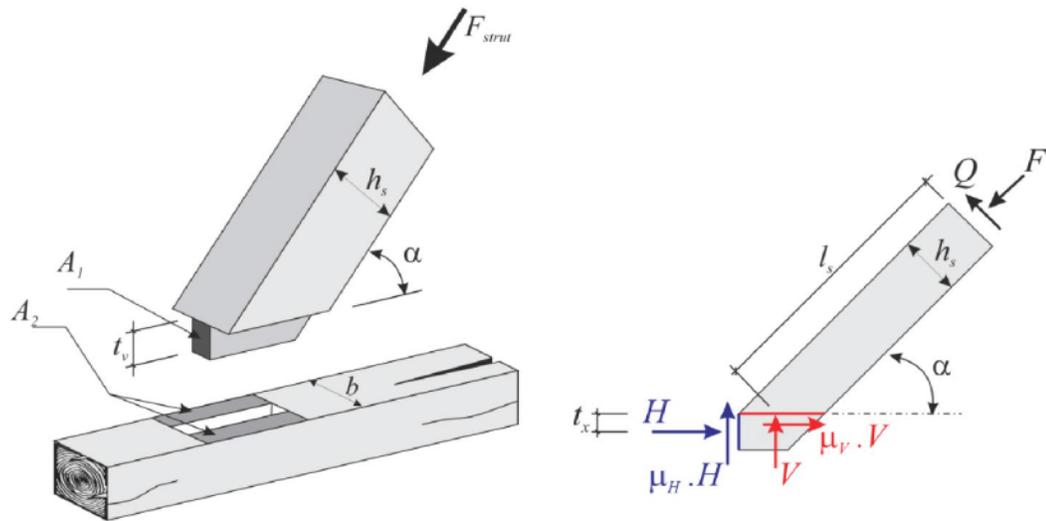
Figure 2-13: Force Mechanism of Skewed Tenon Joint [13]

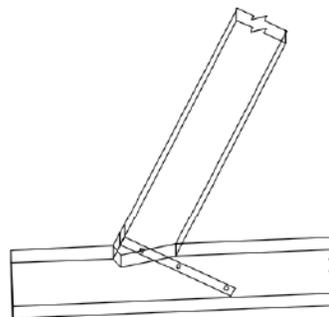
Figure 2-14: Birdsmouth/Heel Joint

A birdsmouth or heel joint is a notched connection of a tie-beam and rafter (Figure 2-14). This connection is referred to by several names among sources. Branco and Descamps describe it as “a “V” shaped groove generally perpendicular to the length of the beam,” [13]. Common variations of this type of joint include the use of metal straps, mortise and tenons or pegs. The heel joint is described by Palma and Cruz as a “front notched joint, with a single tooth in the strut, a notch in the top face of the bottom chord and, frequently, some metal fasteners. [45]”

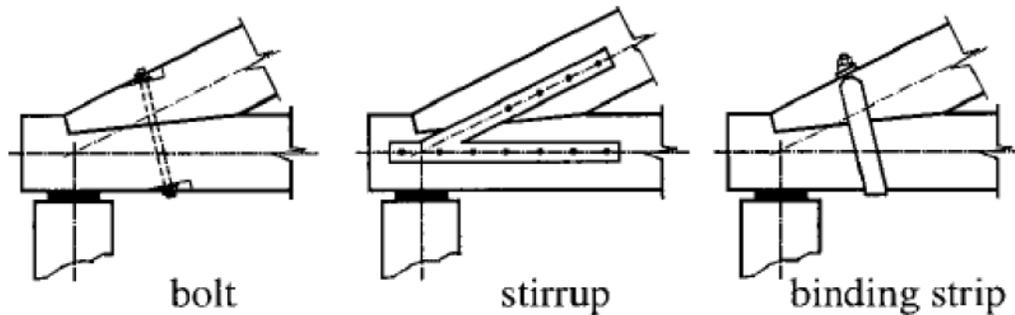
Figure 2-24: Typical Repairs of a Heel Joint [35]

gaps exists between surfaces because joint analysis is based on the assumption of tight fitting joints; prosthesis of the beam at the toe to improve shear resistance; or binding strips, stirrups or bolts to resist reverse loading [13].

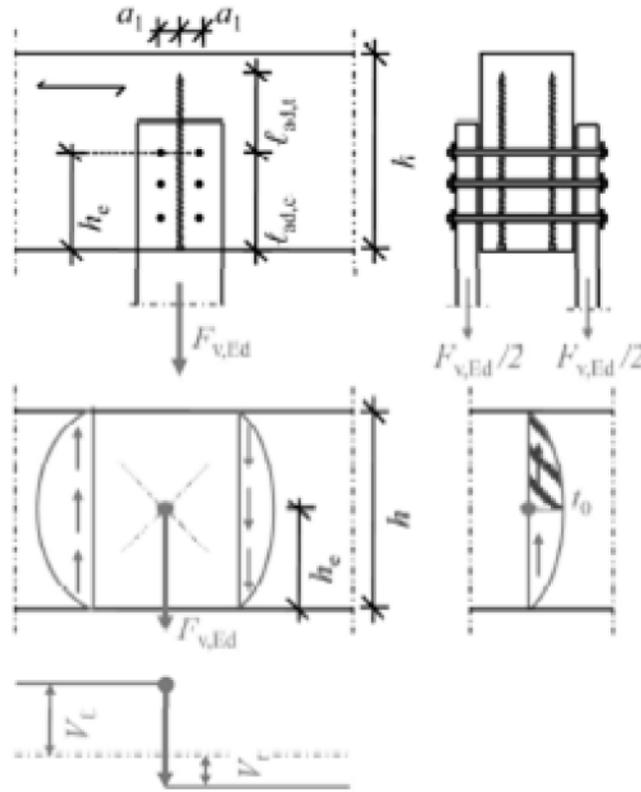
Figure 2-26: Tensile reinforcement [32]

This new section could support practitioners by providing a clear method for the design of tension reinforcement with load applied perpendicular to the grain.

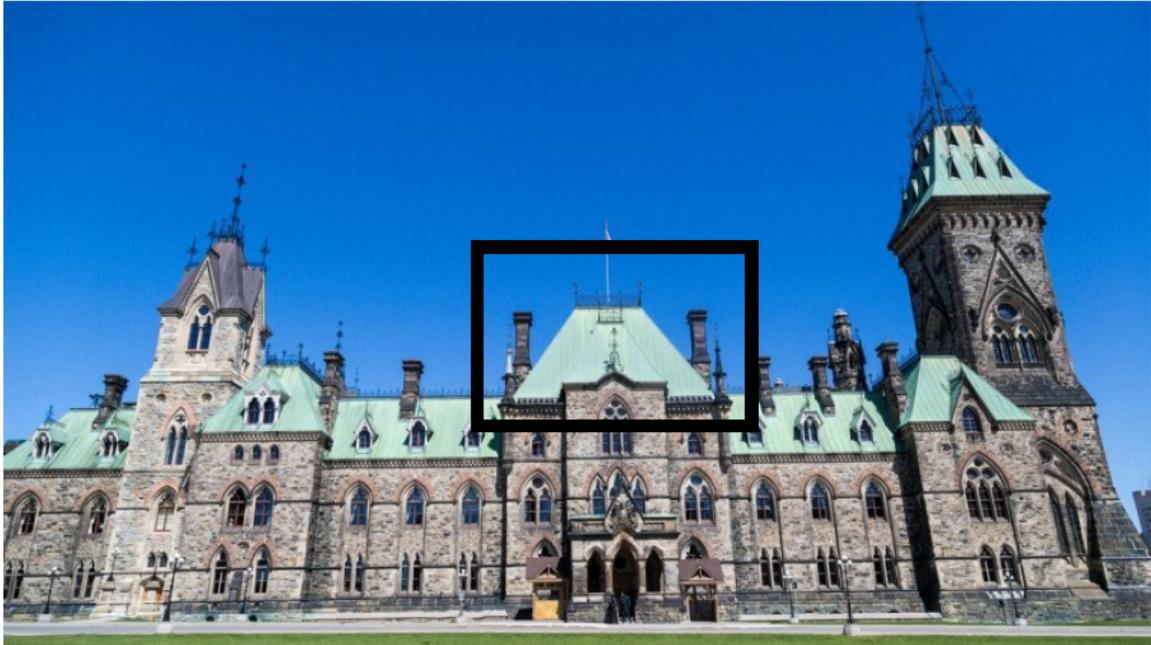
Figure 4-1: Case Study Governor General's Pavilion, East Block

The case study addressed in this thesis is the roof structure over the Governor General's Pavilion in the East Block Building on Parliament Hill in Ottawa, Canada (Figure 4-1). The case study will be used to apply the conservation methodology presented in the previous chapter to demonstrate the possible workflow of a conservation project. Following the conservation methodology outlined in Chapter 3, the case study is presented in three main sections: *Research and Site Visits* (Chapter 4); *Truss Frame Analysis* (Chapter 5); *Traditional Timber Connections* (Chapter 6).

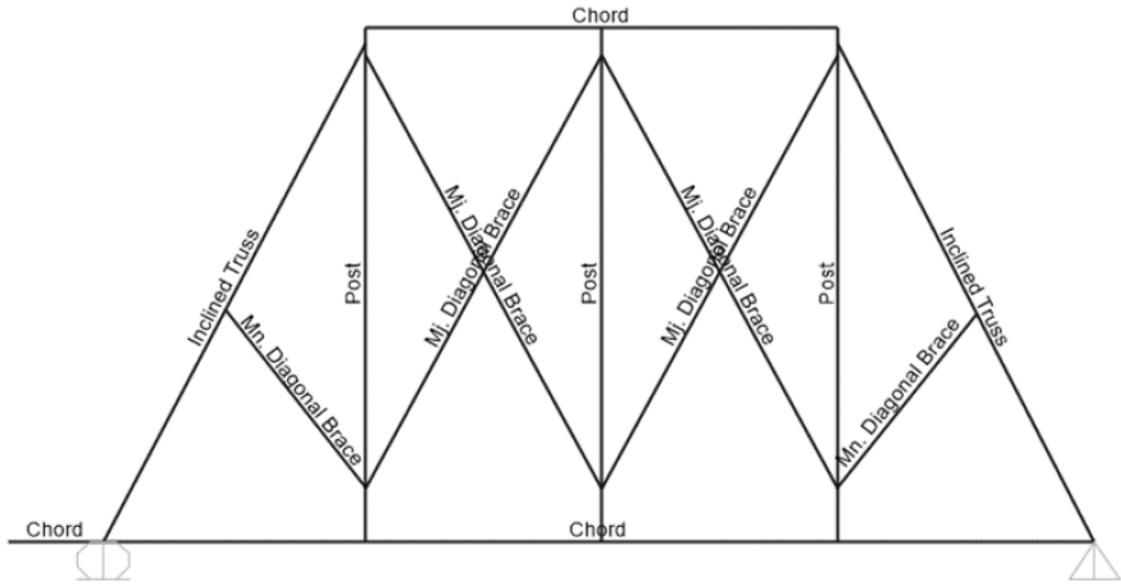
Figure 4-3: Schematic of a main truss and members

The main trusses (Figure 4-3) are oriented east-west and span 15.8 meters, [52']. Perpendicular to the main trusses are half trusses (Figure 4-5) on the north and south side connecting to E1 and E3. Inclined truss members are also located diagonally in the four corners. Floor and roof joists serve as additional connecting members between the main trusses. Framing is extended on the east and west side where aesthetic protrusions are located. Tongue and groove sheathing is used to tie the system all together and the roof is clad with copper sheeting. The heavy timber trusses are supported at the ends by a solid stone masonry wall. Near the middle of the main trusses a (305mm [1' thick]) masonry wall also supports the structure. Typical connections are mortise and tenon joints; pegs are seen in connections with the top chord. Haunches, seen in Figure 4-6, on posts are typical and metal straps and wood wedges are used in some connections. A brick fire wall is present on the north side of truss E1, and two brick chimneys are located on the south side of the attic.

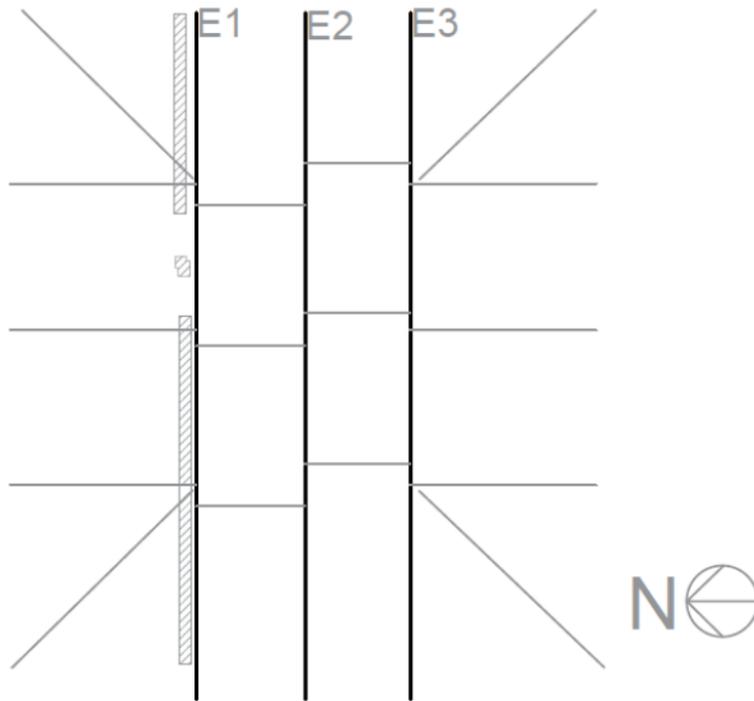
Figure 4-4: Floor Plan Layout Drawing [adapted from [1]]

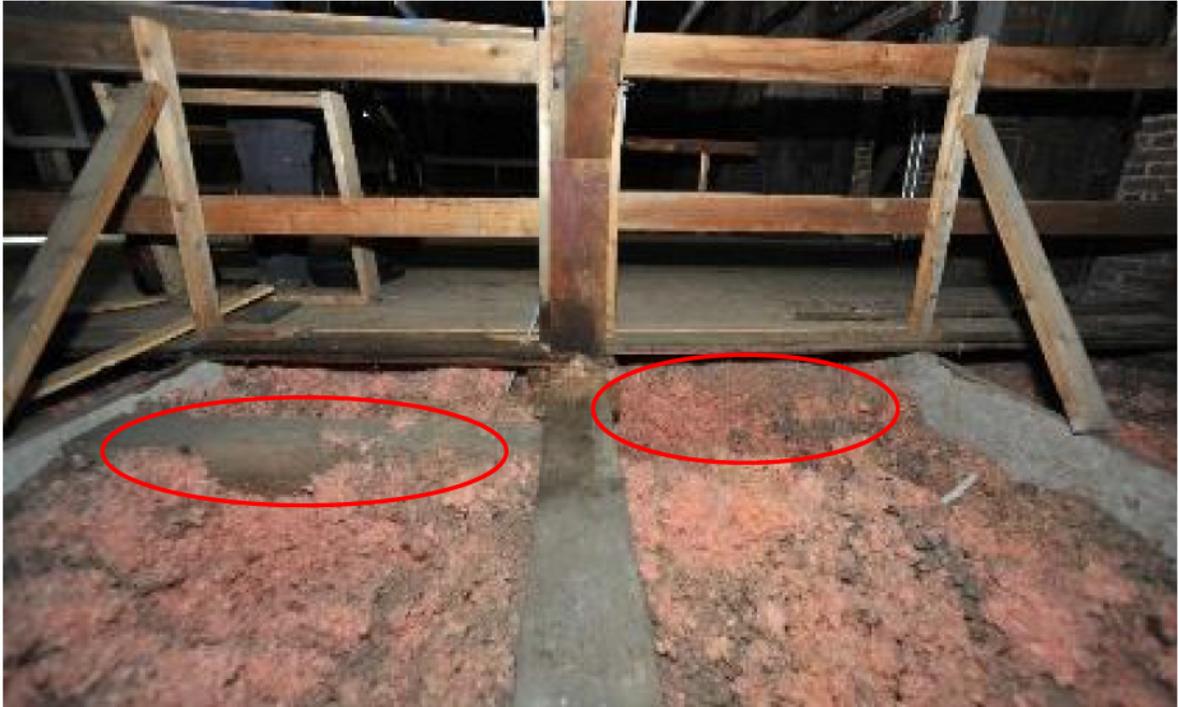
Figure 4-8: Hidden floor joists

area and some minor floor joists remain. These were not included in the structural model. Two main floor joists were left off the previous heritage recording on the east side (Figure 4-8). These joists were measured and added to the model. These main joists have large bolts evident on the outside edge of the bottom chord. Measurements of supporting brick walls under the middle of the trusses were also taken. The brick walls are 1' [305mm] wide and 10' [3.0m] apart from each other and offset from the post connection by 56" [1.4m].

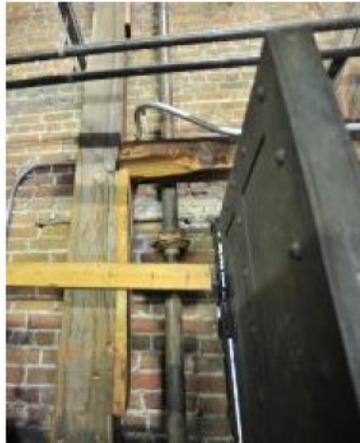
Figure 4-10: Damage to framing around fire doors

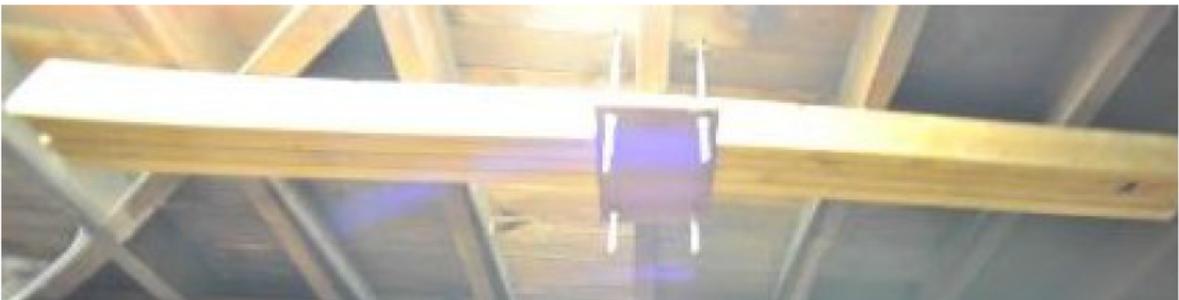
Figure 4-11: Condition Photograph- modifications for roof anchor attachment

Another member that was noted to be notched was the minor diagonal member in the north east corner. This may have been from a previous connecting member, or other requirement. It is noted that HVAC or other interventions have not always respected the structure resulting in reduced cross-sectional area. Interventions may include upgrades to health and safety requirements, for example travel restraint anchors have been added to the roof which has resulted in penetrations through the roof and additional anchoring system members (Figure 4-11).

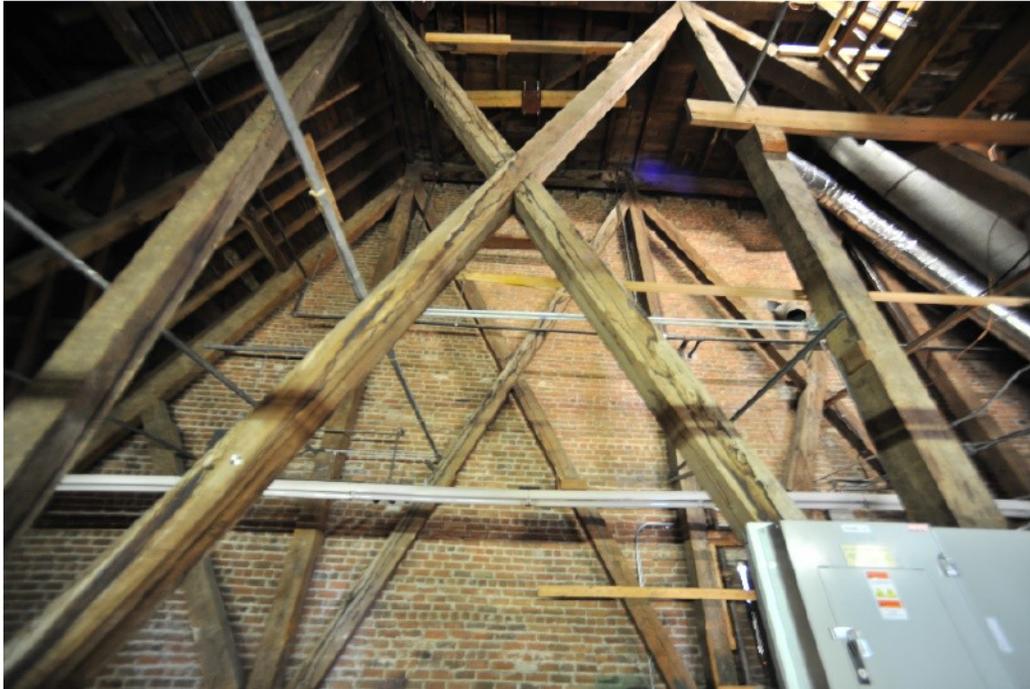
Figure 4-12: Context photograph showing west half of two of the main trusses (E1, E2), facing north.

Photography was used to capture condition, context and details. Condition photographs have previously been described in Figure 4-8 to Figure 4-11. Context is shown in Figure 4-12 and Figure 4-13 capturing the vast size of the truss and the separation of space by the brick fire wall. A sample of detail photographs are included below (Figure 4-14 and Figure 4-16) with additional images in Chapter 6: Traditional Timber Connections. Figure 4-14 shows a corner connection with members framing to a truss post from multiple directions. The “A” seen on the right most member is a traditional marker used to line up members when assembling the structure. The post of this complicated connection varies in size as it has haunches at the joint. This indicates the original timber would have been larger than the 8” [203mm] middle section of the post.

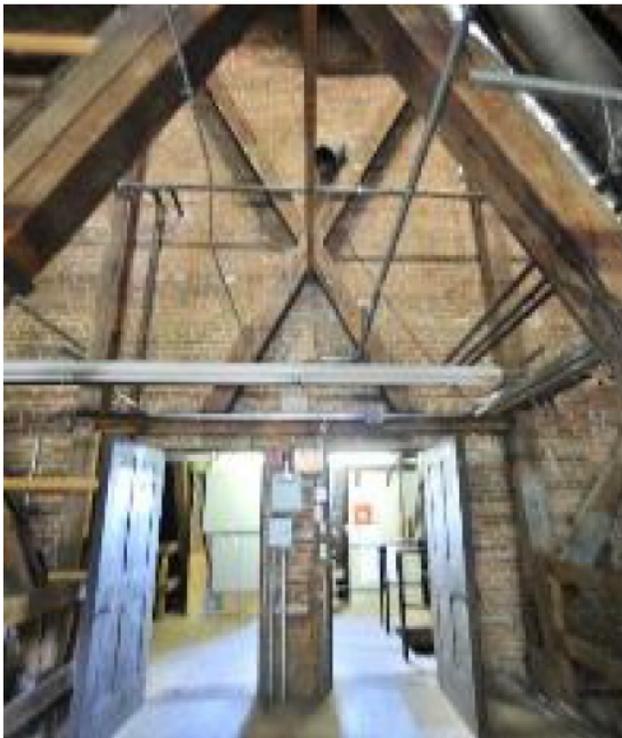
Figure 4-13: Context photograph showing east half of trusses (E1, E2) including around the fire door

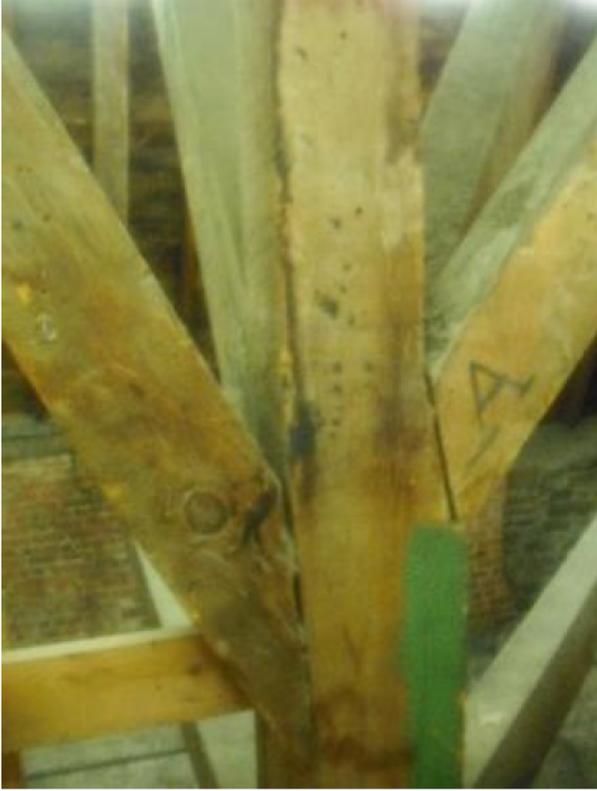
Figure 4-14: Detail photograph of corner intersection with multiple members framing into a post (west post of E3)

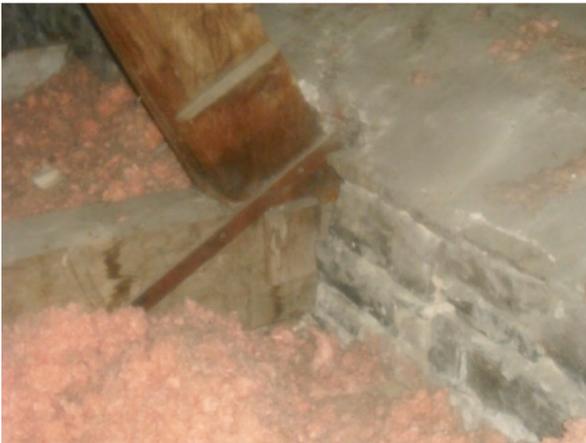
Figure 4-15: Detail photograph – Birdsmouth/Heel joint at masonry wall with metal strap and wood block wedge

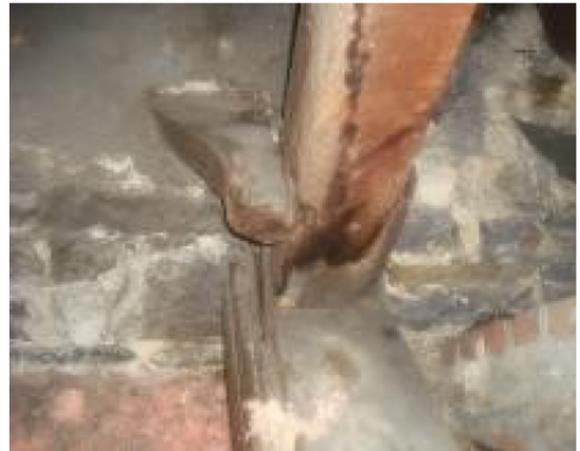
Figure 4-16: Birdsmouth/Heel joint connection of bottom chord and inclined truss member at supporting masonry wall

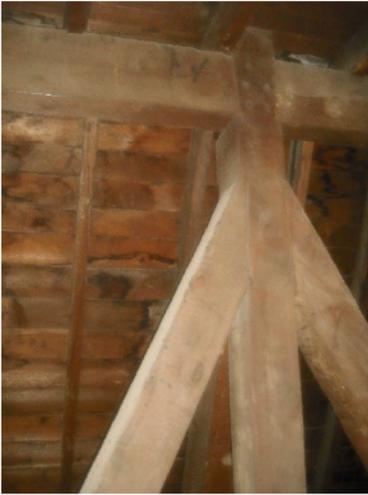
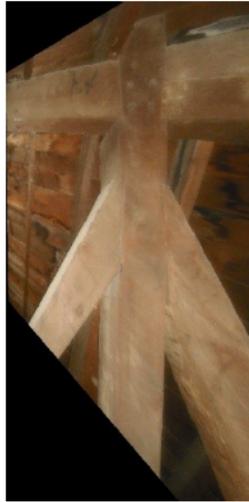
This attempt at rectifying a photograph of Detail C was not very successful as the angle of distortion is too great. The rectified photo does not reflect the actual size of the members, and is not measurable.

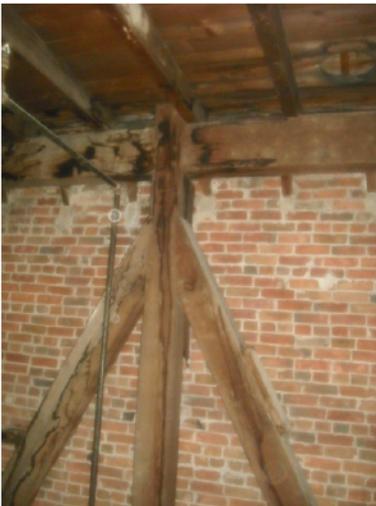
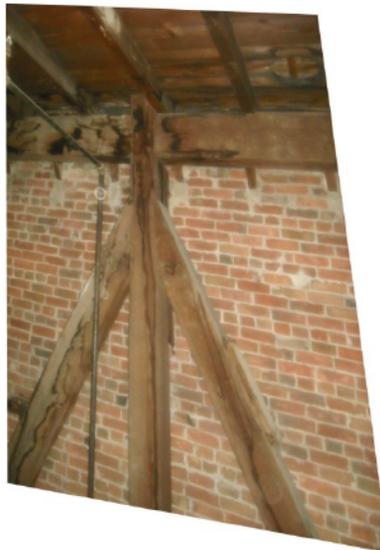
This attempt at rectifying a photograph of Detail C was not very successful as the angle of distortion is too great. The rectified photo does not reflect the actual size of the members, and is not measurable.

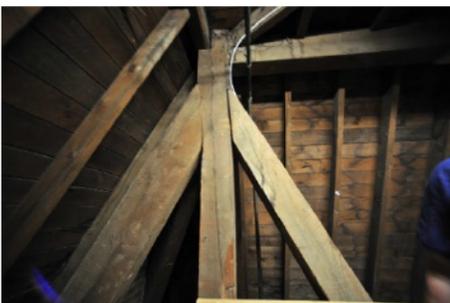
This photograph of Detail E worked better with rectification because it was taken almost parallel and has less distortion.

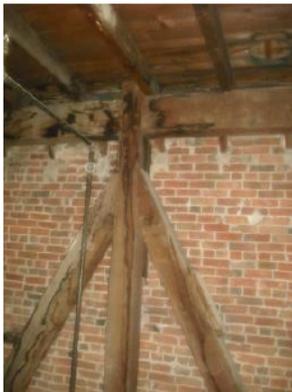
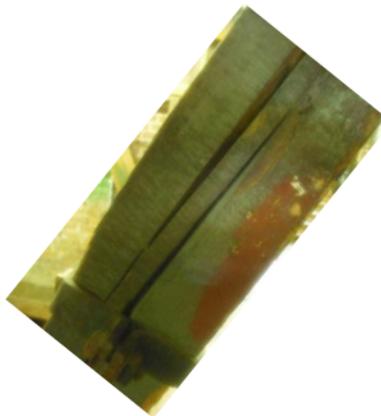
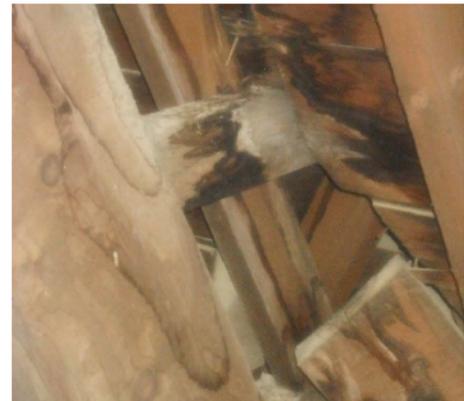
(a) (b) (c)
Figure 4-17: (Left to Right) (a) Dark staining on timber members and brick fire separation wall parallel to truss; (b) Checking in bracing member with metal repair; (c) Dark staining near interior exterior interface

A general review of the GGP timber truss members and their condition was conducted visually; however, a thorough investigation was beyond the scope of this project. Several condition photographs are included below (Figure 4-17). Dark and fairly extensive staining was observed on several of the truss members mostly the top chords, posts, inclined truss members (a) and other vulnerable areas near the sheathing interface (c). The staining is likely due to previous moisture issues. Localized areas of decay as previously reported still remain an issue. Extensive checking was also noted in some of the diagonal bracing members with attempted repairs using metal elements (b). The check does not go all the way through the member and checking tends to follow the grain outward from the pith. The metal strap used here was likely added after the apparent checking, but may serve no real purpose.

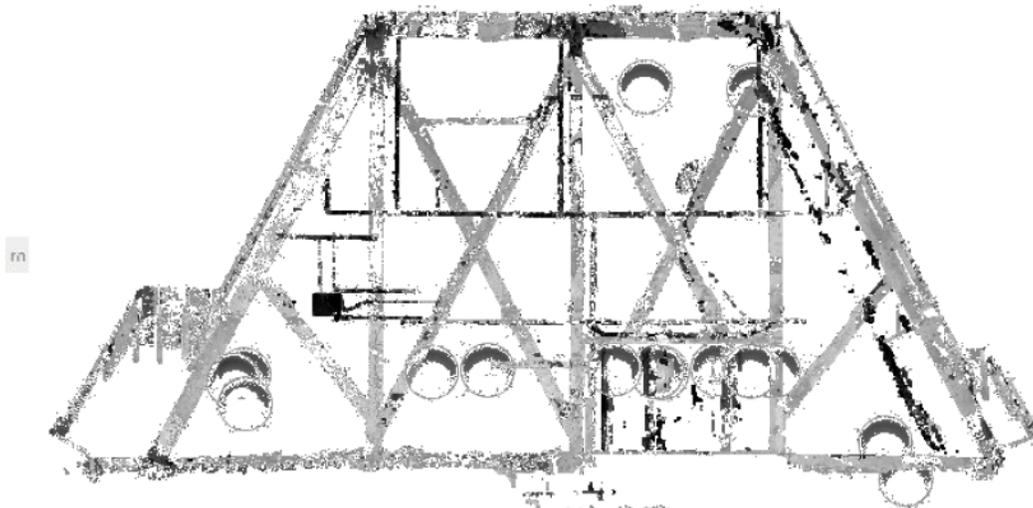
Figure 4-18: Section of Truss shown in ReCAP

Clips from the *ReCAP* [76] file are shown in Figure 4-18 and Figure 4-19. The geometric model of the GGP roof structure created from the existing point cloud data is shown below (Figure 4-20). The model created in *AutoCAD* [68] and can be easily rotated and sectioned to view the area of interest (Figure 4-21). The model was developed using 3D solid members and planar elements to provide a realistic view of the roof system. Color or material could be added for visual impact.

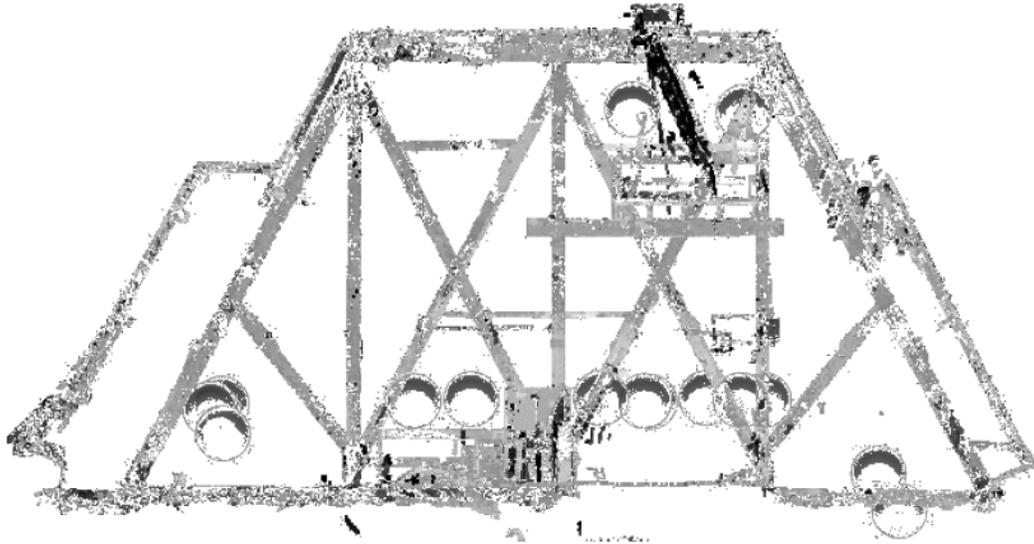
Figure 4-19: Section of Truss shown in ReCAP

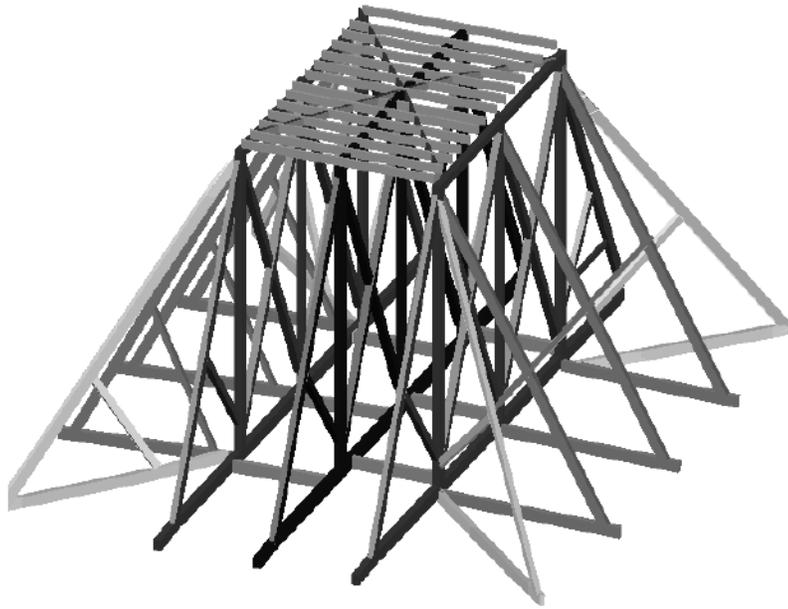
Figure 4-20: 3D solid geometric model of roof assembly using AutoCAD

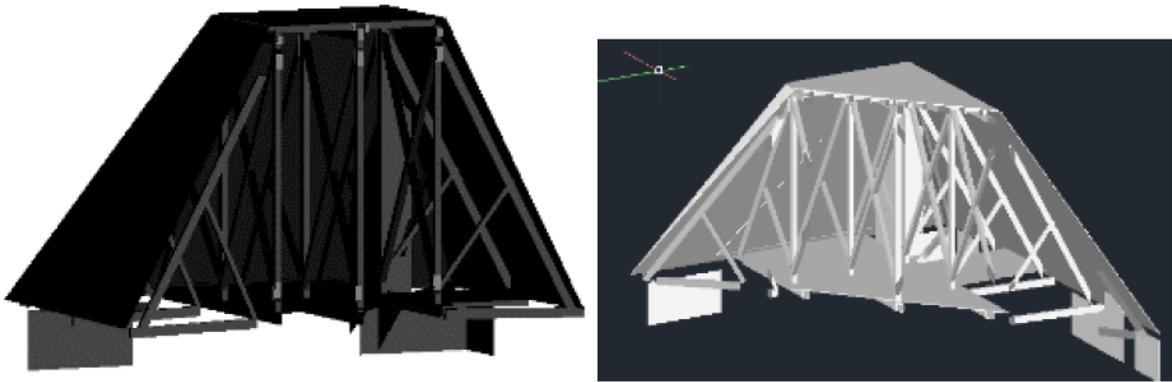
Figure 4-21: Sectioned 3D view of roof assembly AutoCAD

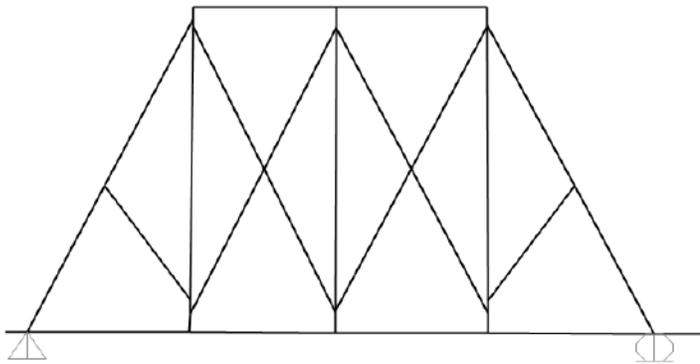
Figure 4-22: 2D wire frame SAP model of truss

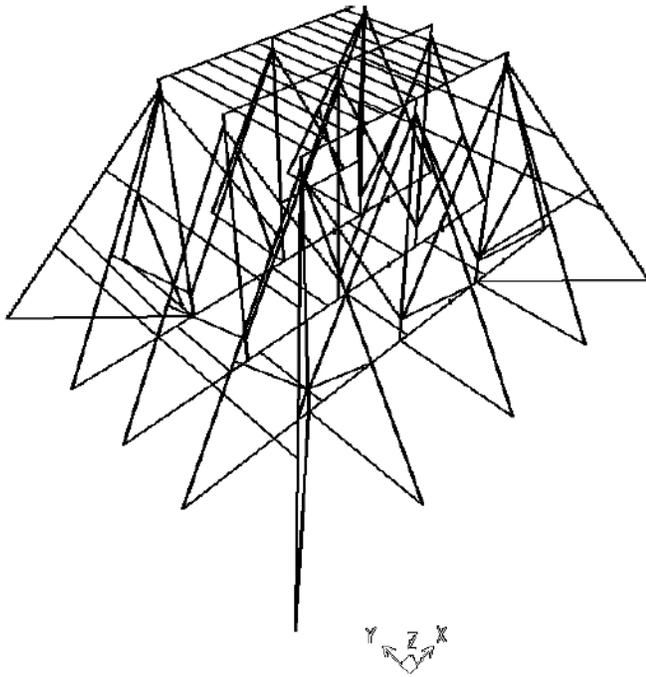
Figure 4-23: 3D wire frame SAP model of major framing members

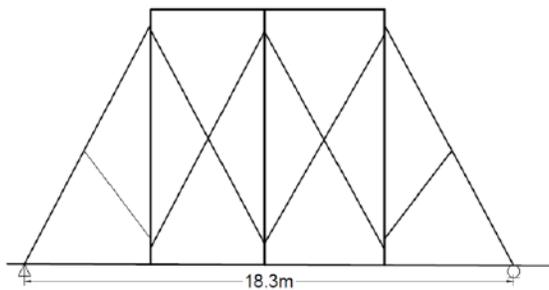
Figure 5-1: Case 1 - Simply Supported

The frame analysis was done using the structural analysis program *SAP2000* [79] where two different scenarios were studied. Case 1 is a simply supported truss (Figure 5-1); while Case 2 has additional supports representing brick walls below the bottom chord as found onsite (Figure 5-2). It is unclear if these additional supports were added as a retrofit at some point or if they are original. By studying the two scenarios the goal is to identify how the additional supports affect the behavior of the truss system and if impacts are positive or negative.

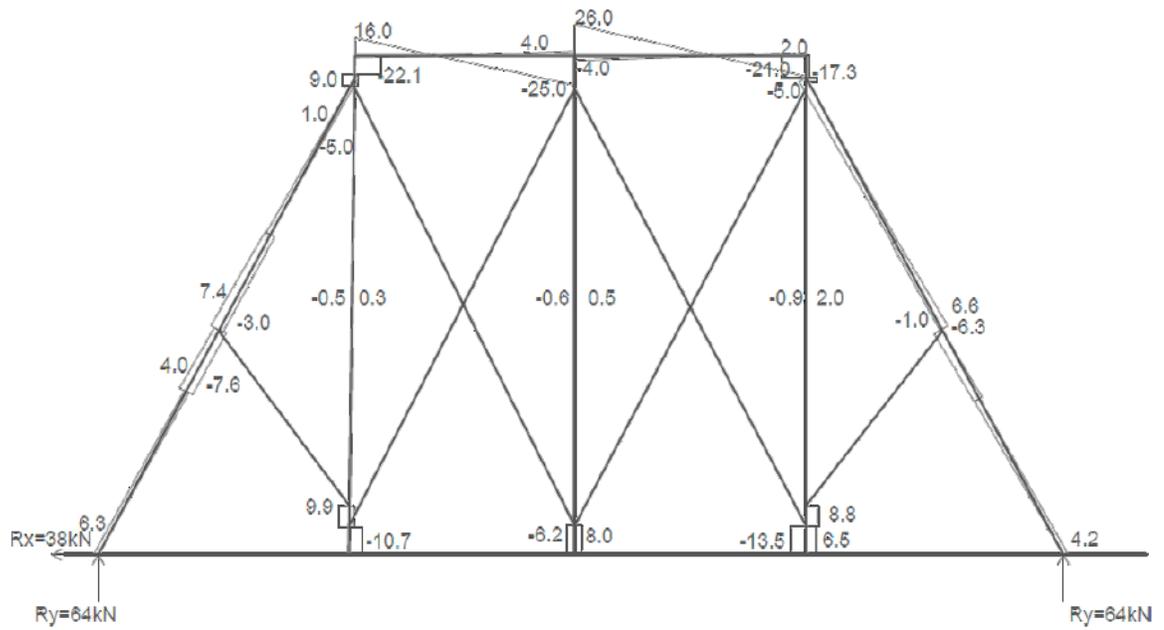
Figure 5-5: Case 1 Envelope Shear Forces

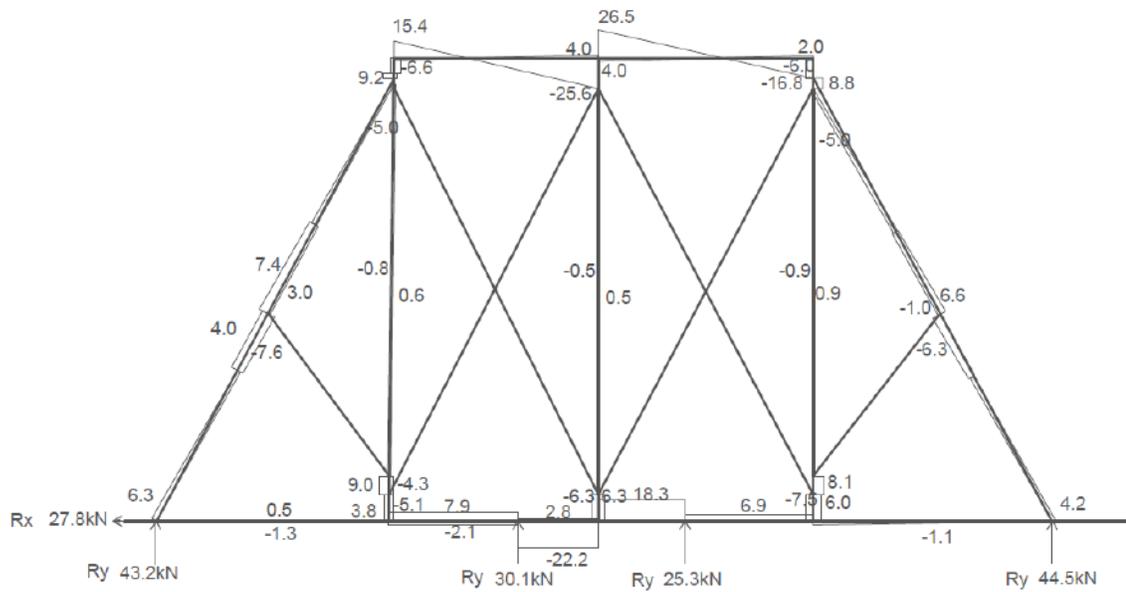
Figure 5-6: Case 2 Envelope Shear Forces

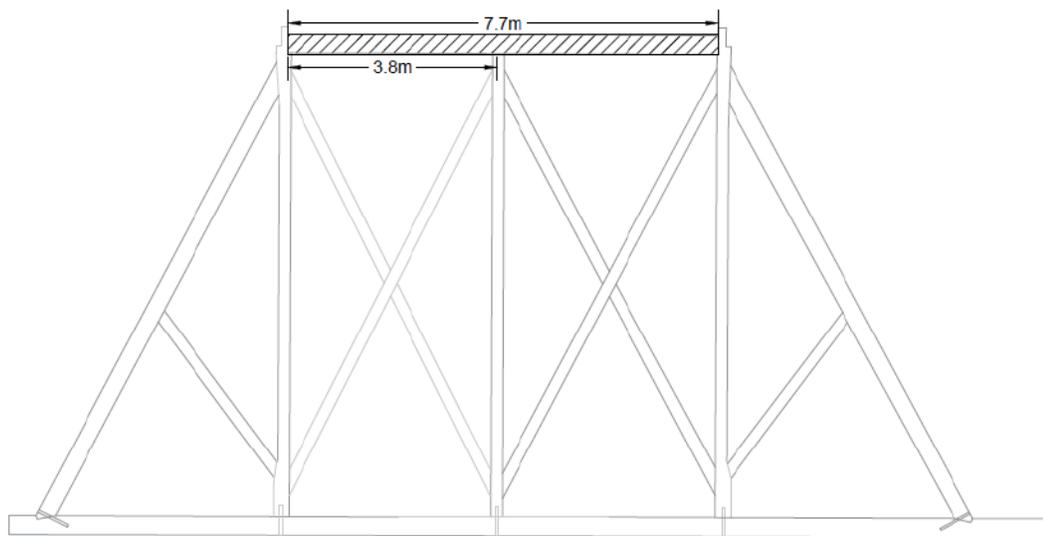
Figure 5-9: Top Chord

While Material A, (Northern No.1) produces greater resistance values compared to Material B (Northern No.2), none of the cases reviewed indicate capacity has been met for the top chord. The governing load combination for the top chord in compression, shear and moment is 3a, with the dominant snow load. The tension cases are governed by the wind dominant load, 4b.

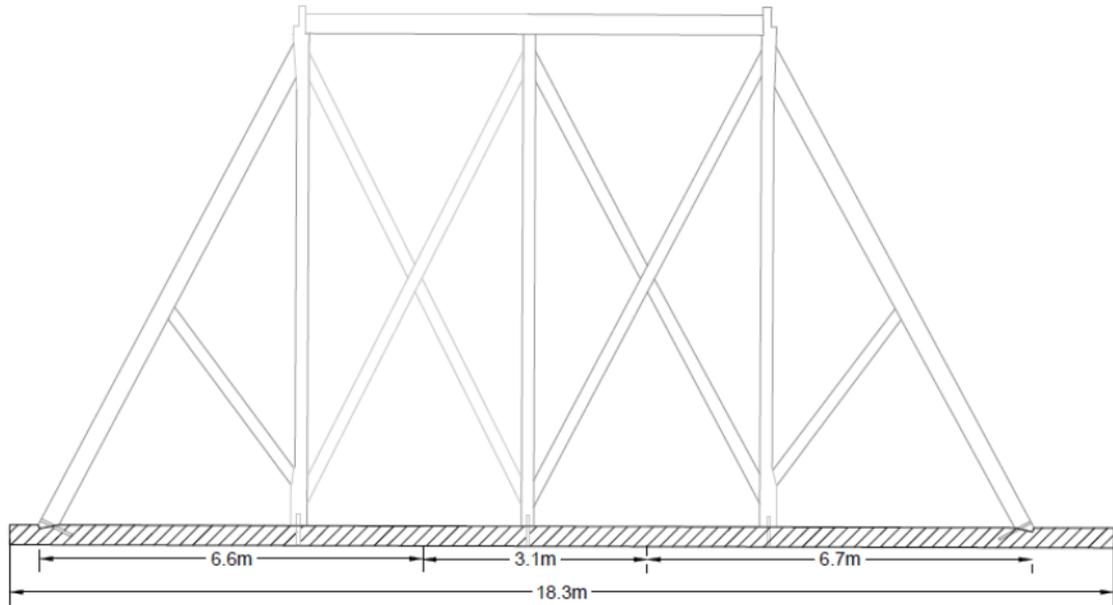
Figure 5-10: Bottom Chord

The bottom chord governing cases tend to be from the wind loads (4a, 4b or 4d) or the snow load (3a) dominant cases. The resistance capacity of each member is dependent on the governing load combination for the load duration factor, therefore wind load dominant cases assume $k_d=1.15$ while the snow load dominant case assumes $k_d=1.0$. The resistance capacities are tabulated for the two material properties to show the upper and lower bound. In all cases reviewed, the bottom chord is determined to have adequate capacity to support the loading determined from the frame analysis. Sample calculations are included in Appendix D.

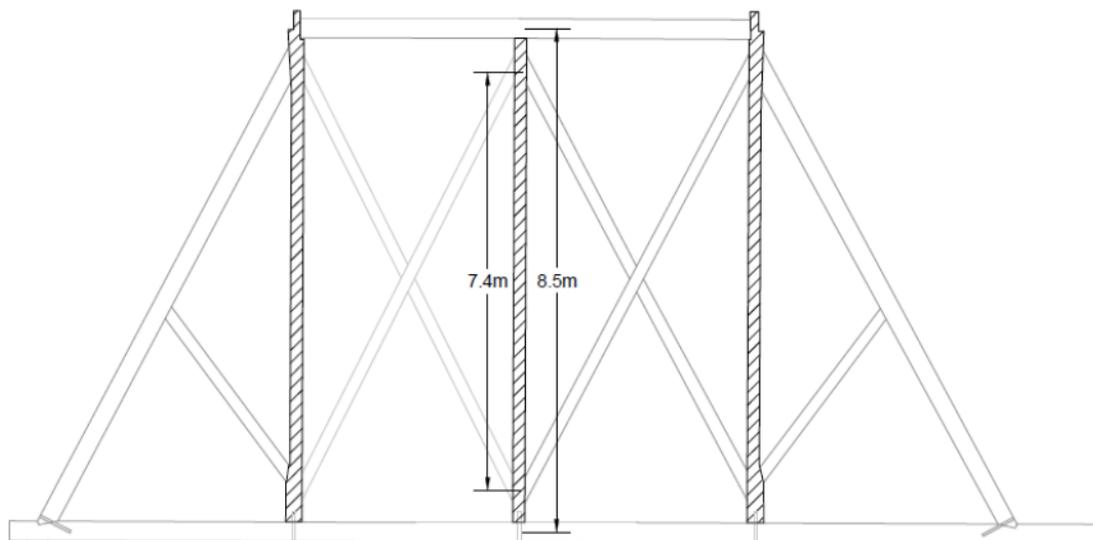
Figure 5-11: Posts

The shear resistance is also calculated to be lower than the possible forces in the post. With the reduced net area, V_f is more than double V_r , and with the allowable limit, V_f is still just shy of the resistance capacity. For bending, the post shows signs of concern when evaluated with the lower grade material.

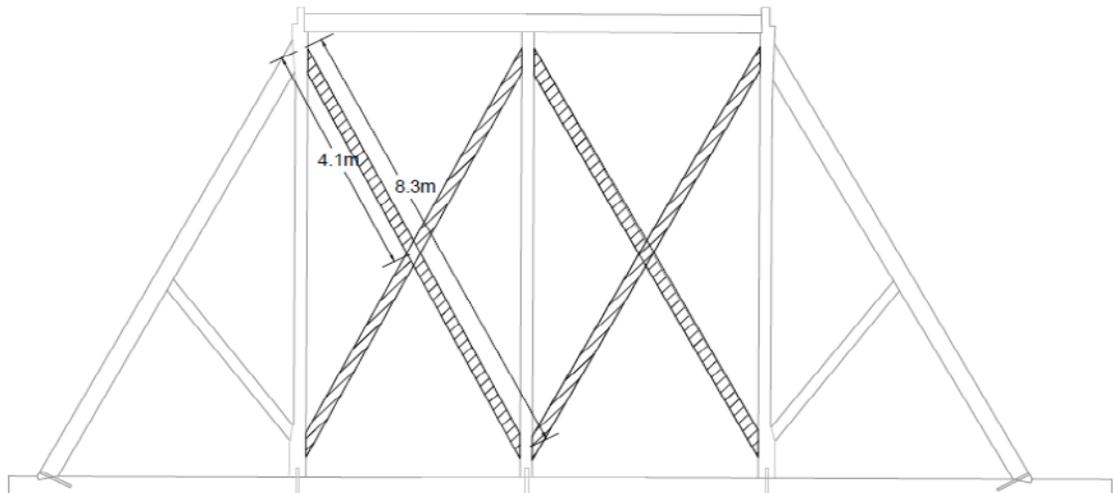
Figure 5-12: Major Diagonal Brace

No shear or bending moment forces are observed in the major diagonal bracing.

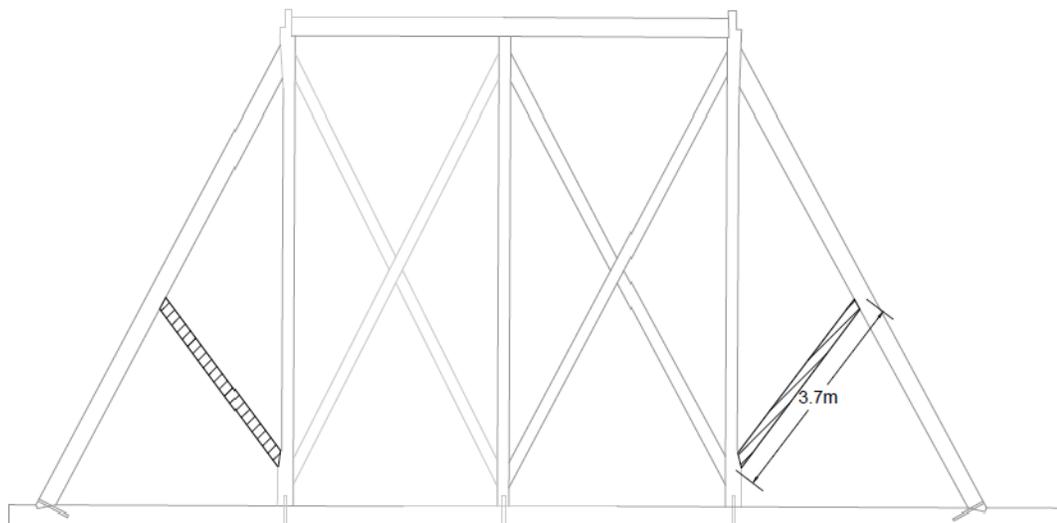
Figure 5-13: Minor Diagonal Brace

Members are determined to have adequate capacity compared to the identified forces. It is also noted that the compression forces are governed by the live load case (2a), while the tension forces are governed by the wind load case (4d).

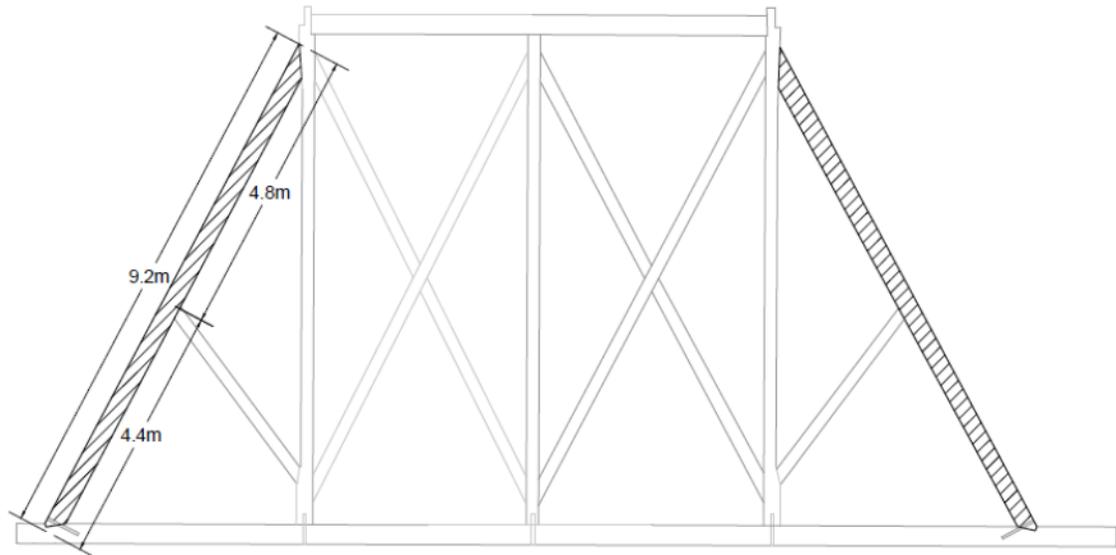
Figure 5-14: Inclined Truss Member

The resistance calculated using the higher grade Material A and lower grade Material B both indicate adequate capacity of the inclined truss member.

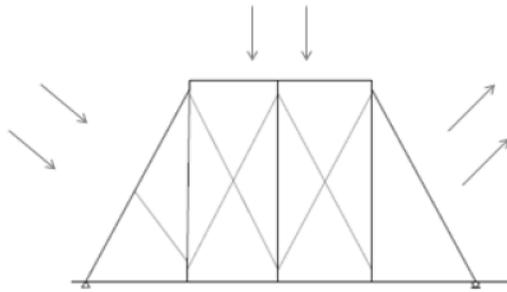
Figure 5-15: Tension Combo 4a (Case 1)

Overall, the tension cases created by removing members that may have little or no tension resistance are found to have inadequate capacity in one or more members. This indicates that the structure is dependent on the ability of the members take tension forces. This means members and connections need to be able to resist tension; therefore, some of the connections may have to be retrofitted (see Chapter 6: Traditional Timber Connections).
