Conservation of Historic Timber Trusses with Case Study
of the Governor General's Pavilion Roof, East Block of
Parliament, Ottawa.

A thesis submitted to the Faculty of Graduate and Postdoctoral
Affairs in partial fulfillment of the requirements for the degree of

Civil Engineering

Carleton University
Ottawa, Ontario

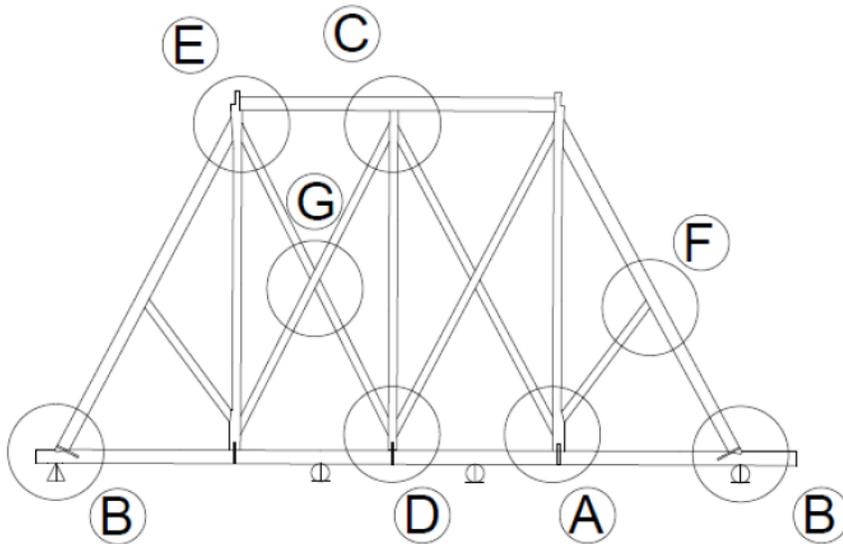
Figure 6-1: Key Plan of Connection Details

Each connection is checked for spacing or notching requirements as well as capacity for compression, tension, shear and bending as applicable. The connection checks make use of current codes where possible and are supported by methods previously discussed in Chapter 2 (Section 2.3.5) and described by relevant papers [13] [35] [33] [52].

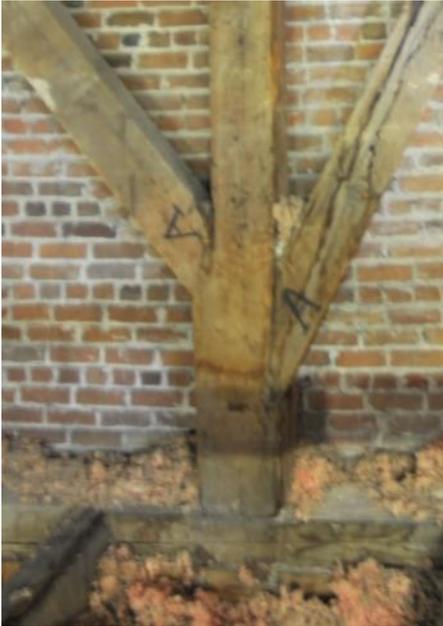
Figure 6-2: Photograph of Detail A (west side of E2)

photograph taken in 2016 (Figure 6-2). There is no indication of notching and therefore the joint is assumed to be a lap joint; however, it is possible there is hidden geometry.

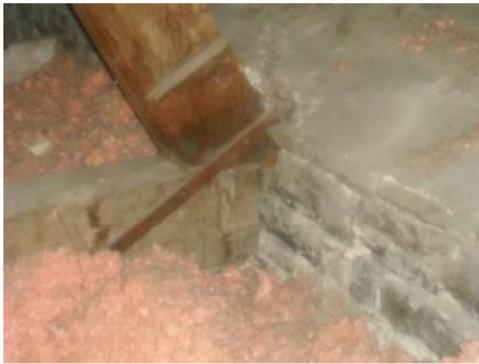
Figure 6-4: Photograph of Detail B (east end of E2)

The connection of the inclined truss members and the bottom chord is referred to as a heel, notched or birdsmouth joint. Detail Bs are identified in Figure 6-5, showing the left and right-hand sides of the truss have different lengths beyond the notched connection, additional detail drawings are found in Appendix E.4. The right-hand side has an extension distance of 1365 mm from the end of the bottom chord to the notch detail, while the left-hand side has a distance of 610 mm; most of this extend portion is hidden in the masonry wall connection and dimensions are not verifiable. The inclined truss member is cut with two opposing angles, one longer and the other shorter one acting as a toe. The bottom chord is notched to fit the geometry of the tapered inclined truss member. A metal strap with bolts and a wood wedge are seen in this connection too. These are typical of this connection type designed primarily to keep the connection tight fitting in case of wood shrinkage after assembly, or as supplementary resistance in case of excessive or reverse loading.

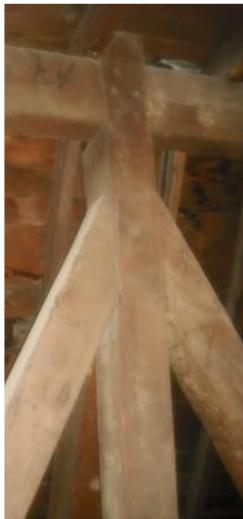
Figure 6-6: Photograph of Detail C

Detail C (Figure 6-6 and Appendix E.3, E.4) is identified as the connection of the top chord with the middle post, and major diagonal bracing framing in just below (Figure 6-7). The top chord and post connection appear overly simplified in the *As Found* drawings [1]; however, in this study efforts are made to approximate the geometry of this detail. It appears the top chord is comprised of two members with pegged tenon connections to the post. It is difficult to access and verify geometry of this detail; further investigation is recommended for a more accurate analysis. The connection of the major diagonal bracing uses skewed tenon joints similar to that observed in Detail A, with a variation on tenon size and shape. It is also noted that the post geometry varies at the top compared to the middle square section or bottom where haunches are observed in some details.

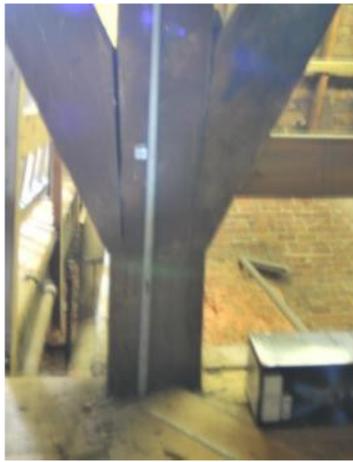
Figure 6-8: Photograph of Detail D

Detail D (Figure 6-8) is identified as the connection at the middle post (Figure 6-9). It connects with the bottom chord as well as the major diagonal bracing members. Skewed tenon connections are assumed symmetrical and include a toe notch. No haunches are present on the middle post. The bottom chord and post connection (not shown in photograph) is assumed to be a lap joint with a metal strap similar to that of Detail A. Dimensioned detail drawings in Appendix E.4.

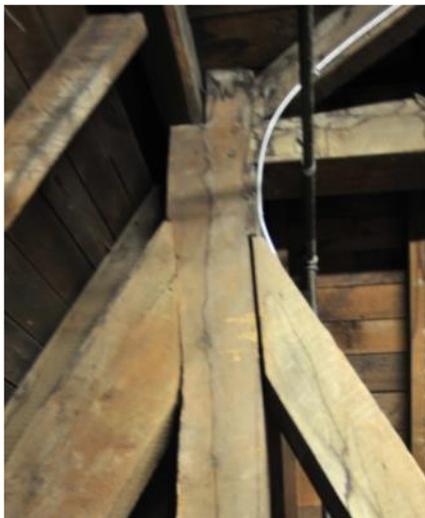
Figure 6-10: Photograph of Detail E

Detail E (Figure 6-10) is labeled as the end connection of the top chord with the post and framing members include the inclined truss and major diagonal bracing (Figure 6-11). Skewed tenon connections with toe notches are used in the inclined truss to post joint as well as the major diagonal to post joint. The top chord is assumed to be a pegged tenon connection. This detail is not noted in the *1974 As Founds* [1] therefore the tenon geometry is unknown and is approximated based on the visible wooden dowels (see Appendix E.4). The top chord appears to taper heavily close to the connection while the post is also notched to accommodate addition roof framing members.

For Detail E, the assumed geometry is based on rectified photography and visible wood dowel locations (Appendix E.4). The post is checked for net area reduction due to the mortise holes of the inclined truss member and major diagonal brace and is estimated to be within the limit of 75% of the gross cross sectional area (Table 6-34). The post is not checked where the top chord connects. There are a number of spacing issues identified in the connection of the top chord and post in Detail E (Table 6-35).

Using the skewed tenon evaluation methods in [13], the inclined truss member shows inadequate compression capacity at the toe of the connection (Table 6-38 to Table 6-40). Based on observations, it noted that the post is not straight as assumed in calculations; the angled post may create additional resistance capacity. The skewed tenons are assumed to have no tension capacity and therefore do not meet requirements of this connection.

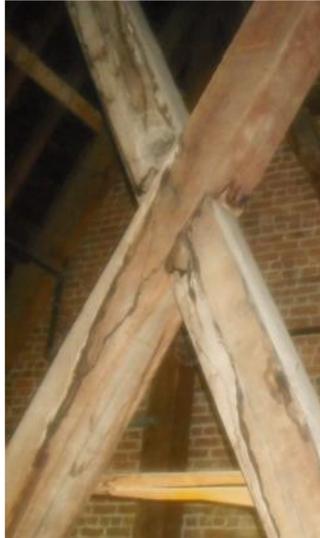
Figure 6-13: Photograph of Detail G

Detail G (Figure 6-13) is not labelled in the *1974 As Founds* [1], however in this report it is identified as the half lap joint between the major diagonal bracing members (Figure 6-14). The lapped joint is angled as the members do not cross orthogonally. This half-lap joint does not appear to make use of dowels.

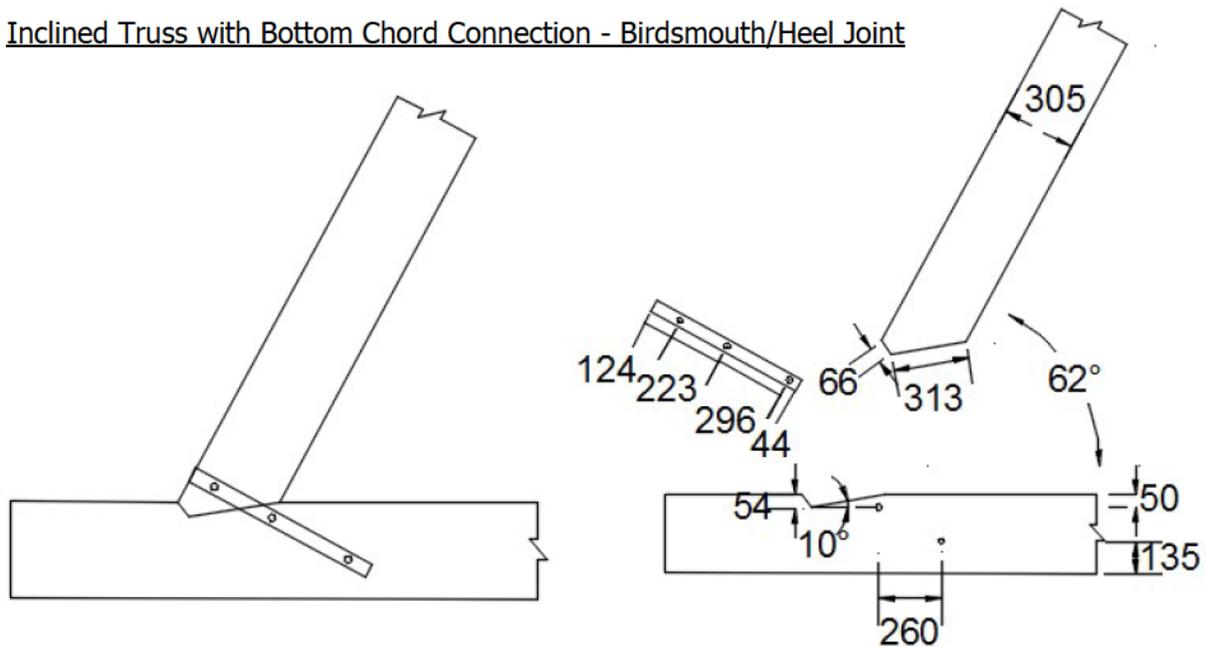
Inclined Truss with Bottom Chord Connection - Birdsmouth/Heel Joint
