**Saving Architectural Heritage:
Climate Change Resilience and Conservation Management**

Maplelawn Estate and Garden

A Conservation Management Plan

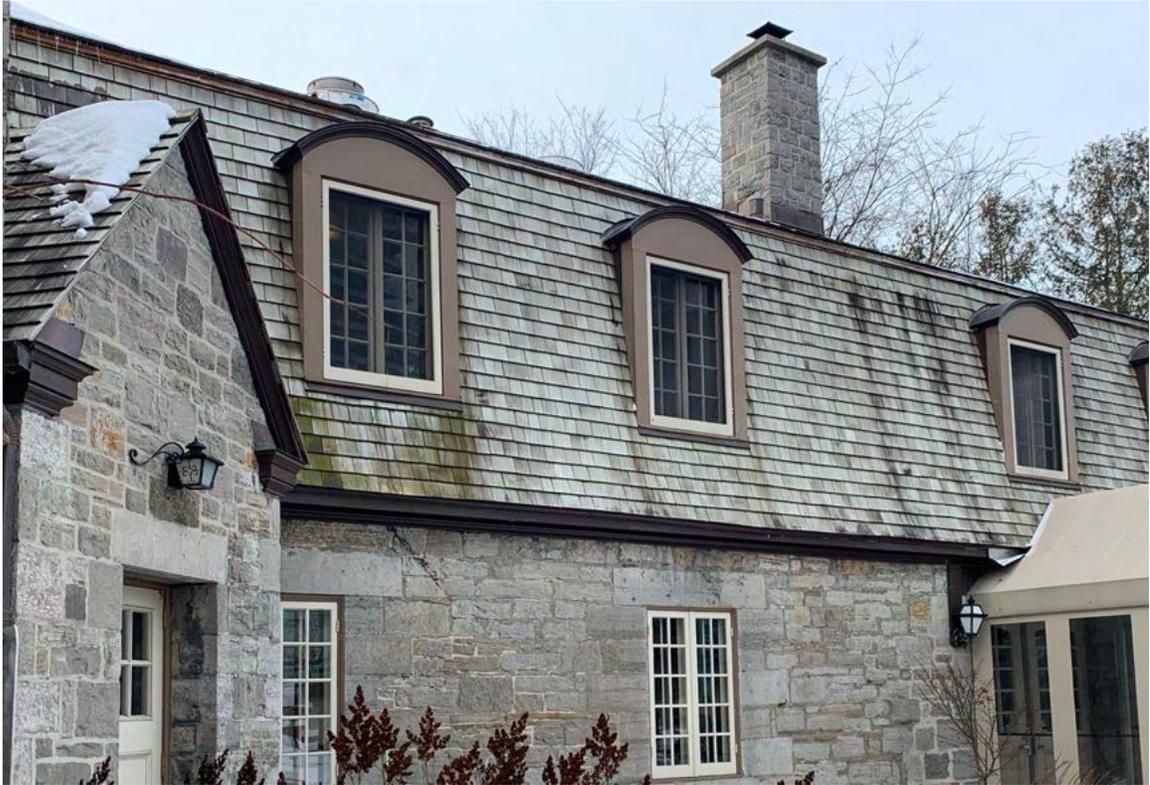
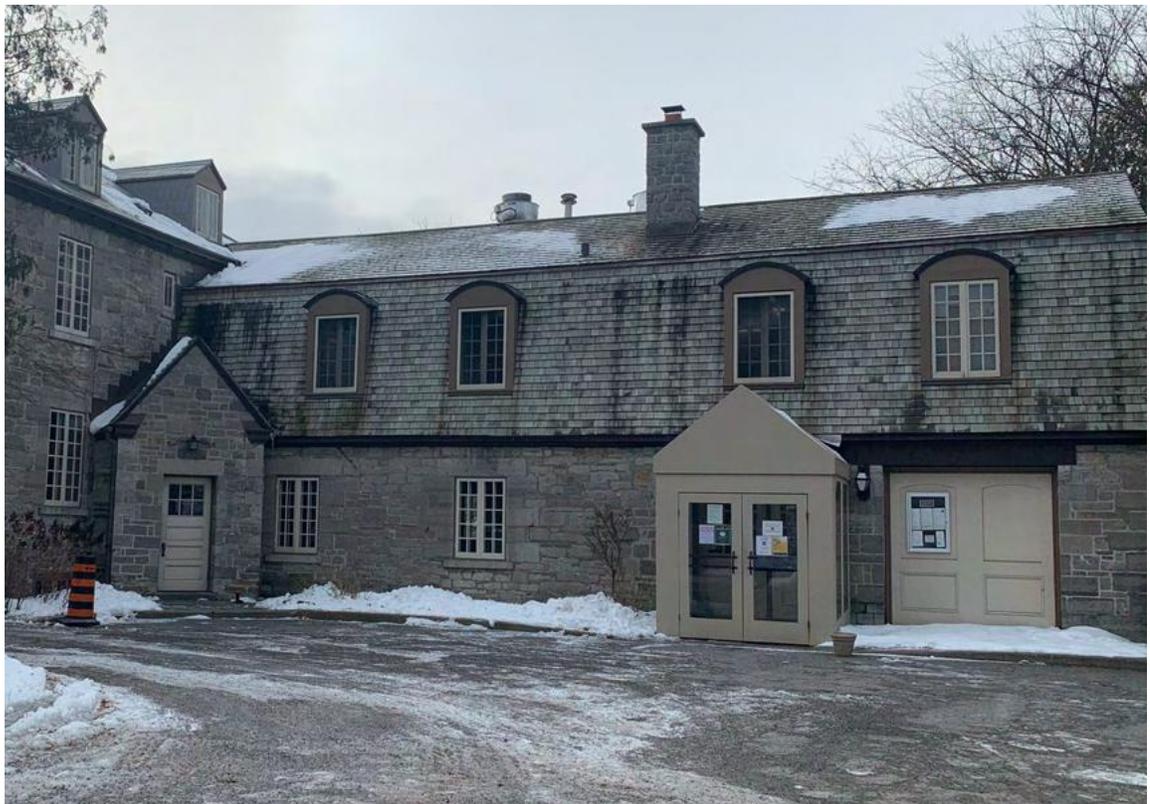
Figure 4: A Visual Assessment of Maplelawn Estate Building with Deterioration Callouts 29

The photographic documentation was very promising in its demonstration of the current good condition of the building and walled garden (fig 4-5). At this point, the former estate house is only demonstrating minor deterioration that is to be expected given the climate changes and surrounding urban development. For example, precipitation accumulation can be seen along portions of the roof. As well, there is minor water staining on the masonry surfaces, preliminary biodeterioration from vines climbing the façades and minor masonry spalling in a few areas. At this point, the current management plan is highly effective in mitigating degradation of the heritage materials.

Water Accumulation, Infiltration & Staining

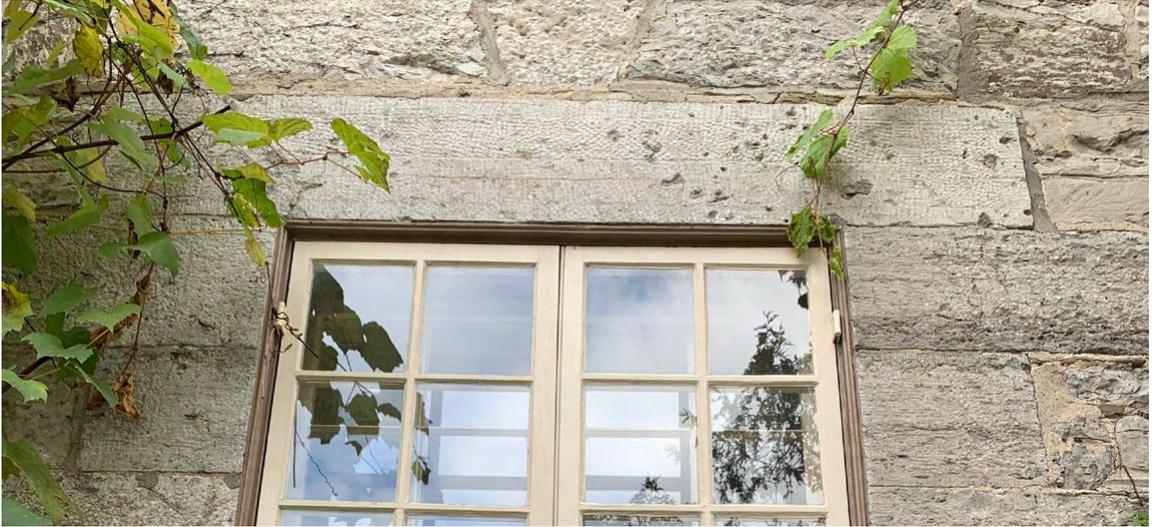
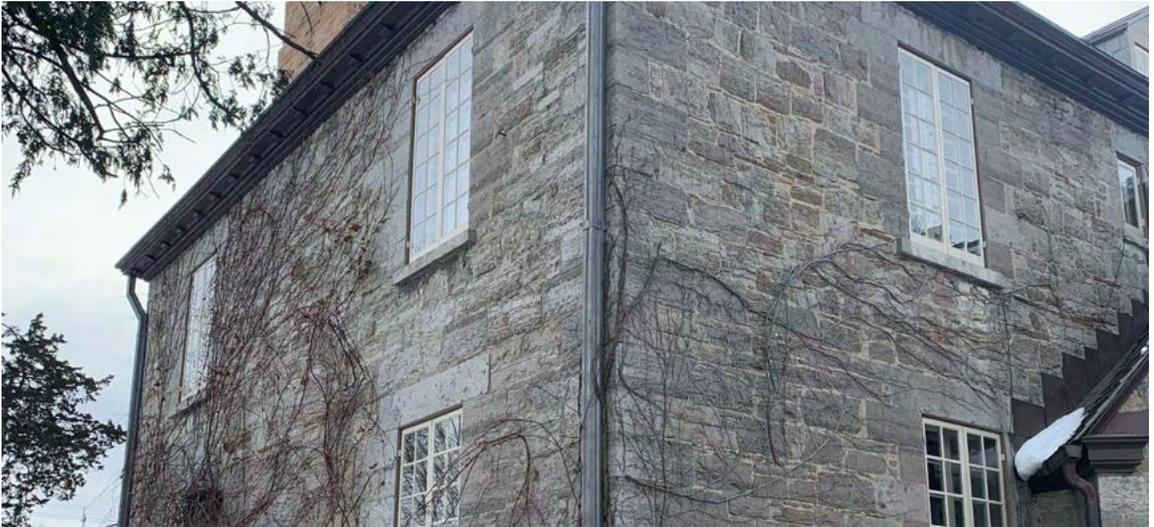
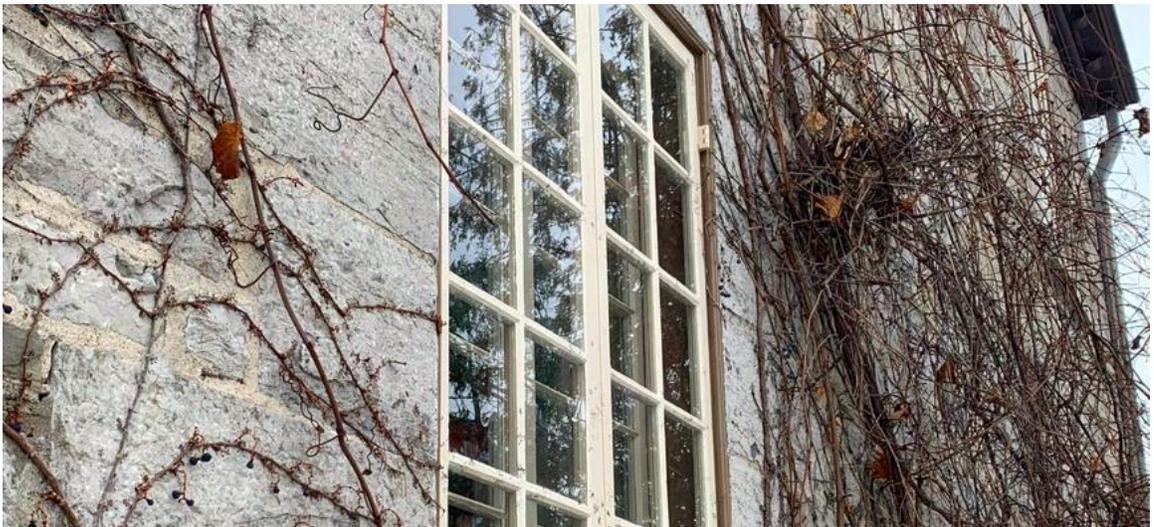
Figure 5: A Visual Assessment of Maplelawn Estate Building with Deterioration Callouts (cont.)

Masonry Deterioration

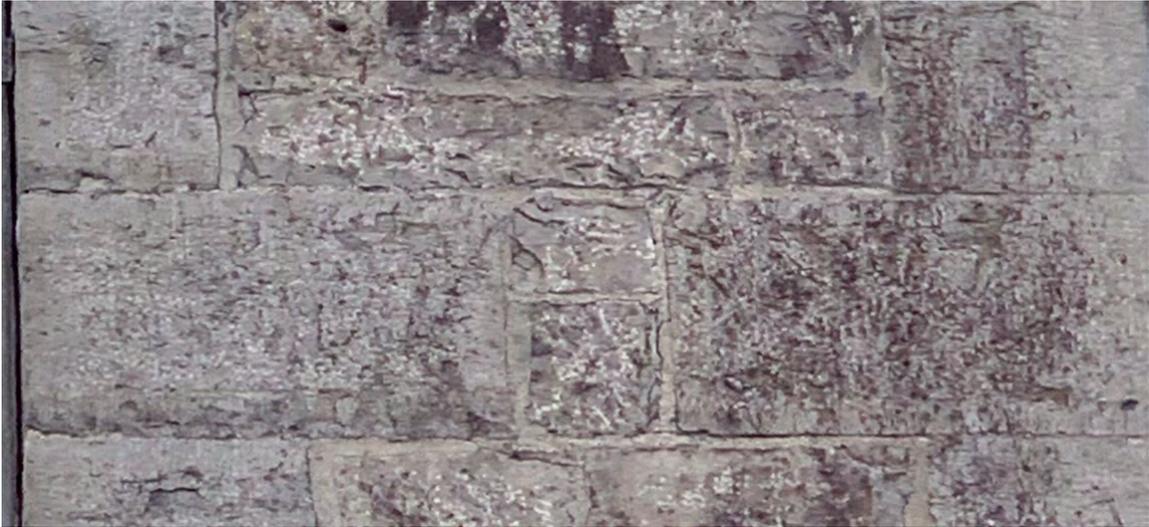
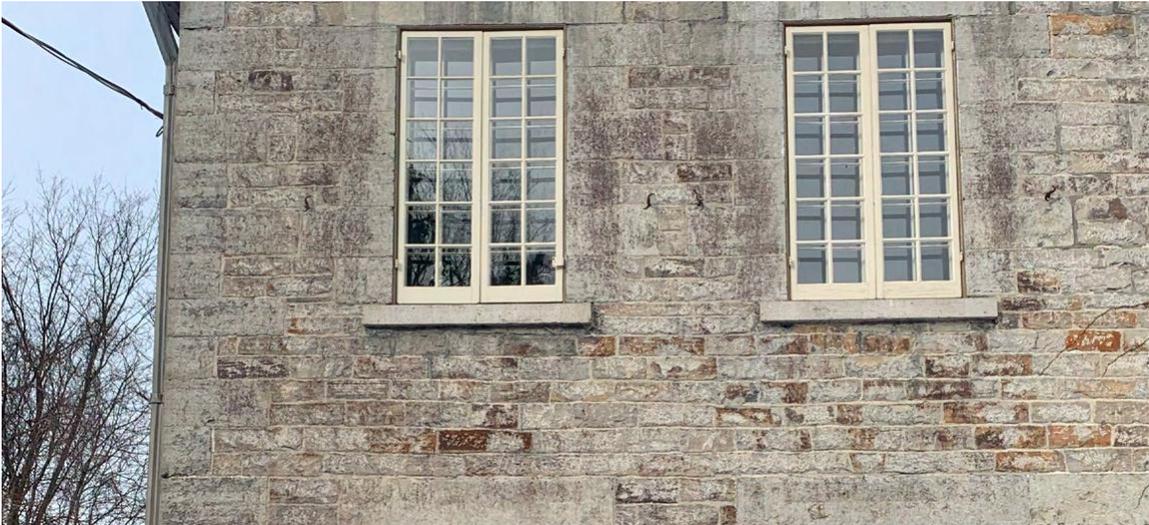
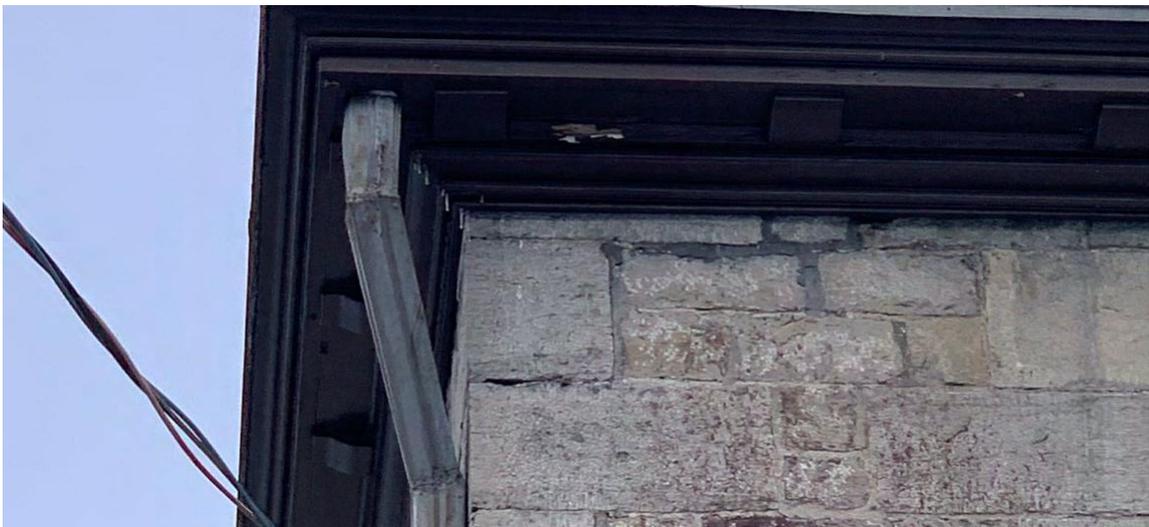
Figure 6: A Visual Assessment of Maplelawn Estate Building with Deterioration Callouts (cont.)

General Deterioration

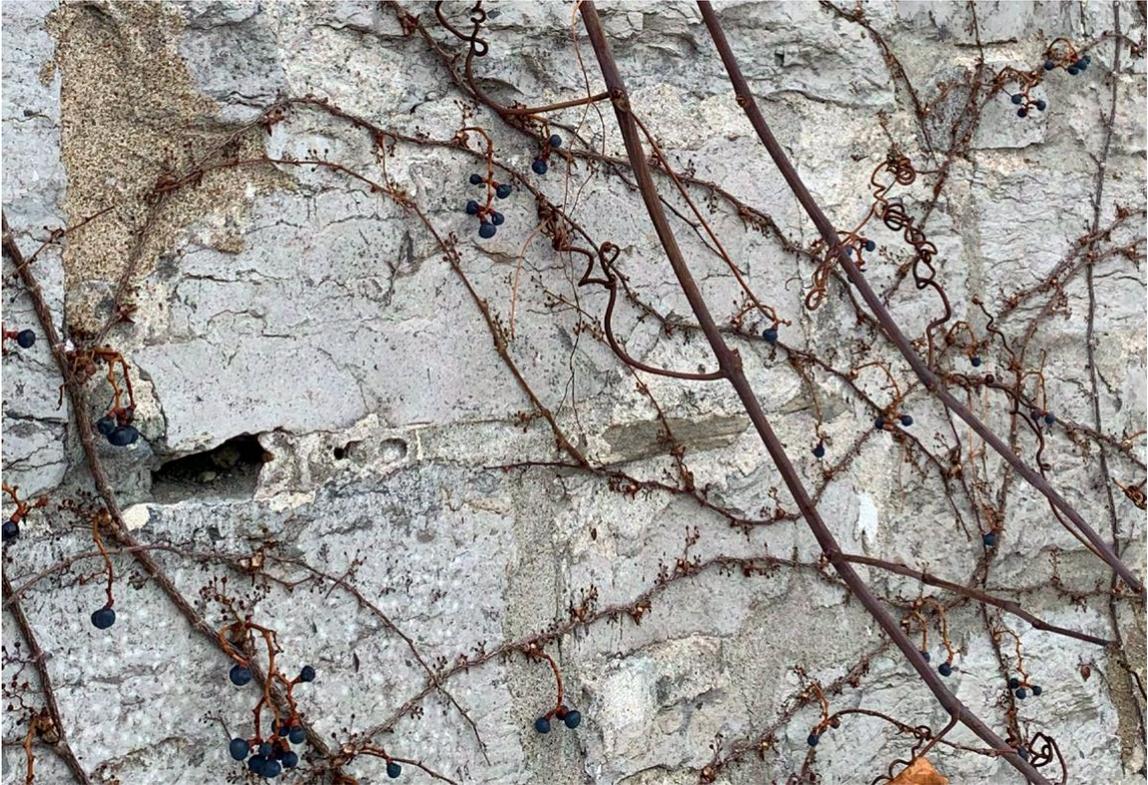
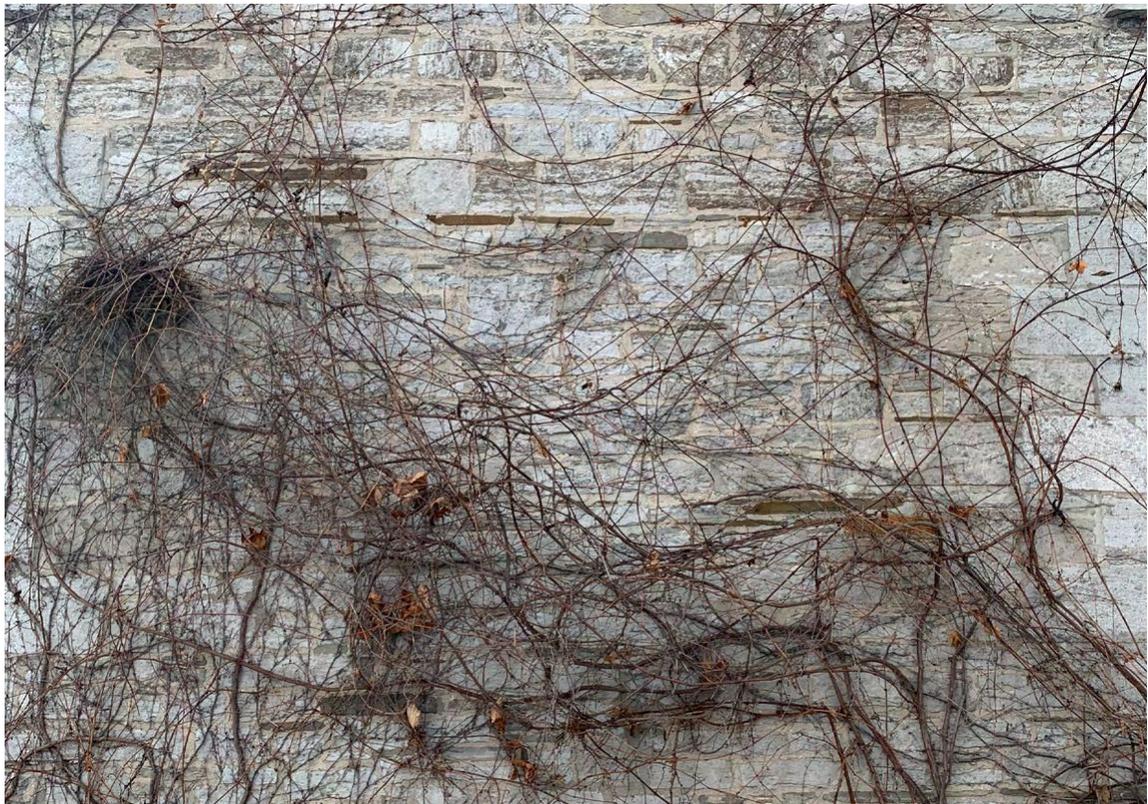
Figure 7: A Visual Assessment of Maplelawn Estate Building with Deterioration Callouts (cont.)

Biodeterioration

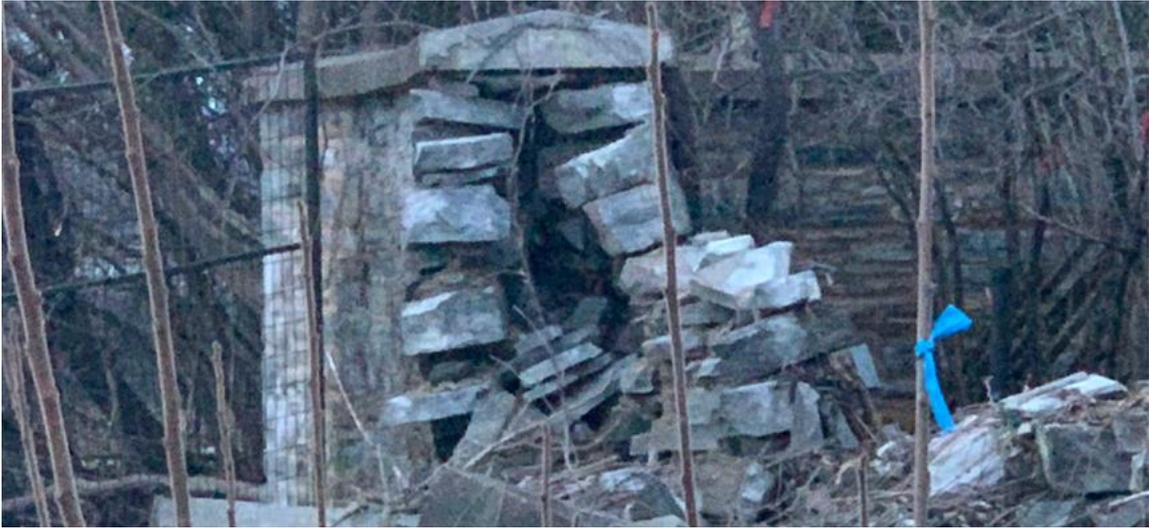
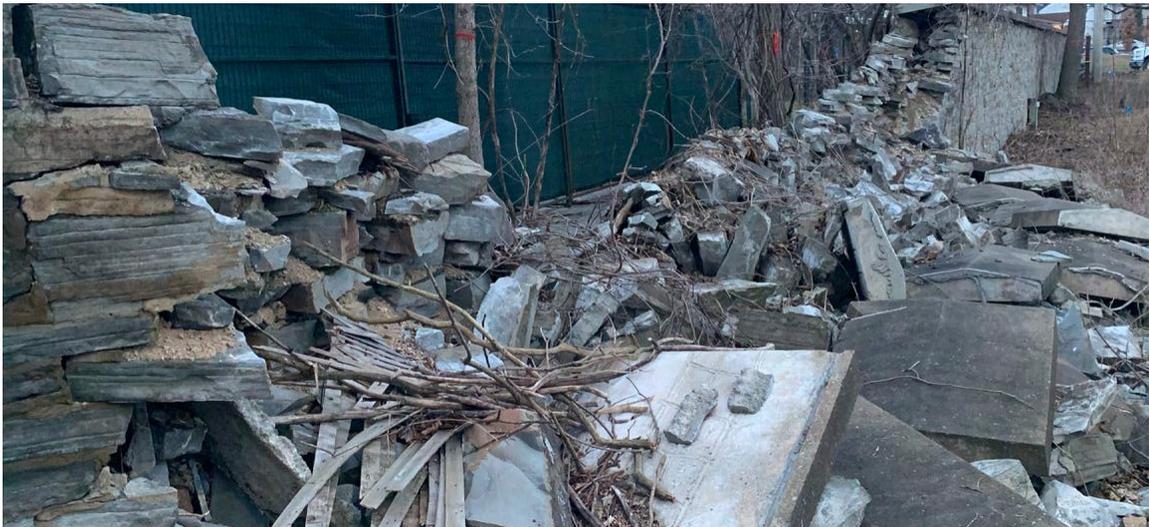
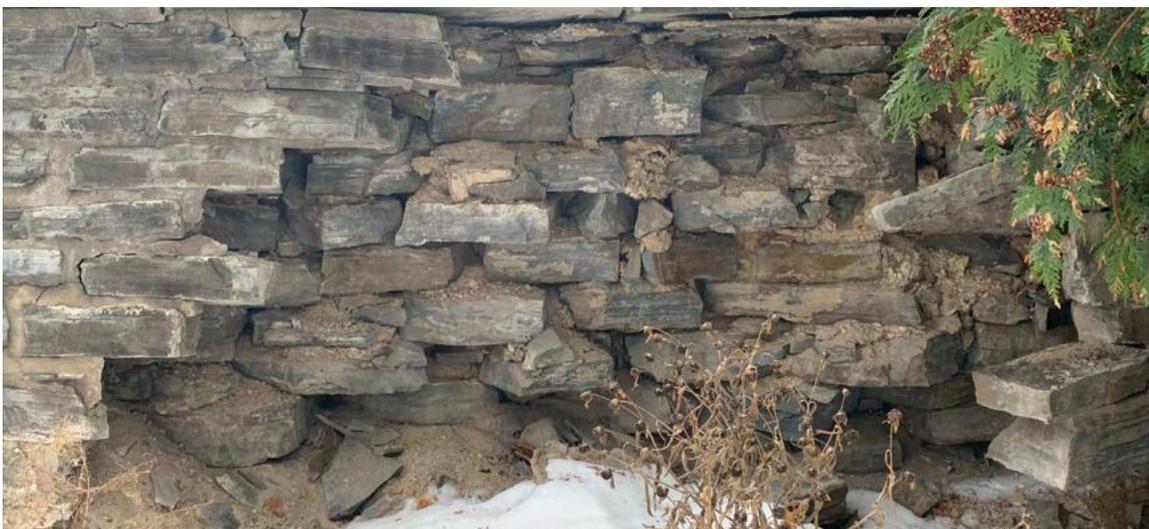
Figure 8: A Visual Assessment of Maplelawn Historic Walled Garden with Deterioration Callouts

Structural Failure

The historic walled garden is experiencing more severe deterioration in comparison to the estate in some areas but is overall in fair condition (fig 6-7). In two areas of the walled garden, a partial and full structural failure is visible, parallel to Richmond Road and the west façade, respectively. It could be hypothesized that these issues are due to recent drastic risk events. Since the walled garden does not have a foundation, it becomes more susceptible to changing forces and loads acting upon the material. The partial failure is only occurring on the interior face of the wall running parallel to the main road. Due to this characteristic of the failure, it could be hypothesized that it is caused by urban development. When the walled garden was built, it was a free-standing structure. Once the city and urban fabric densified within the region, that length became a retaining wall for the newly installed sidewalk and road. Not only does this effect the overall character and grandeur of the walled garden but the built-up soil also exerts a lateral force onto the masonry. As a historic building material, masonry is excellent in compression, but fails quickly through tension and shear forces. On the contrary, the full structural failure seems to have been caused by natural risks, by the soil heaving during global warming-induced freeze/thaw cycles. Over time, this repeated movement would shift the structural masonry until the wall portion began collapsing. This would reveal the masonry rubble core to higher amounts of precipitation than intended, further degrading the structural component. Other signs of deterioration noted on the walled garden include bedding plane

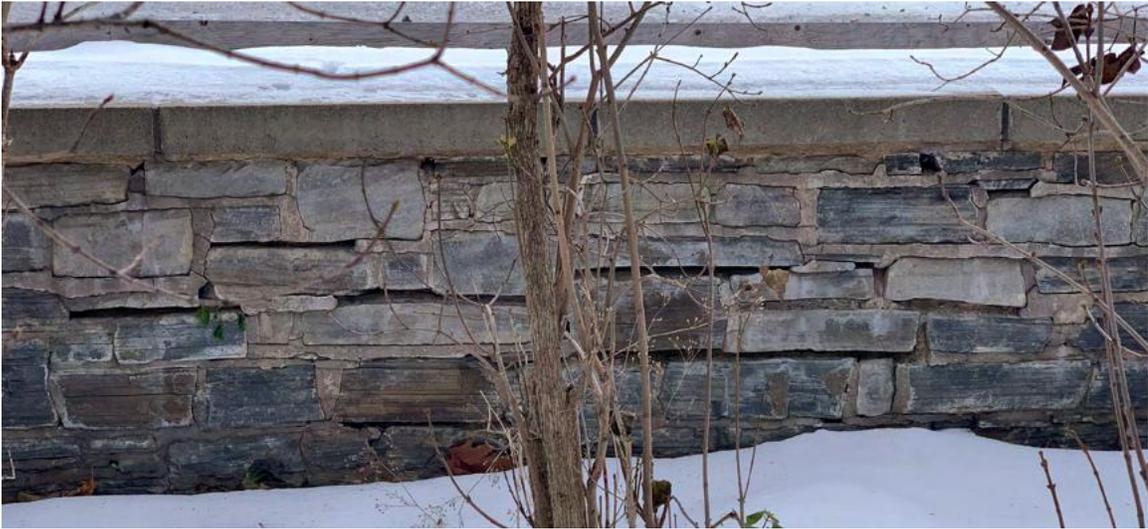
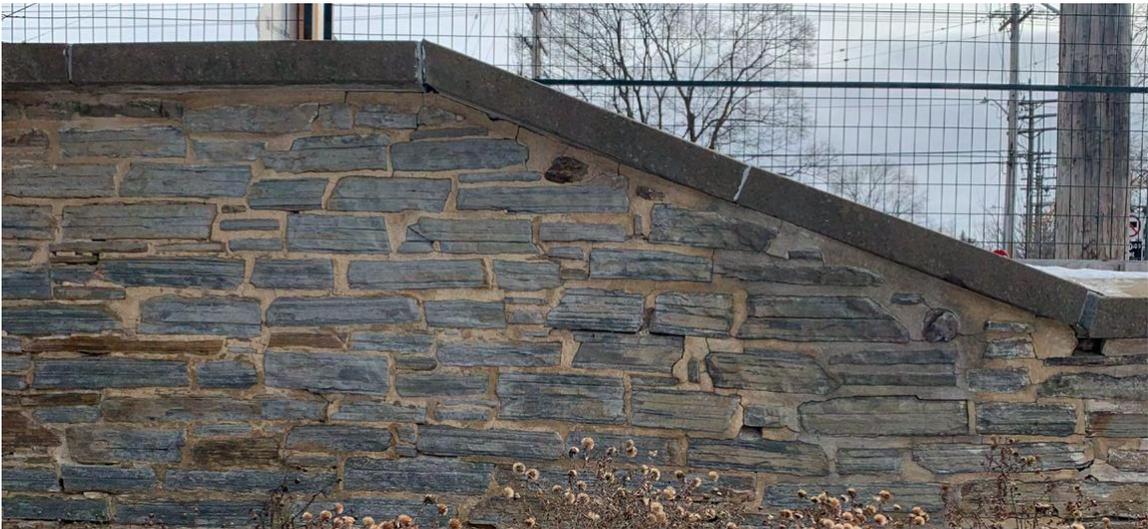
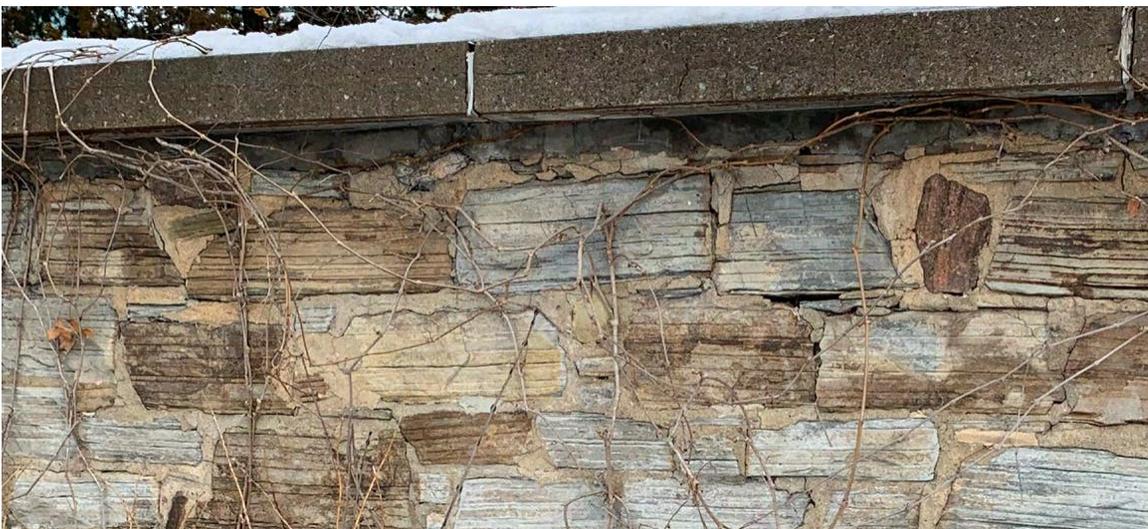
Figure 9: A Visual Assessment of Maplelawn Historic Walled Garden with Deterioration Callouts (cont.)

Masonry Deterioration

degradation on some stones, required mortar repointing caused by routine moisture infiltration and some areas of incorrectly cured mortar.

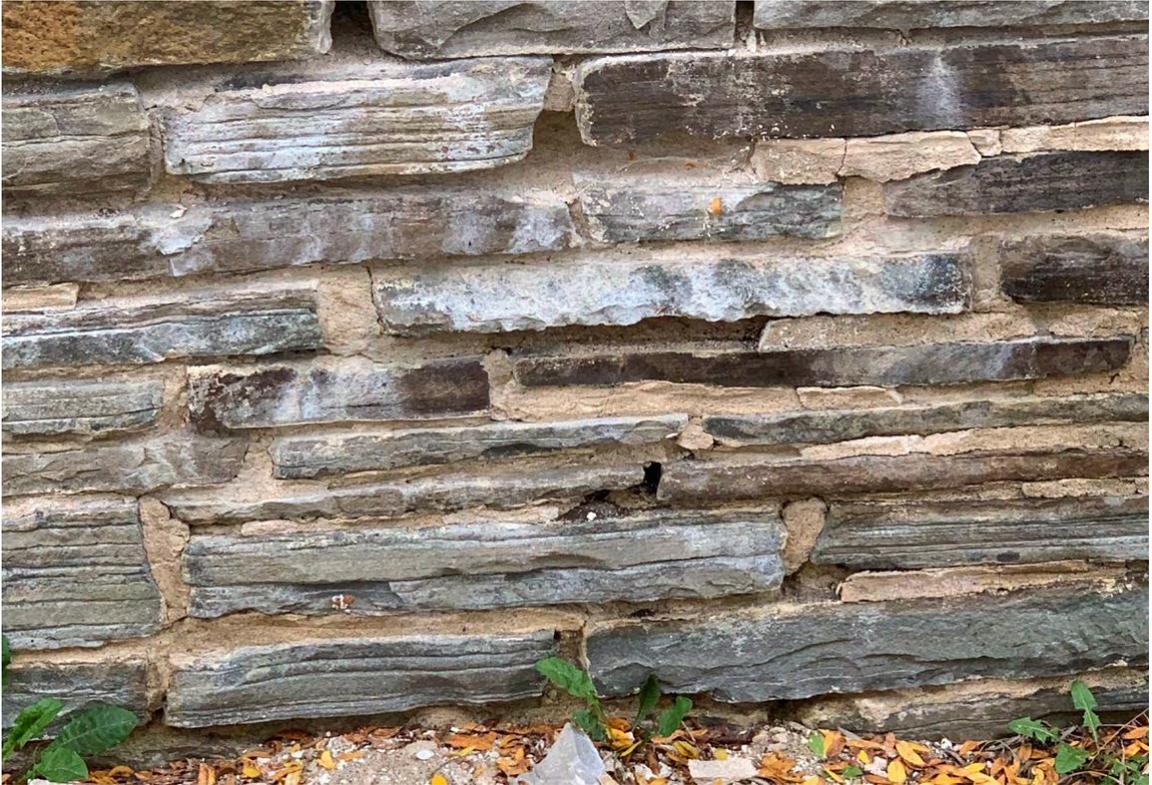
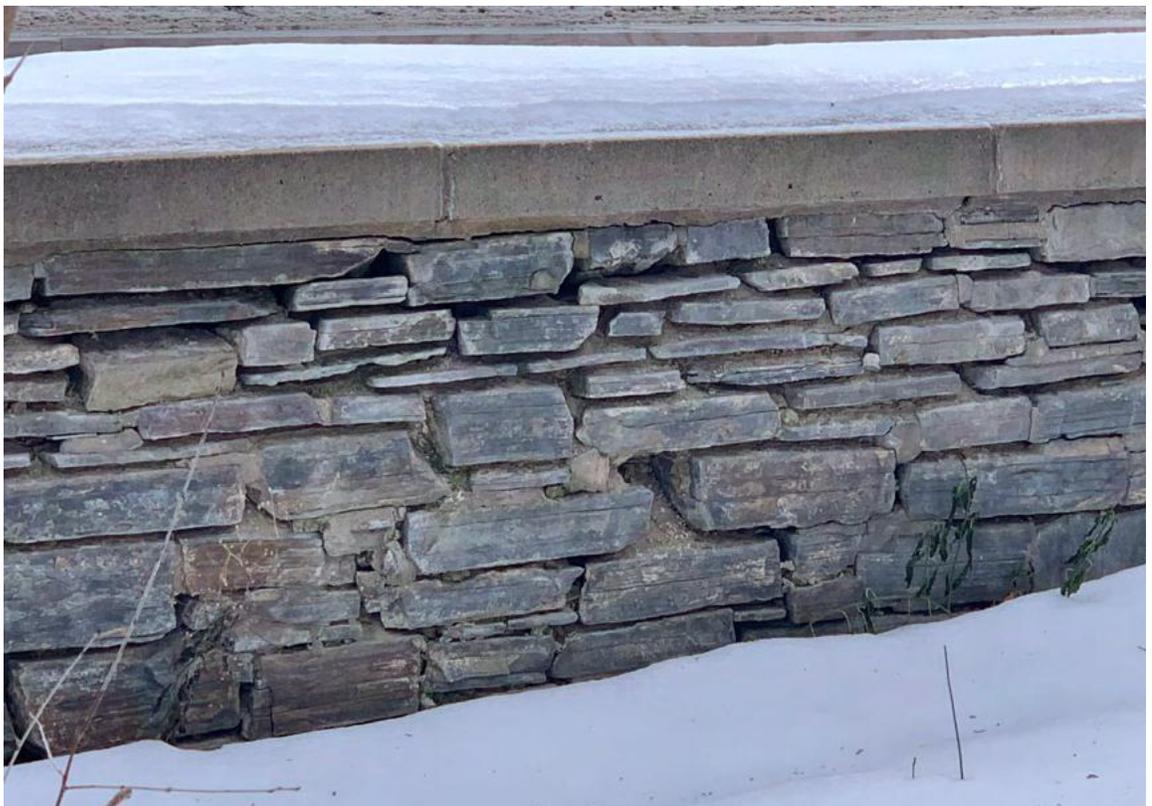
Figure 10: A Visual Assessment of Maplelawn Historic Walled Garden with Deterioration Callouts (cont.)

Mortar Deterioration

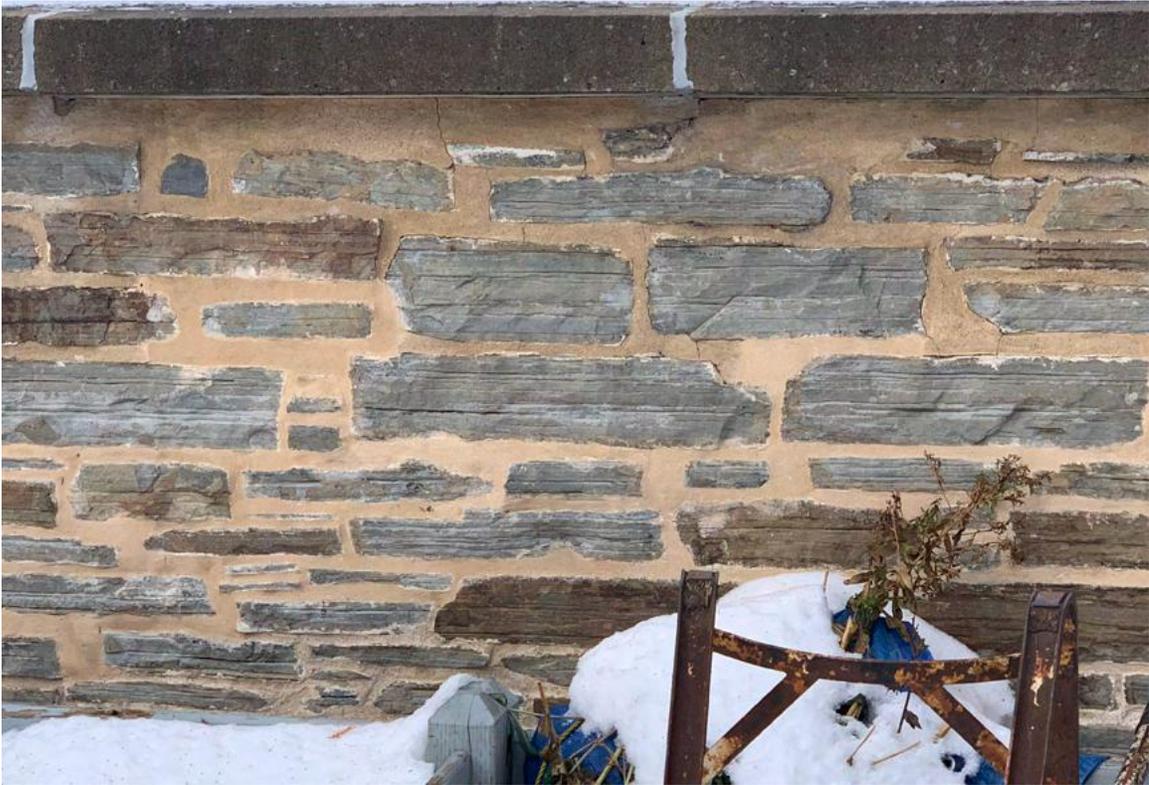
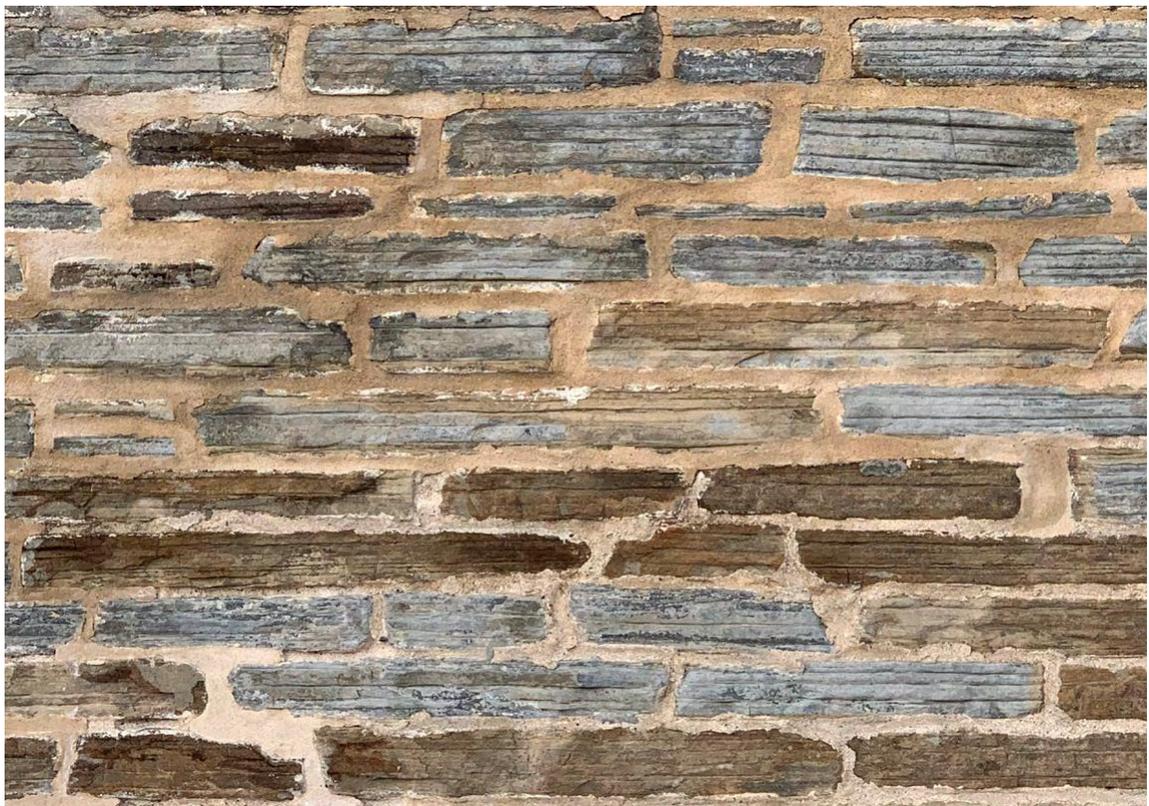
Figure 11: A Visual Assessment of Maplelawn Historic Walled Garden with Deterioration Callouts (cont.)

Inappropriate Interventions

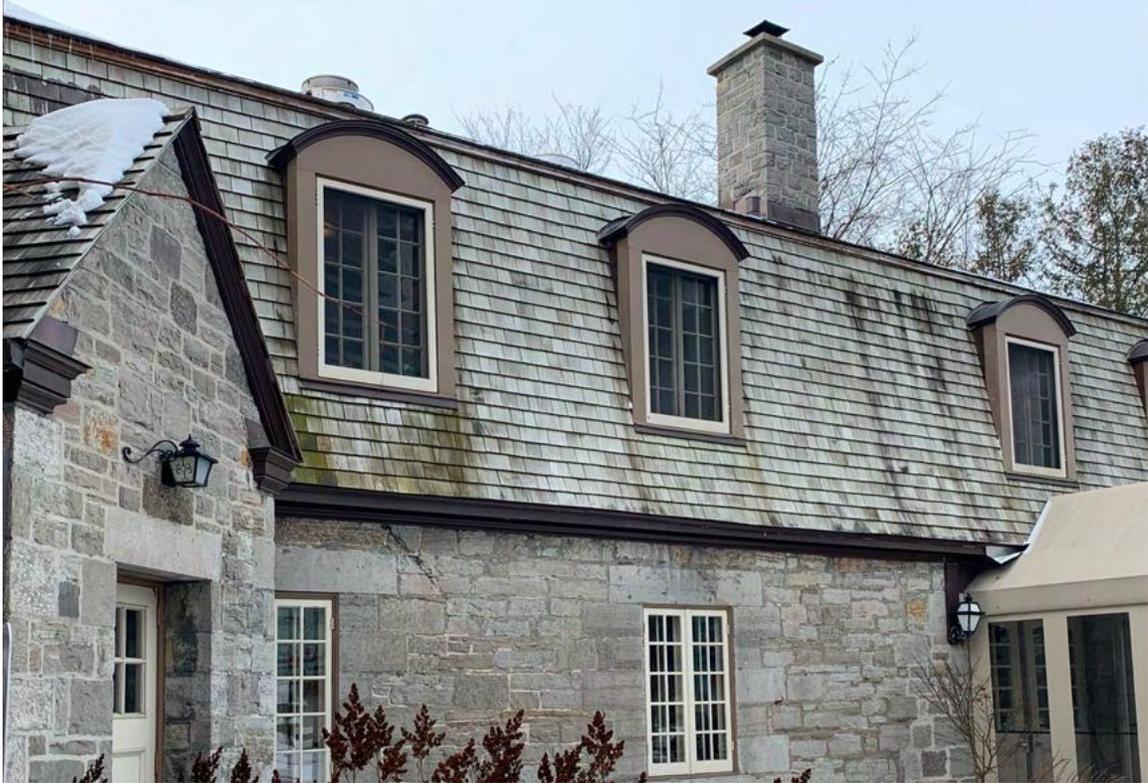
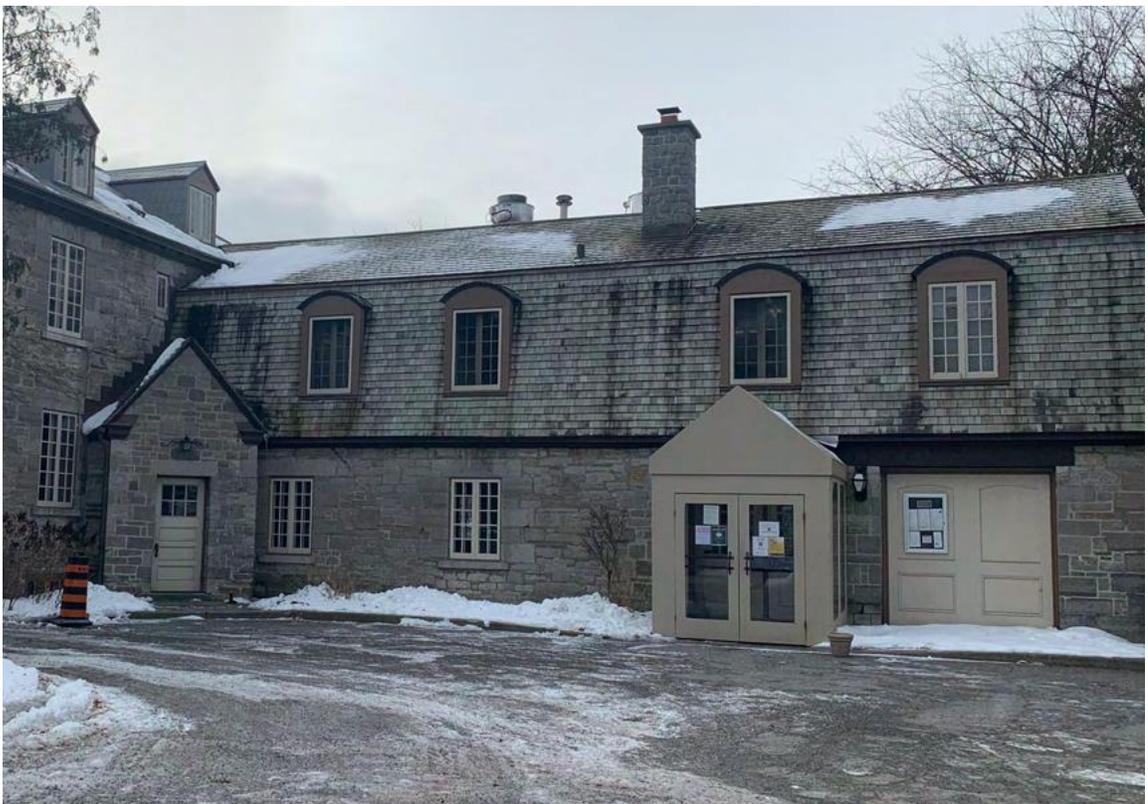
Figure 6: A Visual Assessment of Maplelawn Estate Building with Deterioration Callouts

Water Accumulation, Infiltration & Staining

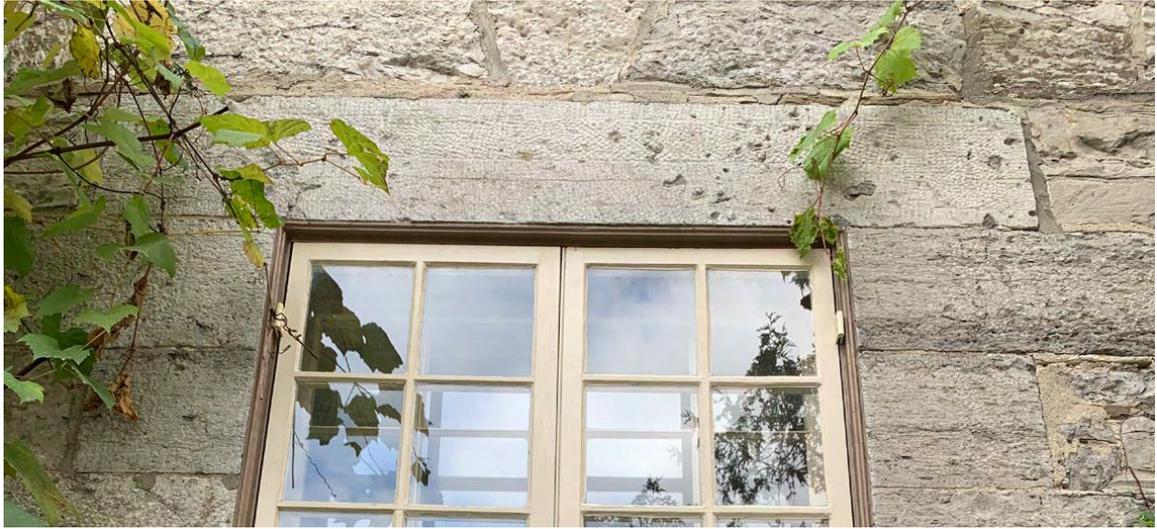
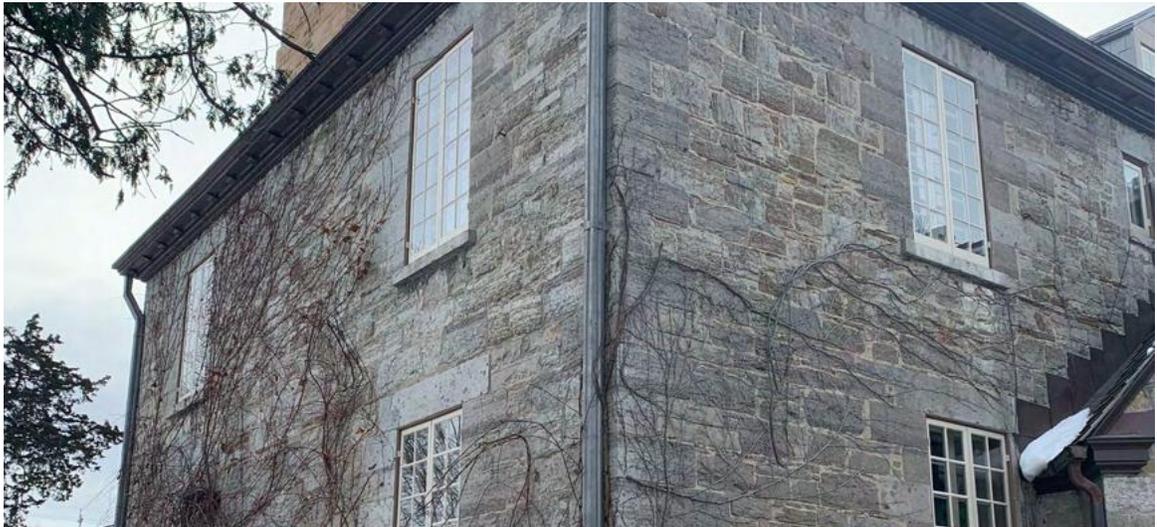
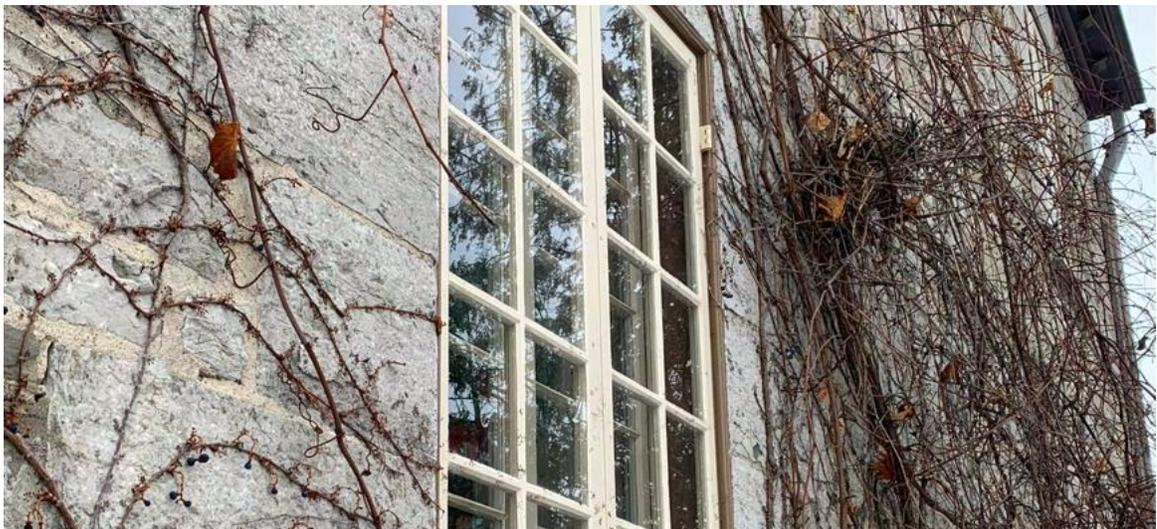
Figure 7: A Visual Assessment of Maplelawn Estate Building with Deterioration Callouts (cont.)

Masonry Deterioration

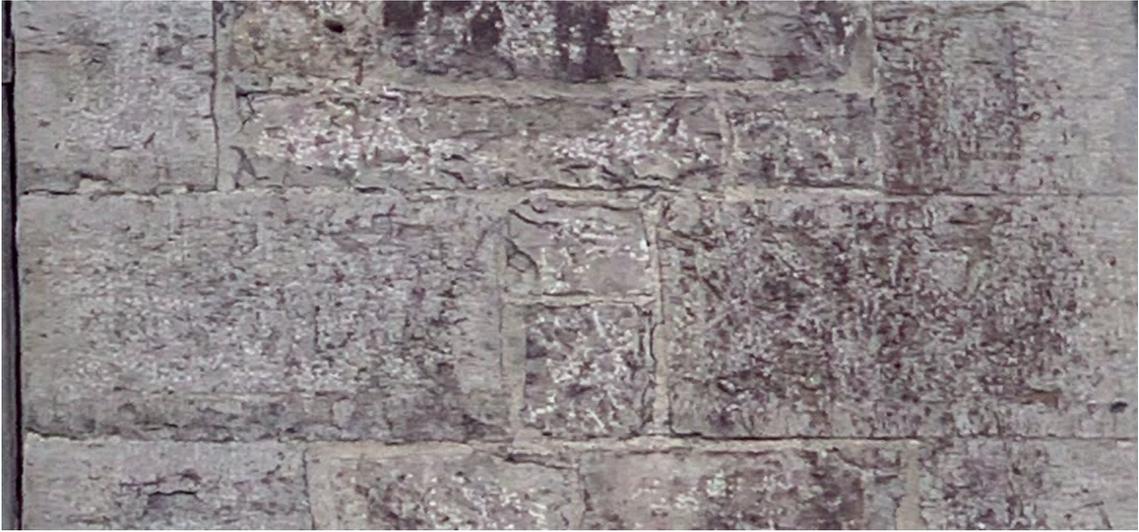
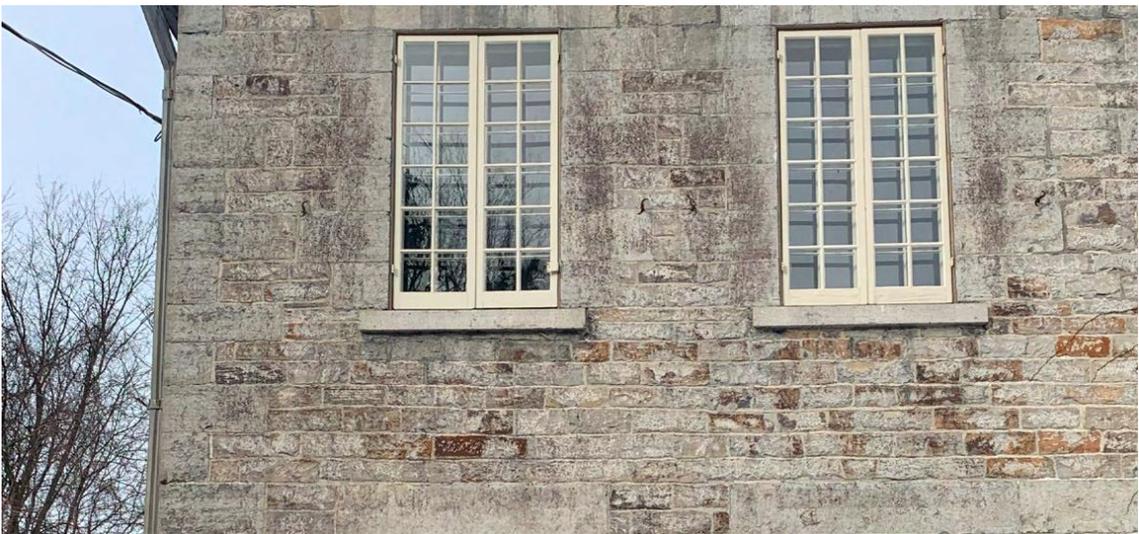
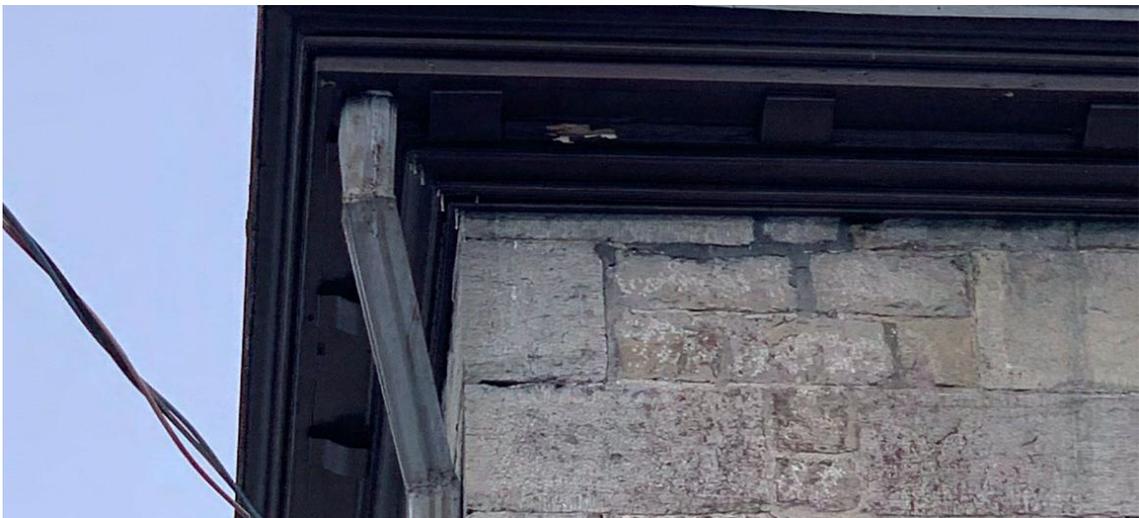
Figure 8: A Visual Assessment of Maplelawn Estate Building with Deterioration Callouts (cont.)

General Deterioration

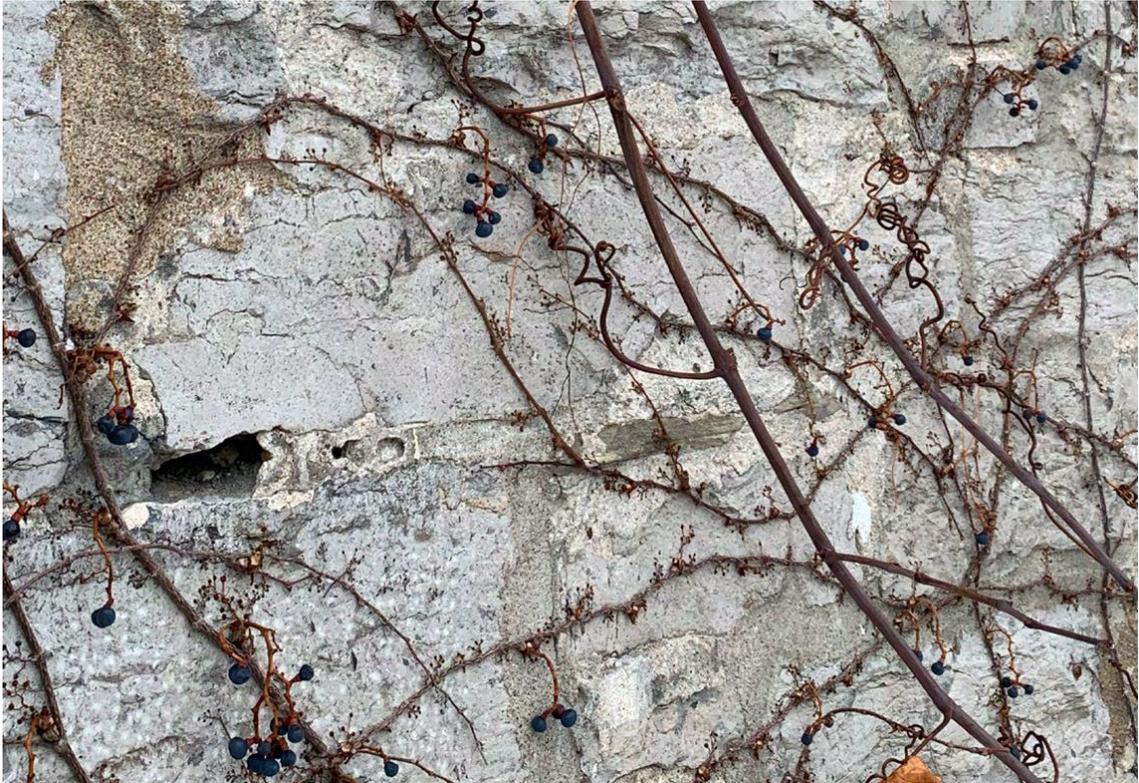
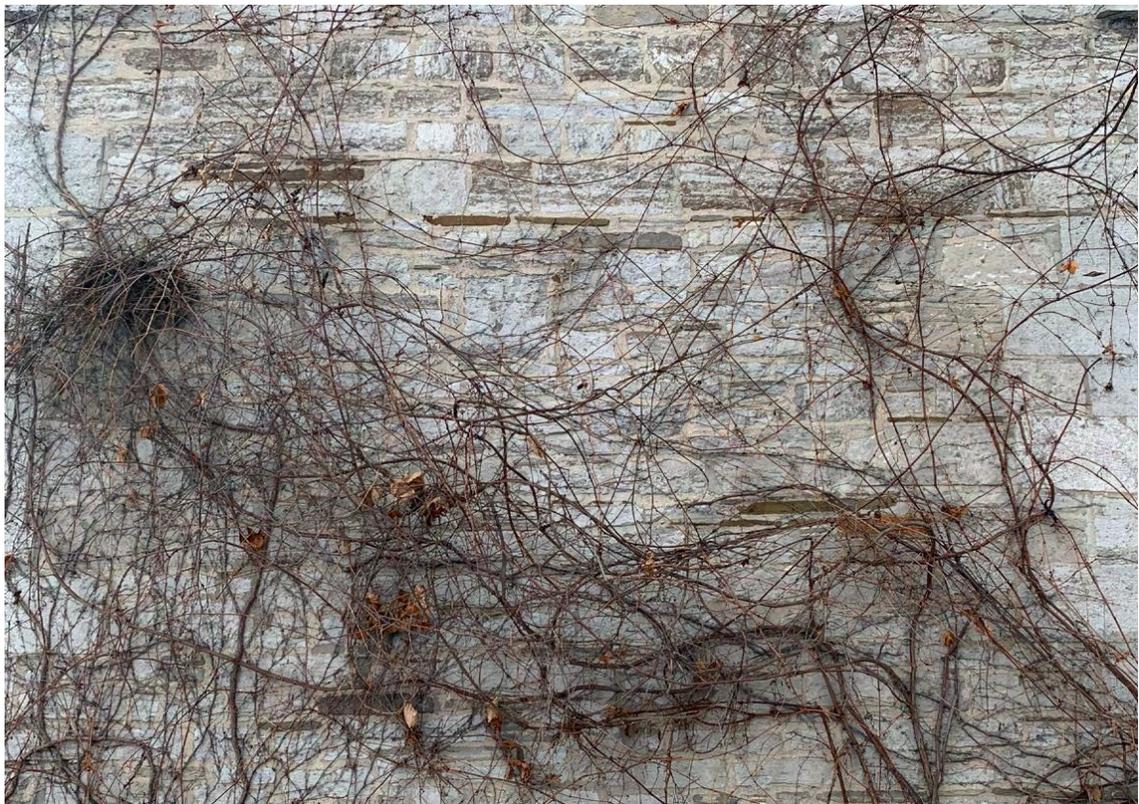
Figure 9: A Visual Assessment of Maplelawn Estate Building with Deterioration Callouts (cont.)

Biodeterioration
