**Saving Architectural Heritage:
Climate Change Resilience and Conservation Management**

Maplelawn Estate and Garden

A Conservation Management Plan

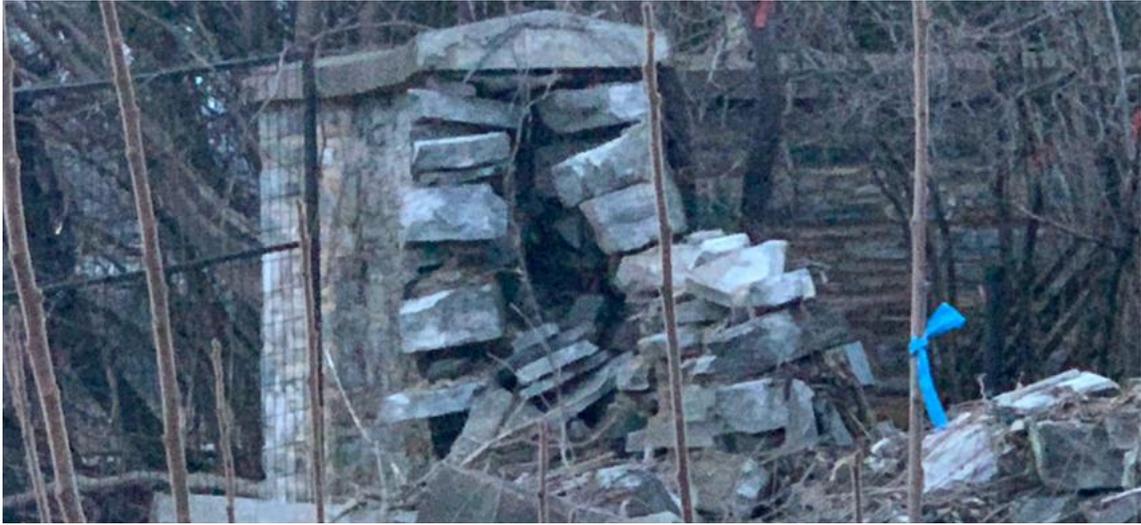
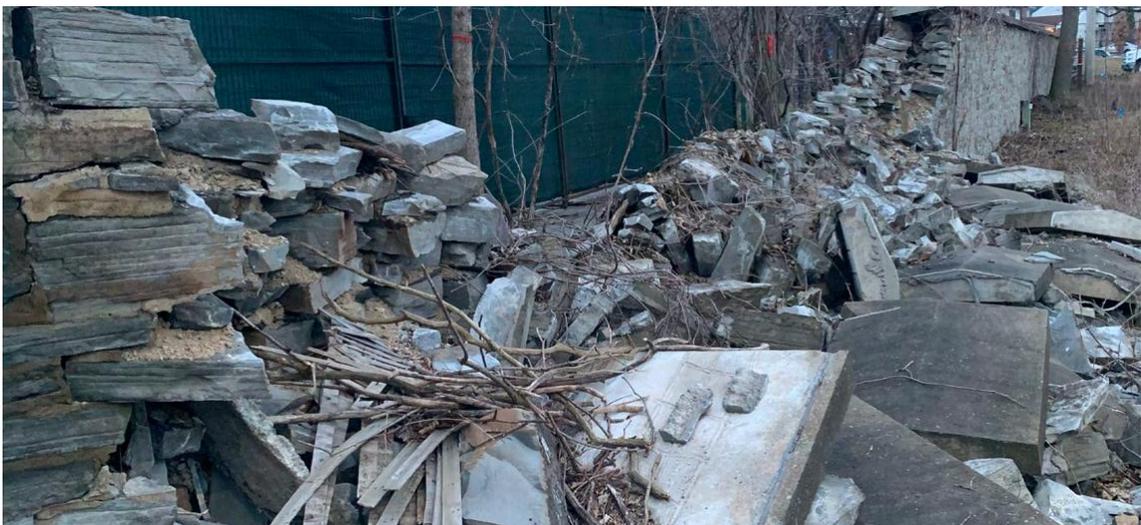
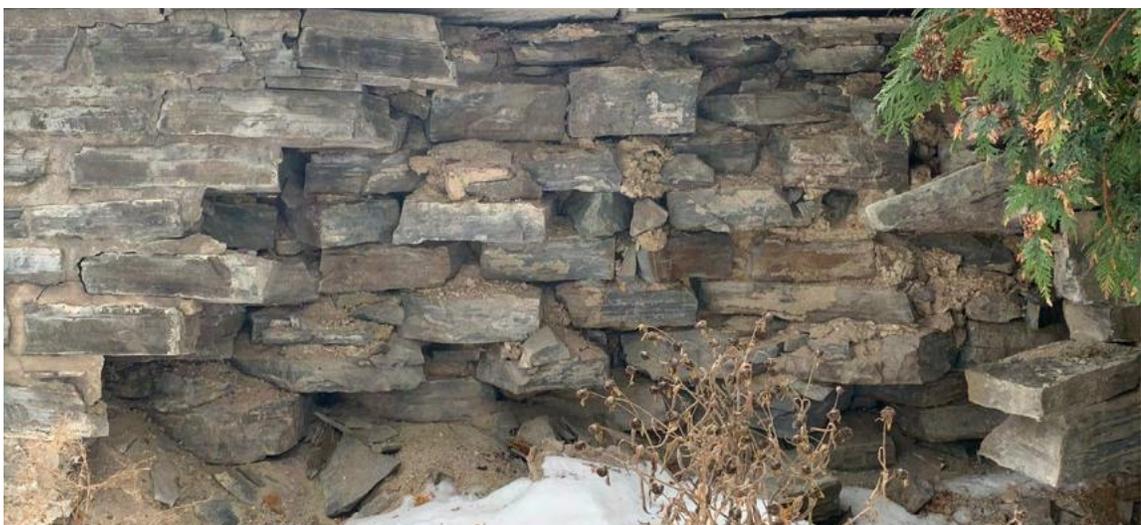
Figure 10: A Visual Assessment of Maplelawn Historic Walled Garden with Deterioration Callouts

Structural Failure

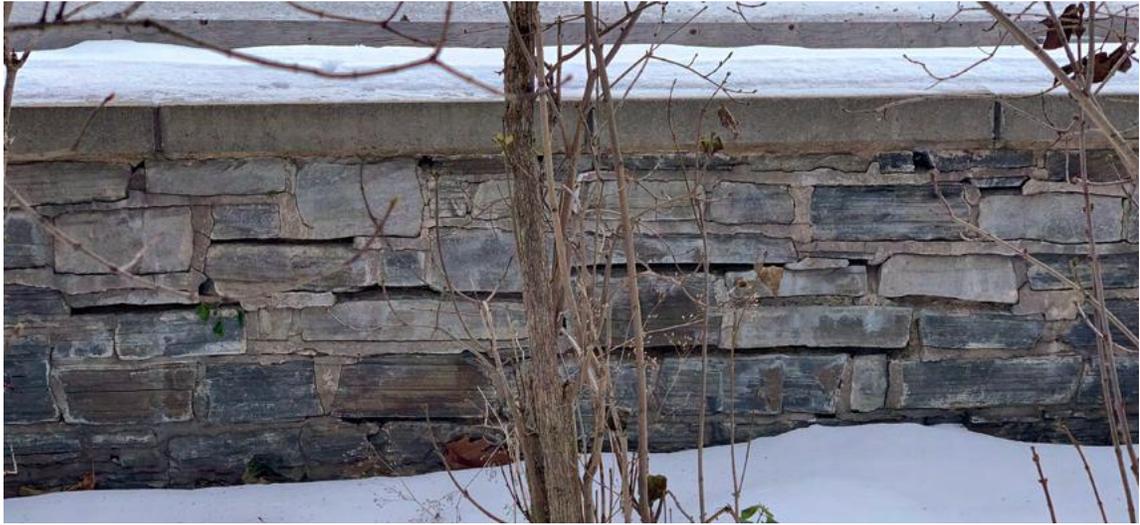
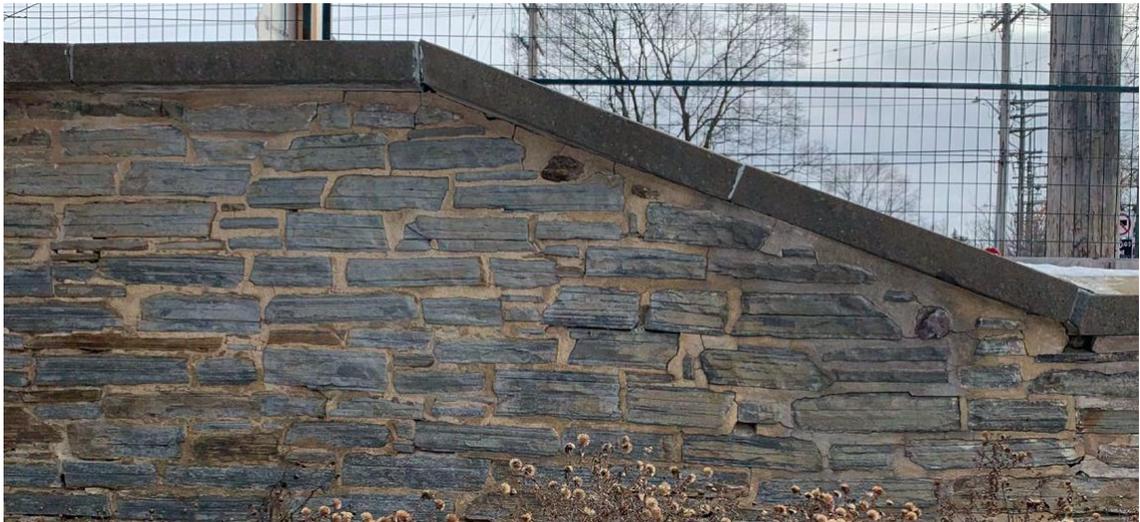
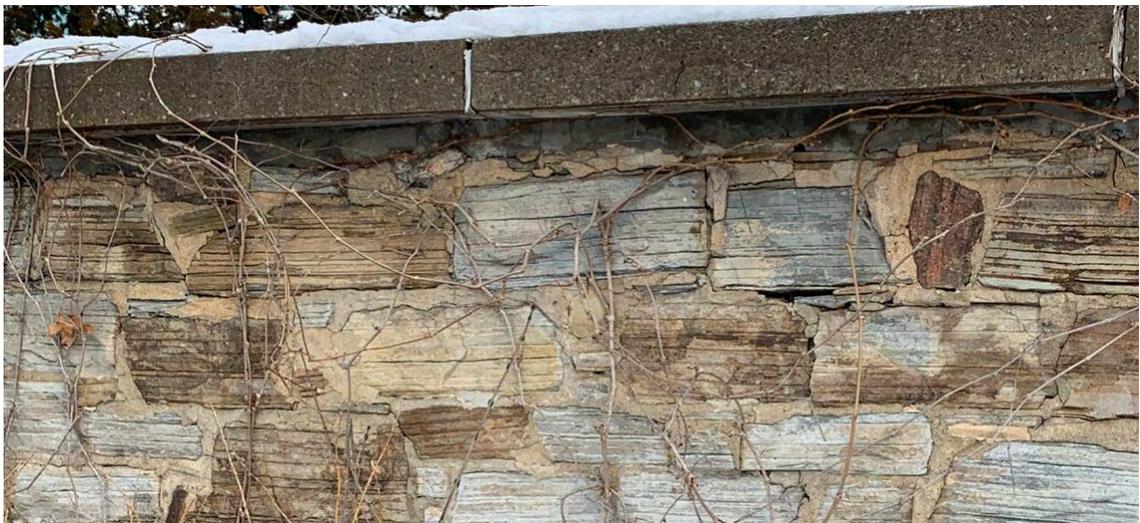
Figure 11: A Visual Assessment of Maplelawn Historic Walled Garden with Deterioration Callouts (cont.)

Masonry Deterioration

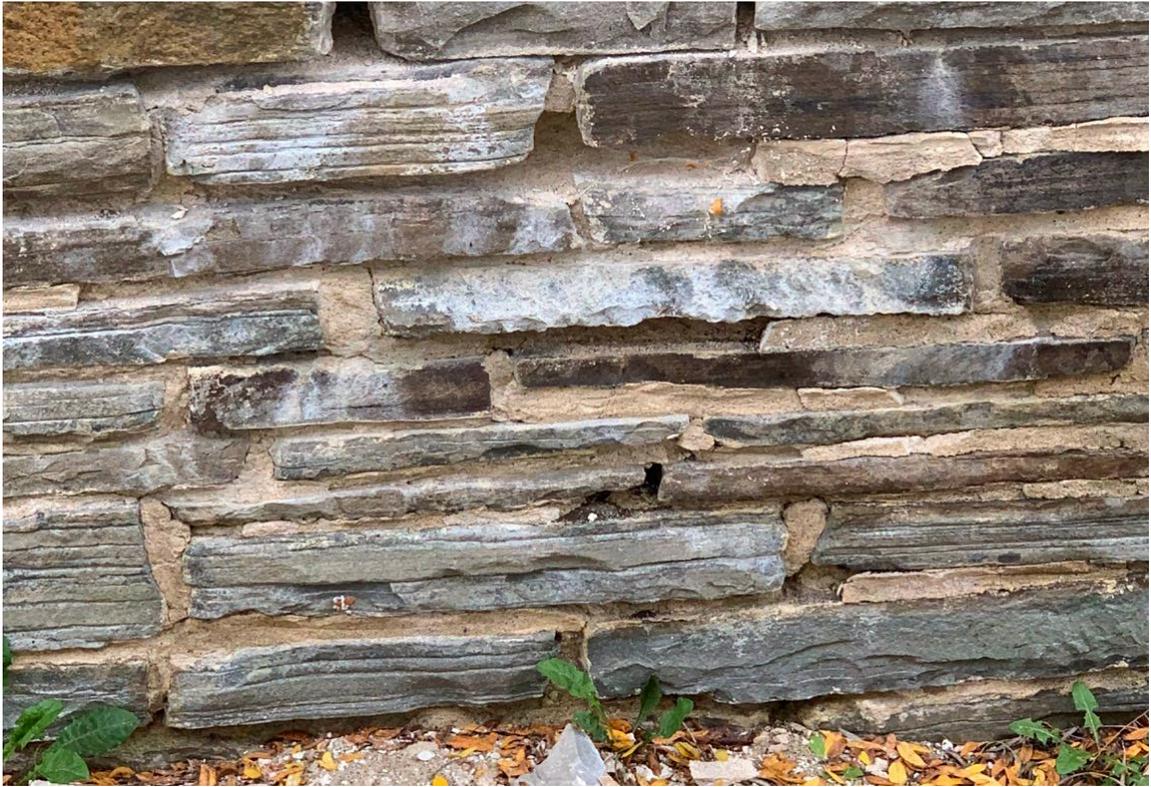
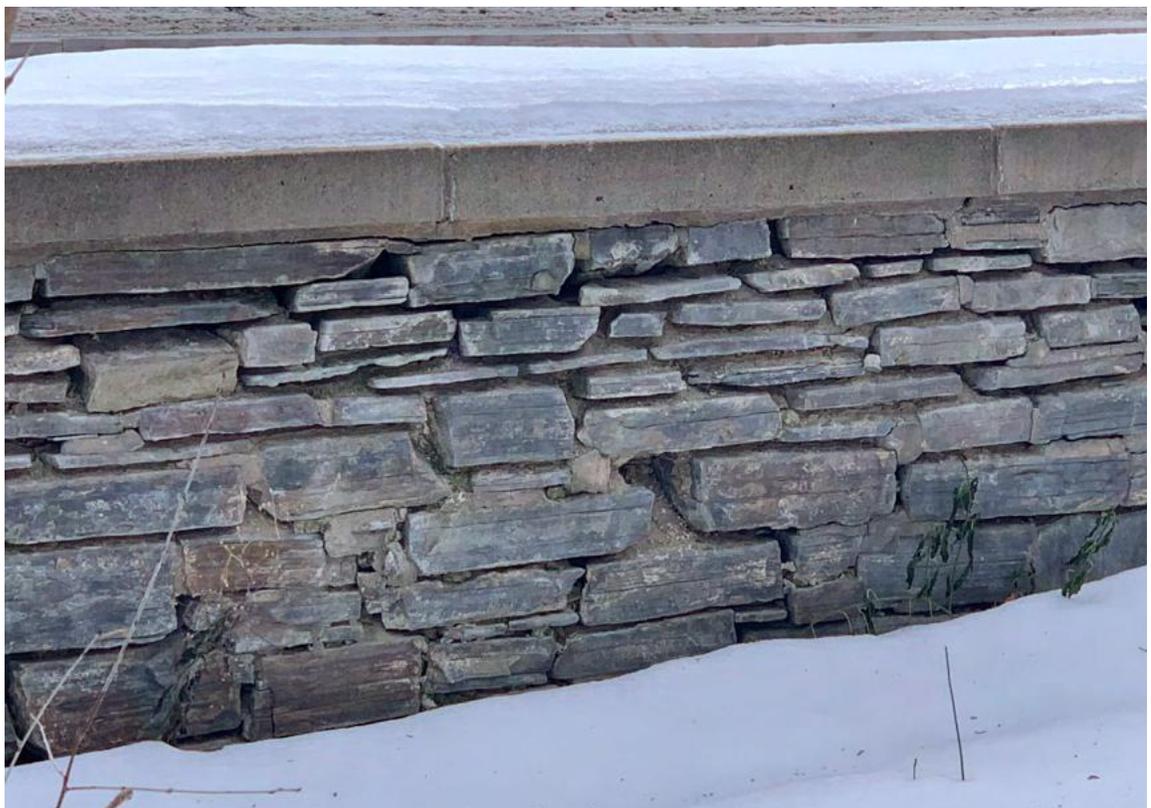
Figure 12: A Visual Assessment of Maplelawn Historic Walled Garden with Deterioration Callouts (cont.)

Mortar Deterioration

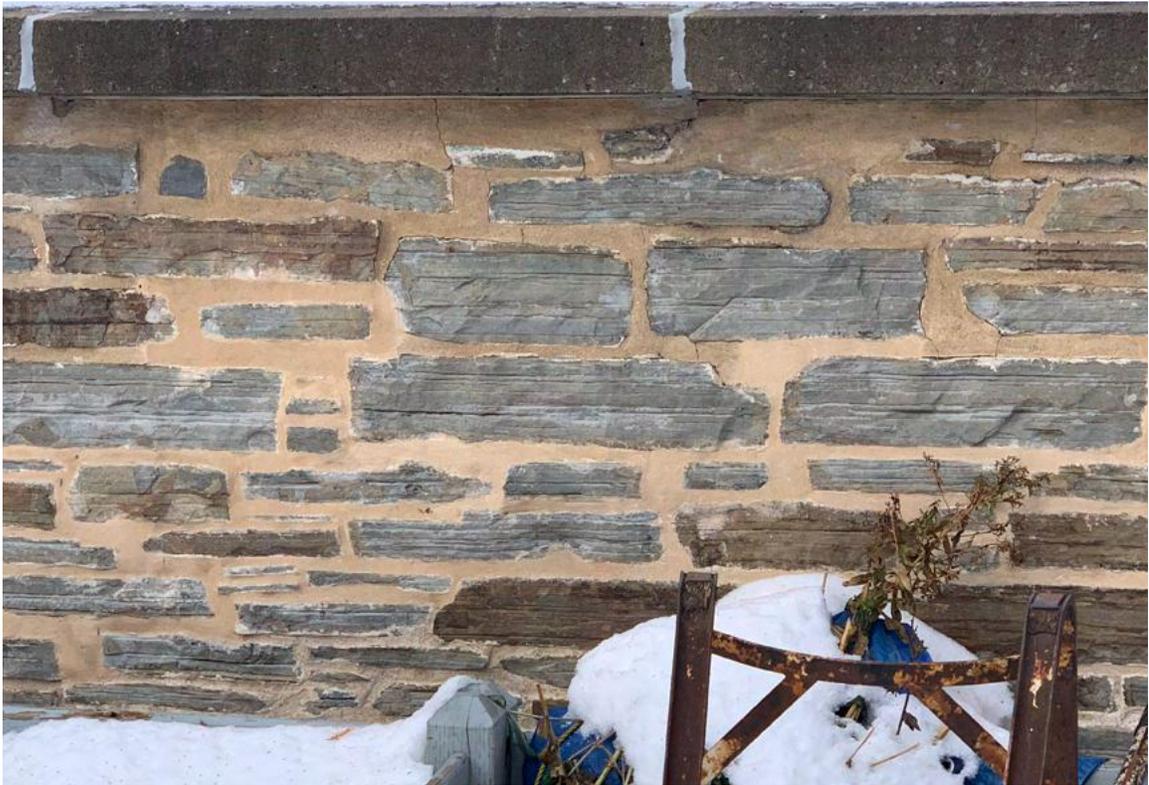
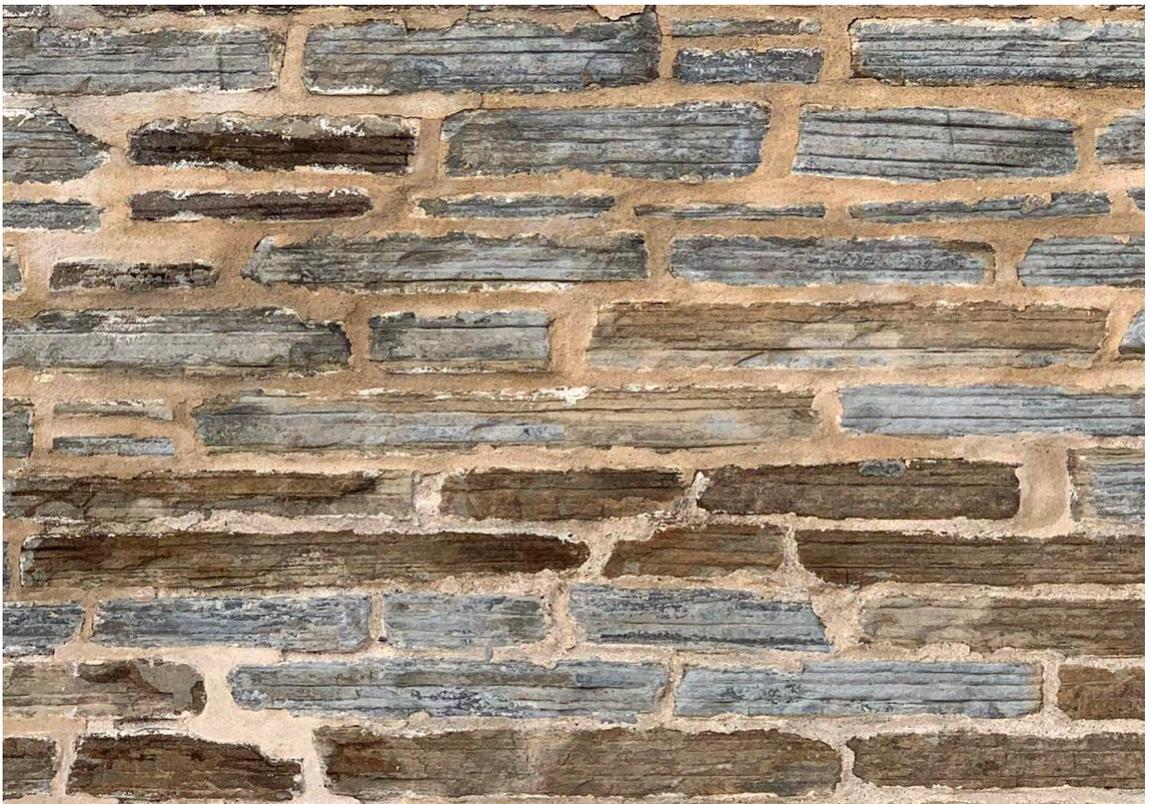
Figure 13: A Visual Assessment of Maplelawn Historic Walled Garden with Deterioration Callouts (cont.)

Inappropriate Interventions

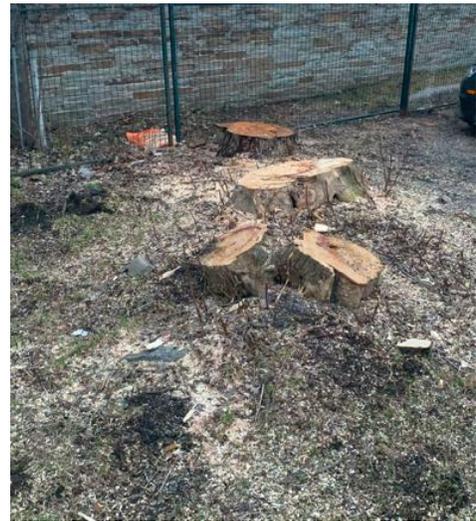
Figure 24: Mature Trees Cut-down to Facilitate Masonry Rehabilitation

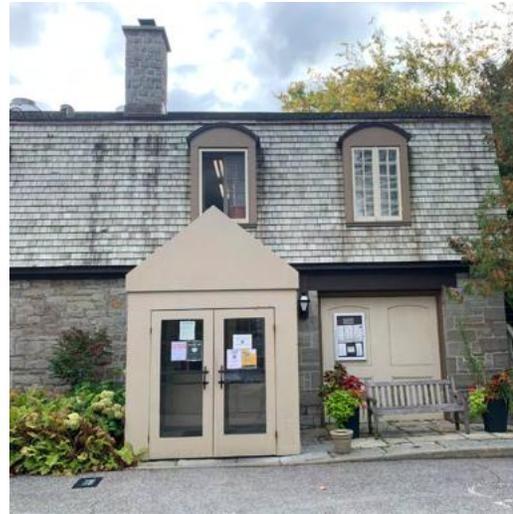
The northwestern addition to the former estate residence features a weathered wooden shingle roof. The small rectangular shingles provide cohesiveness between the summer living areas and the main estate building's dormer walls. The wing covered by the shingles has been used as a service area for the duration of its history.

Figure 25: A View of the Wood Shingled Roof on the later Northern Addition

- Wooden shingles should be replaced as sections begin to fail to ensure continued protection to the masonry facades and to promote interior user comfort

- Should large portions of the wood shingle roof fail, it is worth considering replacing with a metal counterpart that matches or closely resembles that of the main estate building

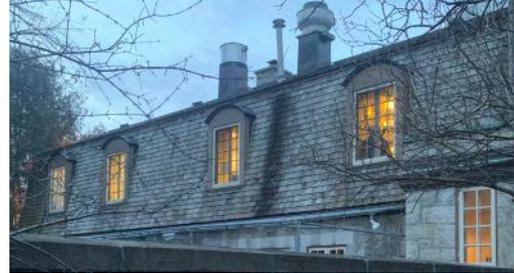
Figure 26: A View of the Wood Shingled Roof on the later Northern Addition at Dusk

- Conduct a more thorough non-intrusive as well as an intrusive investigations to ensure infiltration has not occurred at the water staining locations. Close attention and care should be made to ensure there are not any issues where the two roof lines meet.

- The interior spaces below the roof should be inspected for signs of water damage, including but not limited to bubbles in the paint, staining or changes in surface texture

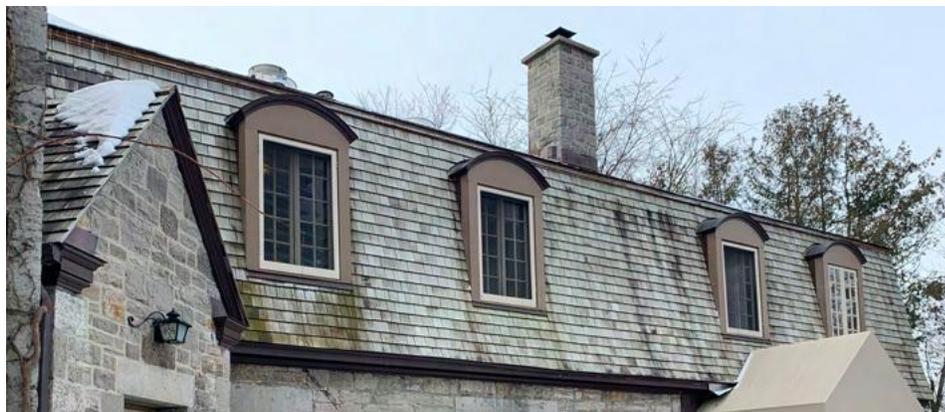
Figure 27: A View of the Wood Shingled Roof on the later Northern Addition at Dusk

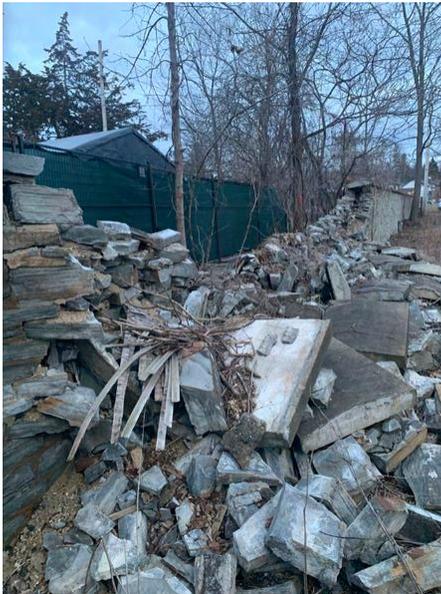
Figure 28: A Photograph of the Full Structural Failure of a Portion of the Property Masonry Wall

- Remove incorrectly cured mortar from the masonry joints. It is distinguishable by its lighter colouring likely due to uncontrolled, accelerated, unprotected curing of the joints.
- Repointing (backpointing and frontpointing) of areas where the mortar has dissolved, due to precipitation exposure and infiltration, with appropriate lime-based mortar mix that does not compromise the structural integrity of the heritage limestone
- Partial or full dismantle and rebuild of portions of the garden wall where

- Create separation between the garden wall and Richmond road. It is predicted that the sideways forces exerted by the contemporary infrastructure are causing structural failure as the wall attempts to retain the built-up soil.
- Apply a clay-based poultice to pull the efflorescent and mineral staining from the surface of the masonry. Once applied, allow the mixture to dry and be allowed to fall off or be brushed off delicately. This procedure can be repeated until the desired amount of staining/colouration has been removed from the limestone face.

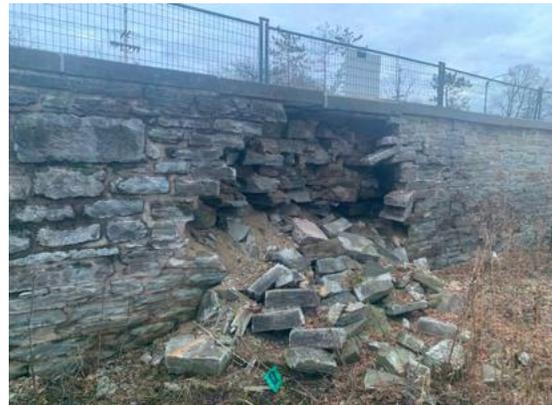
Figure 29: A Photograph of the Full Structural Failure of a Portion of the Property Masonry Wall

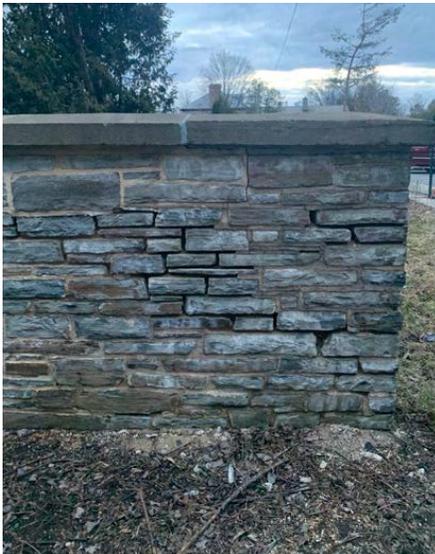
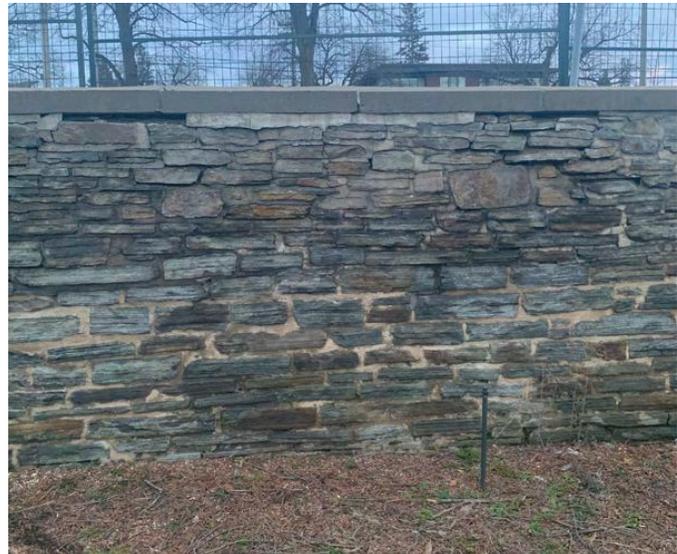
Figure 30-31: The Typical Deterioration Conditions visible on areas of the Masonry Garden Walls

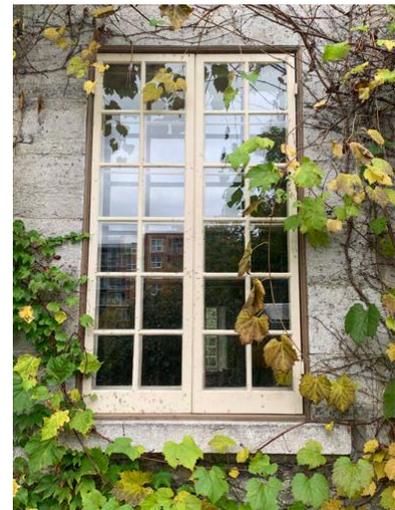
Overall, the casements windows appear to be in good condition. There is no obvious deterioration other than what would be expected given the elements age and exposure to the elements. A more thorough investigation would be required to determine if water infiltration is occurring at these openings to the building envelope. Moreover, the paint may be hiding potential issues in the woodwork. It should be determined if the paint has caused any issues to the operability of the windows themselves nor that they are causing interference to the manual hinge system.

Figure 32: A Close-up Photograph of the Georgian-style Windows

- Utilize dutchman repairs with comparable wood species if areas of the frame require rebuilding or replacement as opposed to complete replacement of the window. Repair should always be favoured over replacement.³⁸

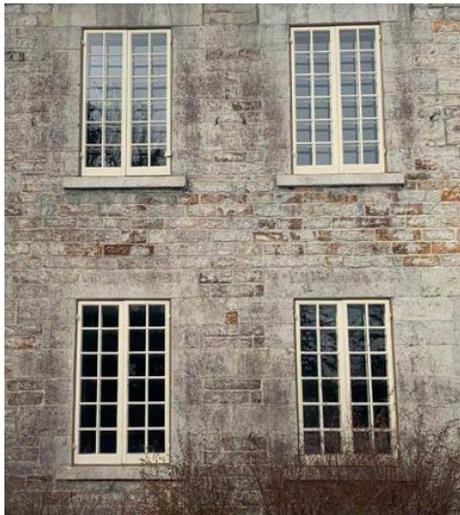
Figure 33: A Series of Georgian Windows within Bays of the Front Facade of the Estate House

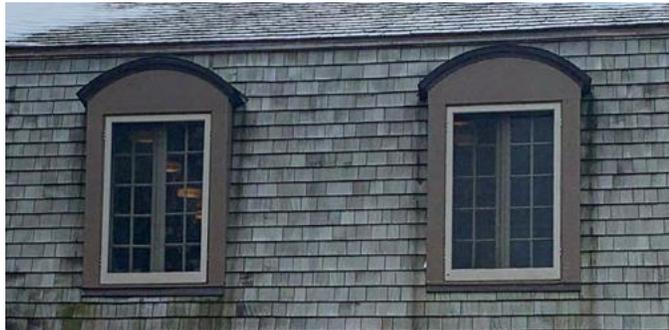
Figure 34: A Series of Segmental Dormers on the Estate House Addition

The dormers appear to be in good condition considering they are that much newer and have been exposed to the elements for less time. It can be hypothesized that there is issues relating to user comfort. On three out the four northeastern windows there is a single pane fixed storm window to mitigate water or wind infiltration.

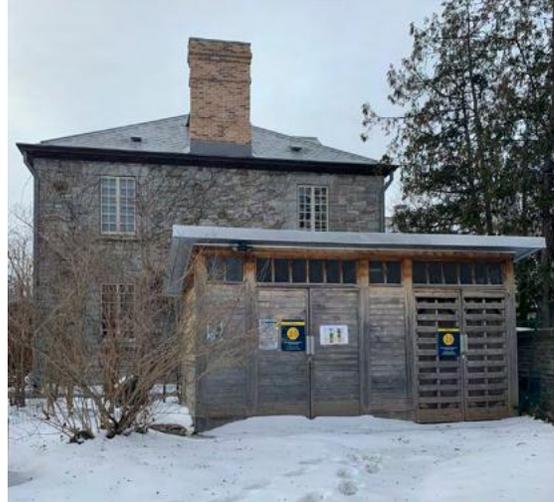
Brick and mortar two end chimneys sit atop the original portion of the rectangular estate building. Three bands of brick provide minor, simplistic ornamentation to the silhouette of the architectural elements. They visually balance the front facade of the building and offset the galvanized hipped roof.

Figure 35: The Masonry Chimney on the Estate House with an Auxiliary Garden Building in the Foreground

- If mortar is beginning to fail, the joints should be cleaned and repointed with comparable strength heritage mix mortar.
- If bulges are noticed, portions or entire dismantling and rebuilding of the effected chimney is recommended to prevent structural failure that could cause a safety risk to tourists visiting the site (ie. a stone falls).

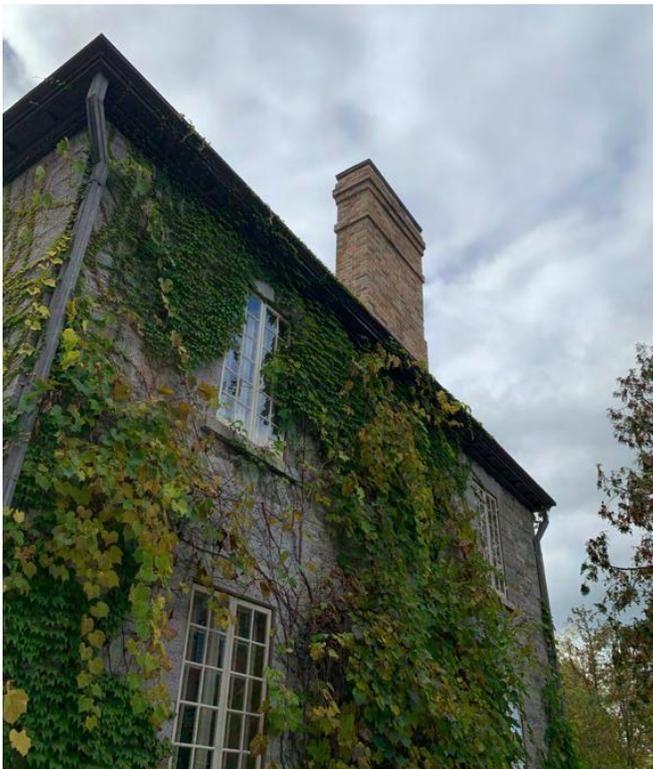
Figure 36 (LEFT): View of the Eastern Masonry Chimney on the Estate House from the East Facade

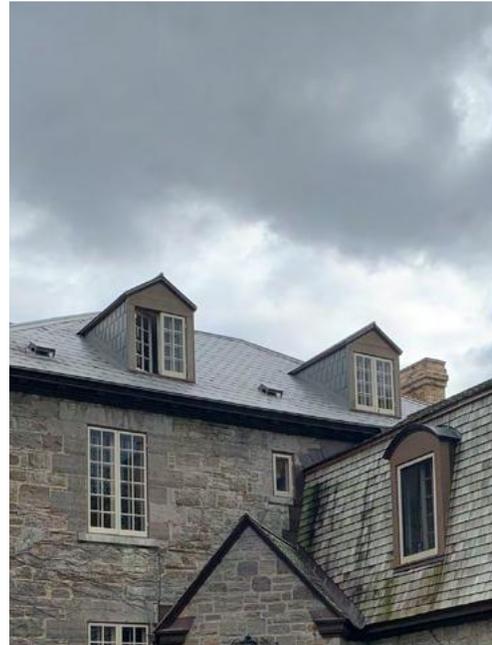
The gabled dormers are located on the north roof line of the estate house and are original to the architectural design. Their main purpose is to provide daylighting to the attic space of the main portion of the building. Created with high degrees of care and craftsmanship, the dormers further reinforce the symmetry of the front facade. Each dormer features a 16-pane double casement Georgian window with manual hinges. Moreover, the gabled roofs match the original hipped roof line to provide cohesion within the design and materiality.

Figure 38: Gabled Dormers Along the Roof of the Estate's North Elevation

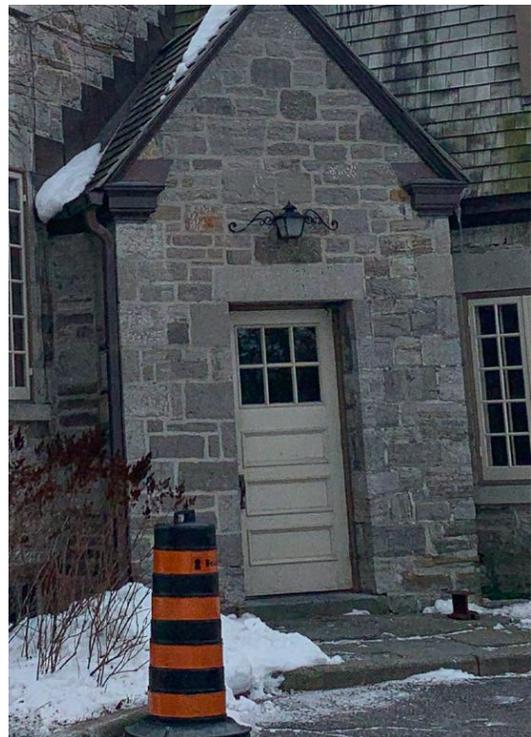
The multi-panel wooden doors are moderately vulnerable to predicted climate drivers for the region. Being situated slightly within the depth of the masonry facades, the woodwork is granted some protection from the environment. With this in mind, strong winds may cause water infiltration to these openings in the building envelope.

Figure 40: A Zoomed-in Photograph of the Owner-Requested Addition of a Garden Entrance

- Perform more invasion investigations to ensure the paint is not hiding deterioration of the woodwork
- At regular intervals, fully remove the exterior paint from the door to ensure the material is allowed to continue expanding and contracting in response to extreme weather conditions. The use of a heat gun and manual scraping will best preserve the craftsmanship of the doors and maintain the characteristics of the wood while still removing the paint. This is essential because as the paint layer becomes thicker and thicker, the material becomes limited in how it can react over time to changing conditions.

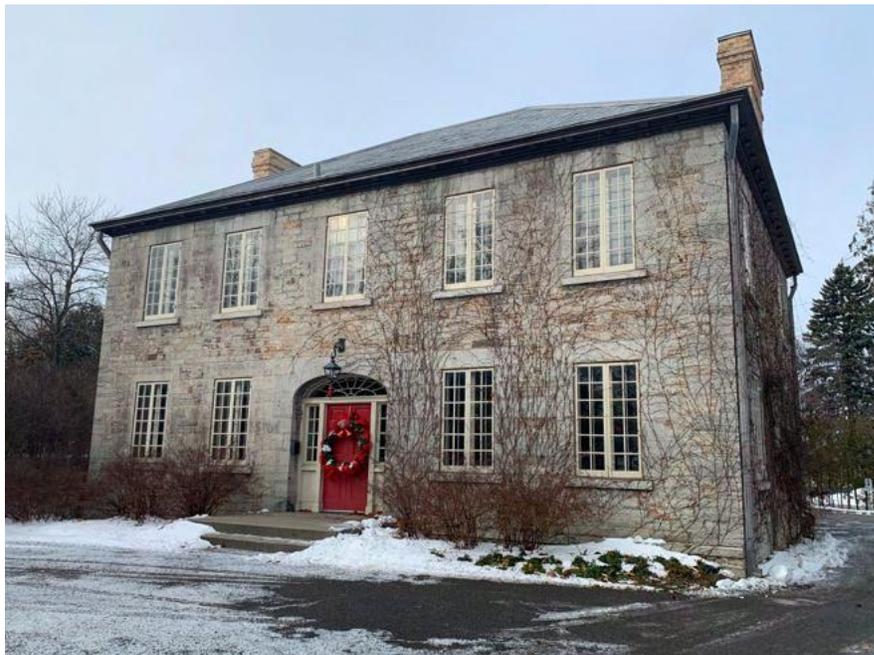
Figure 41: A Three-quarter View of the Front and Eastern Facades of the Former Estate

- Larger deterioration with the masonry faces can be corrected through the placement of stone dutchman repairs of a comparable material
- If the cortification layer becomes too thick and the masonry can no longer breathe, laser cleaning can be conducted on the masonry surface to return its native characteristics.
- If it is desired to remove mineralization/efflorescence, a clay based poultice will remove mineral staining-related discolouration.
- The masonry joints should be routinely repointed with similar lime-based mortar, as needed, to facilitate the breathability of the building envelope and to prevent drastic deterioration

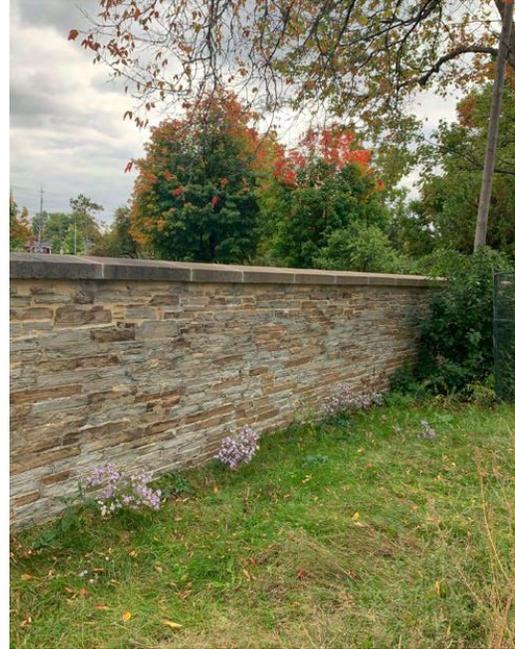
The condition of the surrounding landscaping is fine. The grass and entry driveway appear to be well maintained at regular intervals.

Figure 45: Surrounding Landscaping Growing Along the Exterior of the Garden Wall

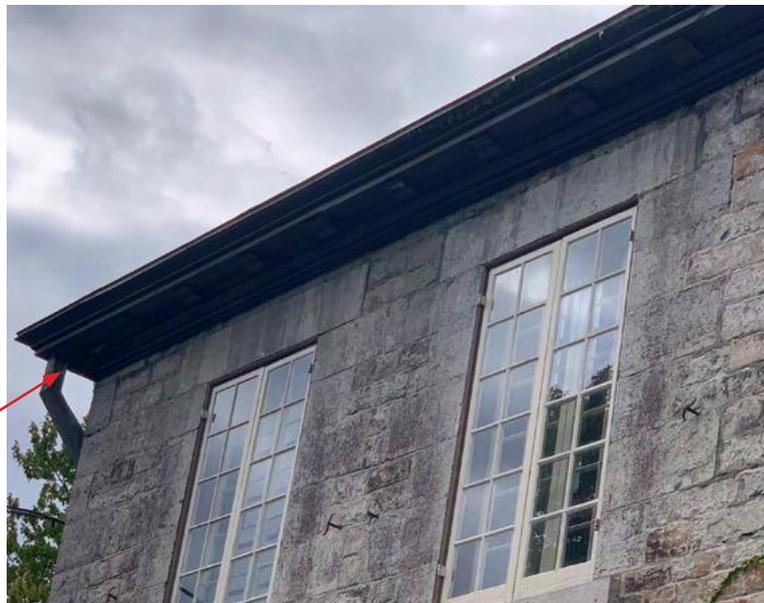
Figure 46: Dentil Ornamentation Situated Below the Roofline of the Former Estate

The dentil ornamentation is complete and in very good condition. The only deterioration remarked during the visual inspection was some minor peeling of the paint.

In much the same way as other woodwork, exposure to precipitation and extreme winds can cause deterioration to the ornamentation. In spite of this, the protection provided by its location below the hipped overhang greatly reduces its vulnerability to changing climates.

- Should a dentil block be damaged or broken off due to climate triggers, a dutchman repair with comparable wood is required

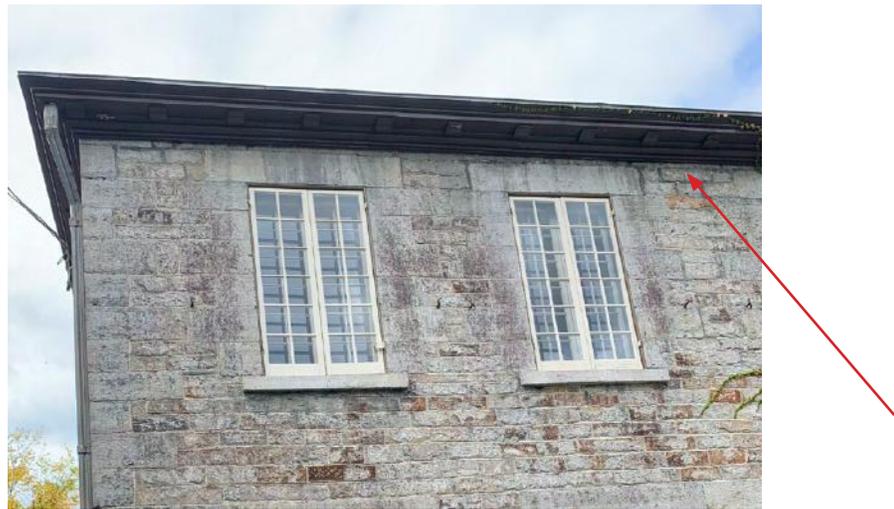
Figure 47: Dentil Ornamentation Situated Below the Roofline of the Former Estate along the Front Facade

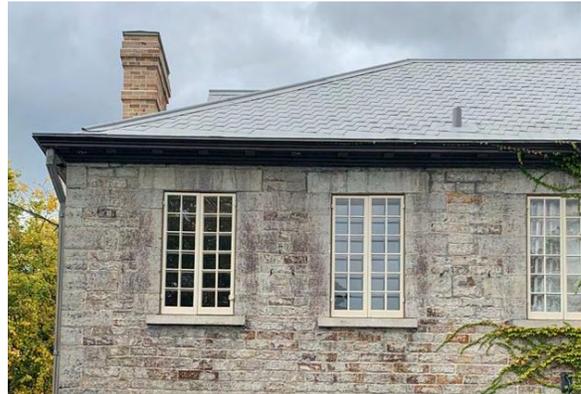
An embossed galvanized metal roof covers the original portion of the residence at Maplelawn. This was likely a later alteration to replace the original weathered wood shingles. The metal has been coated in a neutral grey tone that complements the colour variations in the locally sourced limestone.

Figure 48: A Portion of Galvanized Metal Roof on the Southern Facade of the Estate House

The galvanized metal roof is in excellent condition. No deterioration was noted during the visual assessment of the site.

Galvanized metal roofs are incredibly durable and can withstand various types of extreme weather conditions. It is currently predicted that it will present negligible vulnerability towards worsening climate conditions in the future.

- Monitor the roofing material for early signs of deterioration
- Galvanized metal roofs are very good preventing excessive snow loads because the material promotes the breaking up of snow loads before they can accumulate. Due to this, it is essential that user and tourism safety be prioritized. Areas of significant snow fall should be identified and temporarily blocked off to mitigate potential injuries

- Be prepared to replace the roof once it has reached the end of its lifespan

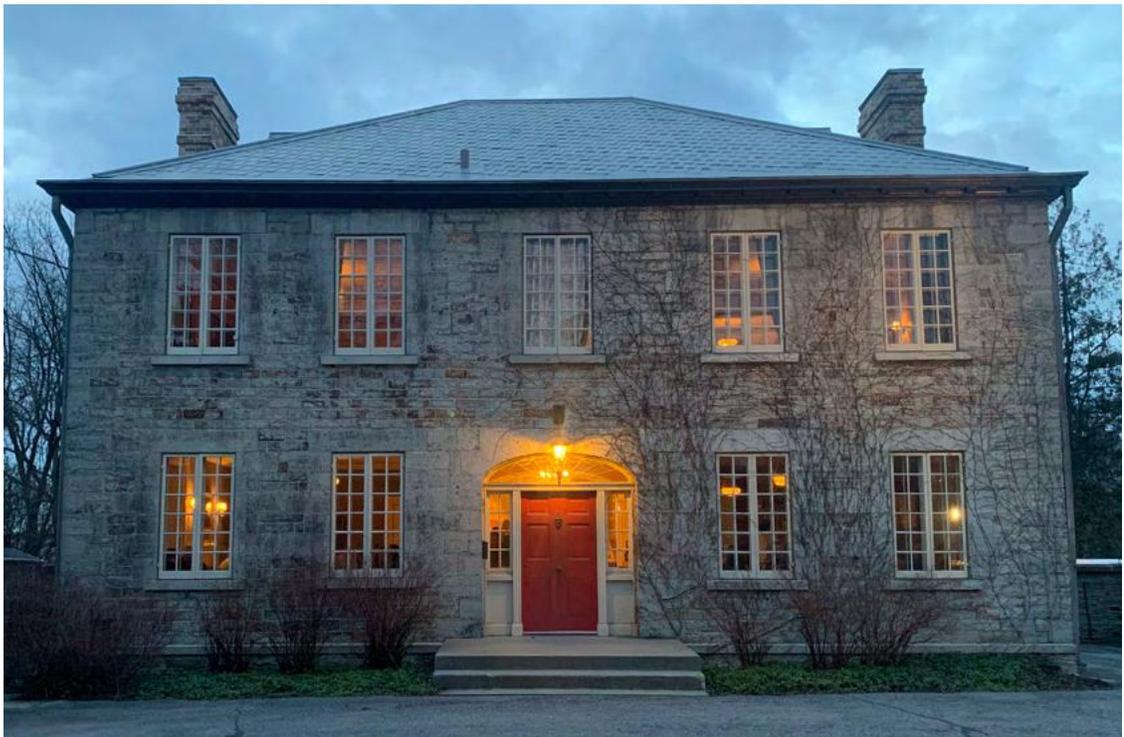
Figure 49: The Front Facade of the Estate with Galvanized Metal Roof Visible
