Design and Construction of a Guarded Hot Plate Apparatus  
to Evaluate the Thermal Resistance of Vacuum Insulated  
Panels using a New Accelerated Ageing Procedure

A thesis submitted to the Faculty of Graduate and Postdoctoral  
Affairs in partial fulfillment of the requirements for the degree of

Master of Applied Science

Sustainable Energy Engineering and Policy

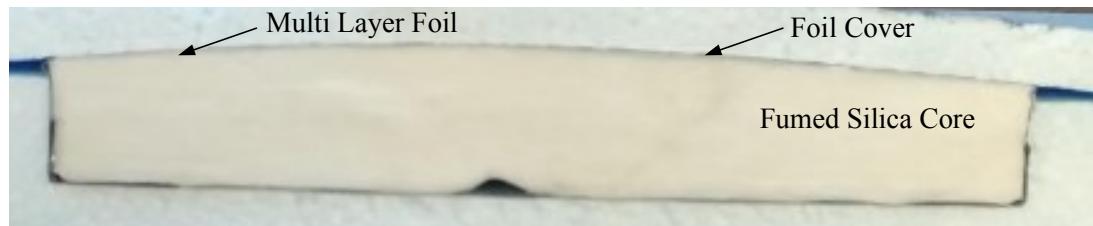
**Figure 1-1: Cross section of VIP**

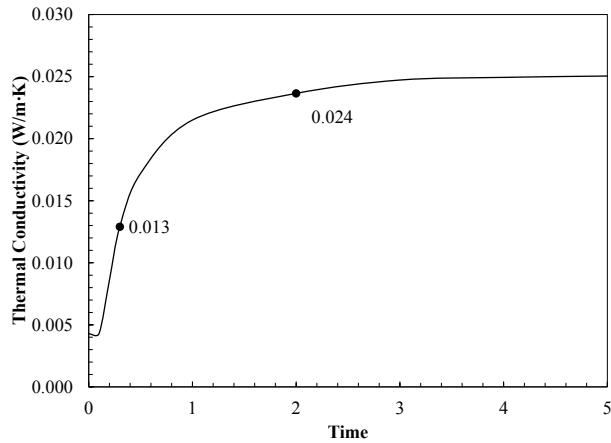
**Figure 2-1: Plot of Baetens et al. [21] service life definitions**

In the first definition, the moment that a VIP's thermal conductivity exceeds a defined value, the panel is considered defective, whereas, for the second definition, the panel's performance throughout its service period is considered. The second definition takes into consideration that a panel may perform exceptionally for a time period before its performance decrease however, its average performance for a period of time may be better than a defined value.

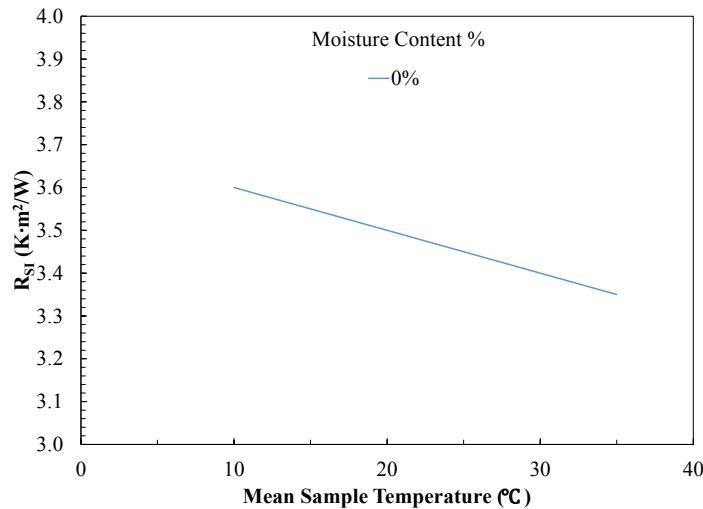
**Figure 3-1: Baseline thermal resistance of a VIP as a function of mean sample temperature**

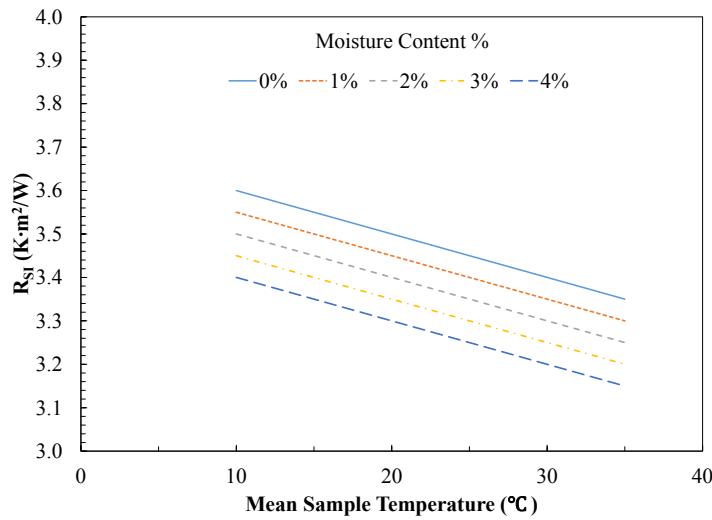
**Figure 3-2: Thermal resistance of a VIP as a function of mean sample temperature and moisture content**

the thermal resistance of a material is dependent on temperature, and when a VIP is subject to an increase in temperature, its insulating properties decrease. Figure 3-2 shows a representation of the second procedure and indicates the possible relationship between thermal resistance results and temperature. Each of the lines in Figure 3-2 represent a different percentage moisture content from dry panels to a saturation point where dry panels thermal performance will be greater than that of the wet or aged VIP.

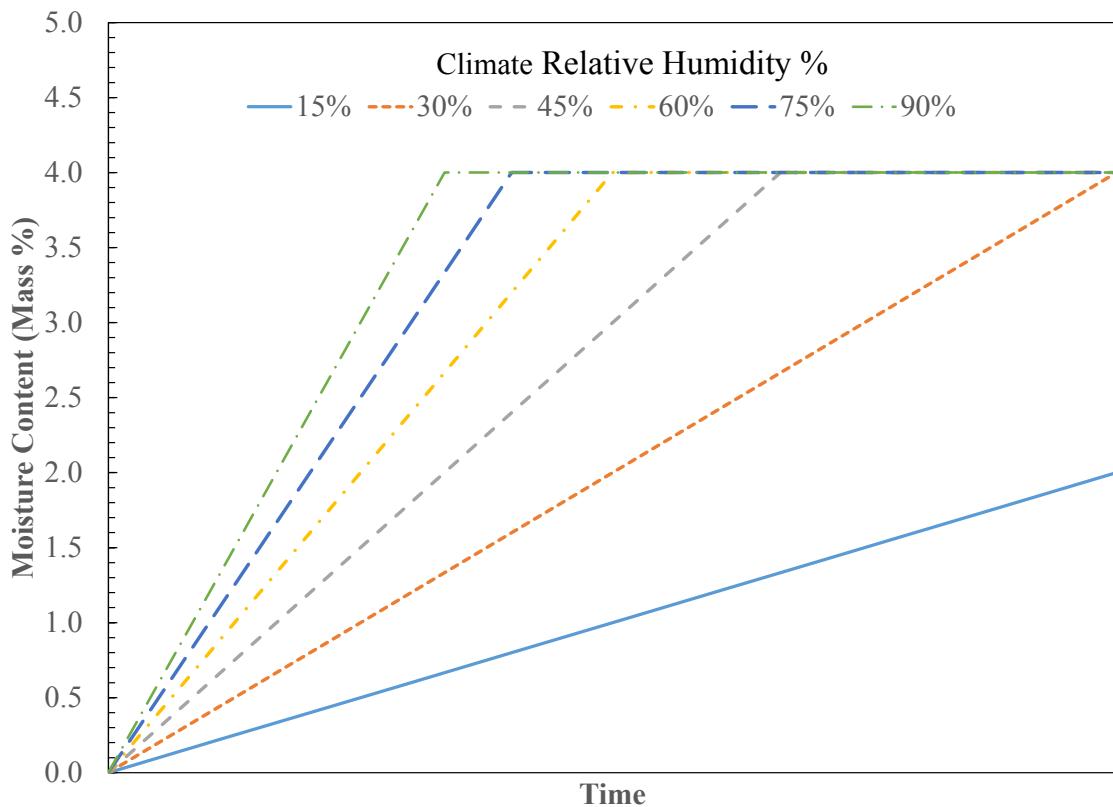
**Figure 3-3: Moisture gain at different humidity levels for panels held at lower temperature**

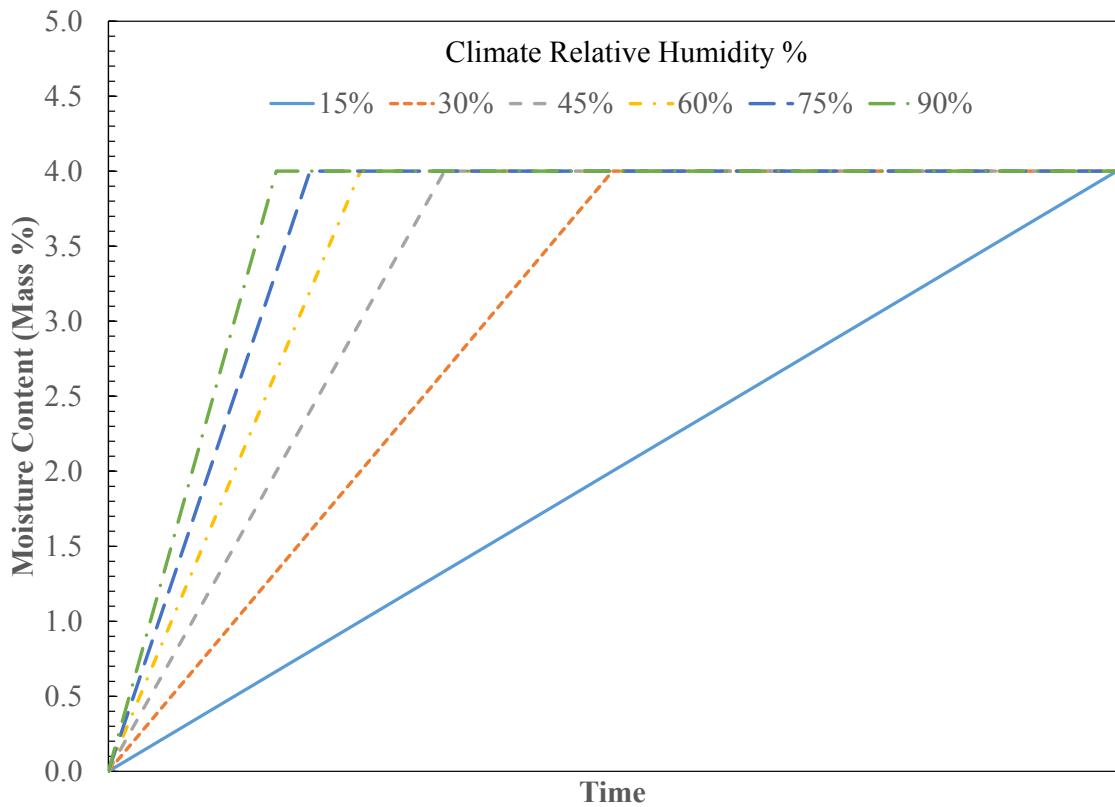
**Figure 3-4: Moisture gain at different humidity levels for panels held at higher temperature**

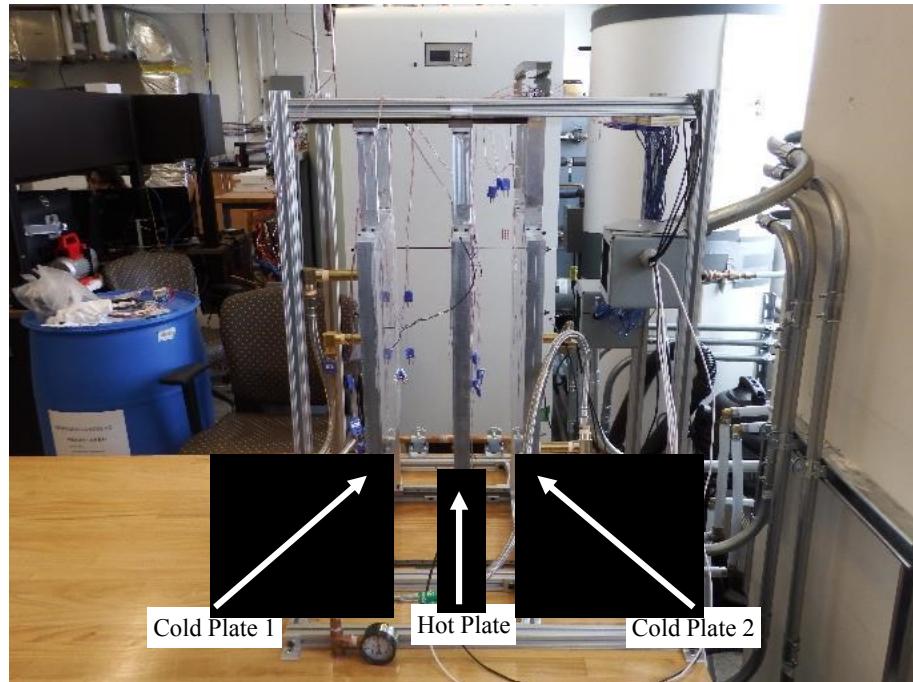
Figure 3-5: GHP before anodizing and secondary guard installation

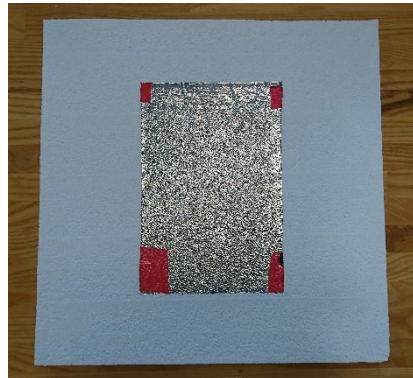
**Figure 3-6: VIP mounted in EPS frame for GHP testing**

Two panels were installed in the spaces between the hot and cold plates of the GHP. Samples tested in the GHP can be of different thickness and size. When testing smaller samples, an EPS frame as shown in Figure 3-6 was installed around the sample to ensure coverage of the otherwise exposed heating and cooling surfaces.

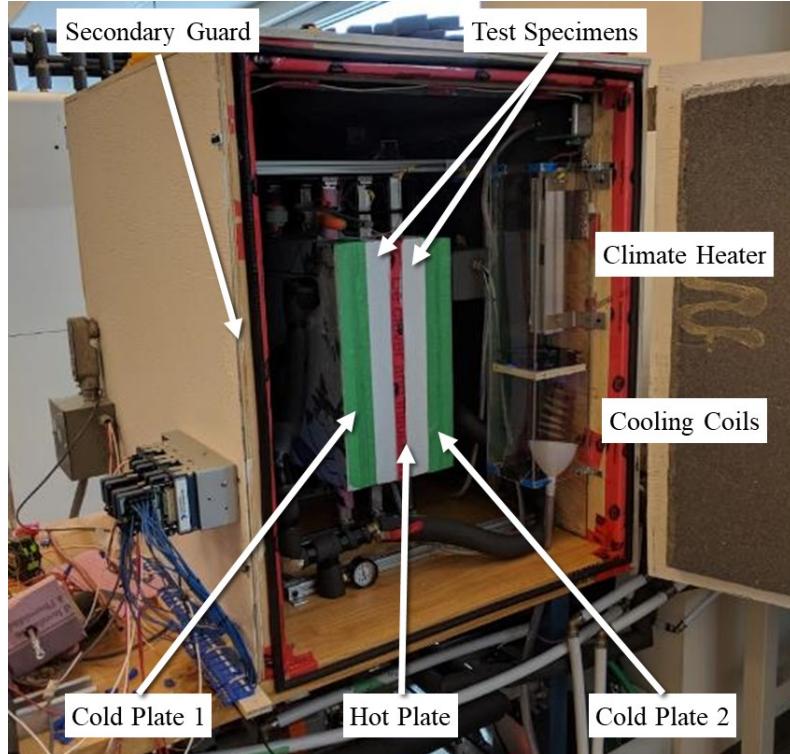
**Figure 3-7: GHP with secondary guard for climate control**

Figure 3-7 and Figure 4-1 both show how the GHP assembly makes use of two cooling surfaces installed on either side of the heating plate. The cooling plates in the GHP setup act as thermal sinks of a uniform surface temperature, maintained by cooling fluid being circulated through internal channels within the plates. Using cooling fluid to cool the plates was chosen as the set-up had access to a circulated glycol line maintained at -10°C. The cold plate assemblies were comprised of two aluminum tooling plates bolted together. Figure 4-4 shows one of the aluminum plates with the cooling channels machined into its face. The plate with the channels was then paired with a non-machined plate, forming internal tubing. An O-Ring was used to ensure fluid remained contained within the closed loop.

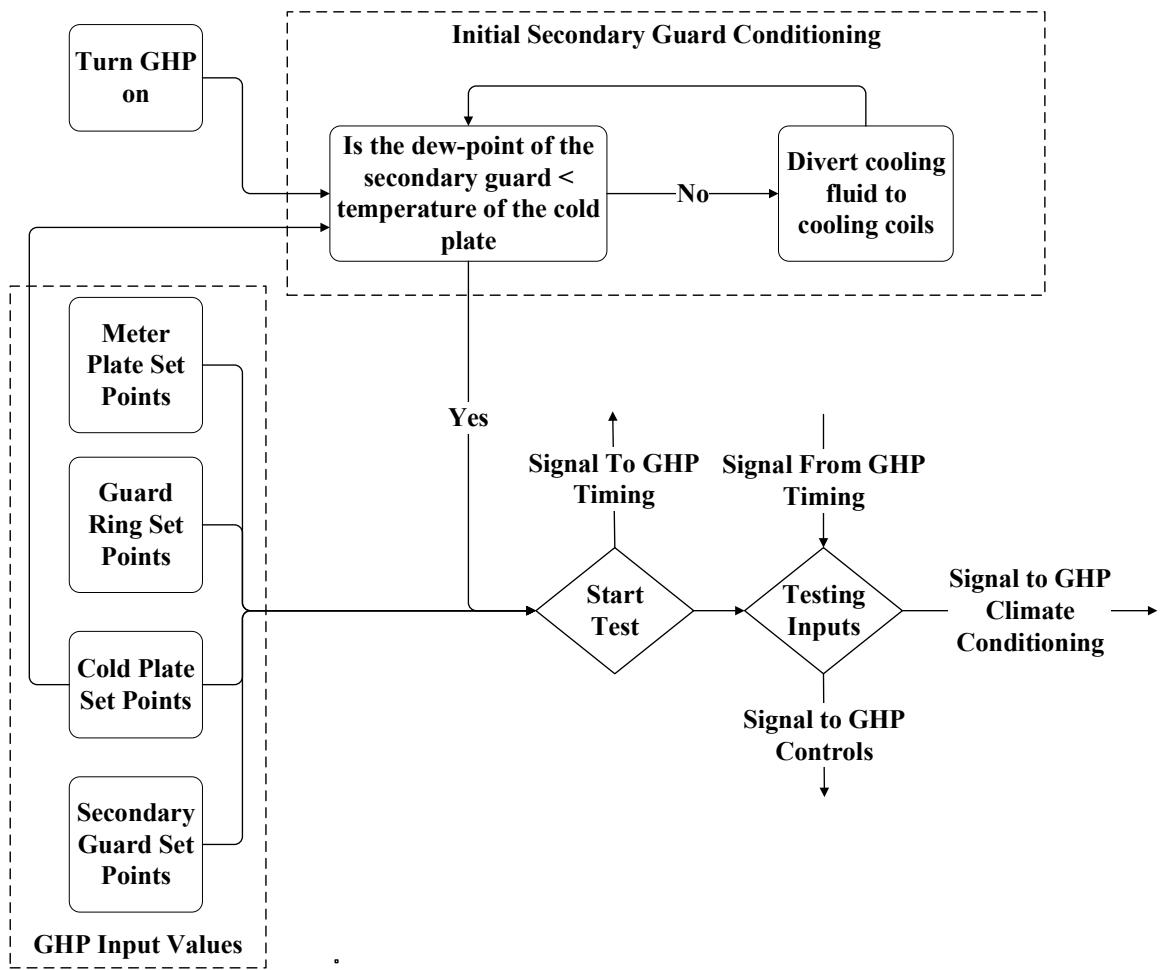
Figure 3-8: GHP start up procedure with input values and initial conditioning of secondary guard

Figure 3-8 through Figure 3-11 show a flow chart of the GHP operating procedure. The operator of the GHP starts by inputting initial set point temperatures for the meter plate, guard ring, cold plate, and secondary guard into the LabVIEW program as outlined in Figure 3-8. The operator also specifies the length of duration of averaging period and the number of averaging periods the test will run for Figure 3-10, before starting the test. In Figure 3-8, when the test is started a signal is sent to start a conditioning period for the secondary guard. Once the ambient conditions in the secondary guard are dehumidified the GHP can begin its testing using the first set point. In Figure 3-11 the set point temperatures are then sent to the controls of the plates. As the testing starts a timer starts, and a counter records the number of test completed as shown in Figure 3-10. The first set point for the GHP is tested according to the number of averaging periods for that set point, with each averaging period lasting for a specified time. Figure 3-10 shows how the GHP cycles to the next set point after the number of averaging periods for that set point have been conducted and the GHP continues this pattern until all set points have been tested. Figure 3-9 shows that during testing, continuous monitoring of the secondary guard takes place to maintain a dry environment at the temperature of the sample being tested.

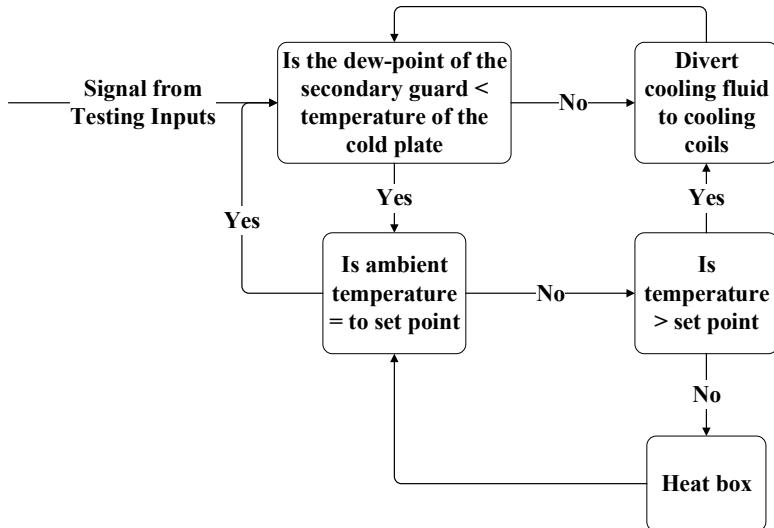
Figure 3-9: GHP continuous conditioning of secondary guard

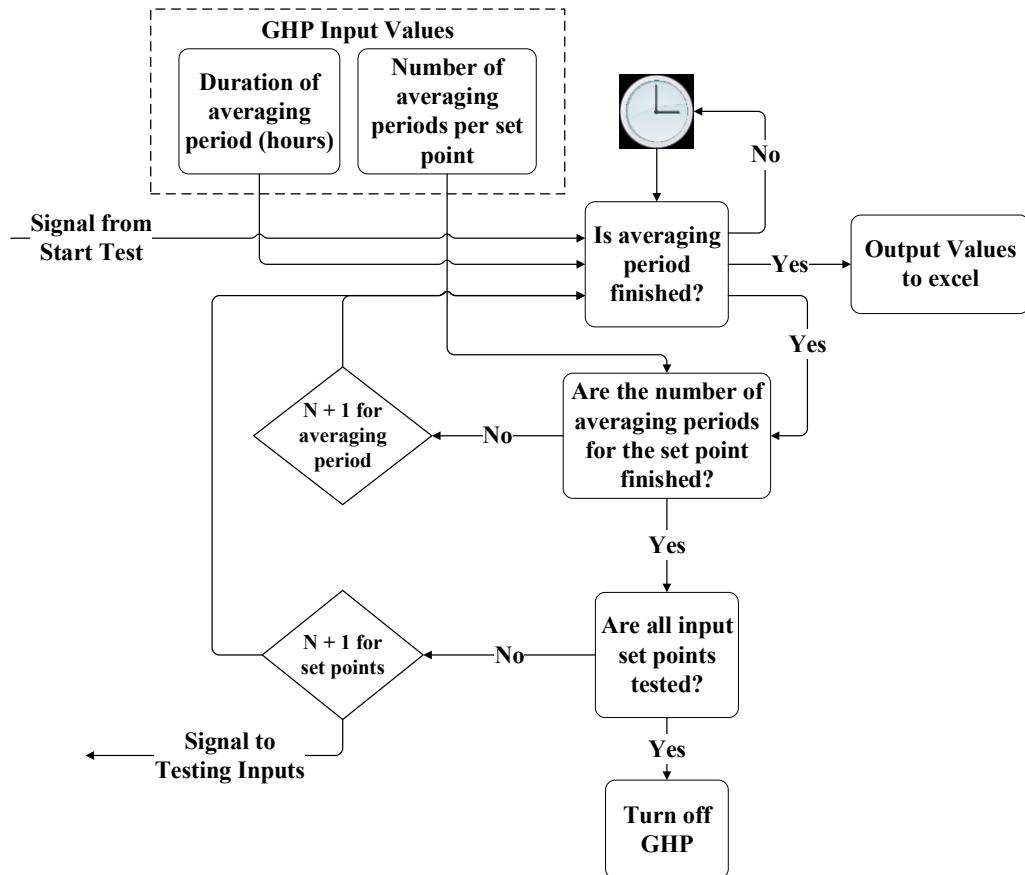
Figure 3-10: GHP timing and set point controls

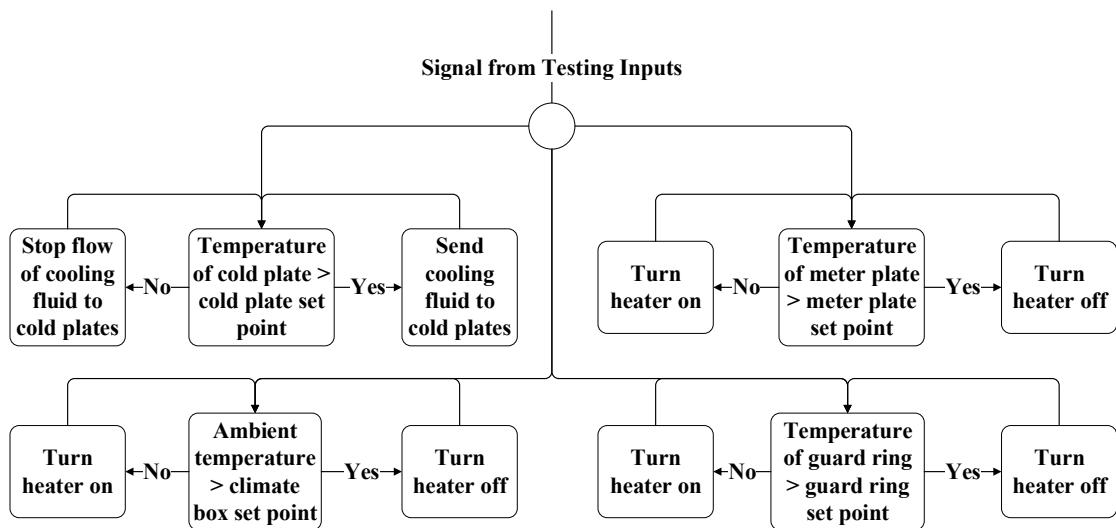
Figure 3-11: GHP controls to maintain plate temperatures and ambient climate

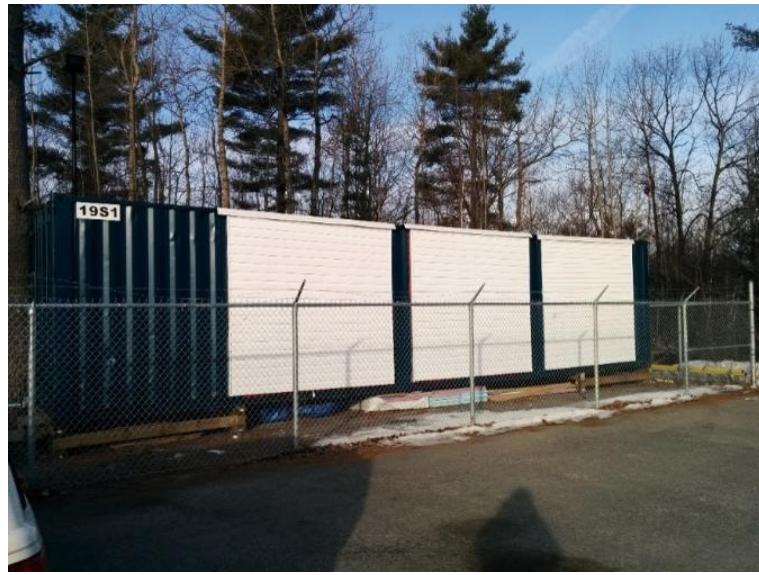
**Figure 3-12: CanmetENERGY Building Envelope Test Hut (CE-BETH) facility at Canmet NRCan**

The interior of CE-BETH is maintained at temperature and humidity levels found in residential homes while the outer surface is exposed to the elements [38]. The internal pressure of the facility is allowed to fluctuate with ambient conditions as the facility is not completely air tight. CE-BETH is a facility designed and built specifically for in-situ testing of building envelopes. The facility is constructed from a shipping container, where three 2.44 m by 2.44 m holes have been cut out of one face to accommodate sample wall sections to be tested. Two of the 2.44 m by 2.44 m openings were allotted for the testing in this thesis. The first 2.44 m by 2.44 m bay was constructed to resemble a wall built to 1960's codes with 2 by 4 studs which has been retrofitted to meet current building standards by adding additional insulation to the exterior of the wall. The 1960's wall was built in two 2.44 m by 1.22 m sections with one section insulated with additional EPS while the other 2.44 m by 1.22 m section was insulated with a composite EPS and VIP layer. Testing a wall built to 1960's standards with and without VIPs provided an opportunity to test how VIPs would perform under a retrofit scenario. The 1960's building standards were selected as there are a large number of older homes within Canada that need to be updated to meet higher insulating standards. The second 2.44 m by 2.44 m wall was constructed to current building standards with 2 by 6 studs. The second wall was also divided into two 2.44 m by 1.22 m sections. The first 2.44 m by 1.22 m section of the new wall was built without VIPs to compare to the second 2.44 m by 1.22 m section that was insulated to a level above current standards using VIPs. The aim of the in-situ testing was to collect hygrothermal data in order to determine how much moisture will be in contact with the panels in a wall section and subsequently how much moisture has accumulated in the VIPs after a specified time frame under normal operation. In order to study the conditions around the VIPs,

instrumentation to measure the temperature, humidity and thermal conductivity on both the hot and cold surfaces of the VIPs were installed throughout the walls. The information gained has shown and will continue to show how moisture accumulates into the wall and under what conditions. The information will be used to develop accelerated ageing conditions and set points for testing VIPs. Developing test conditions that are experienced in real life is important for accelerated testing so that the testing performed can be related back to real time degradation [20]. The four construction styles offer a unique opportunity to monitor the temperature and humidity conditions within different wall types and is the focus in the work done by Conley, et al, [38]. Before the VIPs were installed into the walls, they were numbered and their dry or initial mass was recorded as a baseline weight of the testing. Future work will involve making predictions on the amount of moisture that may have transferred into the panels based on the observed moisture and humidity conditions seen next to the panels.

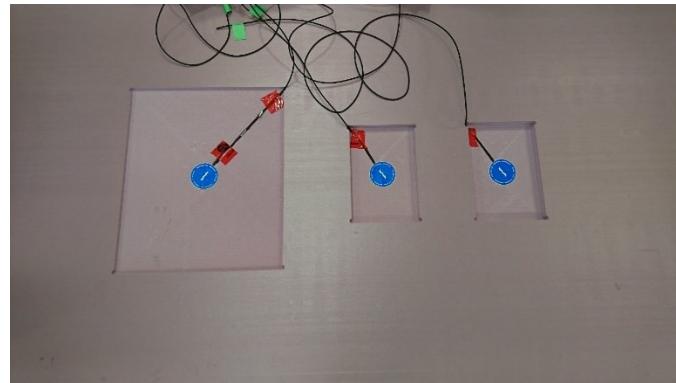
**Figure 3-13: Machined pockets to mount VIPs with heat flux sensors installed**

calculate the amount of power flowing through a known area with the thermocouples allowing the temperature difference across the sample to be known.

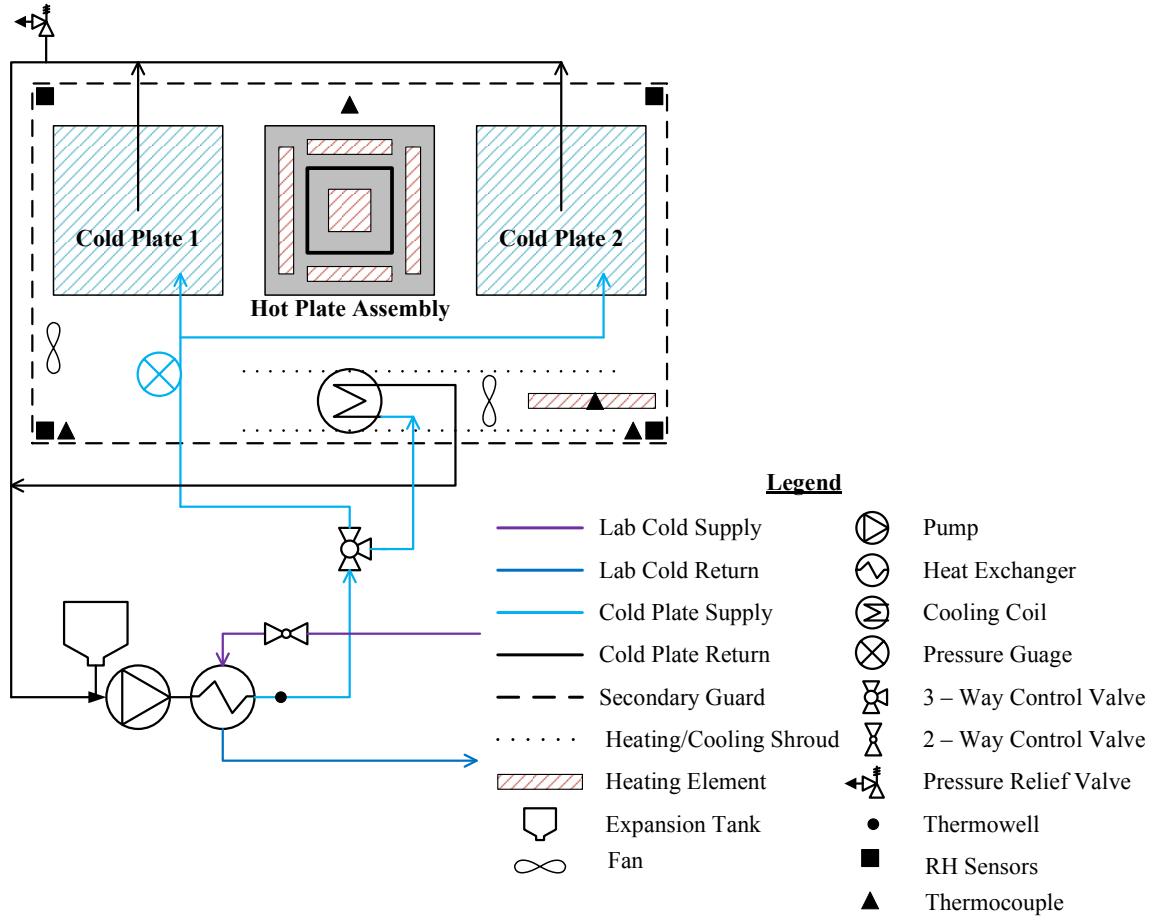
Figure 4-1: System overview for GHP assembly

A more detailed layout of the GHP and supporting equipment is shown in Figure 4-1. The hot plate assembly was comprised of two components being the meter plate and the guard ring, which were separated by an insulating air gap. Figure 4-1 shows the hot plate assembly and the embedded heating elements within both the meter plate and guard ring. The cooling plates were supplied with cooling fluid from a closed supply loop which gained its cooling potential from a heat exchanger and a lab supply line. The heat exchanger allowed the cold plates to operate at a range of temperatures independently from constant temperature of the lab supply line. As shown in both Figure 3-7 and Figure 4-1 the hot plate and cold plates were held within an enclosure known as the secondary guard. The secondary guard was used to maintain the ambient conditions around the plates, to

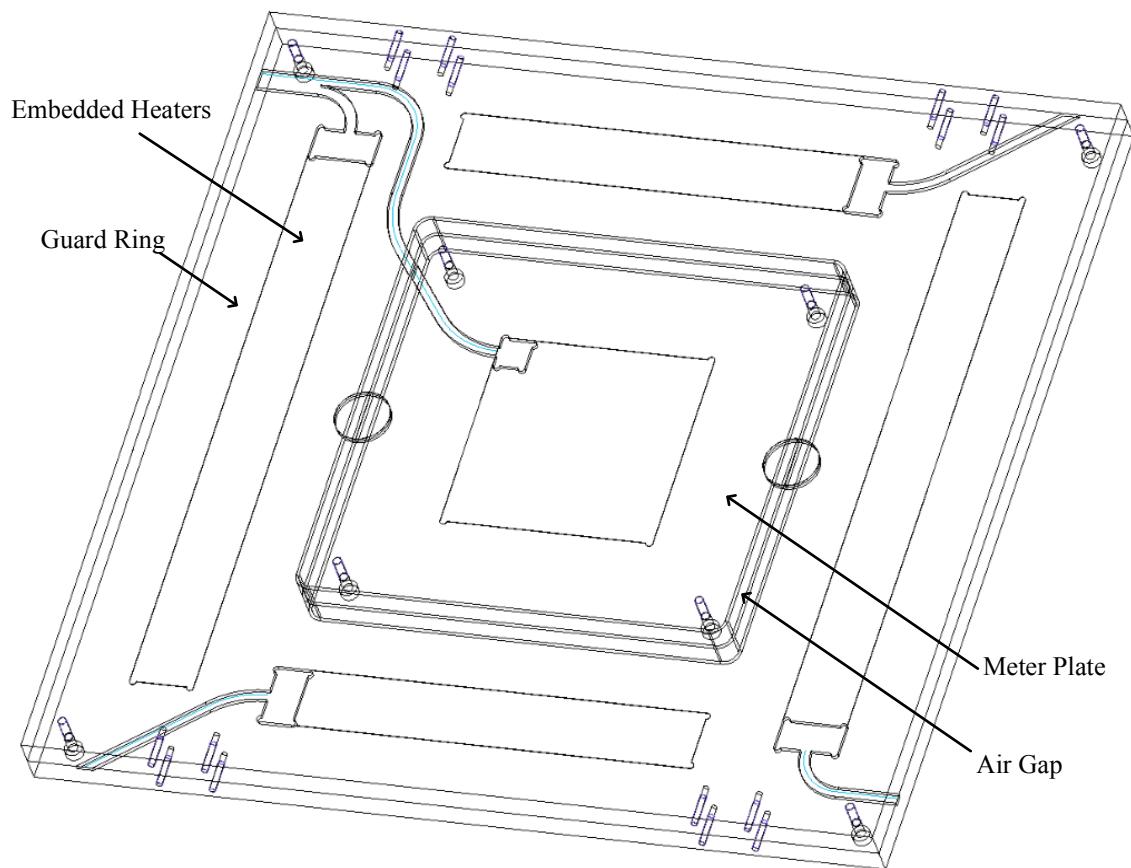
**Figure 4-2: Wireframe view of hot plate assembly**

ring with an insulating air gap between the two plates. The air gap was used as a physical divide between the surfaces of the meter plate and guard ring to prevent conductive energy transfer from the meter plate. When the temperature of the guard ring matches the temperature of the meter plate, there is no energy loss from the meter plate to the guard ring. With this understanding all the energy must travel into the insulating samples being tested along the thermal gradient between hot and cold surface. As there is no standard blueprint for constructing a GHP, a custom GHP was designed and built using ASTM guidelines, to be used for the thermal resistance testing in this thesis.

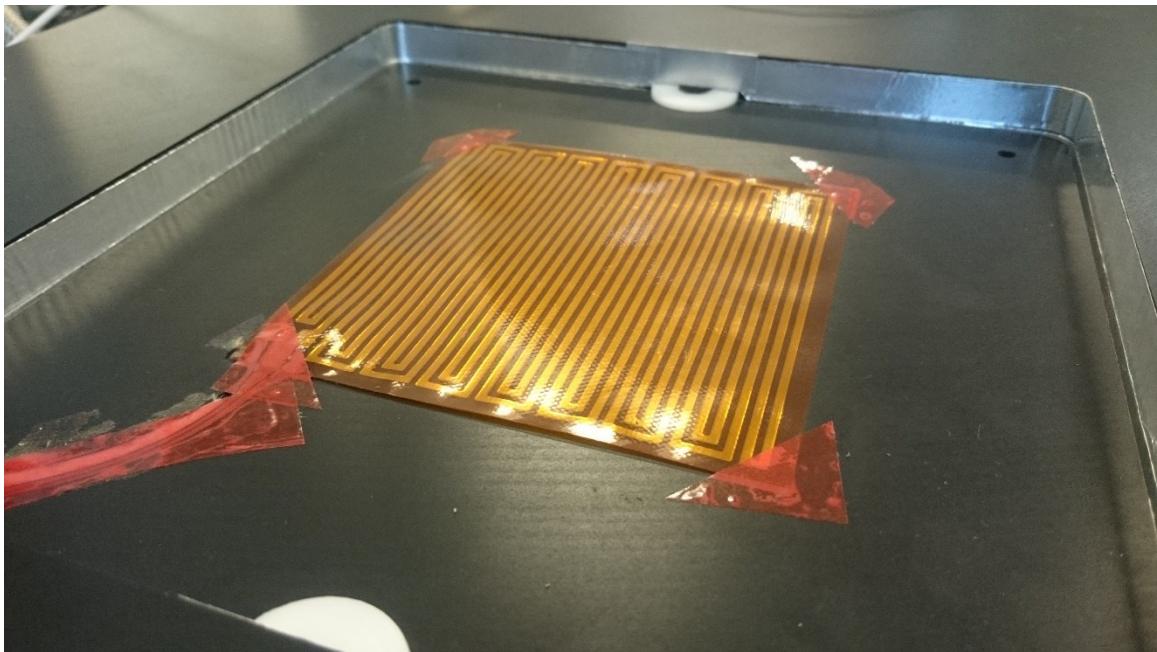
**Figure 4-3: Meter plate and guard ring after anodizing with reflective aluminum tape and embedded meter plate heater**

meter plate were also anodized. Having the sides of the meter plate and guard ring that face the air gap anodized black was undesirable in preventing energy transfer from the meter plate and as such reflective aluminum tape was added to the sides of the meter plate and guard ring to reduce their emittance and increase their reflectance. Figure 4-3 shows the inner face of the air gap with the aluminum tape adhered to it. With all the measures taken to reduce the energy loss across the air gap and to maintain the plate temperatures of the meter plate and guard ring the same, an average temperature difference of less than  $0.1^{\circ}\text{C}$  was maintained across the gap, which was within the limit specified within the ASTM standards (i.e., not more than  $0.2^{\circ}\text{C}$ ).

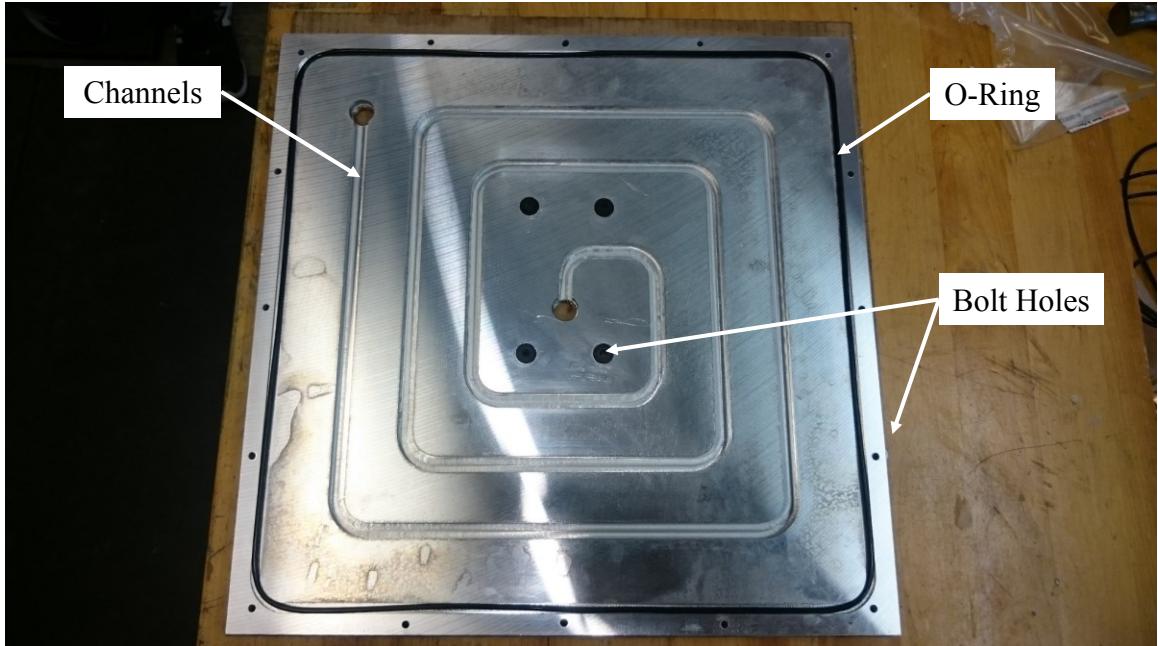
**Figure 4-4: Plate with channels cut into it to form internal channels when combined with flat plate**

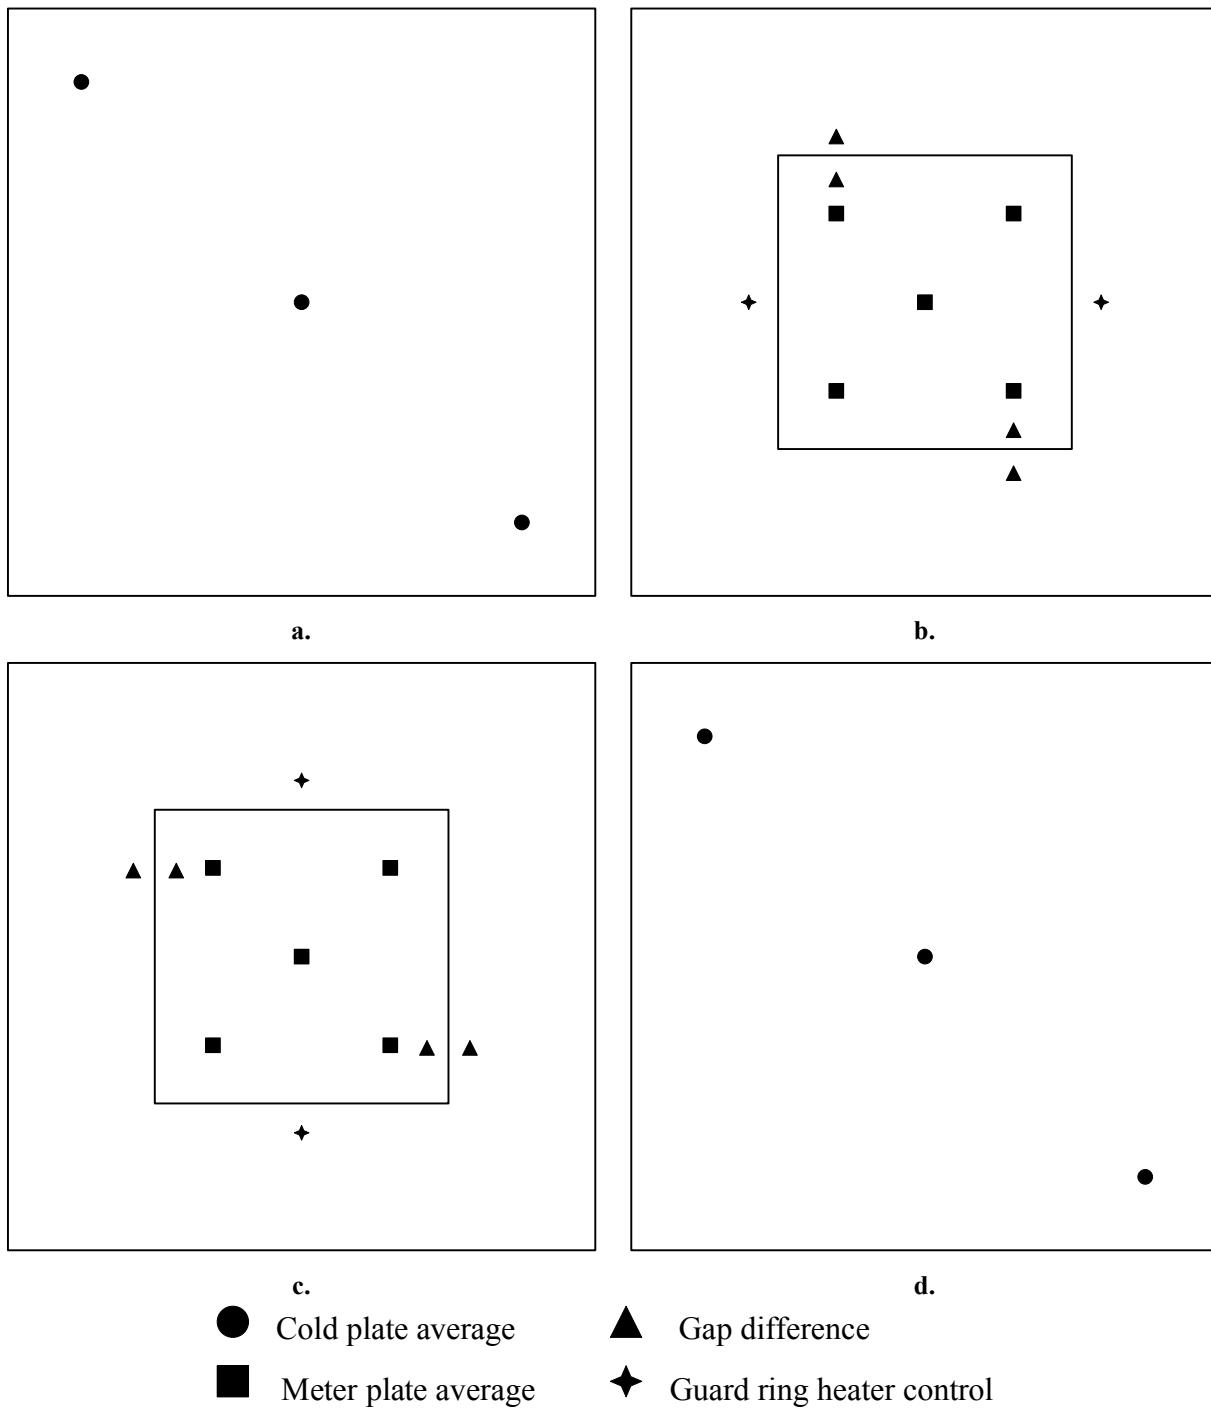
**Figure 4-4: Thermocouple layout for hot plates (b.,c.) and cold plates (a.,d.)**

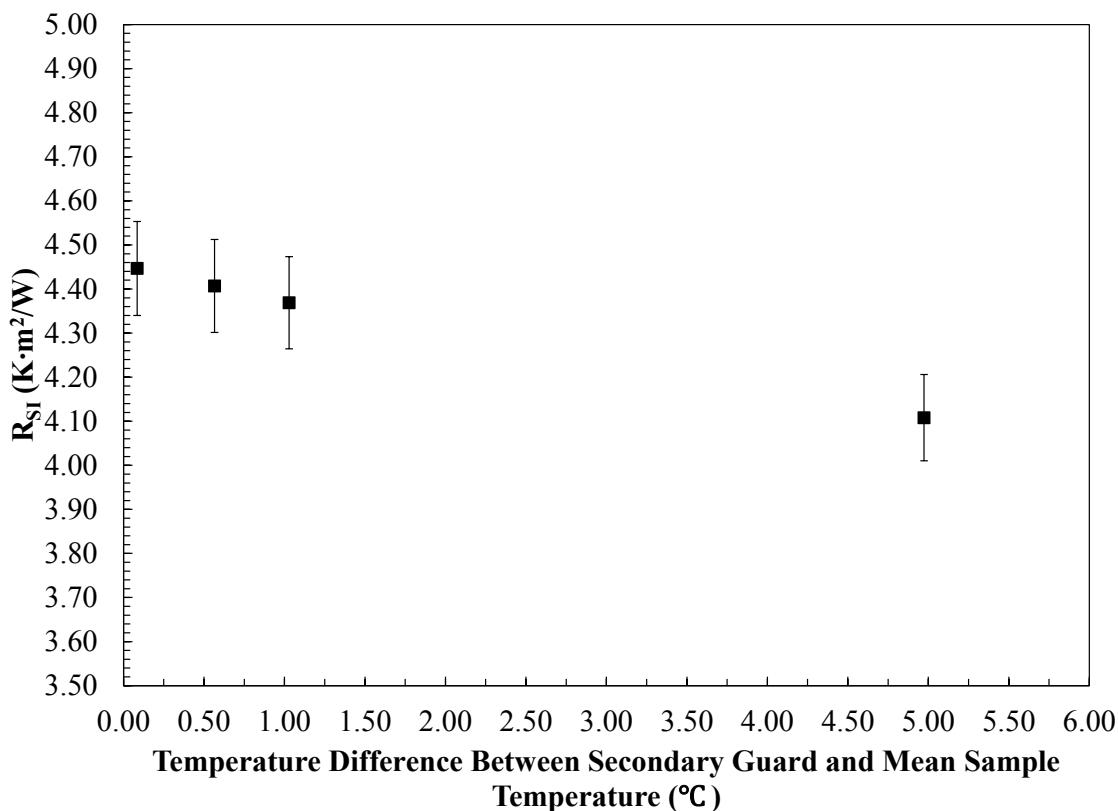
**Figure 5-1: Temperature Difference Between Secondary Guard & Mean Sample Temperature**

The results obtained from this test were then used to assess the validity of future testing where the temperature difference between the secondary guard and the mean plate temperature were compared to determine if the difference was within 0.5°C of each other. If the difference was greater than 0.5°C the results were scraped and the test was rerun.

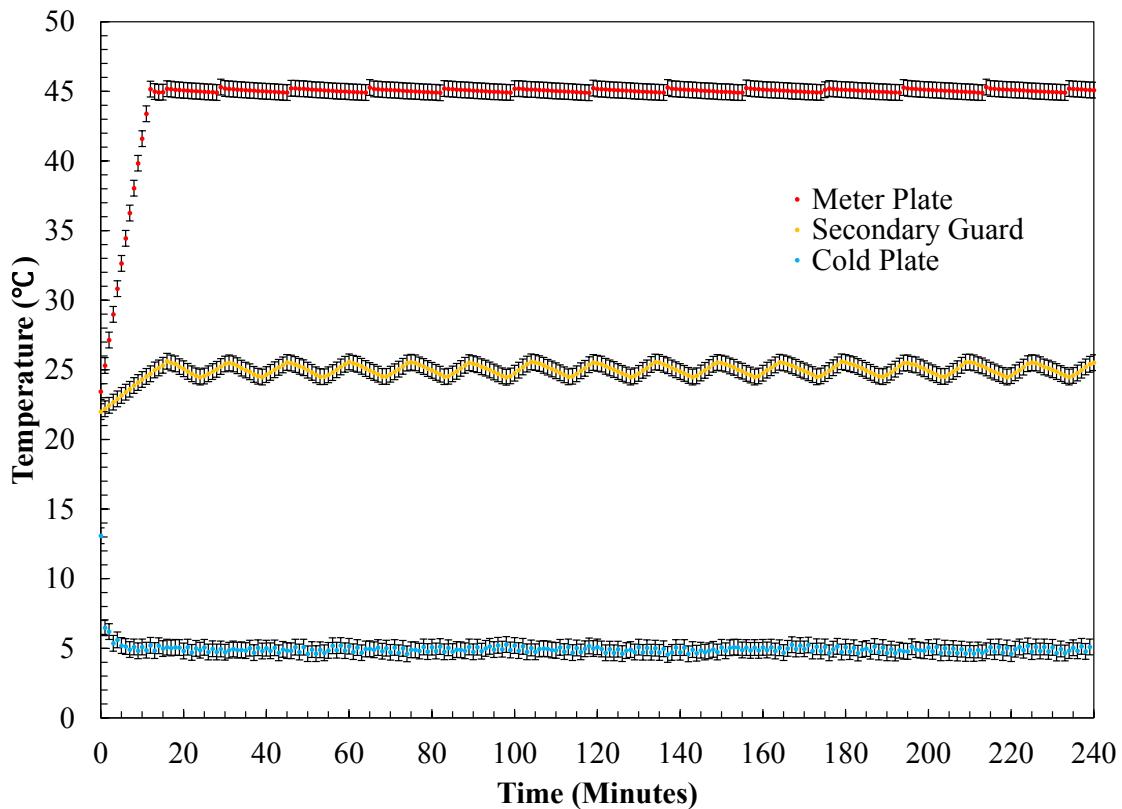
**Figure 5-2: Temperature readings during GHP steady state testing**

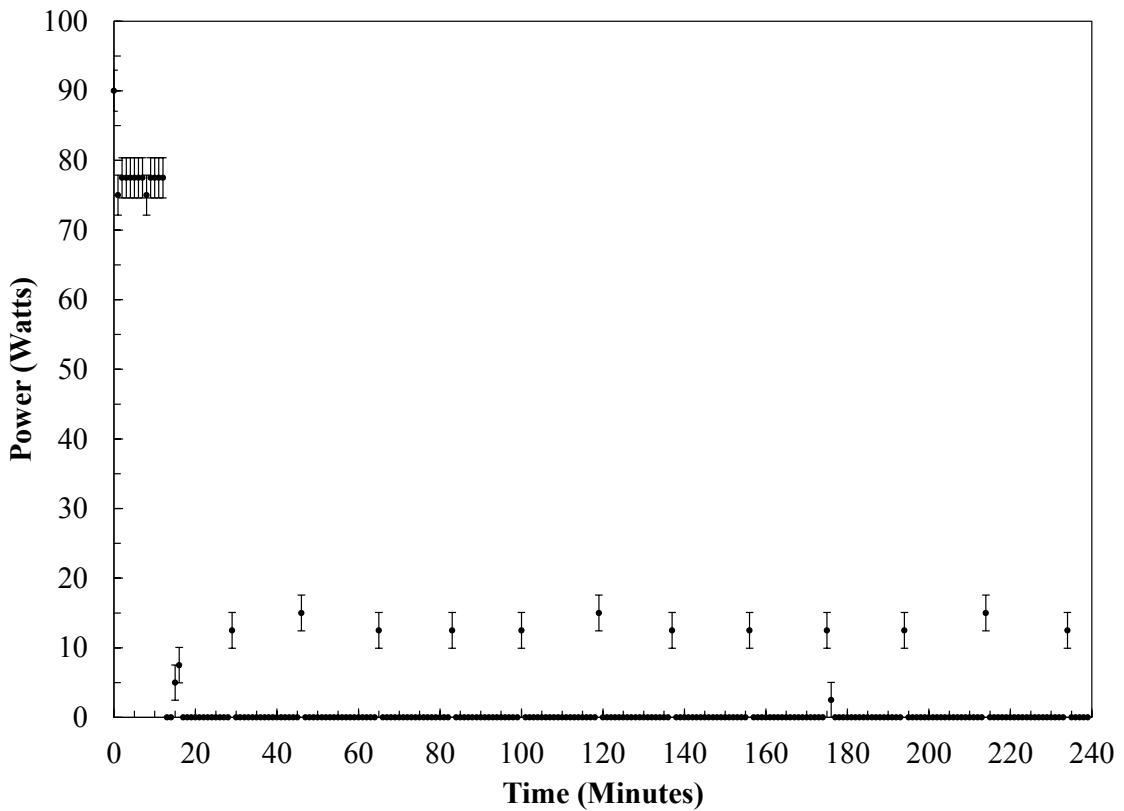
**Figure 5-3: Power consumption during GHP steady state testing**

of power being used at each interval is constant. Figure 5-3 is a plot of the power consumption of the meter plate used through the testing period. A settling period for the power consumed was observed at the two hour mark. After two hours the heater came on at 19 minute intervals and provided approximately 12.5 Watts of power for approximately 1 minute periods as shown in Figure 5-3. The dip in the data at approximately the three hour mark can be attributed to a heating period being split between two time periods on the power meter. As the power was split between the two time periods the amount of power consumed in each instant was less than the 12.5 Watts per time step during steady state. This test helped determine that a 4 hour averaging period was an acceptable length of time for steady state conditions to be reached for a VIP being evaluated for thermal resistance.

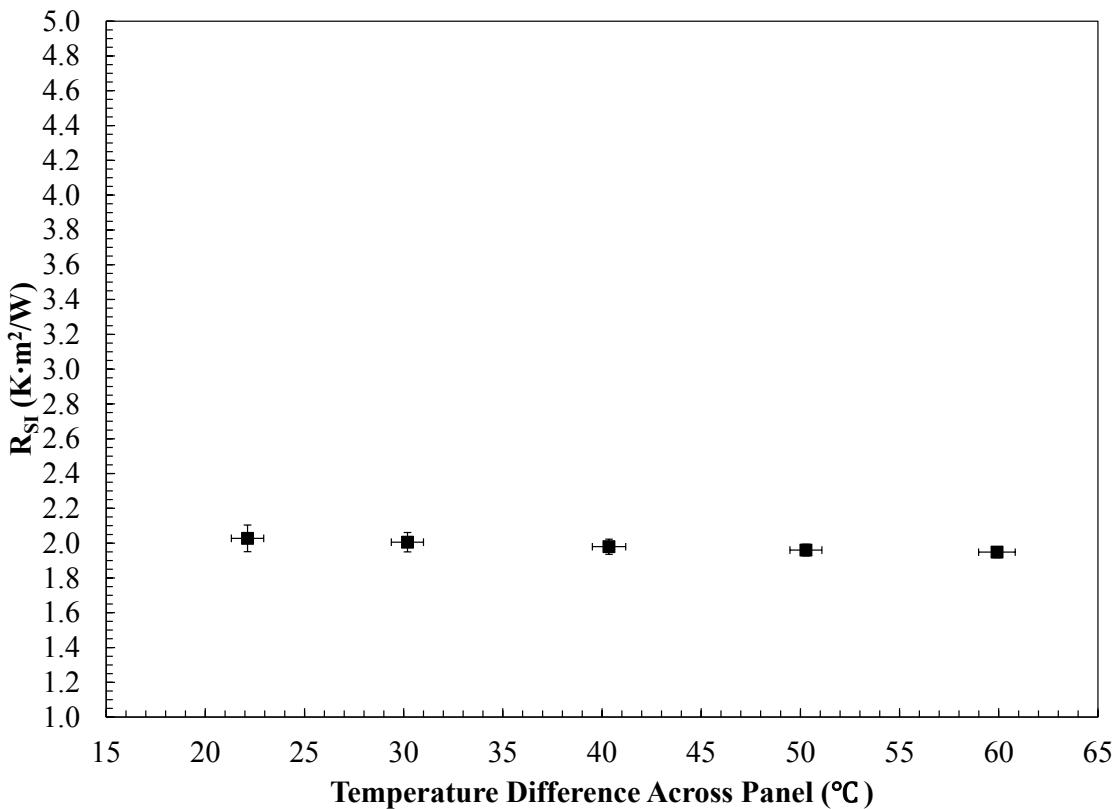
**Figure 5-4: Increasing temperature difference across PM1 with mean temperature constant**

The results obtained from PM1 can be seen in Figure 5-4 which shows that as the temperature difference across the panels increased, the uncertainty in the measured value decreased from approximately 3.7% at  $\Delta T$  22°C to 1.6% at  $\Delta T$  60°C. In Figure 5-4 it can also be seen that the evaluated thermal resistance of the VIP also decreases as the temperature difference across the VIP increased which was a trend observed by Lorenzati, et al [36]. In analyzing the results from this test it was determined that the optimal temperature difference across the panels from PM1 was actually 60°C as the uncertainty of in the value was the lowest and the thermal resistance appeared to have reached a settling point. Upon completion of the testing of the panels from PM1, panels from PM2 were tested through the same conditions.

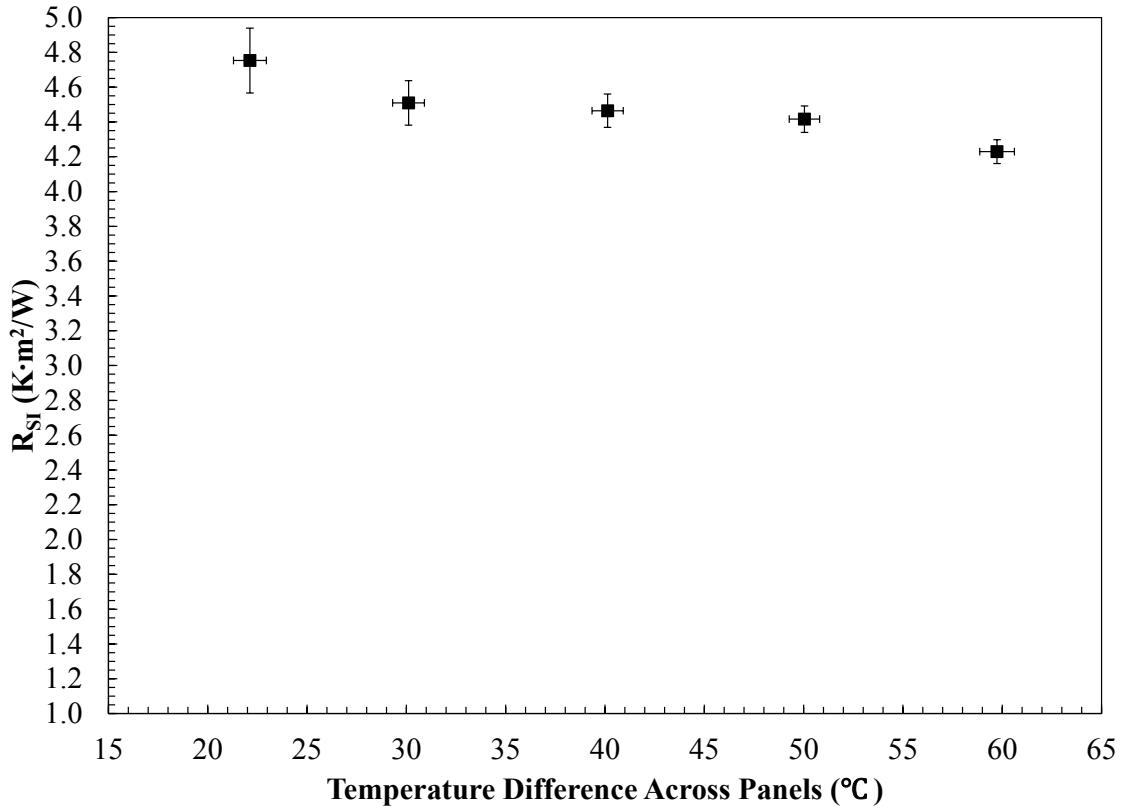
**Figure 5-5: Increasing temperature difference across PM2 with mean temperature constant**

GHP in regards to its maximum and minimum temperatures, the 40°C temperature difference across the panels was selected. A 40°C temperature difference was selected as it helped keep the uncertainty in the evaluated thermal resistance down and it allowed for the most flexibility in testing of difference mean panel temperatures.

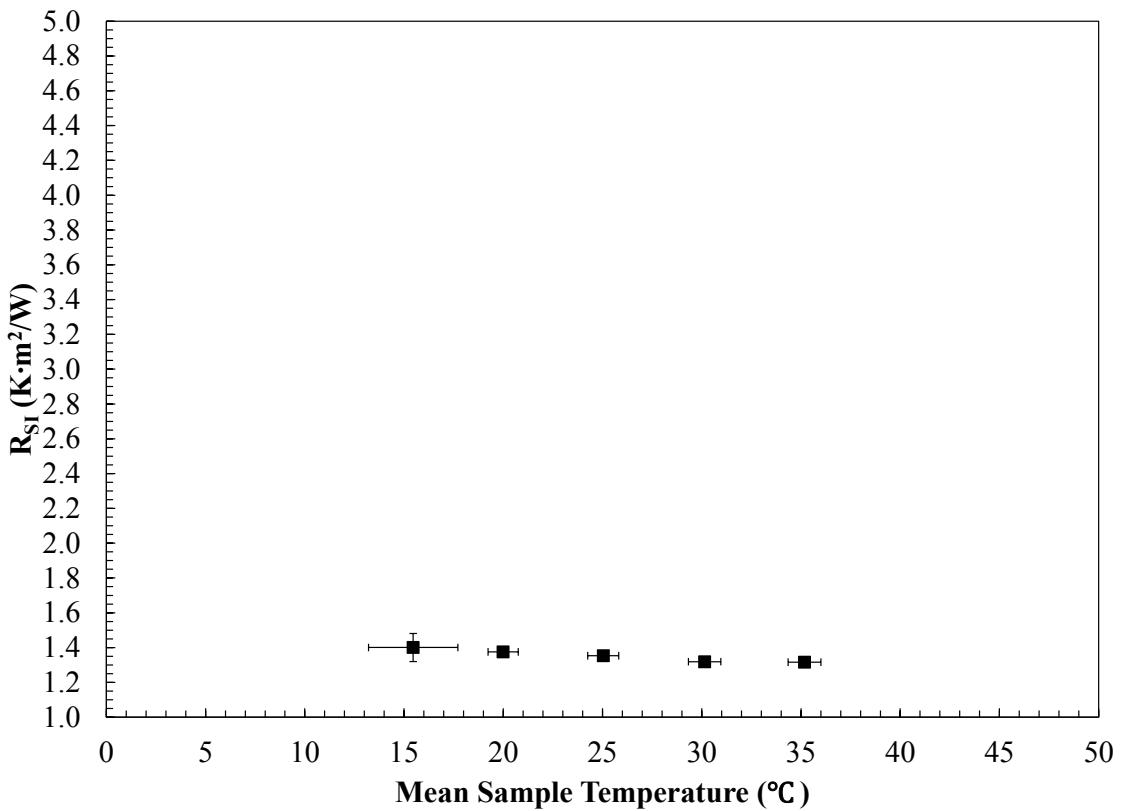
Figure 5-6: Thermal resistance testing of EPS

Testing of EPS was done in order to give a comparison for the VIPs tested in this study. The testing of the 0.058m thick EPS was conducted through the same set point temperatures that were selected for the VIPs. The results from the testing of the EPS are shown in Figure 5-6 which shows the dependence of thermal conductivity on temperature. Over the 20°C temperature range, the EPS dropped approximately 6% from low to high mean temperature. The uncertainty in the measured value at 15°C was larger than the rest of the calculated uncertainties as the cold plate was fluctuating in temperature through the 16 hour period and as such a larger standard deviation in the recorded temperatures was recorded.
