Design and Construction of a Guarded Hot Plate Apparatus  
to Evaluate the Thermal Resistance of Vacuum Insulated  
Panels using a New Accelerated Ageing Procedure

A thesis submitted to the Faculty of Graduate and Postdoctoral  
Affairs in partial fulfillment of the requirements for the degree of

Master of Applied Science

Sustainable Energy Engineering and Policy

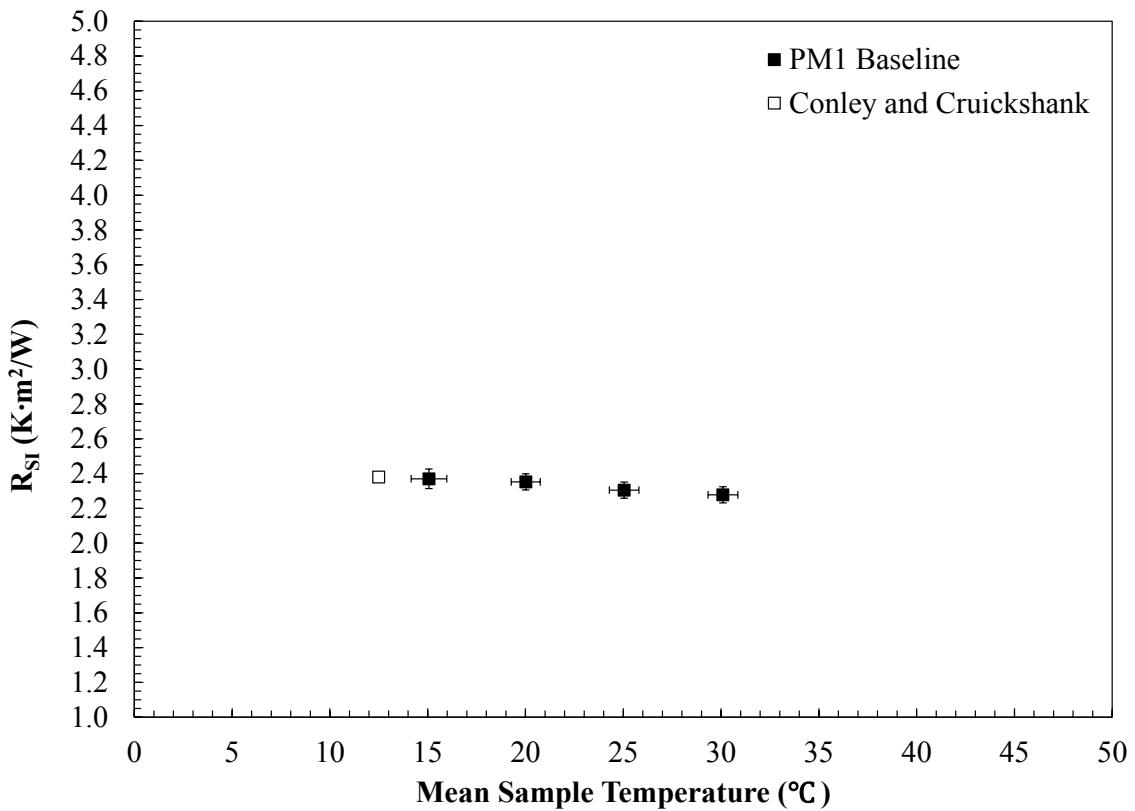
**Figure 5-7: Baseline thermal resistance testing for panels from PM1**

center of panel thermal resistance of  $2.38 \text{ K}\cdot\text{m}^2/\text{W}$  when tested at a mean panel temperature of approximately  $12.5^\circ\text{C}$ . These results were used as a guide to compare calculated thermal resistances from PM1 in this thesis. Figure 5-7 presents the thermal resistance of the two panels from PM1 as a function of the mean panel temperature, illustrating how the thermal resistance of the material decreases as the mean sample temperature increases. Interpolating from the results obtained in this thesis for a thermal resistance value at  $12.5^\circ\text{C}$  a value of  $2.38 \text{ K}\cdot\text{m}^2/\text{W}$  could be possible. Comparing this calculated thermal resistance value to that of Conley and Cruickshank, [31] shows that the evaluated thermal resistance values from the GHP for panels from PM1 are in the range of expected values. In Figure 5-7 the thermal resistance of the VIPs can be seen to drop as the mean sample temperature of the panel increases, and in this test the panels experienced a drop of approximately 3.8% over a  $15^\circ\text{C}$  temperature difference. Looking back to the results of the EPS thermal resistance testing, the EPS experienced a 6% drop over the same  $15^\circ\text{C}$  range of mean temperatures. Comparing the results from the VIPs suggests that the thermal resistance of VIPs are less dependent on mean temperature compared to EPS. Determining how dry VIPs thermal resistance is affected by the mean sample temperature was considered an important characteristic, in order to make the comparison to panel that have been aged. The comparison would determine if the amount of moisture content of a panel affects the rate at which the thermal resistance changes with temperature.

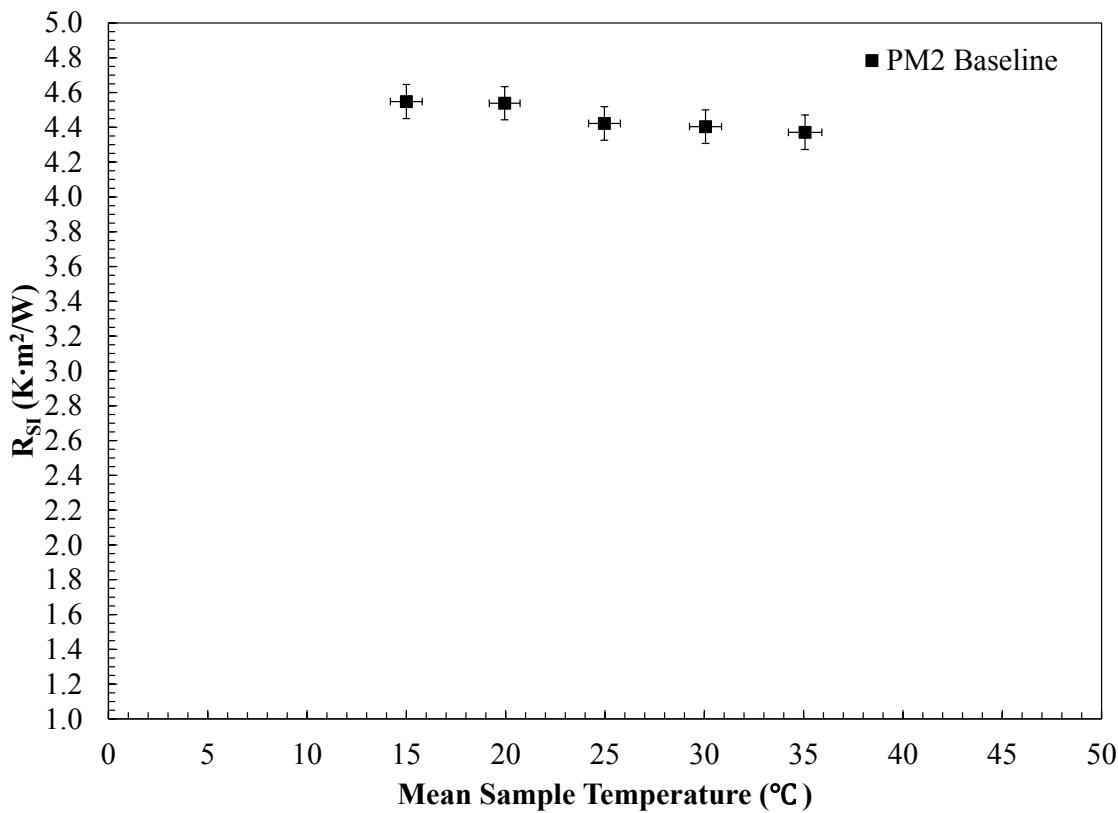
**Figure 5-8: Baseline thermal resistance testing for panels from PM2**

Between 15°C to 30°C the panels dropped approximately 3.2% compared to the 3.8% from PM1. These results from the testing of the panels from PM2 suggest that the thermal resistance is the least dependent on mean temperature compared to panels from PM1 and to EPS. Despite the baseline thermal resistance testing of panels from PM1 and PM2 showing less temperature dependence than EPS, the results still show a dependence on mean sample temperature, which suggests that future testing of VIP should continue to test at different mean temperatures in order to understand how mean temperature and moisture content affect the thermal resistance.

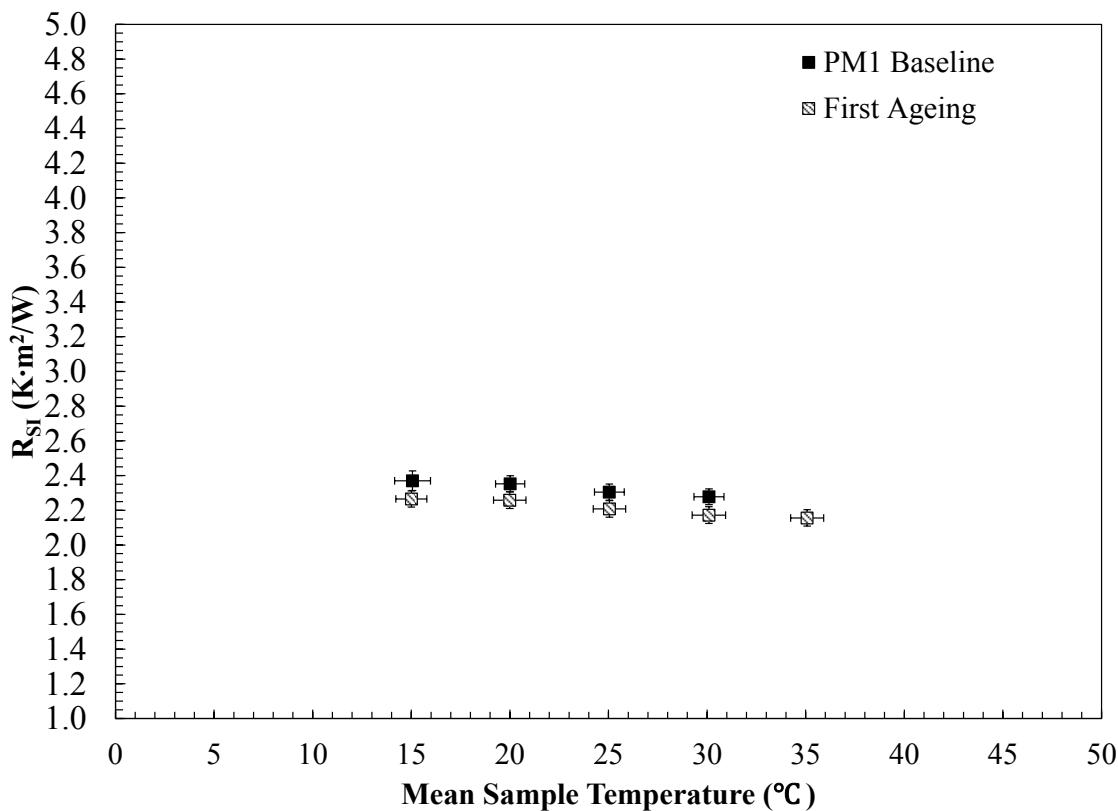
**Figure 5-9: Thermal resistance testing for panels from PM1 after ageing**

on the thermal resistance of VIPs from PM1. The second observation made of the results from the testing was that the dry panels thermal resistance dropped by approximately 3.8% between the mean temperatures of 15°C and 30°C where the drop for the aged panels was greater at 4.4% across the same range. The larger drop of thermal resistance across the range of temperatures suggests that as the mean temperature increases and the moisture content of a VIP increases the rate that thermal resistance decreases increases. The fact that thermal resistance of VIPs are changing with both temperature and moisture content makes a good argument for testing VIPs through a range of temperatures to determine how VIPs respond to moisture content and mean temperature.

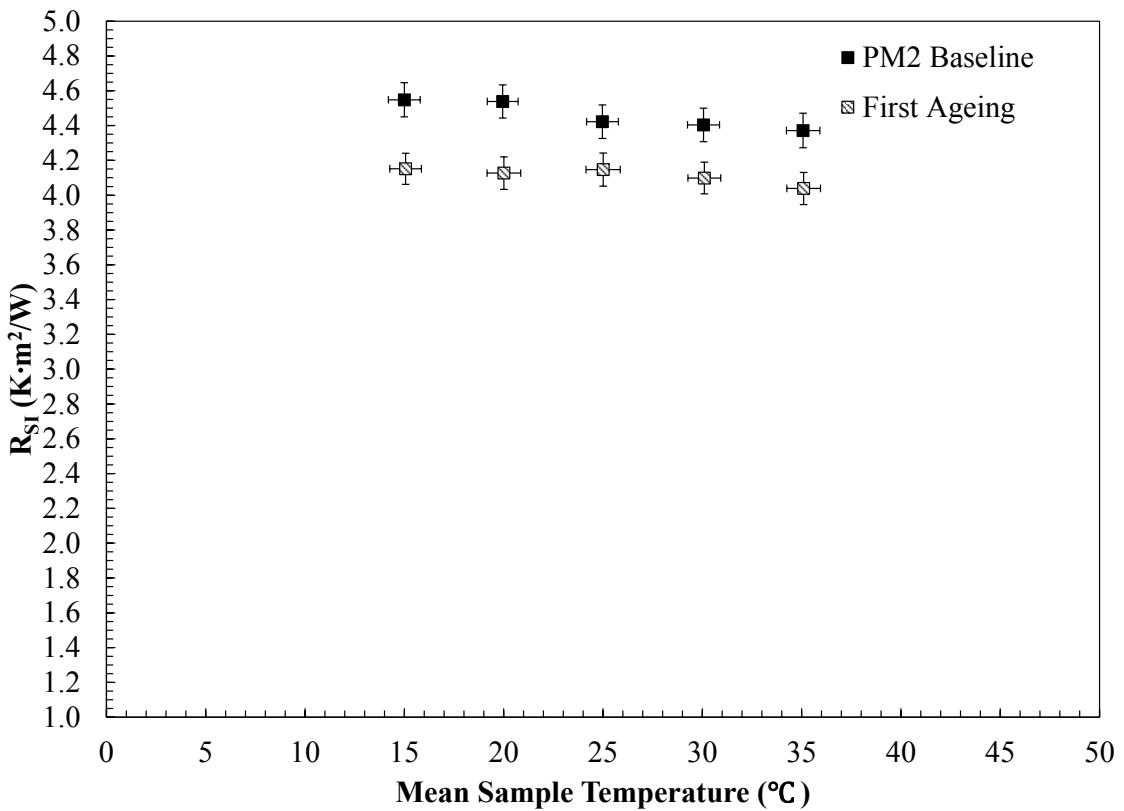
**Figure 5-10: Thermal resistance testing for panels from PM2 after ageing**

In an identical process, the panel from PM2 were also evaluated for thermal resistance after ageing. The panels from PM2 experience a lower gain of moisture compared to panels from PM1, gaining approximately 0.05% mass over the ageing period. Figure 5-10 shows that just like the panels from PM1 the thermal resistance of the panels was affected by the gain of moisture across all the sample temperatures tested. The thermal resistance values that were calculated showed a decrease of 6.5% compared to values obtained from the dry panels. The drop in performance was not expected based on how little moisture was gained in the panels. It can be seen that despite the amount of moisture that transports across the foil, moisture within a panel negatively affects the thermal resistance of a panel. As the foil composition of the panels is closely guarded by the manufacturers, the foil type and composition of the panels from PM2 is not known. It would appear that the foil of PM2 is less susceptible to moisture transport than that of PM1, which is why the amounts of moisture transported across the panels are different. During testing, it was also noted that panels from PM1 had a desiccant within the panel core while the panels from PM2 did not. Comparing the results from PM1 to PM2, the panels from PM1 experienced a larger moisture gain but a lower decrease in performance compared to the panels from PM2 suggesting that the internal desiccant had some effect in contributing to the difference in performance levels. It would be interesting to see how panels from PM2 would perform if an internal desiccant was added to absorb the minimal moisture gain.

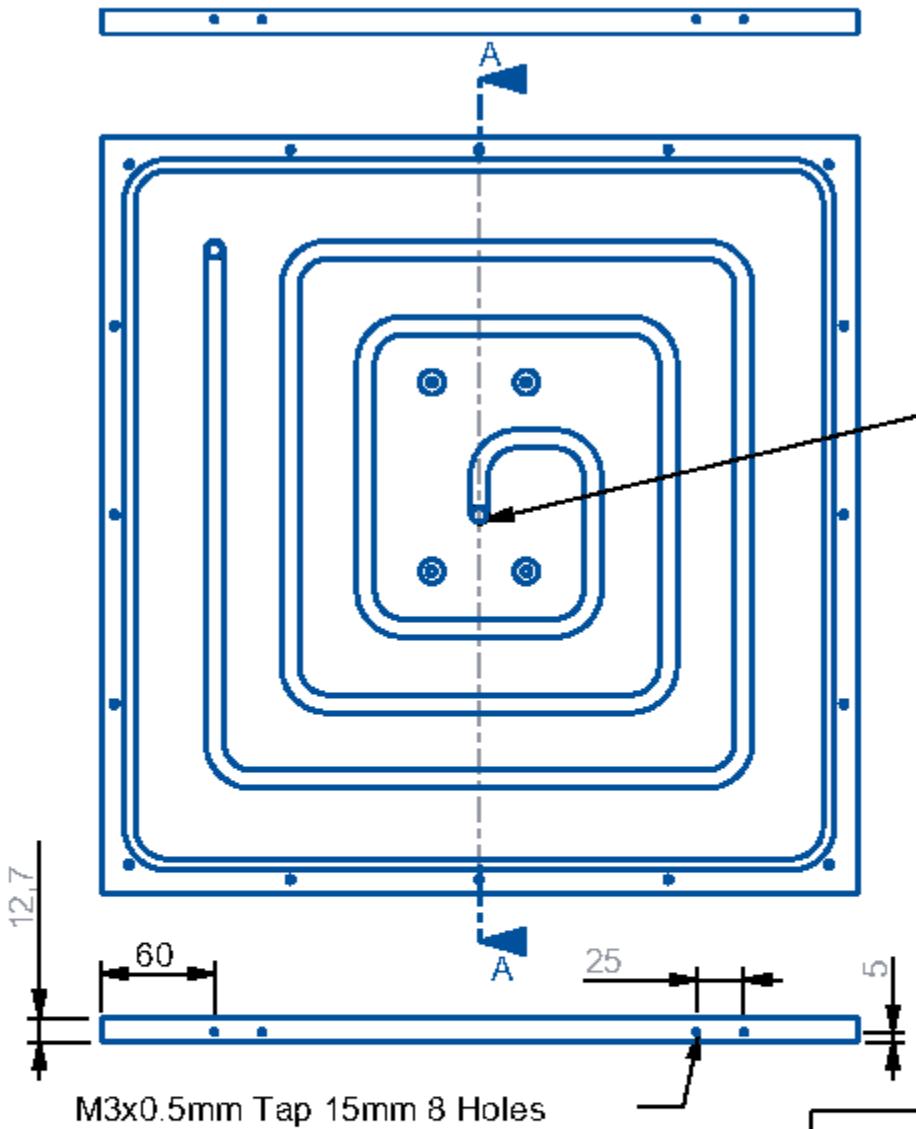
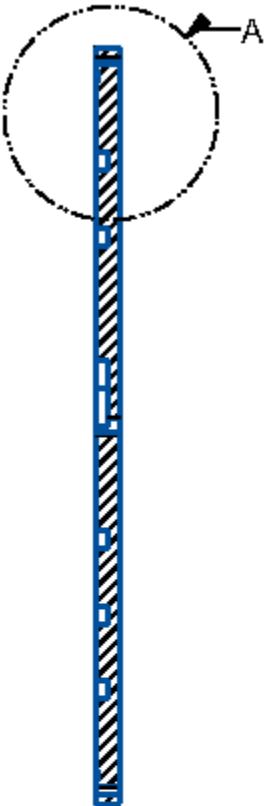
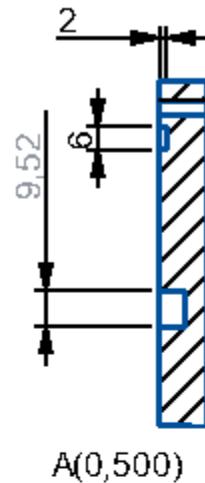
Cold Plate Channel	
DRW FILE: COLD_PLATE_CHANNEL	
MOD FILE: COLD_PLATE_CHANNEL	
SCALE: 0.125	MATL: Mic 6
Black Anodized	DRW by: A Hayes
Units: mm	SHEET: 1 of 2
	DATE: Dec-12-17
	TYPE: PART

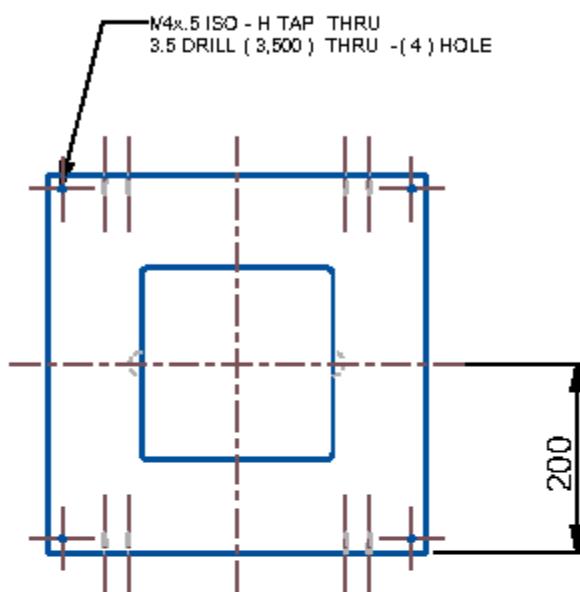
Guard Ring Top	
DRW FILE: GUARD_RING_TOP	
MOD FILE: GUARD_RING_TOP	
SCALE: 0,125	MATL: Mic 6
Anodized Black	DRW by: A Hayes
Units: mm	DATE: Nov-08-16
	TYPE: PART

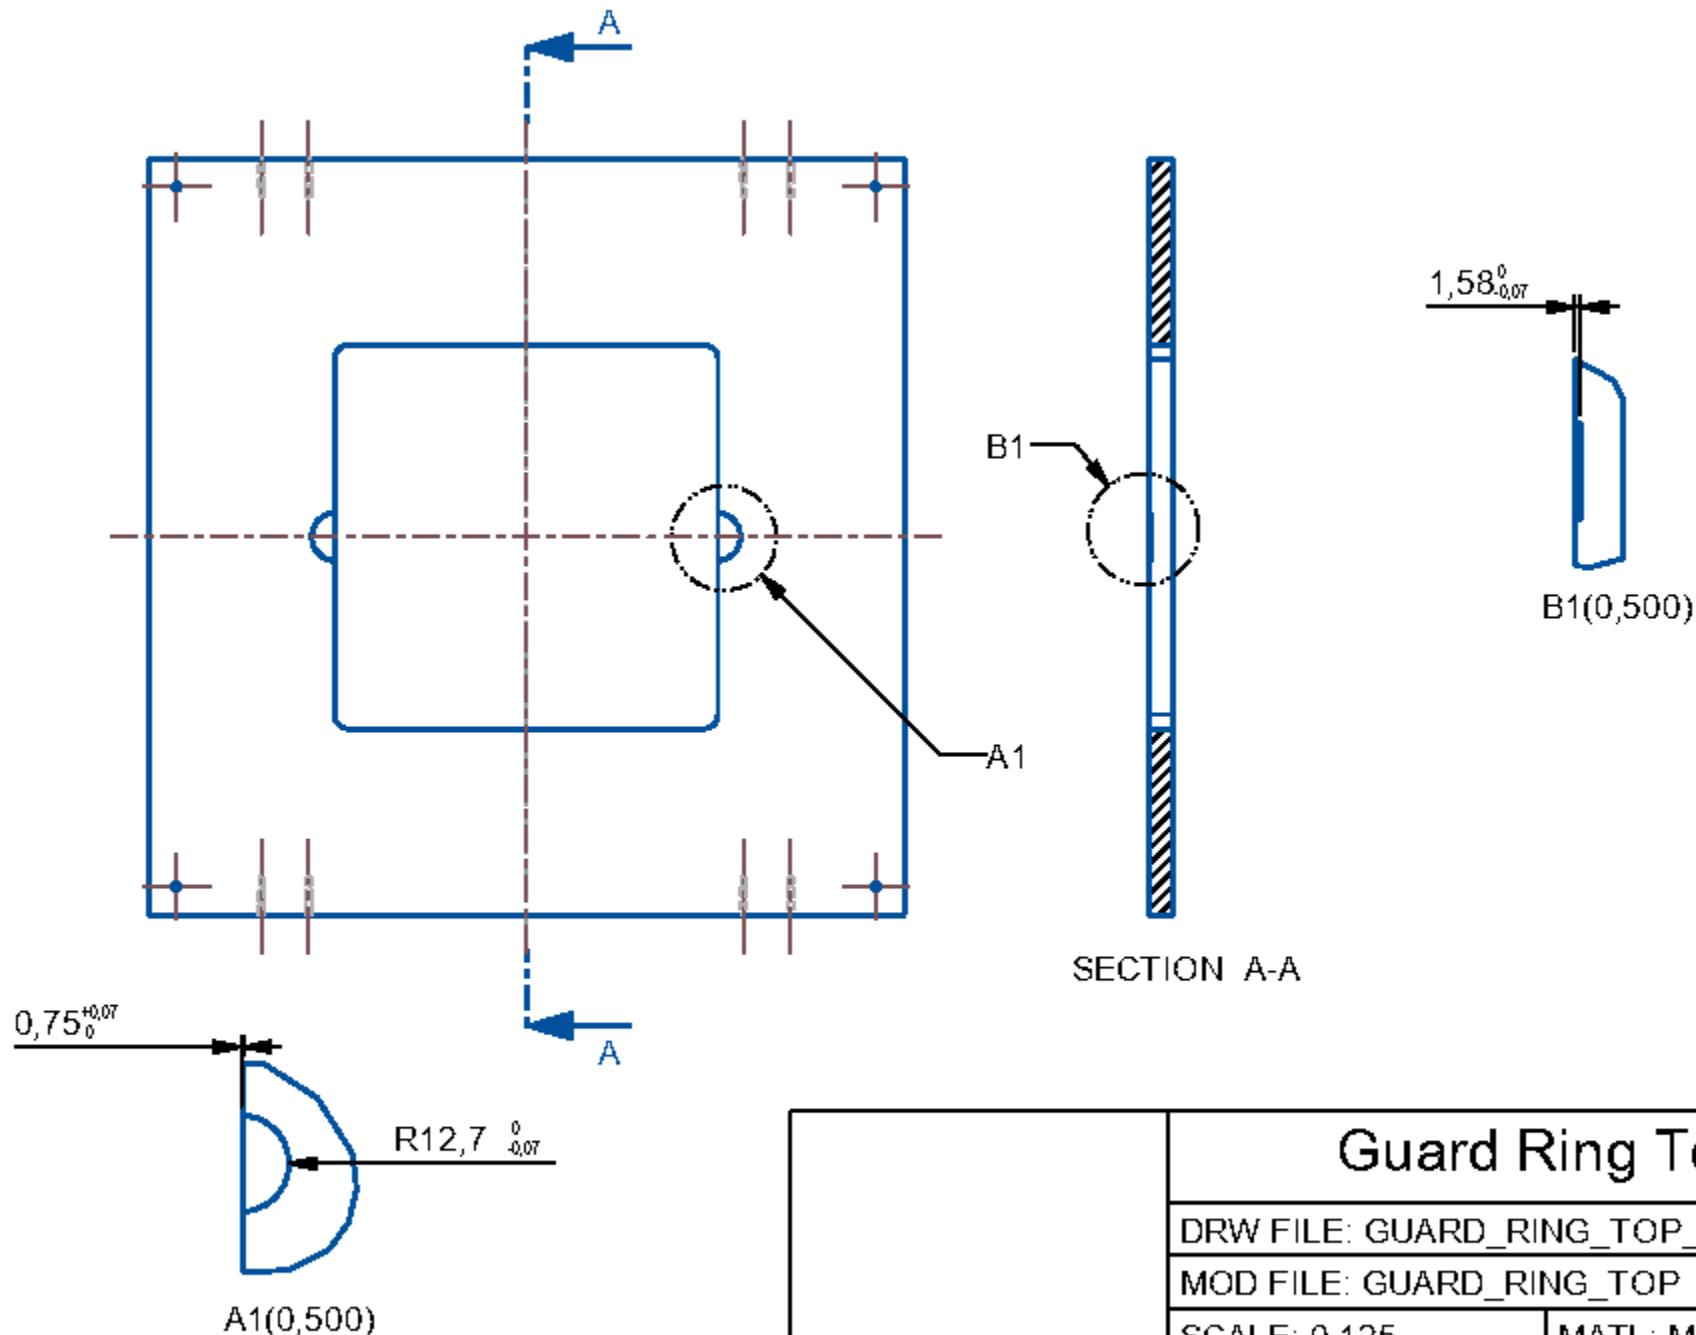
Guard Ring Top	
DRW FILE: GUARD_RING_TOP_2	
MOD FILE: GUARD_RING_TOP	
SCALE: 0,125	MATL: Mic 6
Anodized Black	DRW by: A Hayes
Units: mm	DATE: Nov-08-16
	TYPE: PART

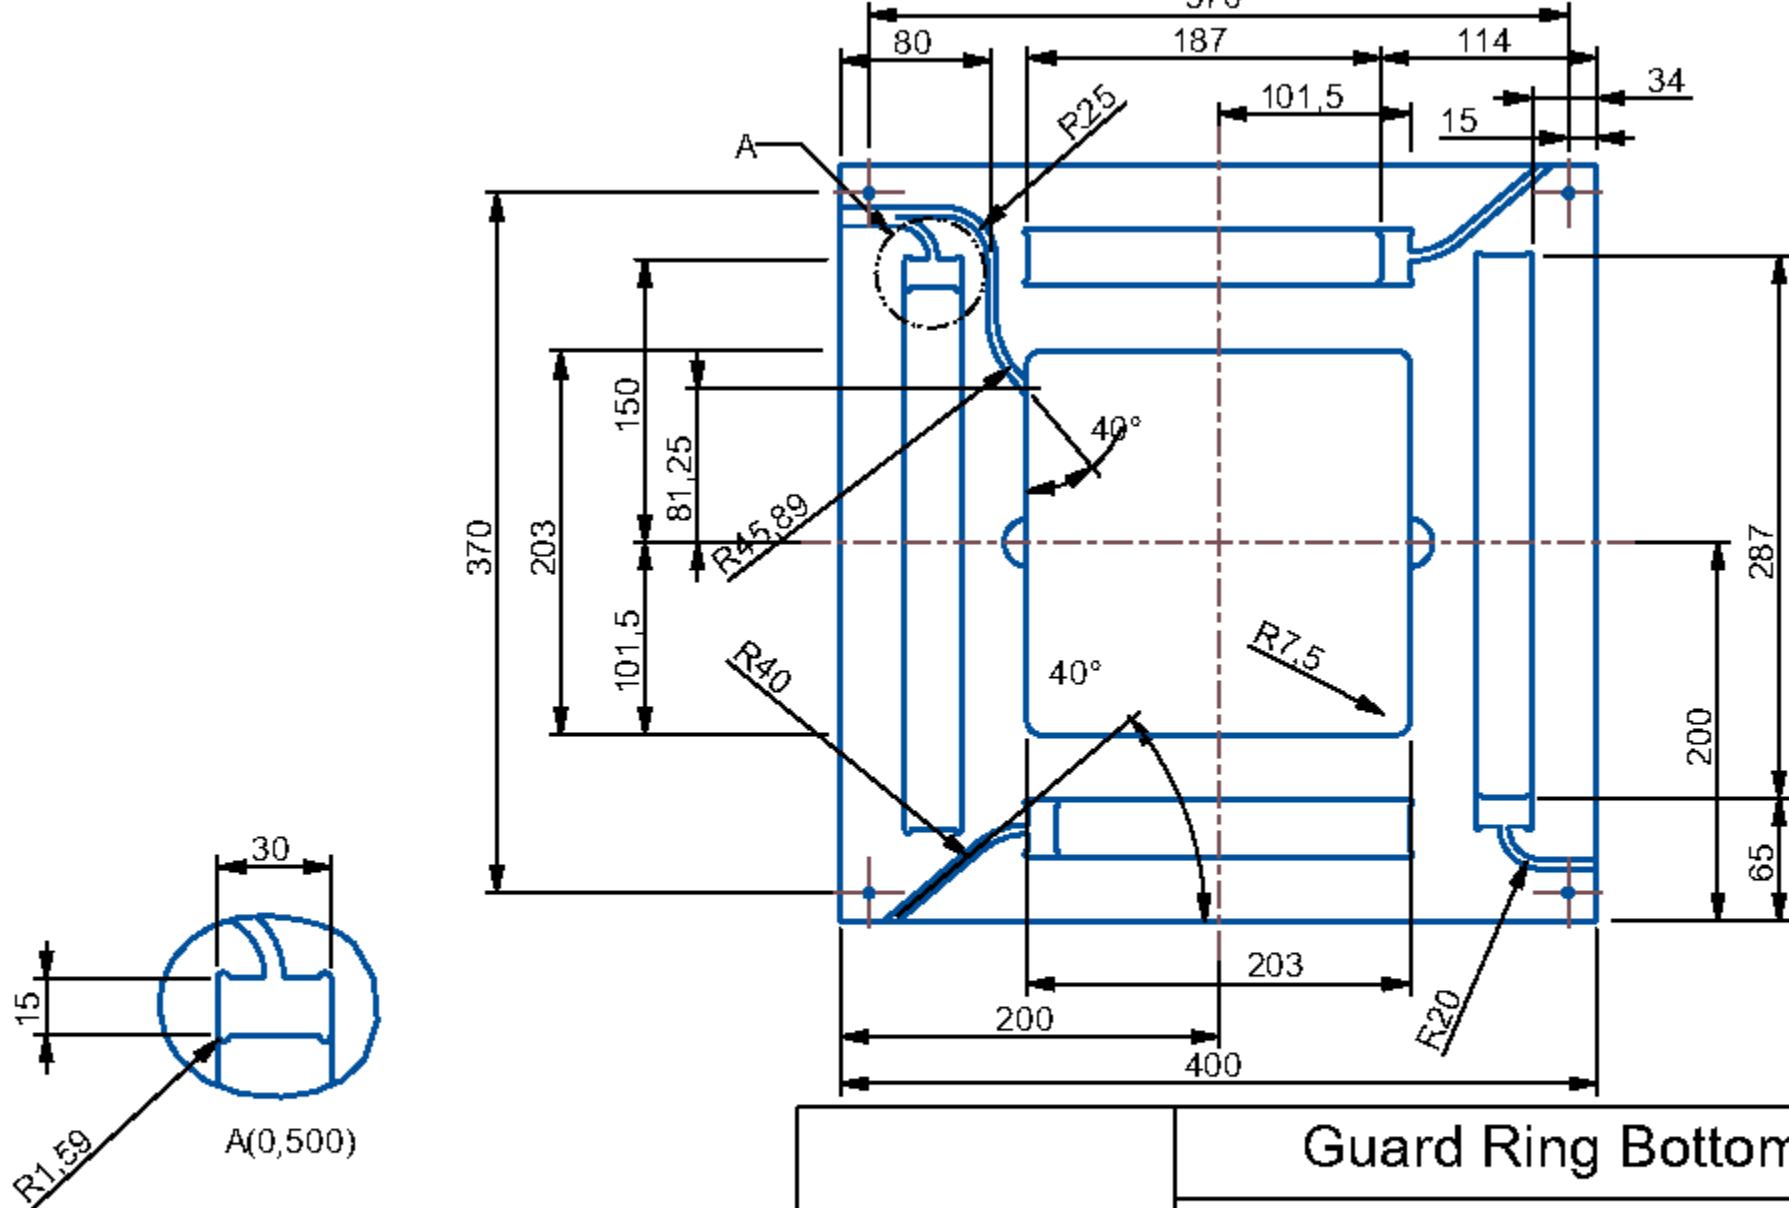
Guard Ring Bottom	
DRW FILE: GUARD_RING_BOTTOM_2	
MOD FILE: GUARD_RING_BOTTOM	
SCALE: 0,250	MATL: Mic 6
Anodized Black	DRW by: A Hayes
Units: mm	DATE: Nov-08-16
	TYPE: PART

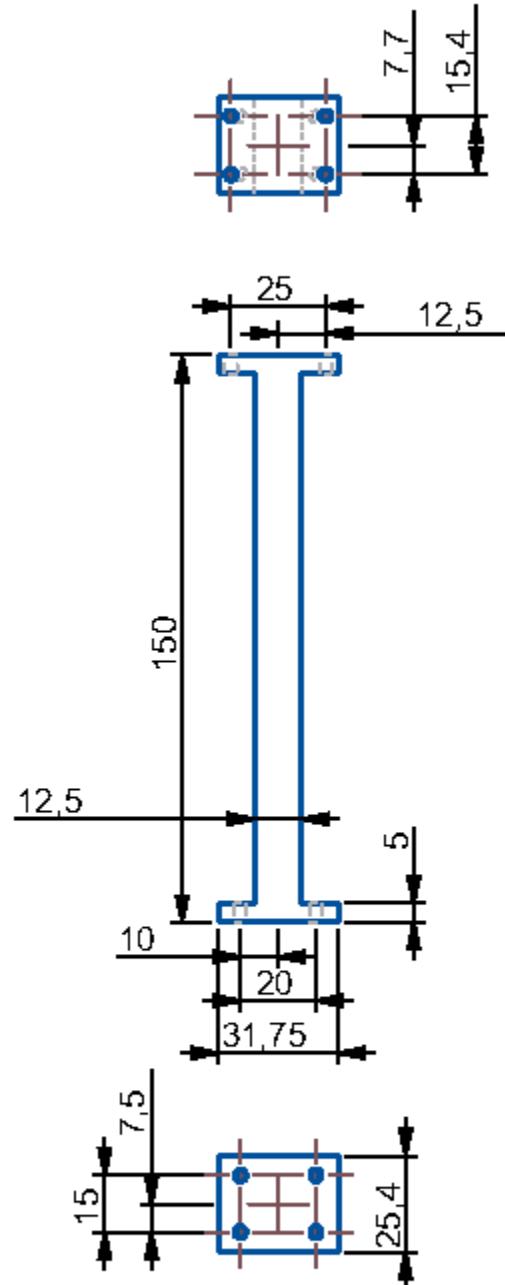
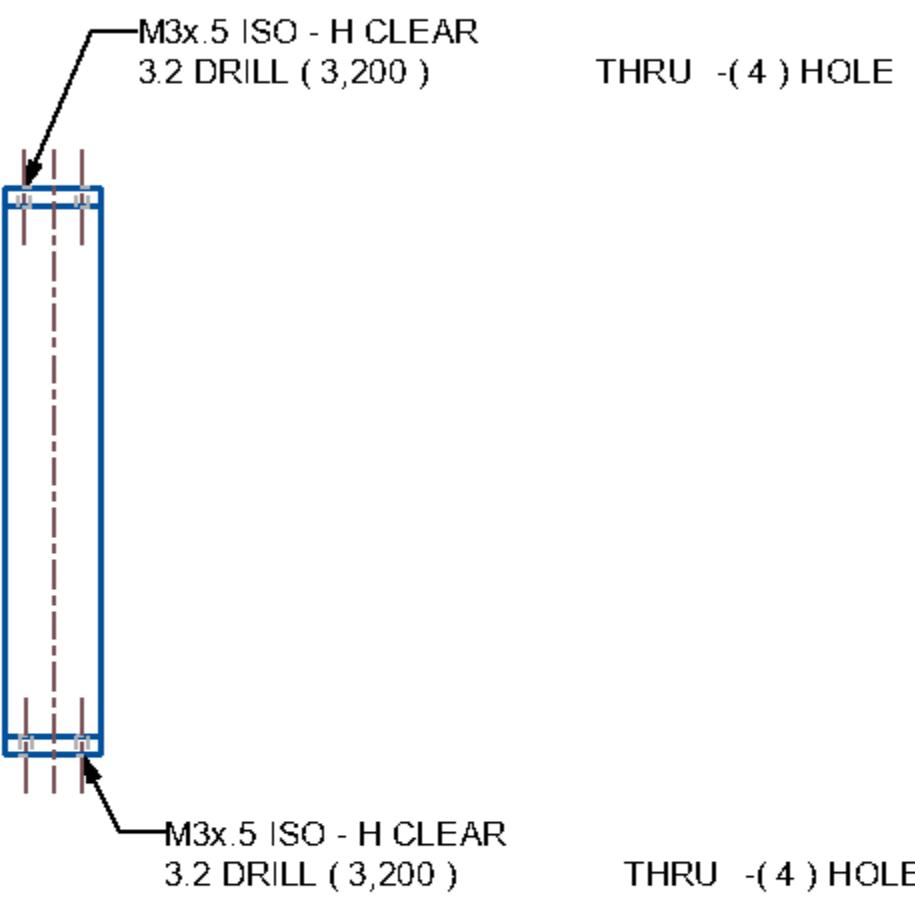
Meter Plate Spacer	
	DRW FILE: METER_PLATE_SPACER	
	MOD FILE: METER_PLATE_SPACER	
	SCALE: 1,000	MATL: Polyoxymethylene
	DRW by: A Hayes	SHEET: 1 of 1
Units: mm	DATE: Nov-08-16	TYPE: PART

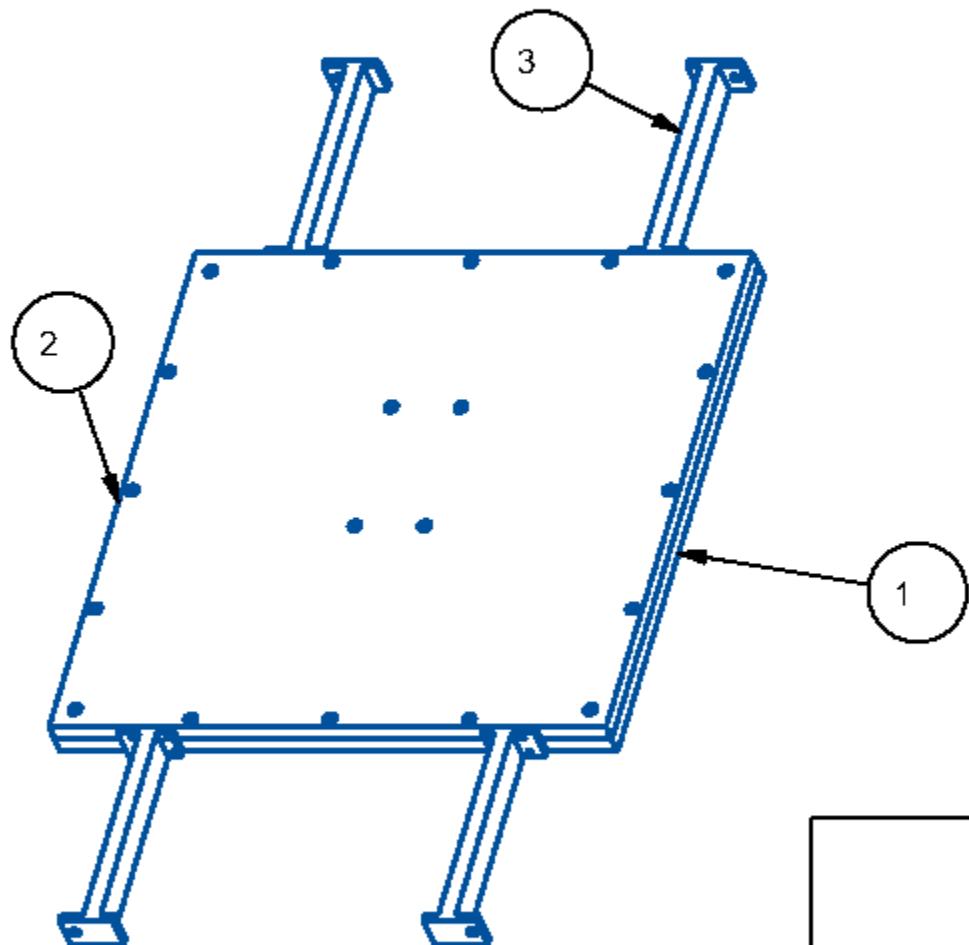
Cold Plate Fixed Assembly	
	DRW FILE: COLD_PLATE_FIXED	
	MOD FILE: COLD_PLATE_FIXED	
SCALE:	0.2	
DRW by:	A Hayes	SHEET: 1 of 1
DATE:	Dec-12-17	TYPE: ASSEM

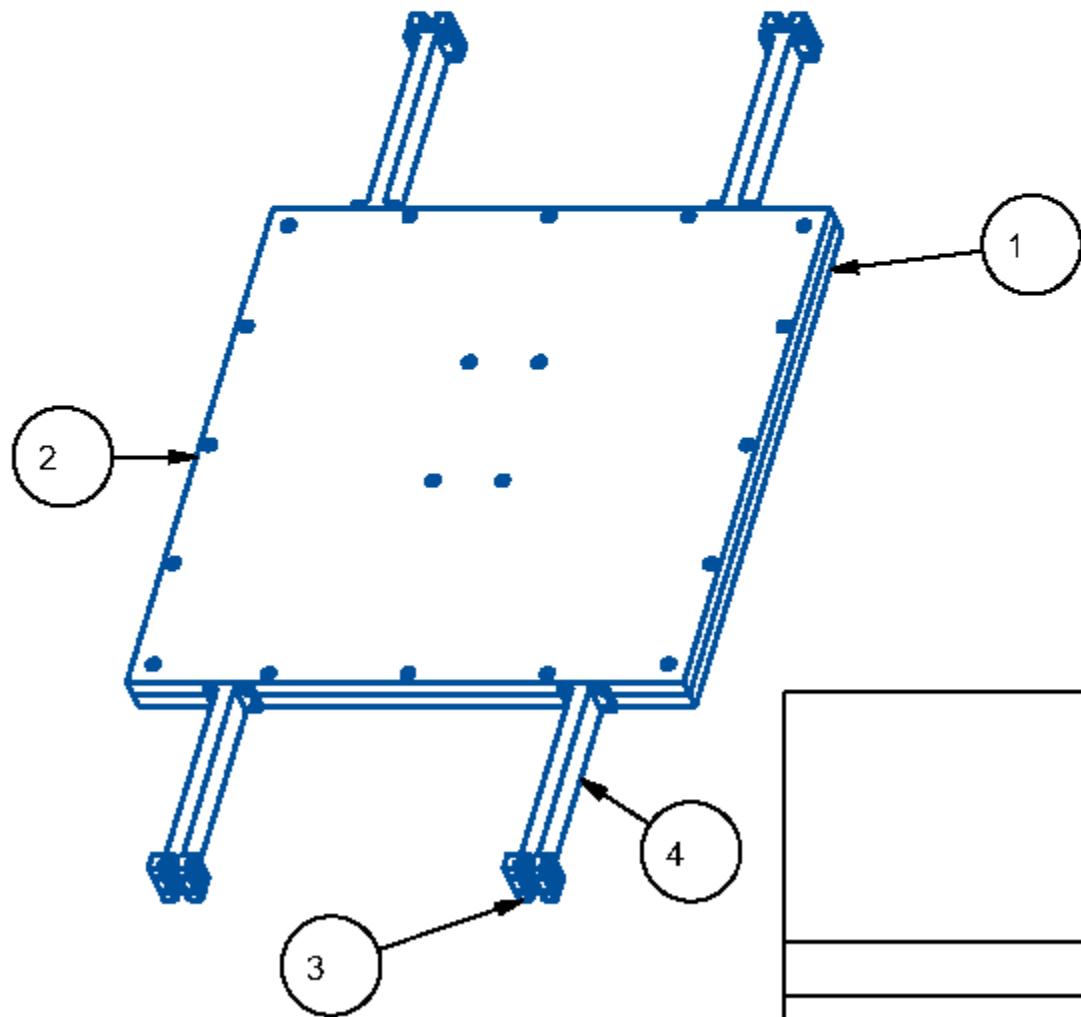
Cold Plate Free Assembly		
	DRW FILE: COLD_PLATE_FREE	
	MOD FILE: COLD_PLATE_FREE	
SCALE: 0.2		
	DRW by: A Hayes	SHEET: 1 of 1
	DATE: Dec-12-17	TYPE: ASSEM

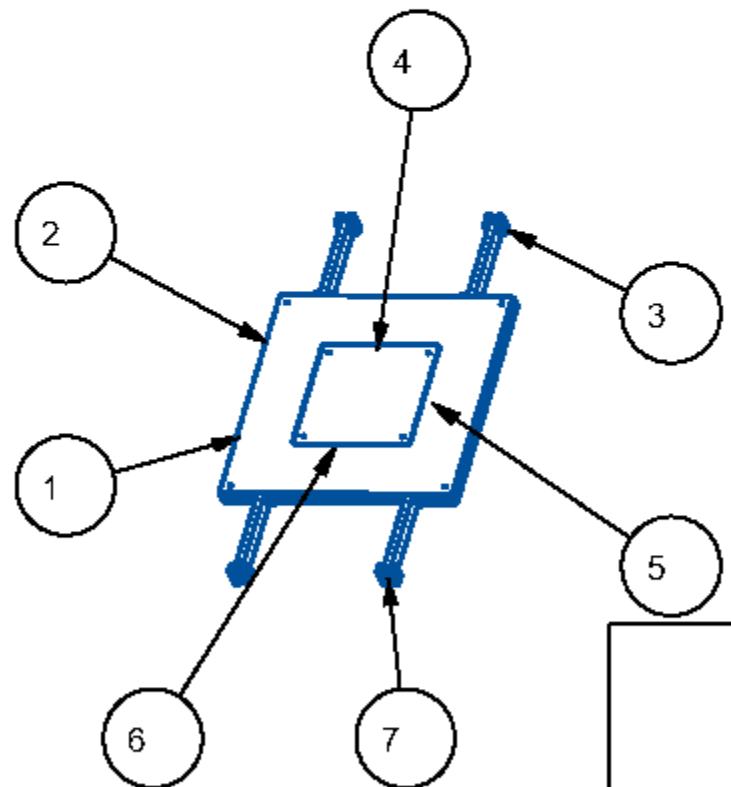
<b>Hot Plate Assembly</b>	
DRW FILE: HOT_PLATE	
MOD FILE: HOT_PLATE	
SCALE: 0,083	MATL:
DRW by: A Hayes	SHEET: 1 of 1
DATE: Nov-08-16	TYPE: ASSEM
