Near-Field Explosion Effects on Reinforced Concrete Columns: An Experimental Investigation

Master of Applied Science

Civil Engineering

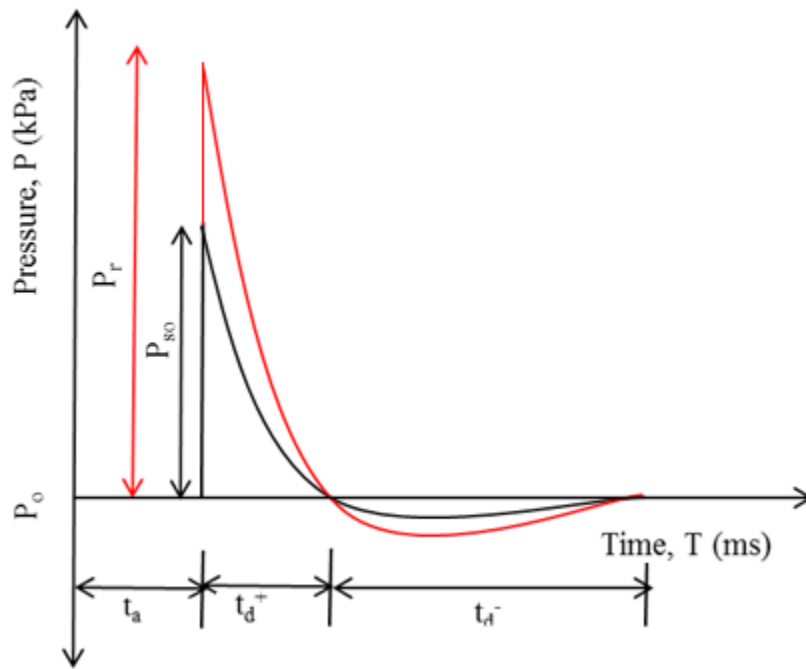
Figure 2-1: Air blast pressure profile

front velocity and time of arrival can be determined. The impulse of the blast wave is determined by calculating the area under a blast pressure-time profile. There are charts available in military handbooks to evaluate these blast parameters. The Friedlander waveform is a graph used to describe the profile of a blast wave. Figure 2-1 presents a typical blast pressure profile of a blast wave.

Where: $P(t)$ is the peak pressure at time t , P_{so} is the peak incident overpressure, t_d^+ is the positive phase duration of blast, b is the decay parameter.

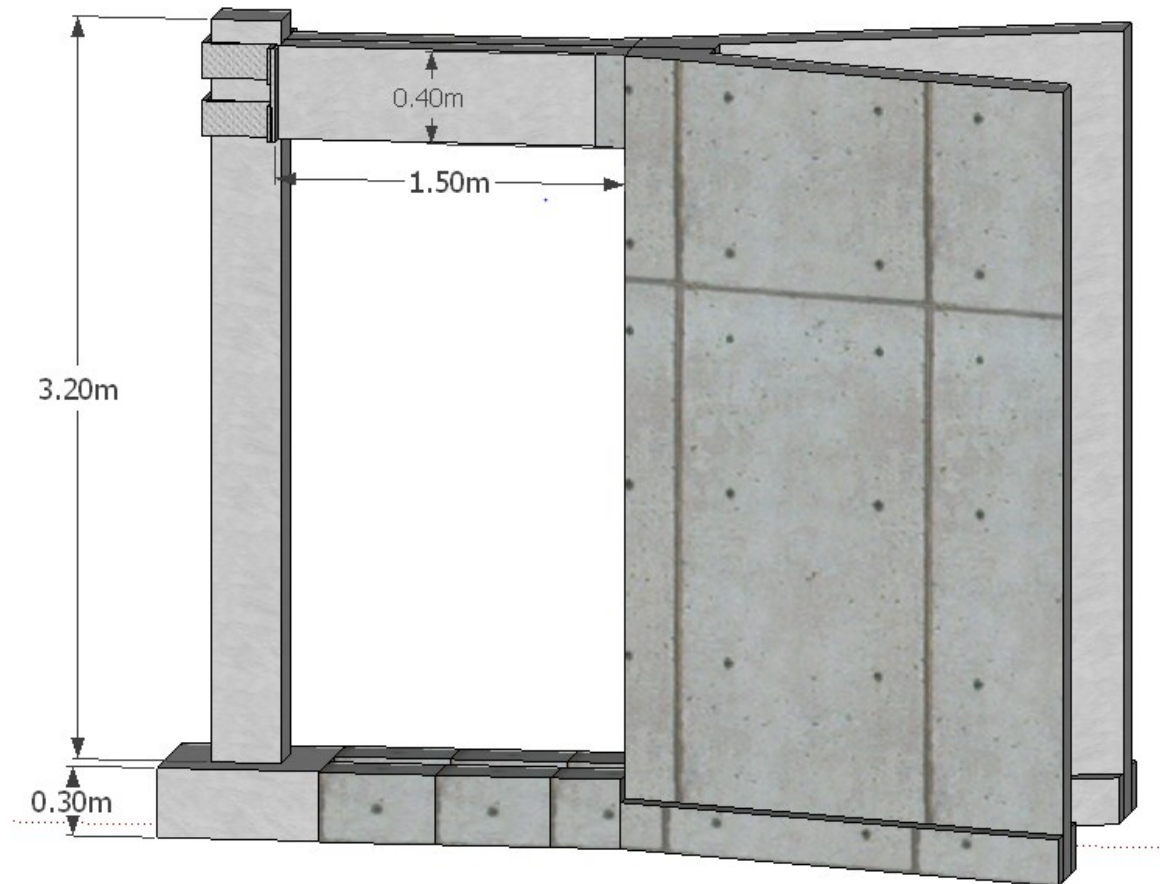
Figure 3-1: A modeled support structure with column affixed

Threadbar was stressed to 527.5 kN resulting in a precompression of 3.20 MPa in the support structure. Ancillary testing on concrete cylinders cast with the support structures gave a 28-day compressive strength of 80.3 MPa.

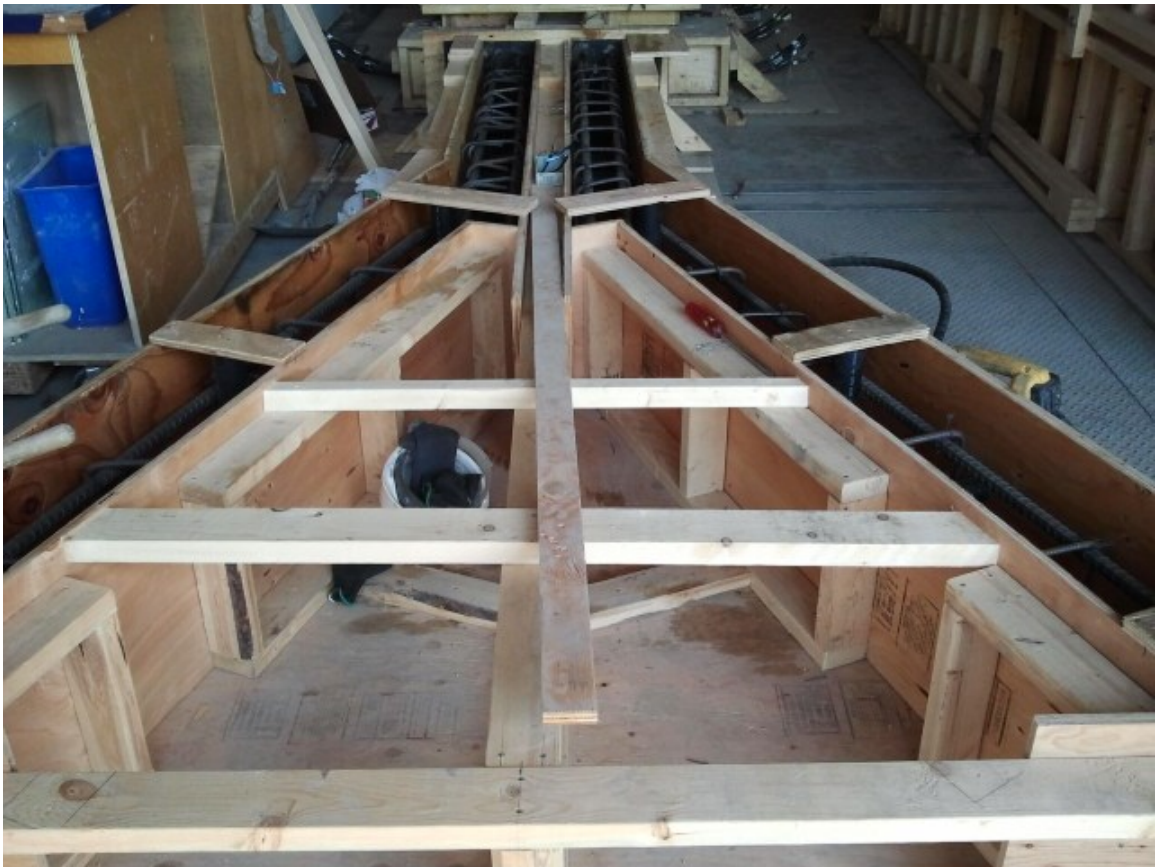
Figure 3-4: Formwork of support structure’s cantilevered Y-section

A reusable formwork was built for the purpose of constructing the support structure. Considering the height of the support structure (3.4 m), the formwork was divided into a four (4) paired sections, resulting in eight components for each support structure. The paired sections were designed and built to have “V” and “Y” shapes. These shapes, cast in pairs, made it easier to assemble the components. 19-mm thick plywood was cut to appropriate shapes and sizes and assembled using 51-mm screws and a hand drill. 38×89 mm wood studs were also cut to size with a circular saw and used to brace the 19-mm thick plywood. The prepared formwork was oiled and the reinforcement cages placed in them before the concrete was poured (Figure 3-4 and 3-5).

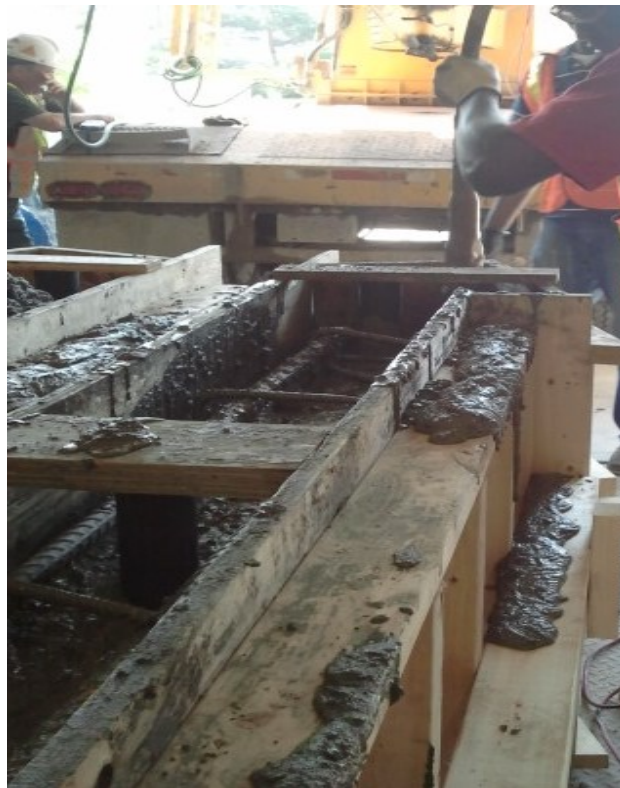
Casting of the various components for one reaction structure was completed before the second was cast after initial curing and removal of forms from the first. Concrete was poured into form of the various components using the hopper and the extensions on the chute of the concrete truck. A poker vibrator was used to ensure that the concrete pour is even, free from air bubbles as well as distribute aggregate uniformly to all edges and corners of the formwork (Figure 3-6). The concrete was covered with wet burlap and plastic sheating, 8 hours after casting, and wetted daily in accordance with ASTM C192/C192M-07. Forms were subsequently removed after 3 days in accordance with ASTM C192/C192M-07, and reassembled for the second support structure, while the burlap was kept in place and continued to be wetted daily. Five concrete cylinders were prepared in accordance with ASTM C192/C192M-07, to obtain the strength

Figure 3-6: vibration of support structure concrete during casting

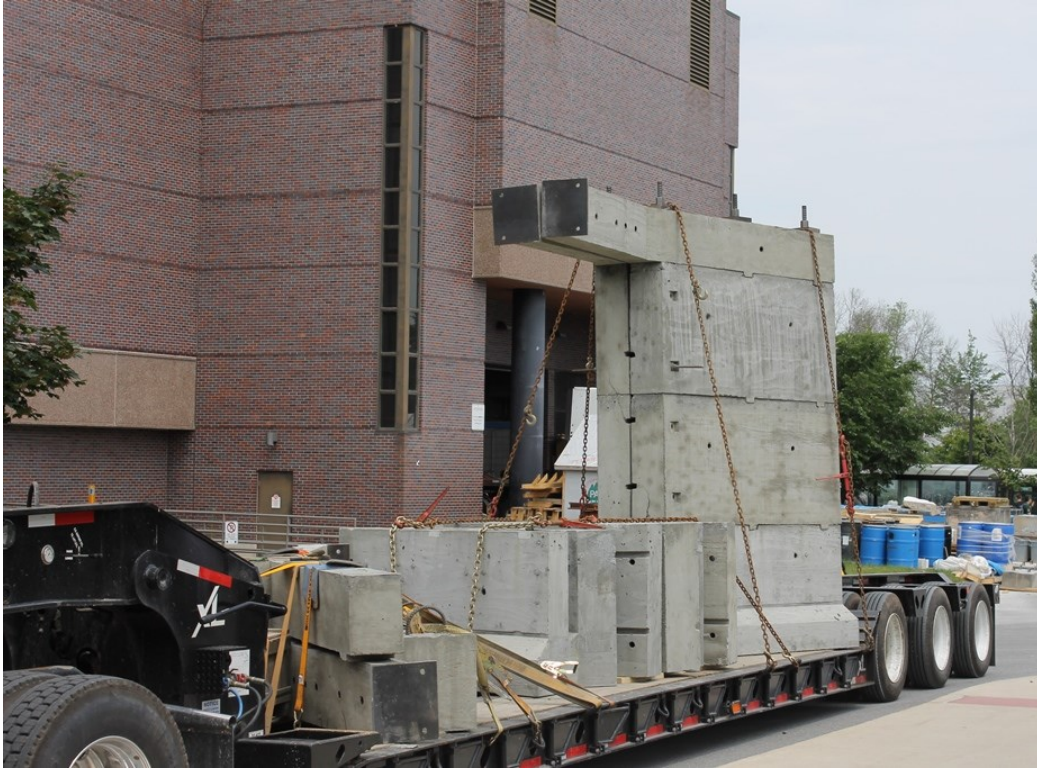
characteristics of the concrete. The components of the support structures were assembled using cranes and prestressed using a hydraulic jack. One of the support structures was assembled in the structures laboratory of Carleton University and transported to the site (Canadian Forces Base, Petawawa) while the second was assembled on site. Figure 3-7 shows the assembled support structure and components of other support structure ready to be transported to site.

Figure 3-7: Transport of support structure to site

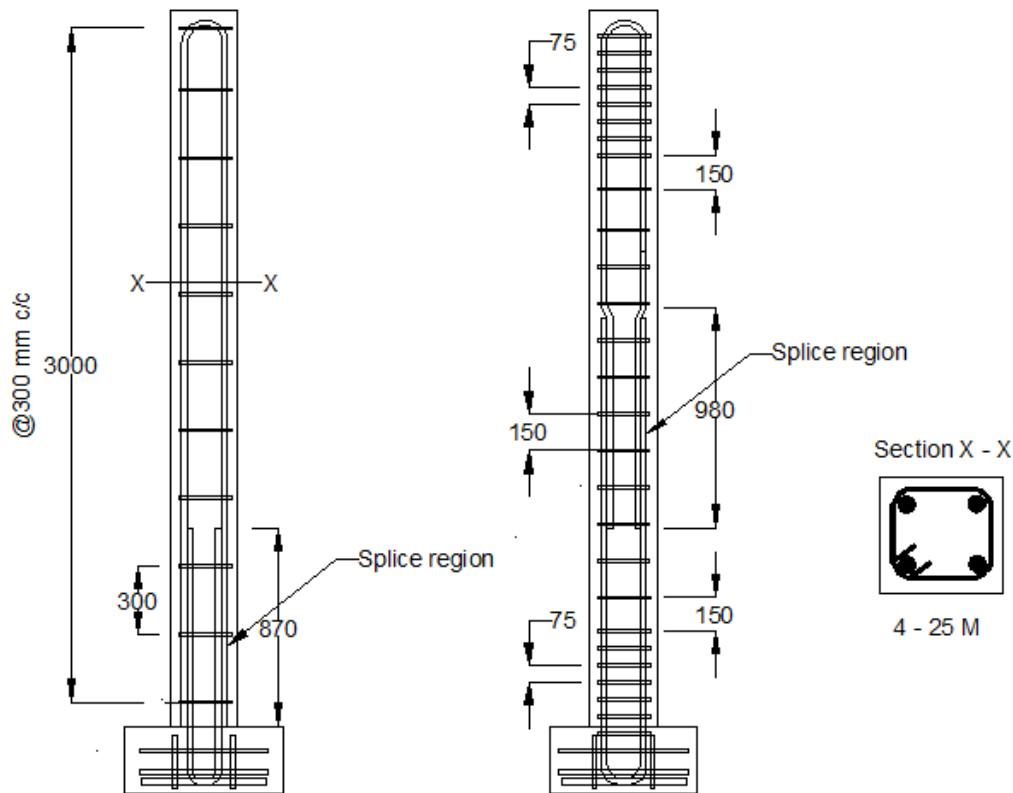
Figure 3-8: (a) Conventional column detailing (b) Seismic column detailing

also meets clause 21.7.2.2.5. Over the remainder of the column the tie spacing was taken to be 150 mm (Figure 3-8b) as per clause 21.7.2.1.3, this clause ensures that diagonal flexural crack must cross at least two ties. The rebar splicing is located at mid span of the column so as to ensure that the splice is well clear of the plastic hinge region of the column, this is in accordance with clause 21.4.3.2. The lap length is 980 mm (Figure 3-8). As all the columns were cast in two pours, the footing of each column contained bars with a 90° hook embedded in the footing. The bar then extends beyond the footing to lap with vertical (longitudinal) bars of the column. However, the location of the lap splice within the column differs between the two column types (Conventional and Seismic Columns). Both the Conventional and Seismic Columns had a 300×300 mm cross-section and a height of 3200 mm. The concrete columns had a concrete cover of 40 mm to the ties.

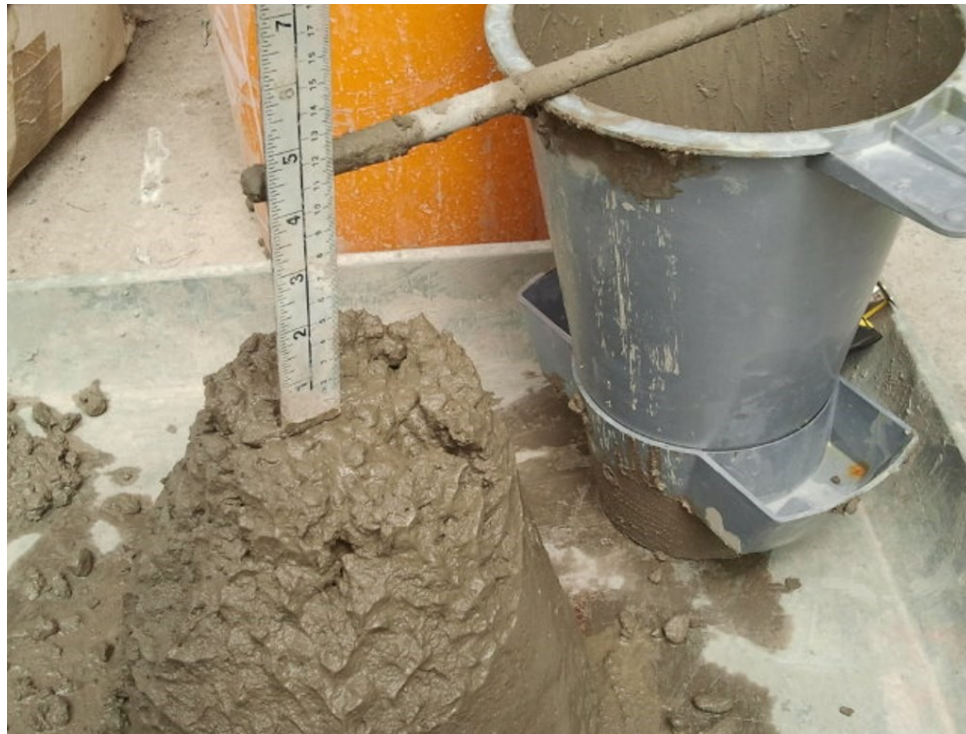
All the reinforced concrete columns were cast from the same concrete mix. A 28-day concrete compressive strength of 35 MPa was specified and a local concrete supplier designed the mix and supplied the concrete. The concrete mix had a limestone aggregate size of 10 mm. A slump test was performed in accordance with ASTM C143/C143M and was found to be 110 mm (Figure 3-9). Twelve (12) 100×200 mm concrete cylinders were prepared in accordance with ASTM C39/C39M-12a, and five (5) of these cylinders were tested on the twenty-eighth (28) day (Figure 3-10 and 3-11) to determine the compressive strength. The average compressive strength obtained for the column concrete mix was 41.3 MPa. Table 3-2 shows the results of the concrete compressive

Figure 3-9: Slump test of concrete mix

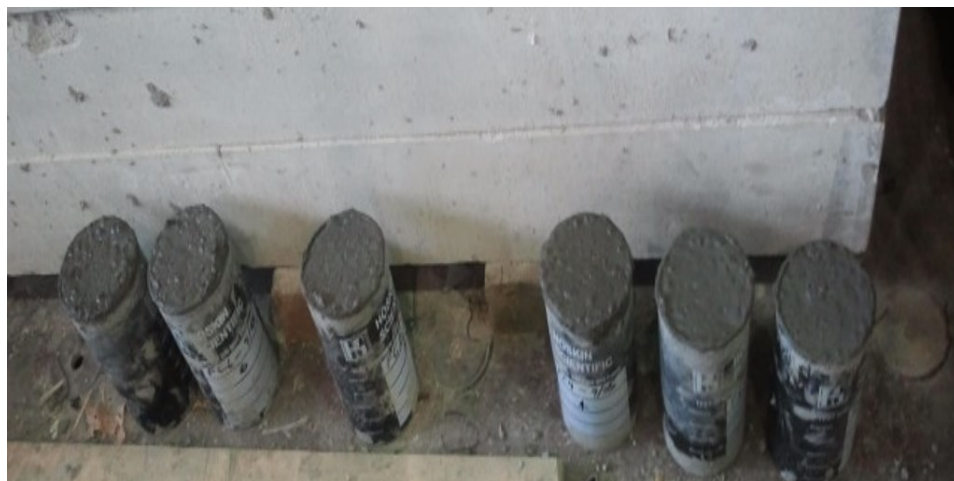
tests for the reinforced concrete columns. Similarly, two 100×200 mm concrete cylinders from the concrete mix of the support structure were prepared and tested in accordance with ASTM C39/C39M-12a. The average twenty-eight (28) day strength obtained was 80.3 MPa. Table 3-3 presents the results of the concrete compressive strength test for the support structure.

Figure 3-10: Sample of concrete cylinders

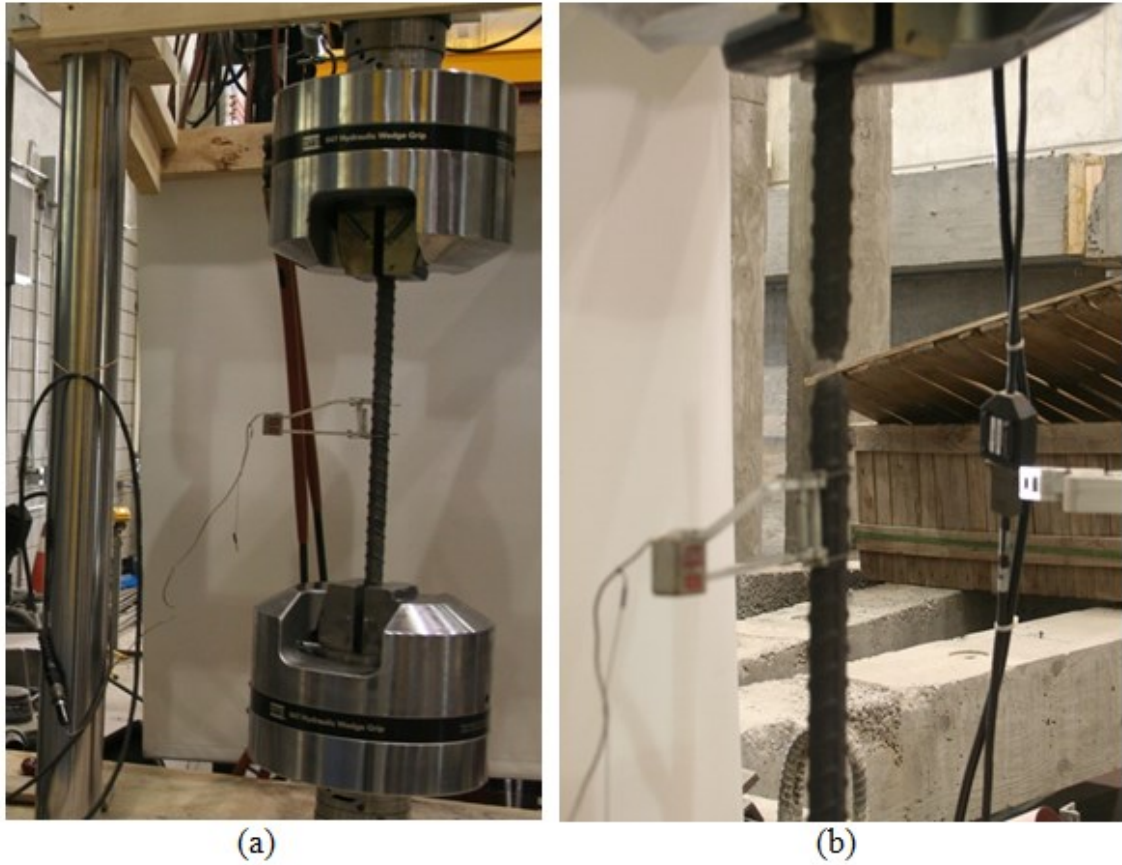
Figure 3-12: Tension test for 25M rebar (a) before necking (b) after necking

Tension test specimens were sampled from the longitudinal and transverse steel reinforcement (25M and 10M), used in constructing the reinforced concrete columns and support structures, and tested in accordance with ASTM E8/E8M-09 in an Instron testing machine (Figure 3-12). The yield strength obtained from the 10M (11.3 mm diameter) transverse reinforcement test was 465.2 MPa at a yield strain of 0.0022. The yield strength obtained from the 25M (19.5 mm diameter) longitudinal steel reinforcement test was 474.4 MPa at a yield strain of 0.0024. Table 3-4 and Table 3-5 show the strengths (yield and ultimate) and the strain values of the transverse and longitudinal steel reinforcements, respectively. Figure 3-13 presents a typical stress-strain curve for 10M rebar, and Figure 3-14 presents a typical stress-strain curve for test 25M rebar.

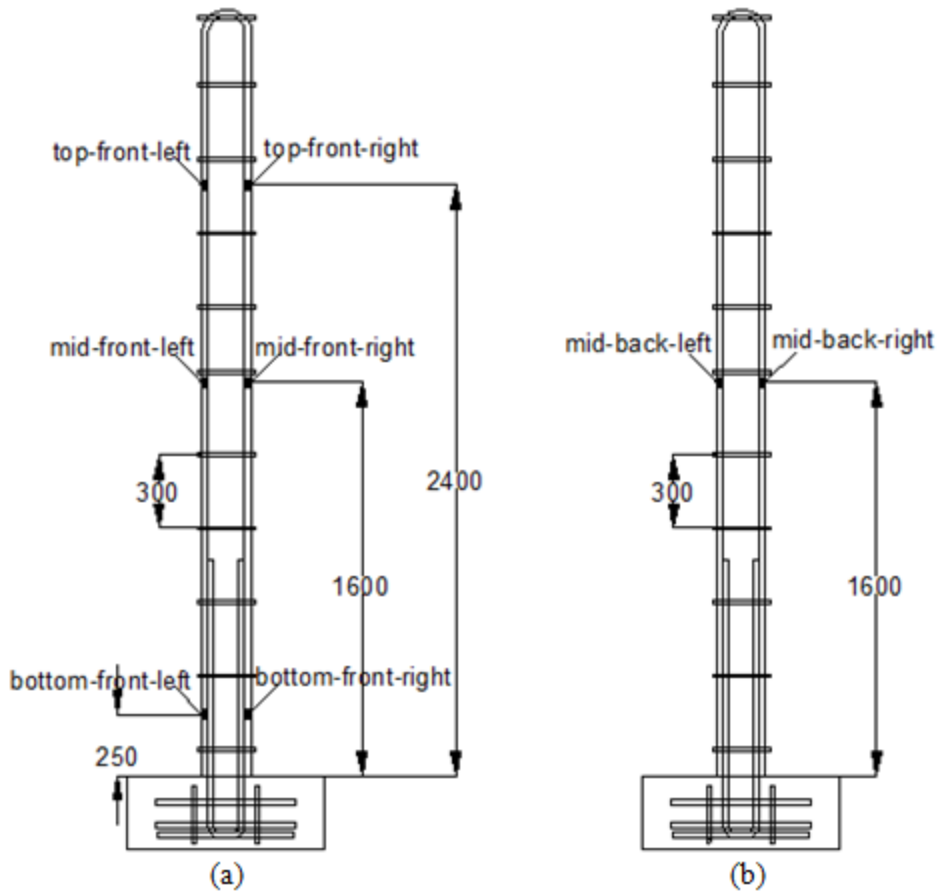
Figure 3-15: Strain gauge positions for both (a) frontal face and (b) rear face for a typical conventional cage

The strain gauges were tested using a multimeter to check that the resistance readings from the gauges was 350Ω . The leads from the strain gauges were lengthened to about 100 m to enable connection to the data acquisition system.

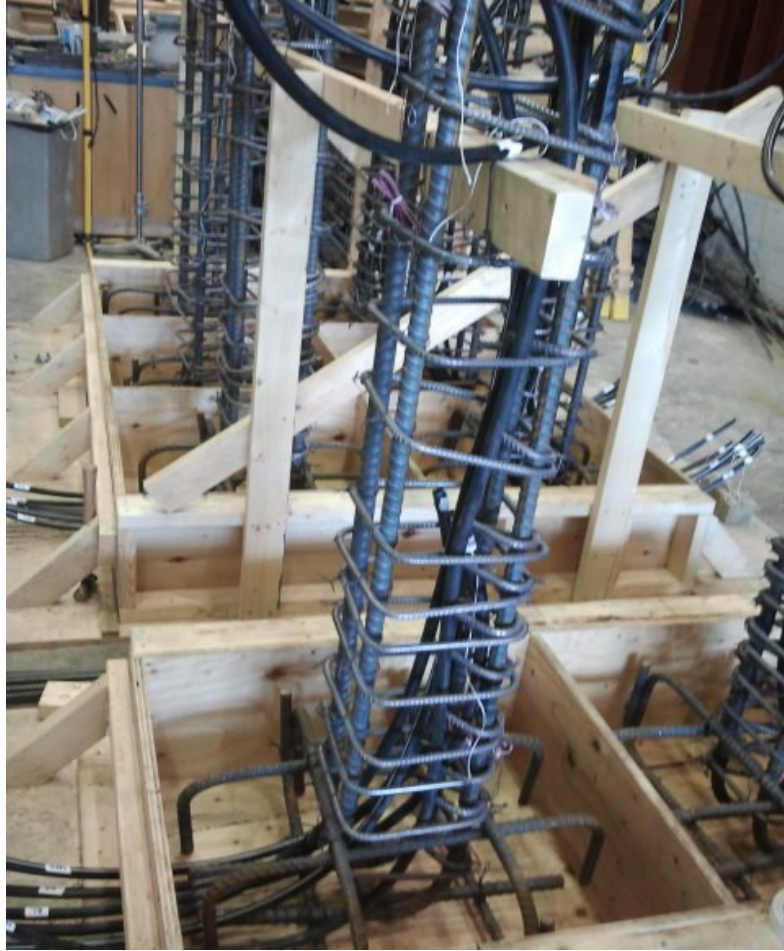
Figure 3-17: Column footing formwork with cages placed inside

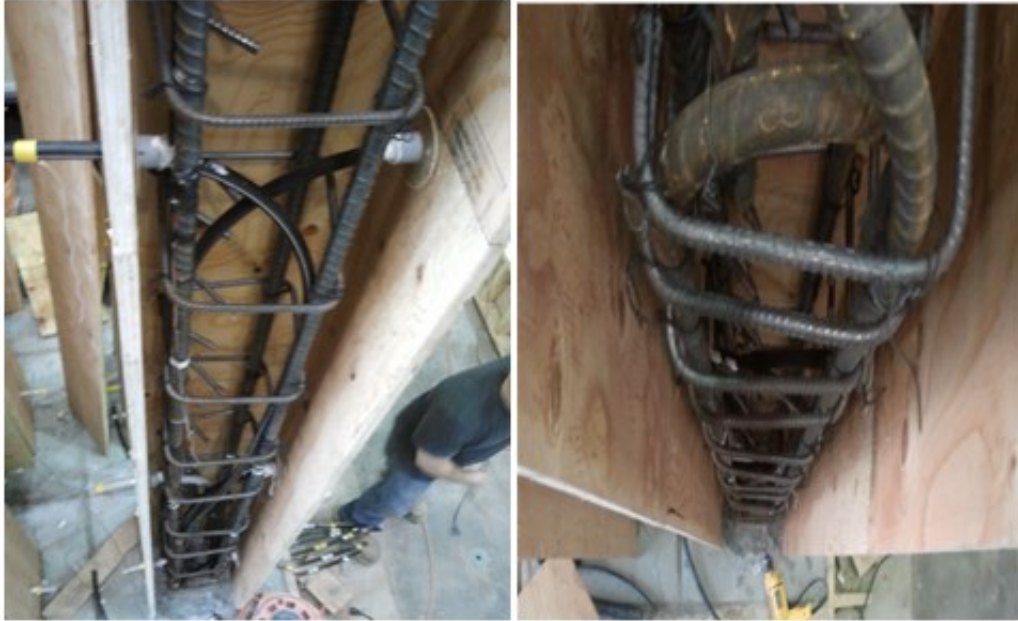
The formworks for the columns were constructed similar to that of the footing. 19-mm thick plywood and 38×89 mm wood studs were used. The 19-mm thick plywood was cut into rectangular shapes of 3.2×0.34 m and 3.2×0.3 m with the aid of a circular saw. Three holes (19 mm diameter) were formed along the longitudinal line of symmetry of the 3.2×0.34 m and 3.2×0.3 m rectangular plywood. These holes were positioned at the bottom, mid-height and top of the column to accommodate the pressure gauge on each column. A disc of 90-mm diameter was nailed to the plywood at the location of the holes. This was to provide the inserts for the pressure gauges, while the gauge cables run through a flexible tube within the centre core of the column (Figure 3-18a). The 3.2×

0.34 m and the 3.2×0.3 m plywood were assembled to form a channel shaped formwork. The formwork was then oiled and placed around the reinforcement cages (Figure 3-18b). The channel shape was then closed by a 3.2×0.3 m rectangular plywood to complete the 300×300 mm by 3.2 m high column formwork (Figure 3-19a). 38×89 mm wood studs were cut to lengths of 340 mm and 300 mm. 102-mm screws were used with the aid of a hand drill to form L-shaped 38×89 mm wood elements, which were screwed to the formwork in order to increase their stiffness. A spirit level was used to ensure that the columns were vertical and plumb. This verticality was maintained by bracing the columns with 38×89 mm wood ties (Figure 3-19b) before the concrete pour took place.

Figure 3-18: Column formwork placed around reinforcement cage

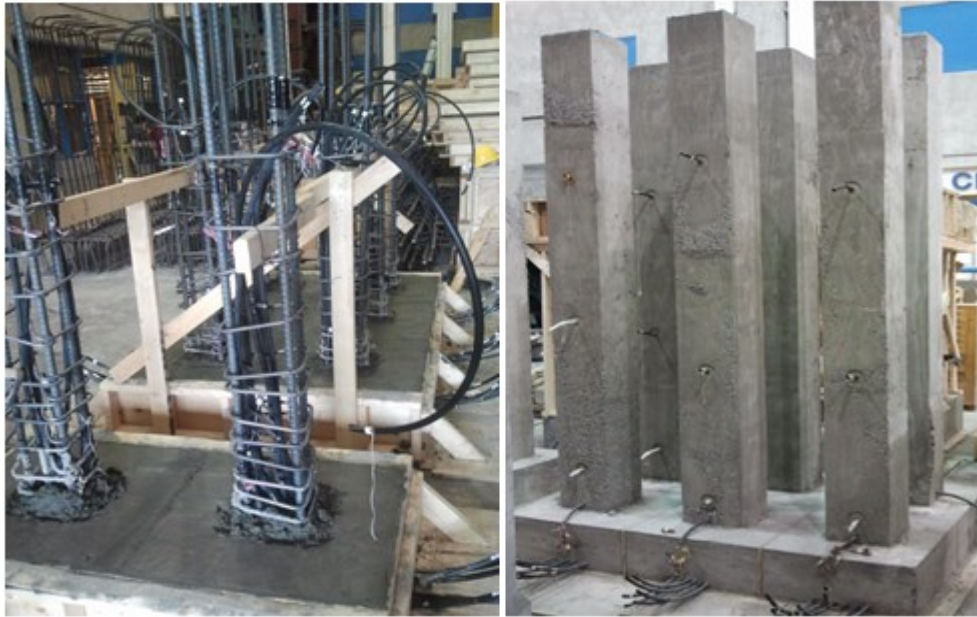
Column footings were the first to be cast (Figure 3-20a). The concrete was poured into the forms of the footings using the hopper and extensions on the chute of the concrete mixing truck. A concrete poker vibrator was used to ensure that the concrete pour was even and free from air bubbles as well as distribute aggregate uniformly to all edges and corners of the formwork. The concrete surface was covered with wet burlap and plastic sheets, 8 hours after casting, and wetted daily in accordance with ASTM C192/C192M-07. After the footings were cured for fourteen (14) days, the column reinforcement cages were lapped to the kicker (starter) bars from the footings and the column forms placed around them. Concrete was then poured into the column forms using the hopper and extensions on the chute at the back of the concrete mixing truck. A concrete poker vibrator was used to vibrate the freshly poured concrete in order to ensure that no honey combs developed within the column. The concrete surface was covered with wet burlap and plastic sheets, 8 hours after casting, and wetted daily in accordance with ASTM C192/C192M-07. Twelve (12) 100×200 mm cylinders were also cast from the concrete used for the columns in order to obtain the strength characteristics of the concrete. These concrete cylinders were prepared in accordance with ASTM C192/192M-07. The column forms were removed 24hrs after casting, while curing of the concrete continued for fourteen (14) days (Figure 3-20(b)).

Figure 3-20: (a) Column footings and (b) Concrete columns

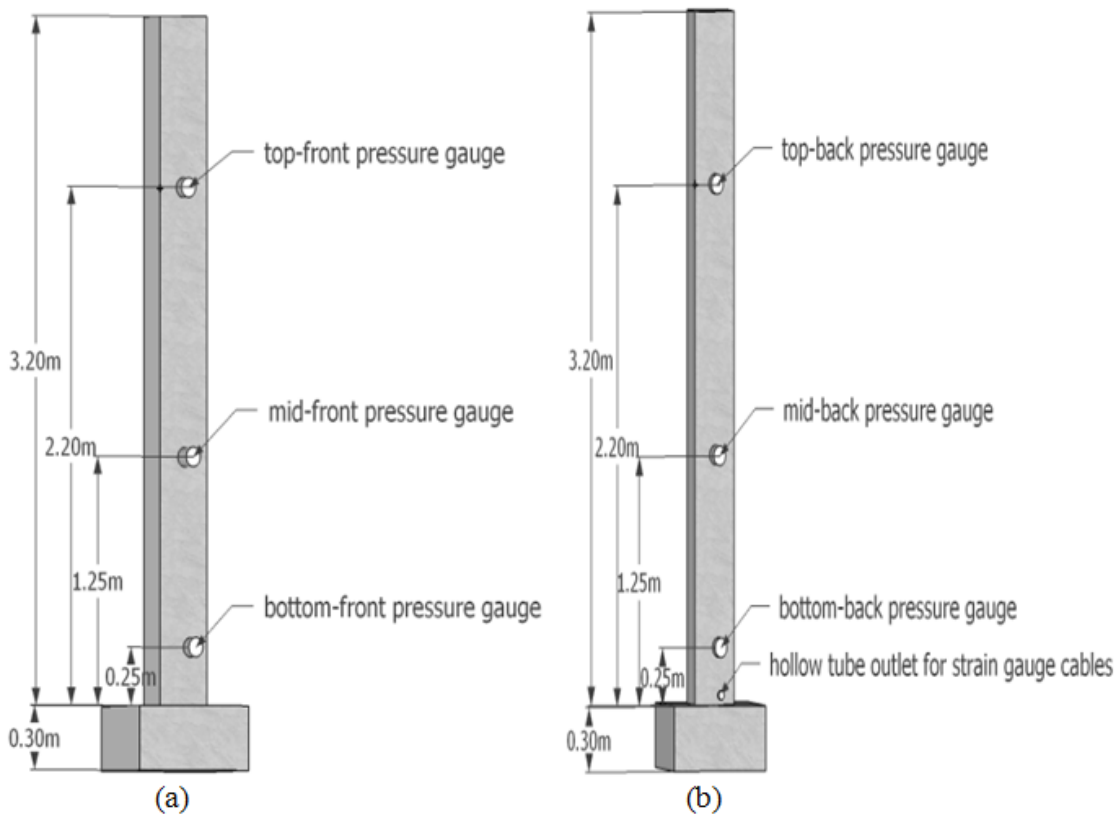
Figure 3-22: Pressure gauge locations for; (a) Front face of column and (b) Rear face of column

Each column was instrumented with PicoCoulomb (PCB) piezotronics model 481 pressure gauges to record the blast pressure time history along the height of the column during field testing. Six (6) pressure gauge inserts were provided for each column. The pressure gauge locations varied slightly from column to column, but were generally located at the bottom, mid-height and top of the front and rear faces of the columns. Figure 3-22 shows the locations of the blast pressure gauges and the nomenclature adopted for their identification. Table 3-7 shows the positions of pressure gauges for each column.

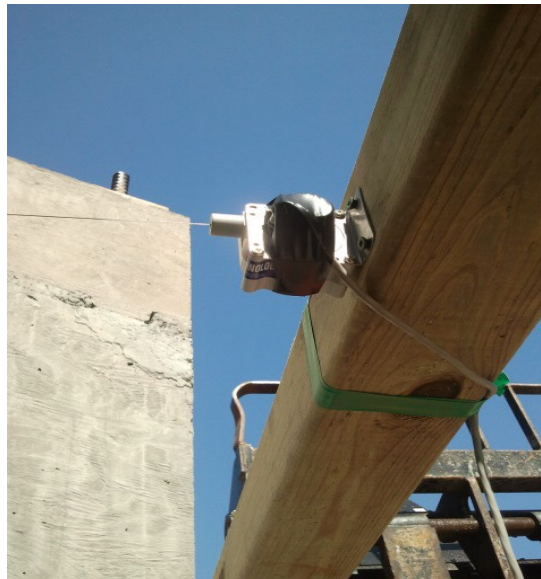
Figure 3-23: Transducer mount on 89×89 mm wood stud

housing, a stainless steel cable is wound on a precisely machined constant diameter cylindrical spool that turns as the stainless steel cable reels and unreels. Figure 3-23 is a photograph of a transducer mounted on an 89×89 mm wood stud attached to the support structure.

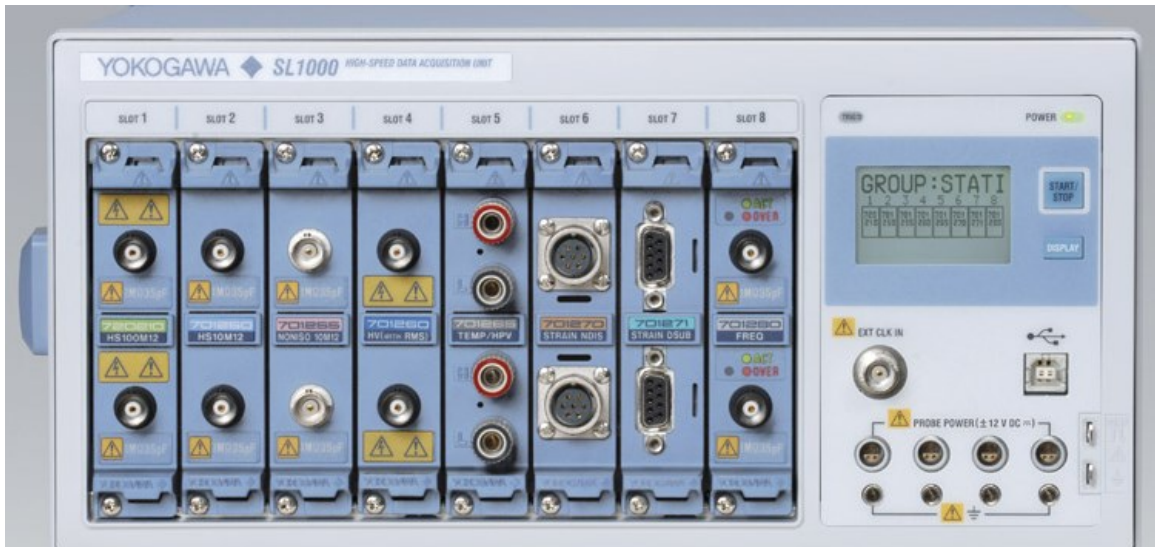
A high speed data acquisition system (Yokogawa SL1000 model) was used to sample test data at 100 MHz. Though Yokogawa SL1000 can work as a standalone data acquisition unit, it was connected to a personal computer and the data backed up onto the hard disk of the computer. Sixteen (16) input-channels recorded strain reading, twelve (12) input-channels recorded pressure readings, and Six (6) input-channels recorded displacement readings. A fibre optic cable placed in the explosive was used to trigger the data acquisition system. A high speed video camera, NAC Memrecan GX-8, was also used to capture images of the explosions for each test. The same trigger signal was also sent to

The NAC Memrecam GX-8 to start recording simultaneously. Figure 3-26 and Figure 3-27 show photographs of SL1000 and NAC Memrecam GX-8 respectively.

Figure 3-26: Photograph of Yokogawa SL1000 data acquisition system

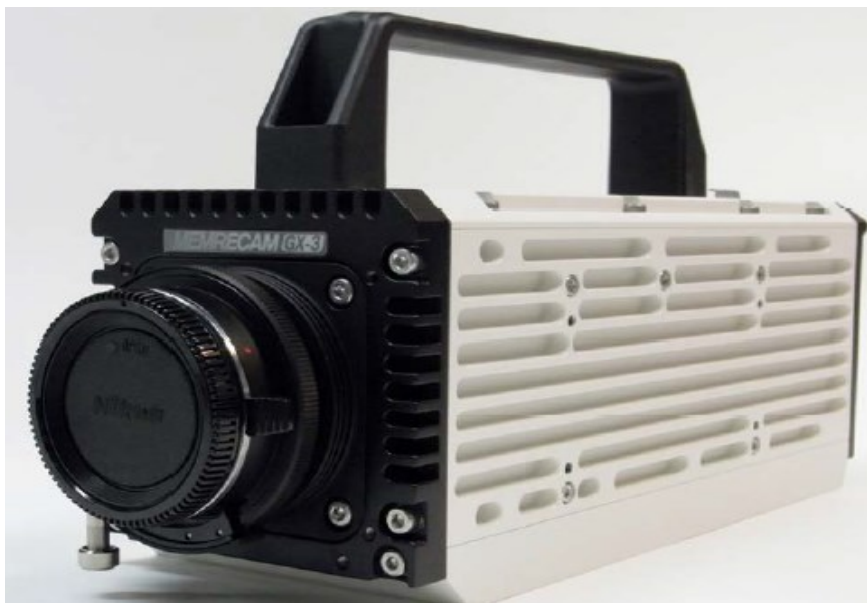
Figure 3-27: NAC Memrecam GX-8

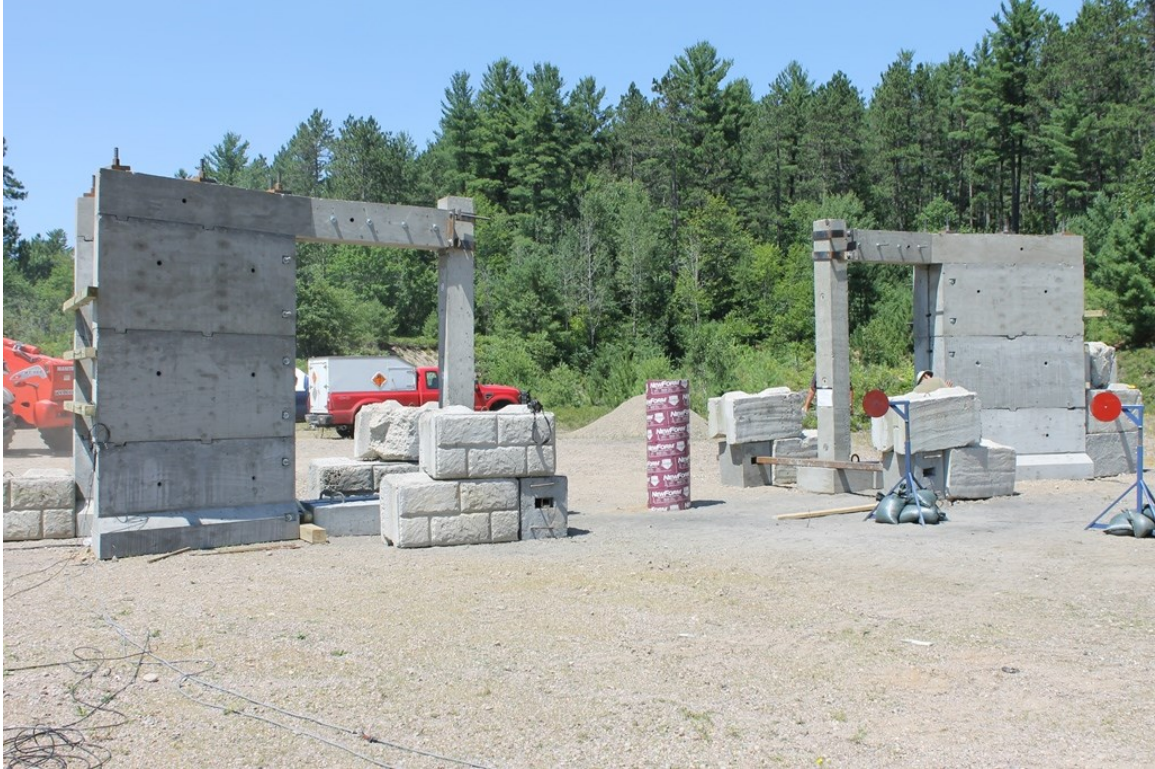
Figure 4-2: Photographs of columns (CONV-7 and SEIS-8) prior to explosion

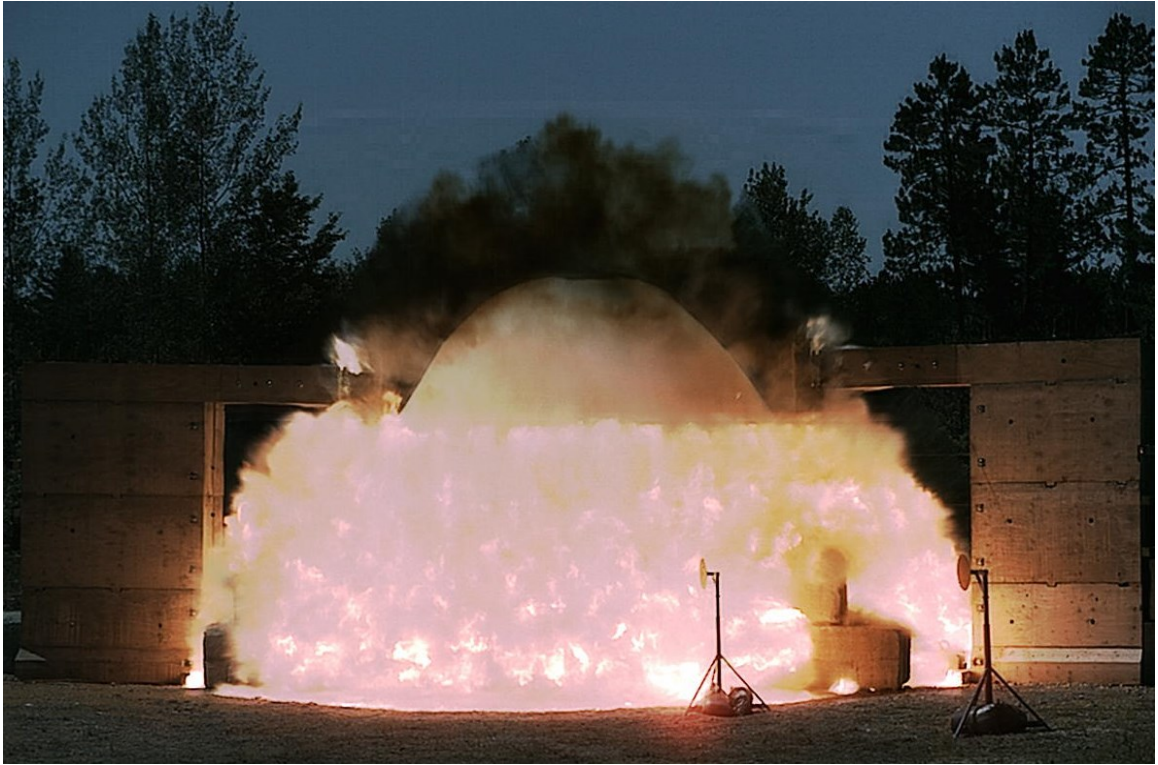
Figure 4-3: Photograph of columns engulfed in the fireball

After detonation of the ANFO explosive, the fireball engulfed the reinforced concrete columns and support structures. Thus, the video recording did not show response of the columns (Figure 4-3), however, the evolution of the blast pressure and fire ball was captured. Figure 4-4 shows a typical blast wave (fireball) evolution during the test.

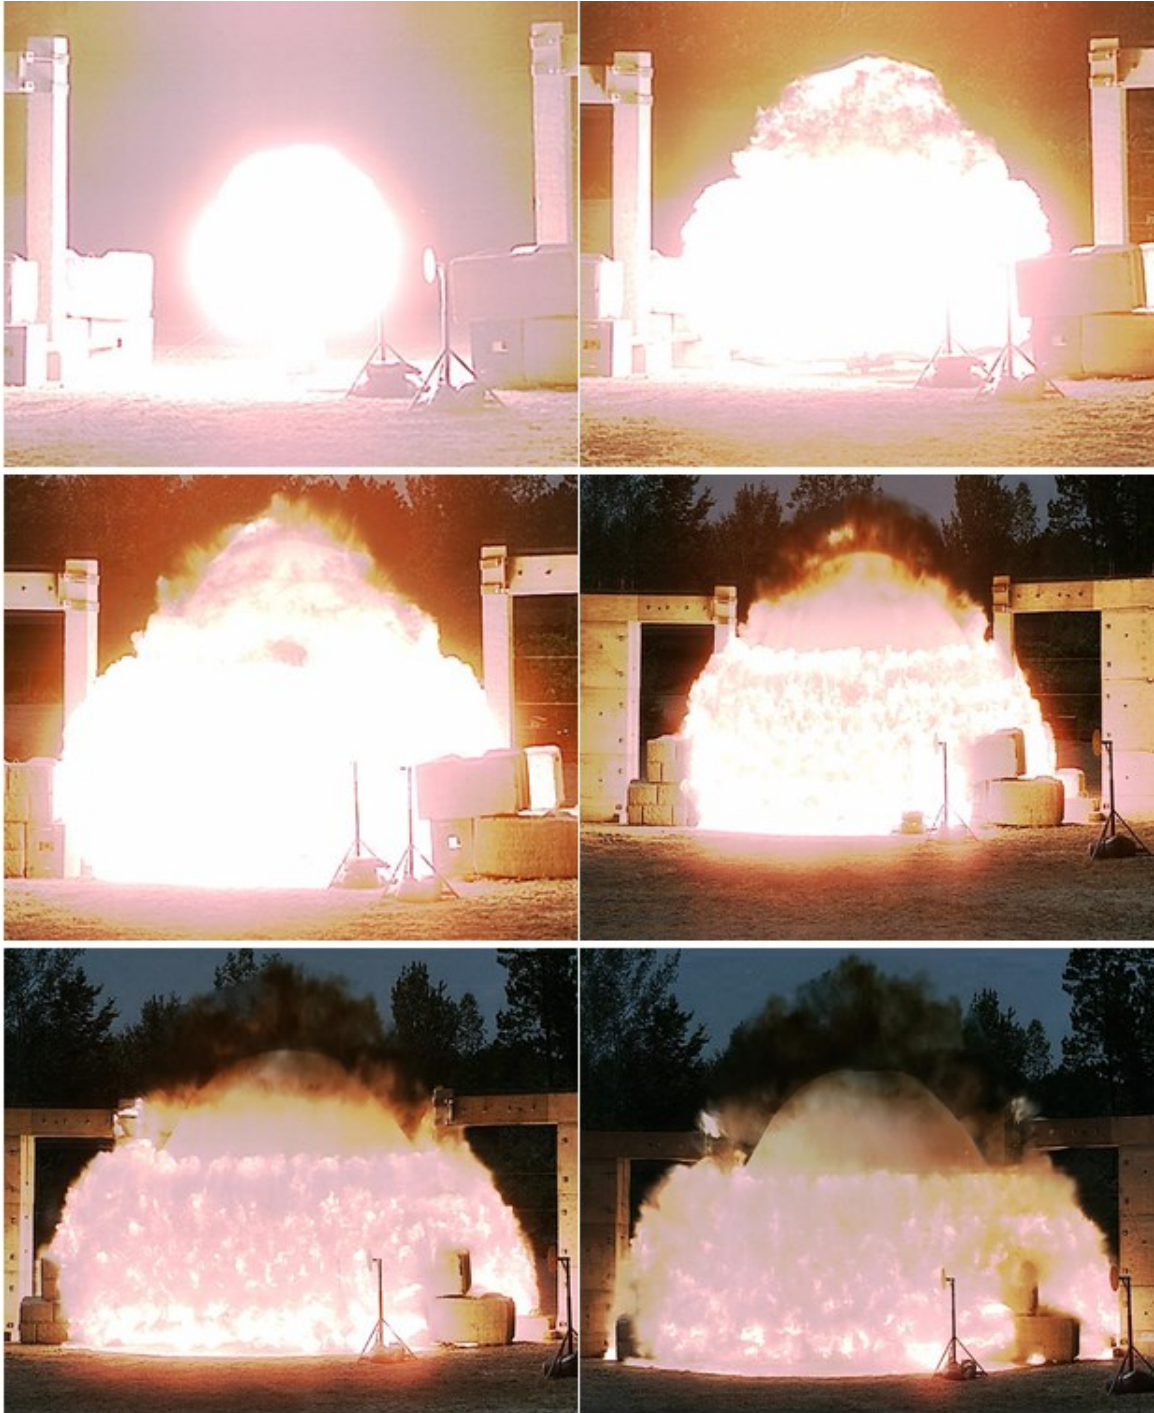
Figure 4-4: Blast wave propagation

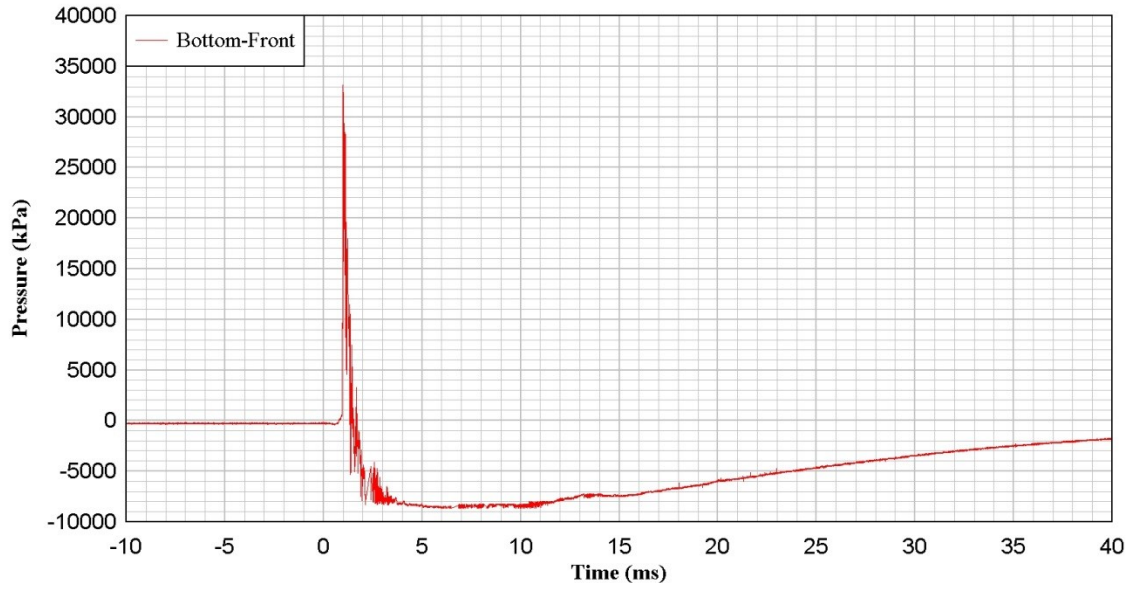
Figure 4-5: Blast pressure profile for Column CONV-7 and SEIS-8 (Bottom front)

The prime objective of Test 1 was to test out the data acquisition system. The data acquired was good except for the damage of the mid-front pressure gauge and one string pot as well as no meaningful data recorded by the strain gauges.

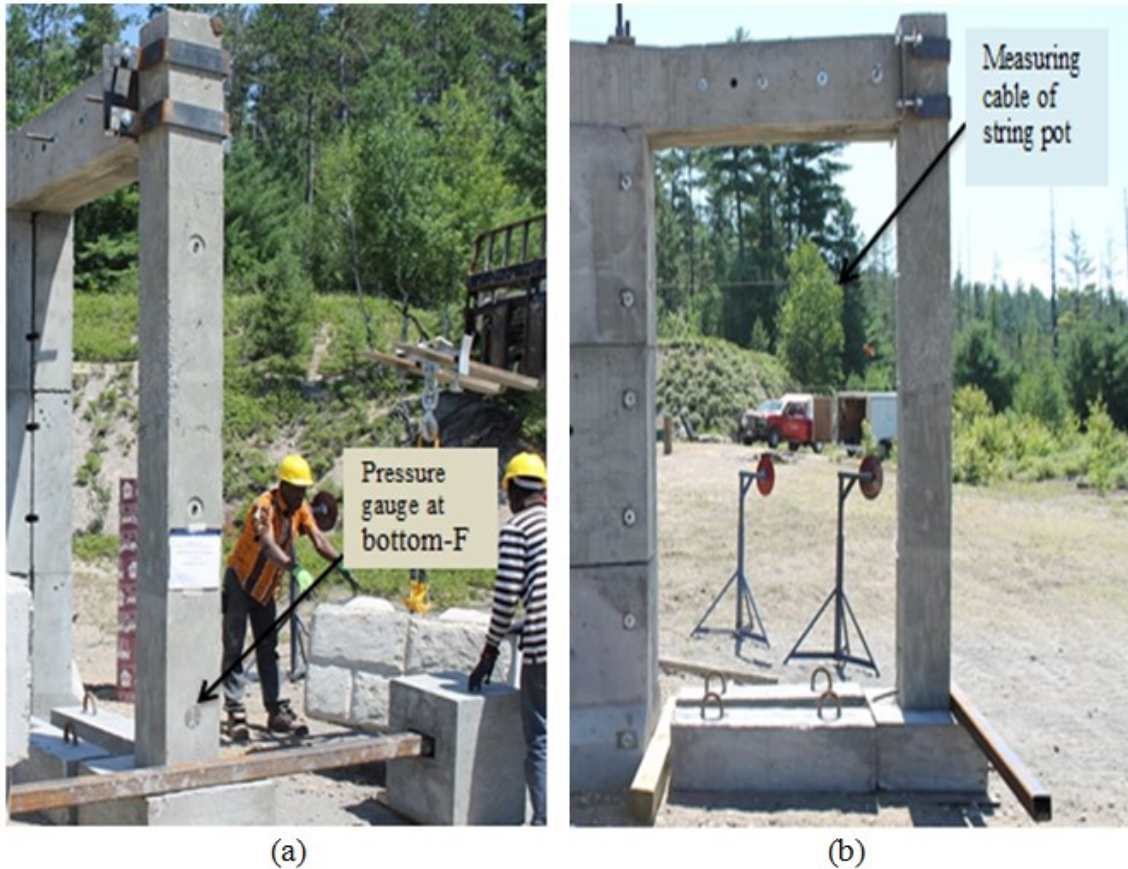
Figure 4-11: Photograph of Column CONV-7 showing; (a) pressure gauge location (b) measuring cable of string potentiometer at 2 m from the base of the column

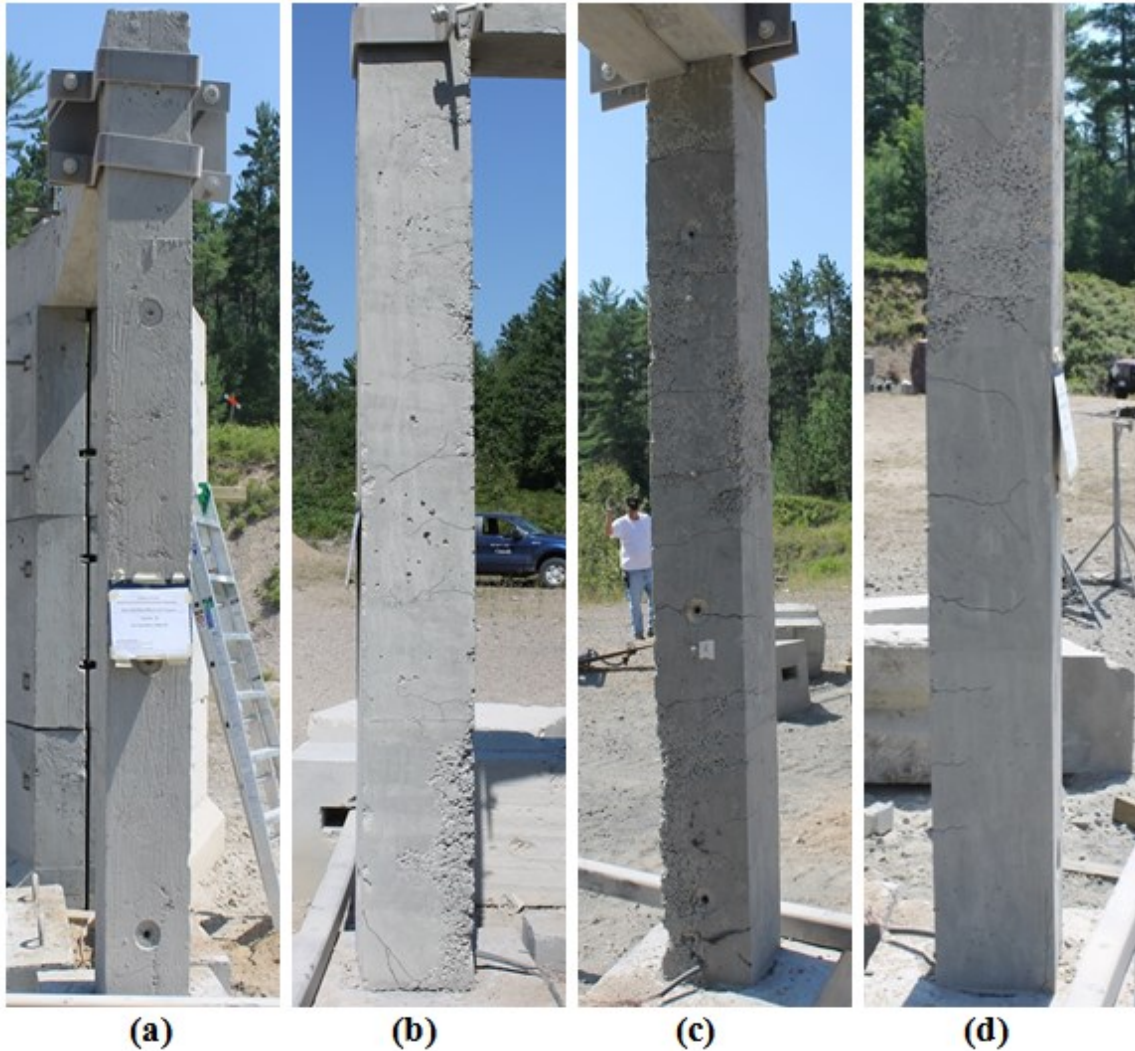
Figure 4-13: Post-test photograph of Column CONV-7 faces: (a) Front face, (b) Side face (right), (c) Back face, an (d) Side face (left)

Figure 4-13 presents the post-test photographs of faces of column CONV-7. No concrete spall on any face nor visible residual cracking was observed on the front face (Figure 4-13(a)). Flexural cracking was however observed on the back face (Figure 4-13(c)) and sides (Figure 4-13(b) and 4-13(d)) of the column. These cracks were mainly in the mid-height region where maximum moment was expected on inbound blast loading. Interestingly, no flexural cracking was observed on the front face towards the ends of the column where maximum moments due to inbound blast loading was expected. This observation could be indicative of the lack of restraint at the ends of the column.
