Near-Field Explosion Effects on Reinforced Concrete Columns: An Experimental Investigation

Master of Applied Science

Civil Engineering

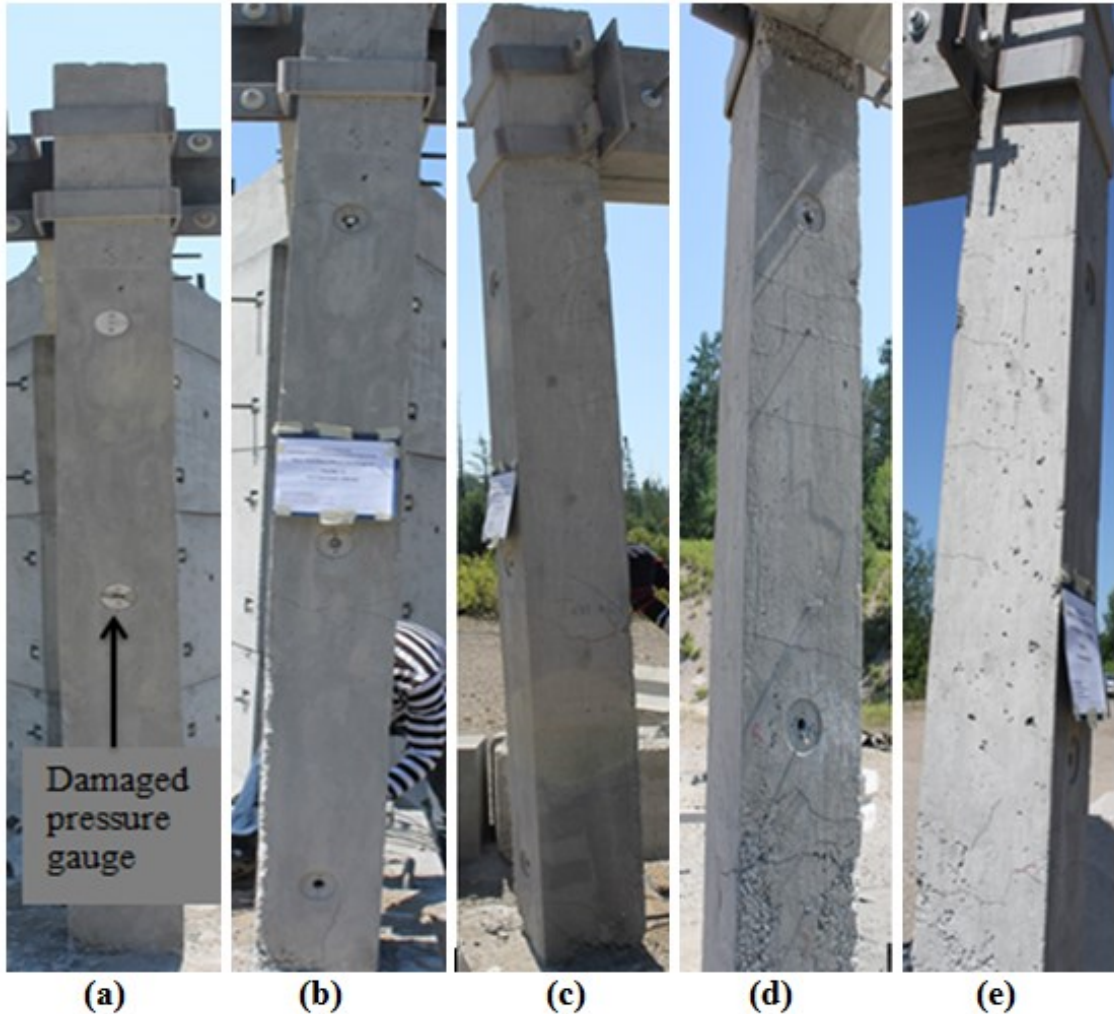
Figure 4-16: Post-test photograph of Column SEIS-8 faces: (a, b) Front face, (b) Side face (right) (c) Back face, ad (d) Side face (left)

observed that, mid-front pressure gauge (Figure 4-16(a)) on column SEIS-8 got damaged during the test as such no blast pressure data was recorded for at this location. While the other gauges produced data, some of them were spurious and could not be used. In order to elevate the charge to a height of burst of 1.0 m, the sonotube used to contain the ANFO explosive was pre-filled with sand to a pre-determined height and then the explosive added to fill the sonotube to the top. The ratio of the diameter of the sonotube to the height of explosive was 1:1. This was to simulate shape of a spherical charge to produce uniform spherically expanding shock front. To a larger degree, this was achieved (see Figure 4-4) however, upon detonation the sand was dispersed and thrown from the centre of detonation. It is suspected that the sand cloud striking the pressure gauges lead to the spurious data read from some of the pressure gauges.

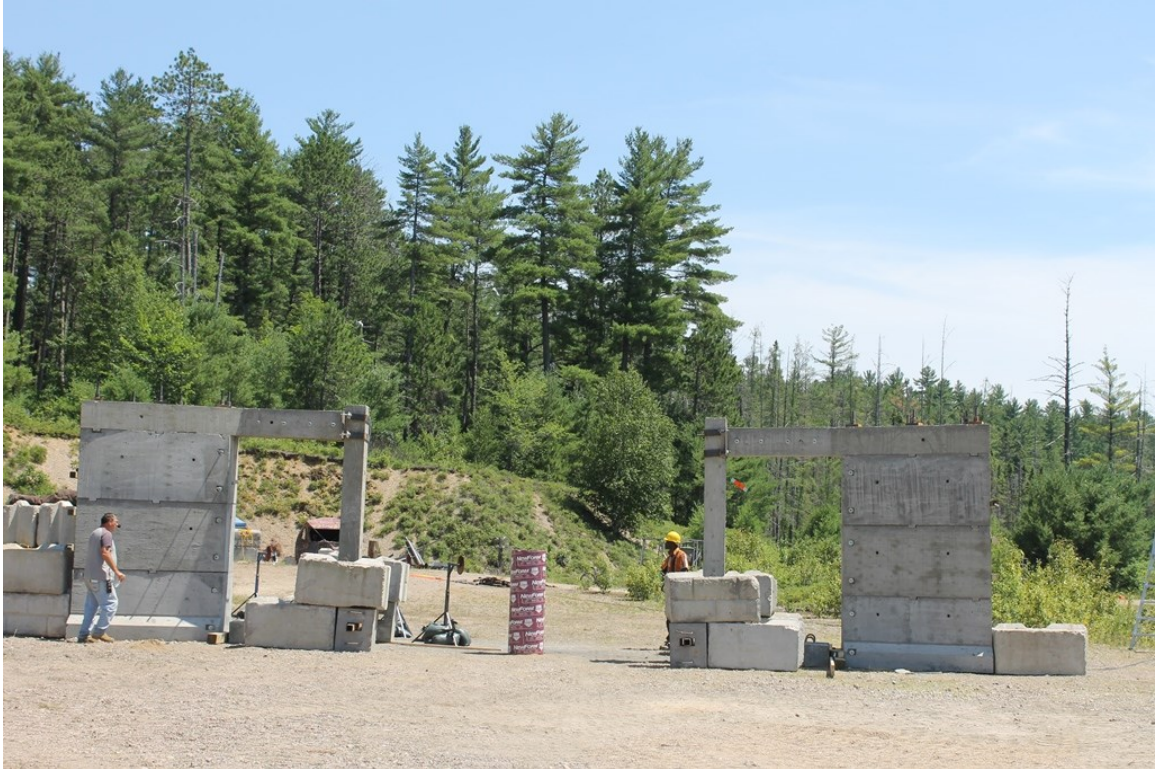
Figure 4-18: Pre-test setup of Test 2 (SEIS-9 and CONV-20)

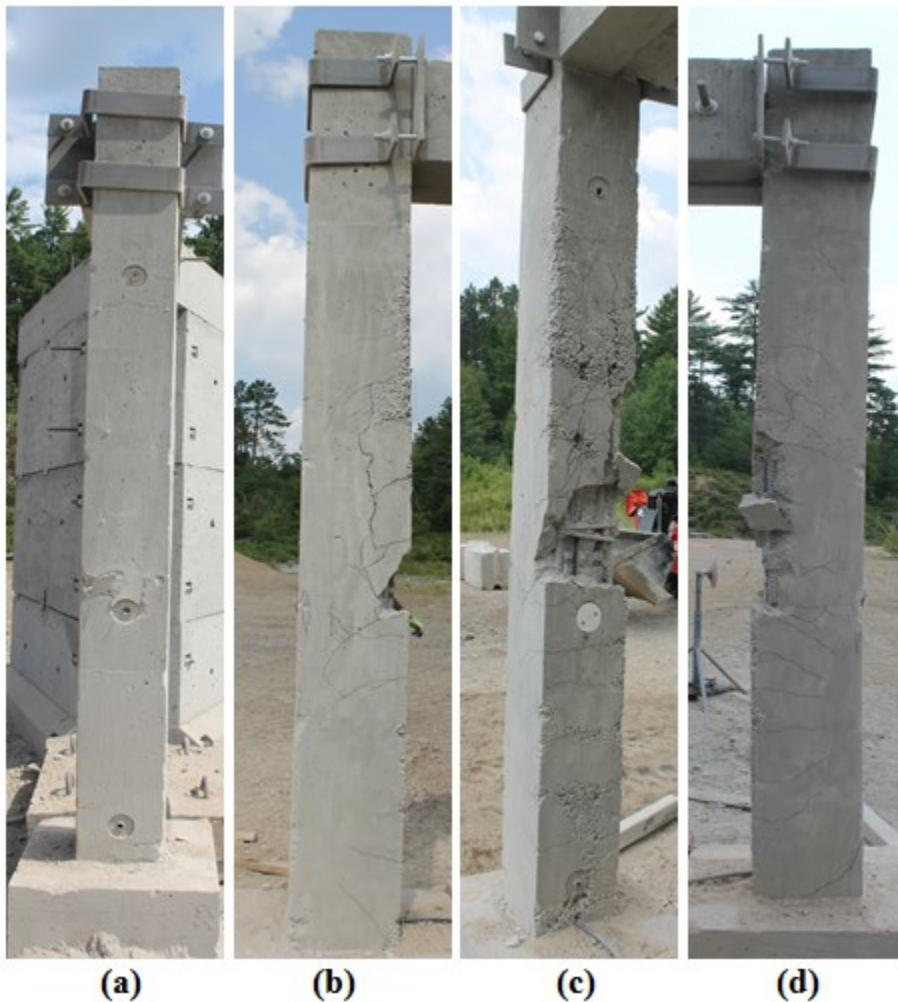
Figure 4-25: Post-test photograph of Column SEIS-9 faces: (a) Front face, (b) Side face (right) (c) Back face, and (d) Side face (left)

Figure 4-25 presents the post-test photographs of SEIS-9. Severe flexural cracking and spalling of the concrete at mid-height were observed (Figure 4-25(c)). The height of spall is 660 mm, with a depth of 140 mm. There were also minimal shear cracks in the lower bottom (near the support) of the column (Figure 4-25(b) and (d)). Because of lack of cracking at top support in comparison to bottom, it appears there was higher fixity at the bottom support. Along the entire height of column, flexural cracks occurred at the back and sides of the column (Figure 4-25(b), (c), and (d)).

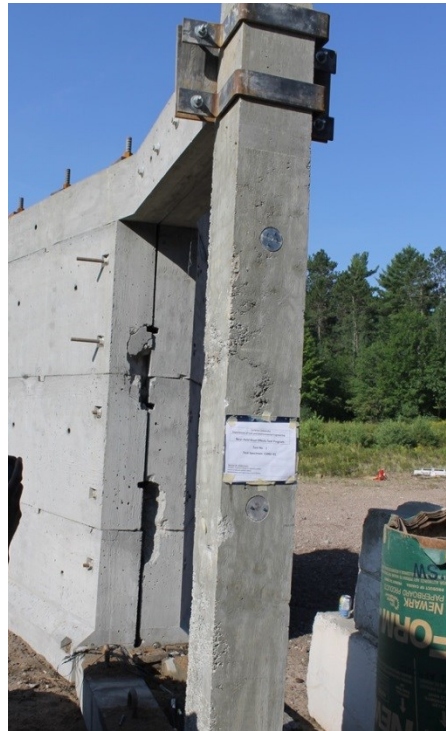
Figure 4-26 shows a photograph of column CONV-20 prior to testing, while Figure 4-28 shows post-test photographs of column CONV-20 with extensive cracking and spalling of concrete revealing reinforcement in the lower one-third region of the column. Buckling of the 25M rebar in the back face of the column was observed. Minimal flexural cracks were also observed on the column. These cracks were wider on the back face and sides of the column (Figure 4-28(b), (c), and (d)). The spalling and cracking of concrete in the lower part of the column, close to the concrete footing, likely led to the damage of the bottom-front pressure gauge. The maximum displacement of 14.3 mm of CONV-20 was measured at mid-height (Figure 4-27).

Figure 4-26: Photograph of column CONV-20 prior to test

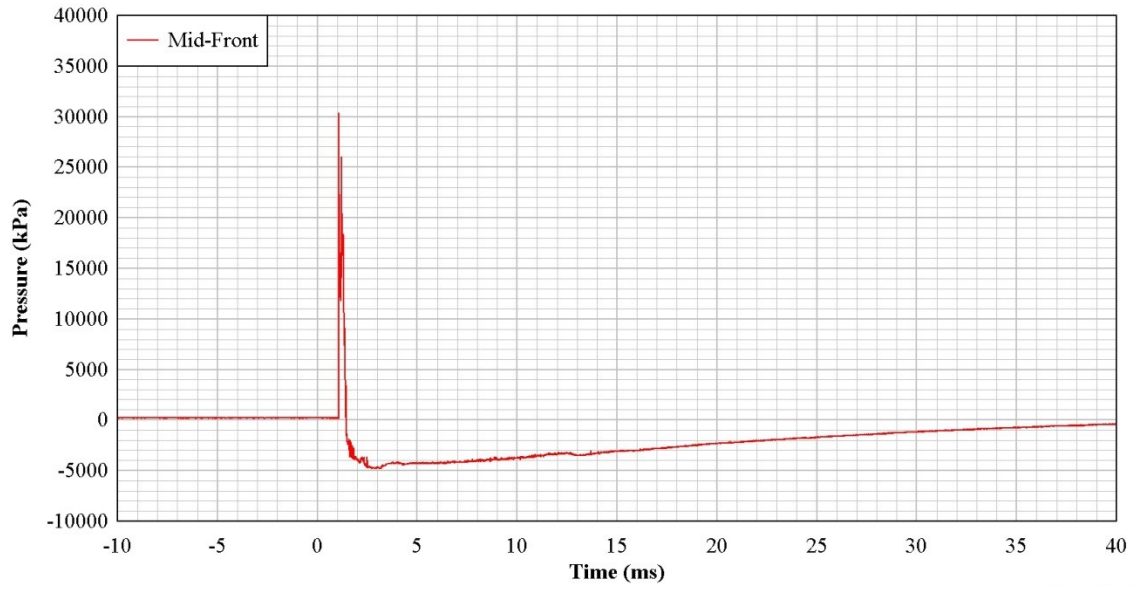
Figure 4-30: Blast pressure profile for Column CONV-6 and CONV-10 (mid-front pressure gauge)

Figure 4-30 and Figure 4-31 present the blast pressure profile at the mid-front and top-front respectively. When the 150-kg ANFO was detonated, the blast wave arrived at the mid-front face of the column at 1.09 ms with peak pressure of 30,376 kPa (Figure 4-30). The wave arrived at the top-front gauge at 1.40 ms with a peak pressure of 8,796 kPa (Figure 4-31). The pressure gauges at the bottom-front and mid-back face of the column failed during the test, as such no data was recorded for at these locations. Free-field pressure gauges were used to record the incident overpressure remote from the centre of detonation. Figure 4-32 presents the experimental free-field incident pressure profile at standoff distances of 10 m and 20 m. The incident overpressure at 10 m was 273 kPa with an arrival time of 8.05 ms, while the incident overpressure at 20 m was 80.6 kPa with an arrival time of 27.7 ms (Figure 4-32). The arrival time of the experimental blast wave is shorter than that of CONWEP prediction. The peak incident pressures are higher than the peak incident pressure calculation from CONWEP.

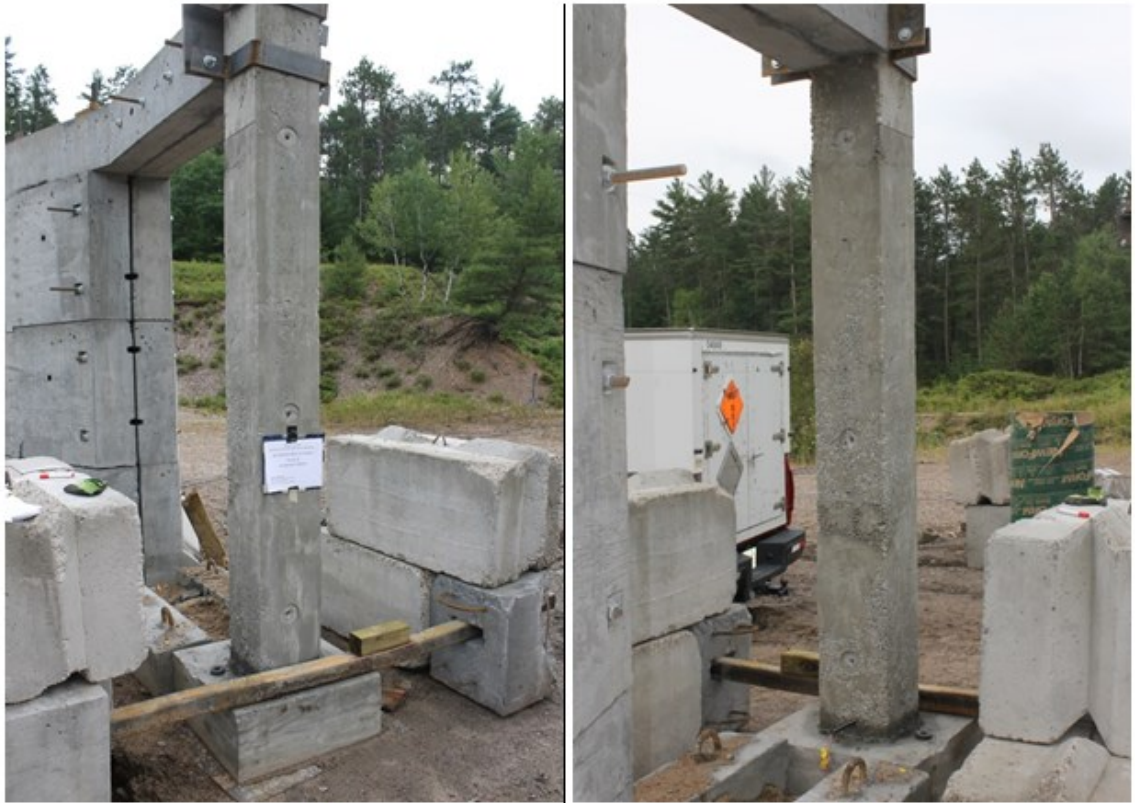
String potentiometers were connected to the back face of each column at 1 m, 1.5 m, and 2 m of CONV-6 to record displacement-time history of the column. Figure 4-33 present the pre-test photograph of column CONV-6.

Figure 4-33: Photograph of Column CONV-6 before test: (a) Front face (b) Back face

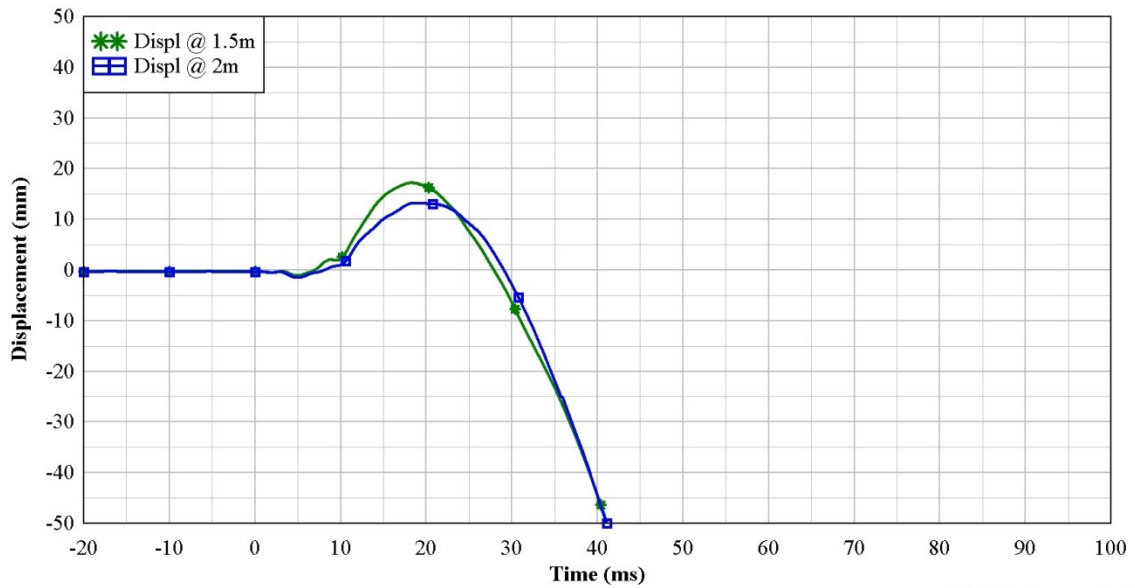
Figure 4-34: Displacement-Time history for Column CONV-6

Figure 4-34 presents the displacement-time response of CONV-6. The string potentiometer at the lower third-point was damaged during the testing and thus no data is provided. The maximum displacement of 17.2 mm occurred at mid-height of the column. The upper third-point displacement was 13.2 mm (Table 4-6(b)).

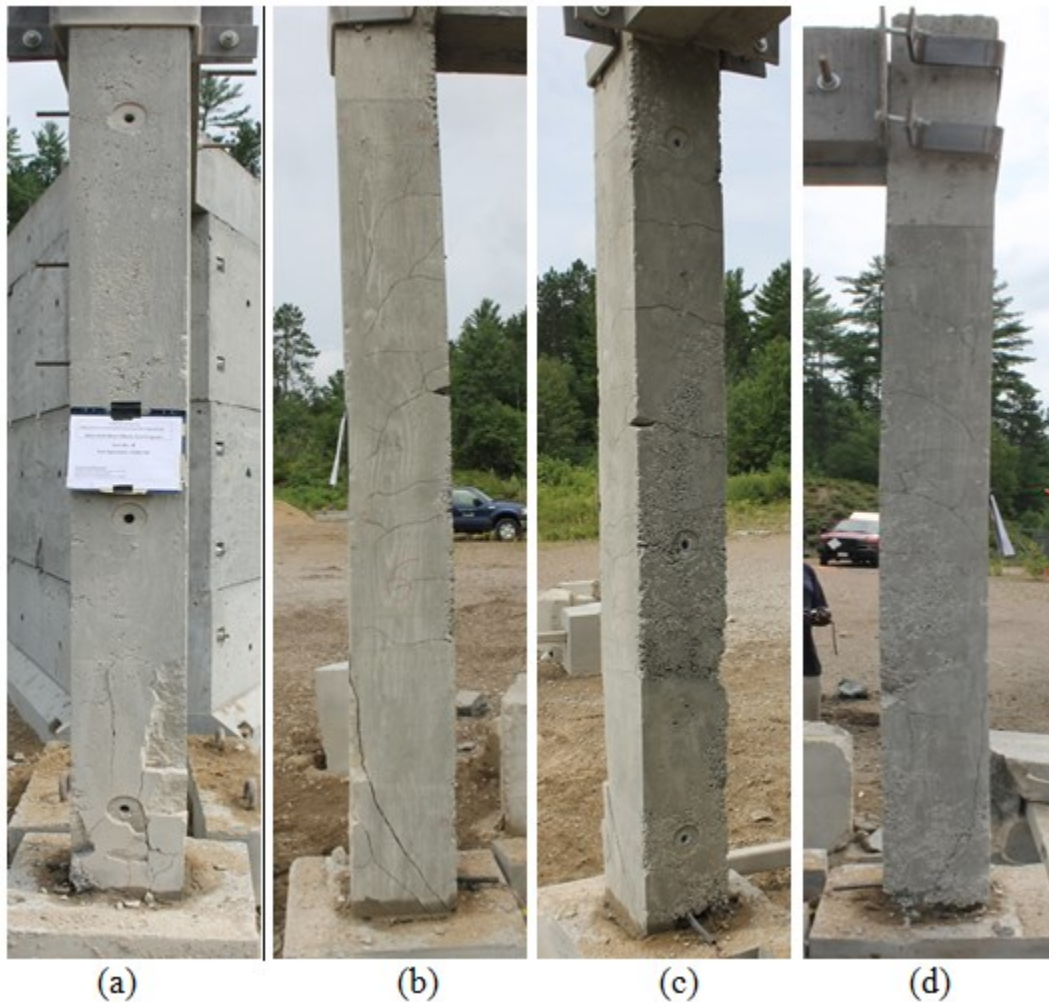
Post test observation of column CONV-6 revealed cracking and spalling of concrete at the lower one-third region of the column (Figure 4-35(a)). Shear cracks were observed near the bottom support of the column (Figure 4-35(b) and (c)). The cracks are visible on the side faces of the column, while wide flexural cracks visible on the back face and sides of the column (Figure 4-35). No discernible data was recorded from the strain gauges. Figure 4-34 is a photograph of column CONV-6 prior to test.

Figure 4-35: Post-test photograph of Column CONV-6 faces: (a) Front face, (b) Side face (right), (c) Back face, and (d) Side face (left)

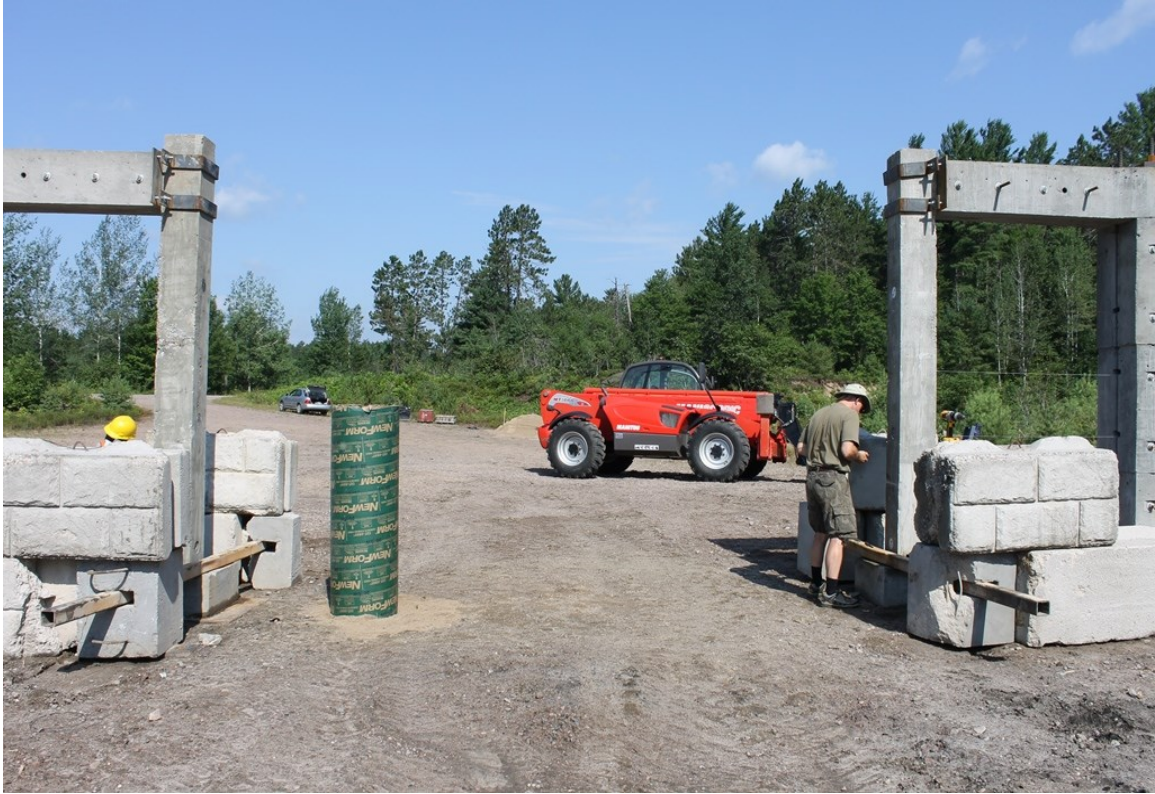
Figure 4-39 presents a sketch while Figure 4-40 is a photograph of the experimental setup for Test 4. The two columns (column CONV-1 and column SEIS-13) were instrumented with pressure gauges, string potentiometers and strain gauges. High speed videography, using a NAC Memrecam GX-8 video camera, was also used to monitor the response of the concrete columns during testing. Column CONV-1 was designed as a conventional column, while column SEIS-13 was designed as part of a structures lateral load resisting system.

Figure 4-40: Pre-test setup of test 4 (CONV-1 and SEIS-13)

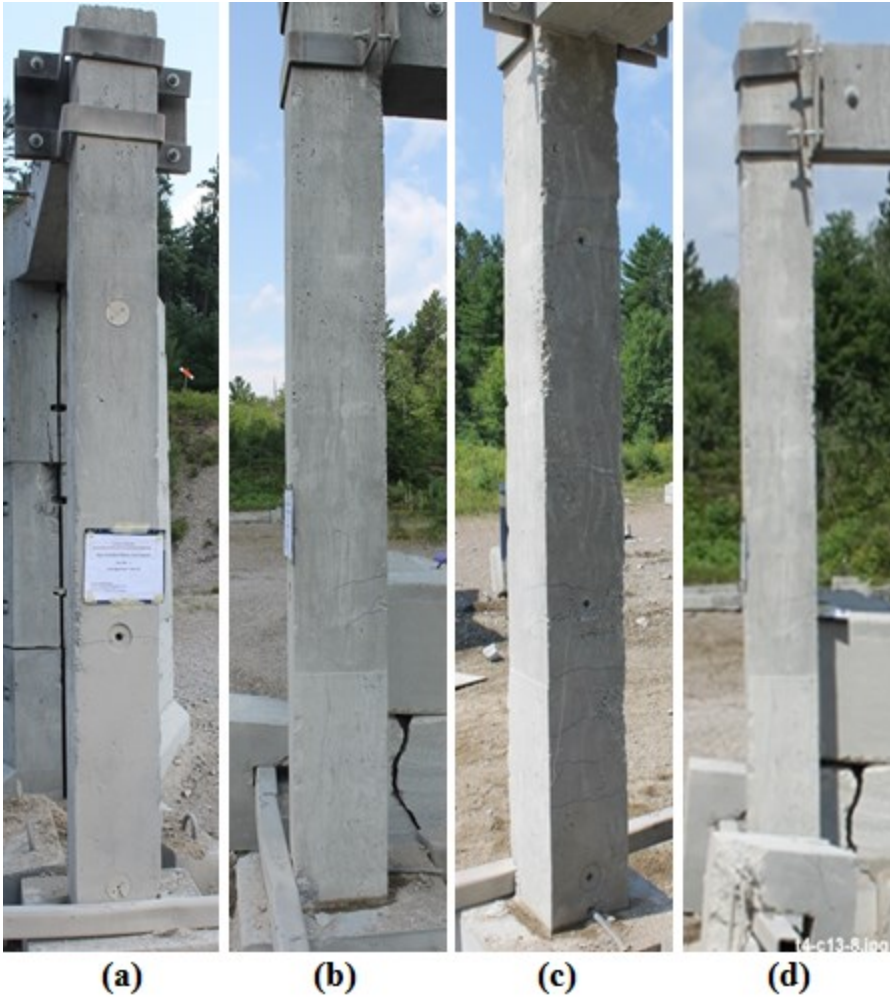
Figure 4-47 presents the post-test photographs. Post-test observation of column SEIS-13 showed minimal cracking on the back face of the column. The few cracks on the surface appeared to be flexural.

Figure 4-47: Post-test photograph of Column SEIS-13 faces: (a) Front face, (b) and (d) Side face (right), and (c) Back face

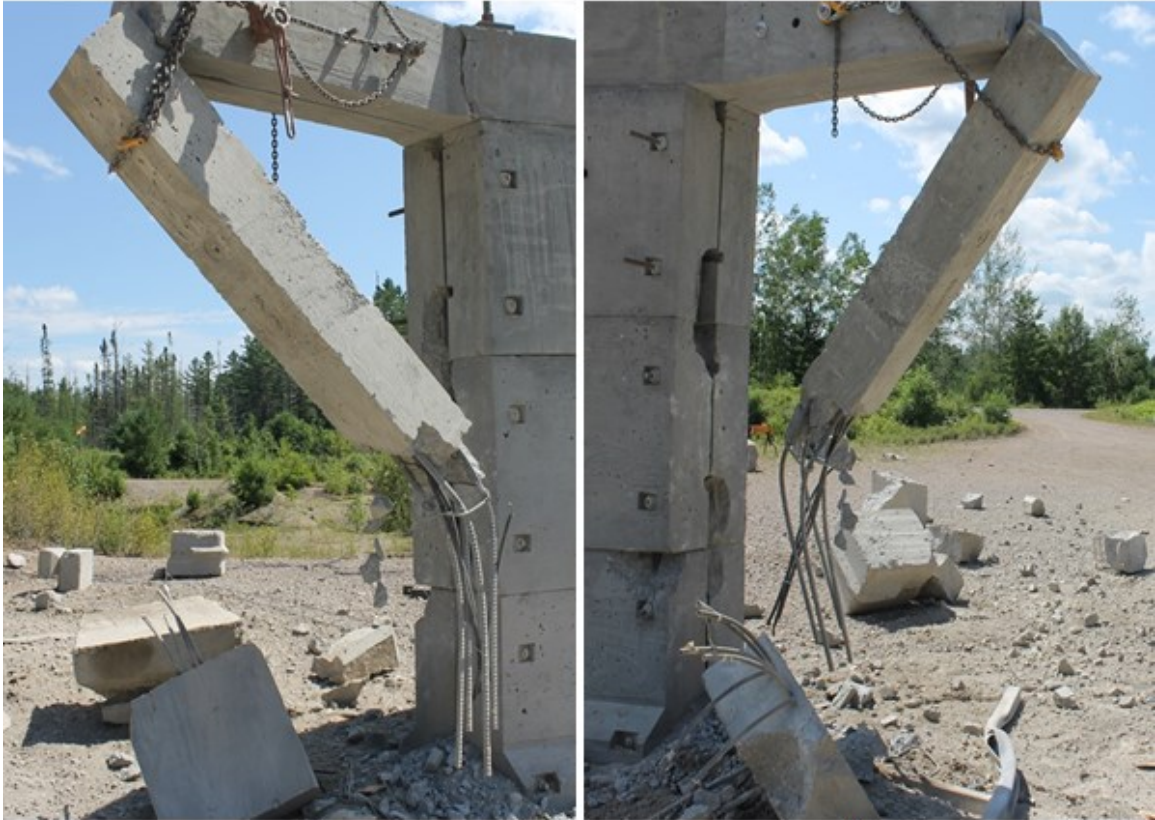
Figure 4-49 shows pre-test photograph of CONV-2 while Figure 4-50 shows a post-test photograph. CONV-2 was tested at a scaled distance of $0.26 \text{ m/kg}^{1/3}$ resulting in very high blast pressures on the column. The column failed catastrophically after the blast pressure impact. The concrete in the lap-splice zone was striped and blown off rebar. Consequently, the column severed into two at the column-footing joint (Figure 4-50).

Figure 4-50: Post-test photograph of column CONV-2

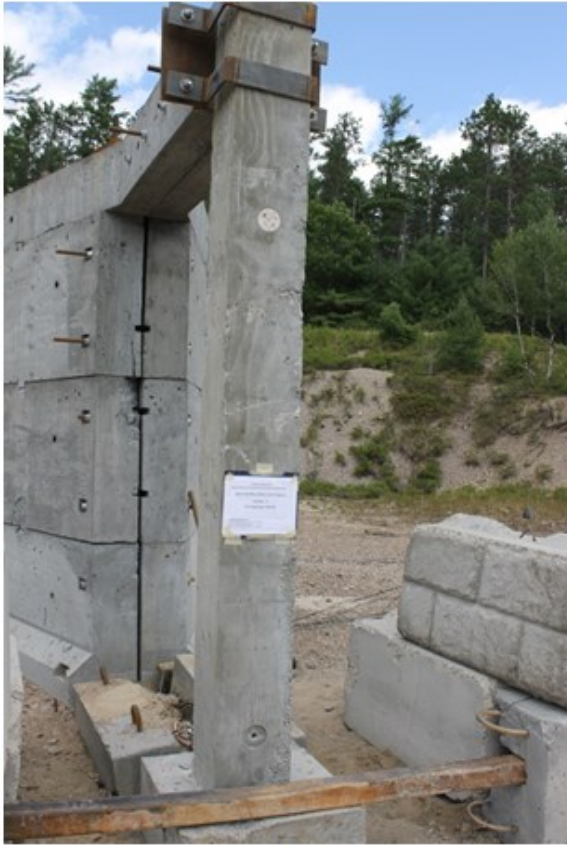
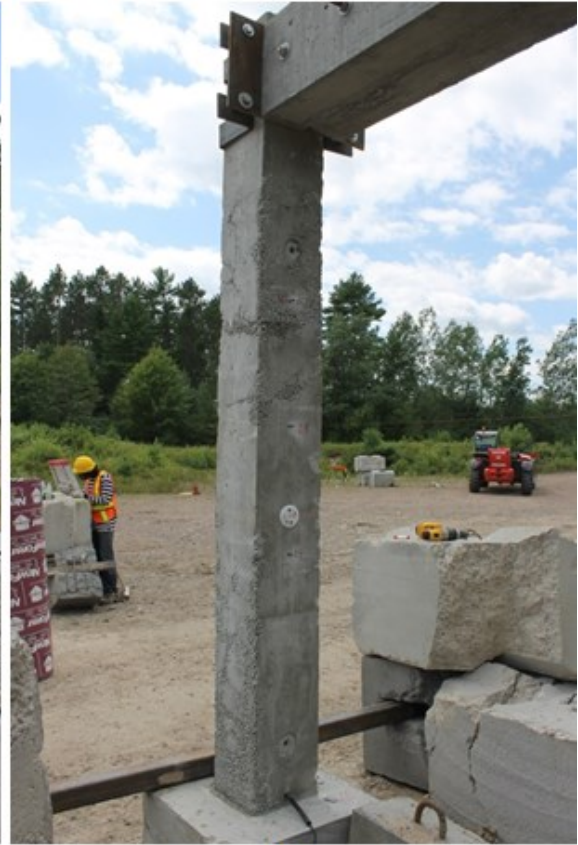
Figure 4-51: Photograph of Column SEIS-14 before test: (a) Front face of column with top-front pressure gauge (b) Back face column with mid-back pressure gauge

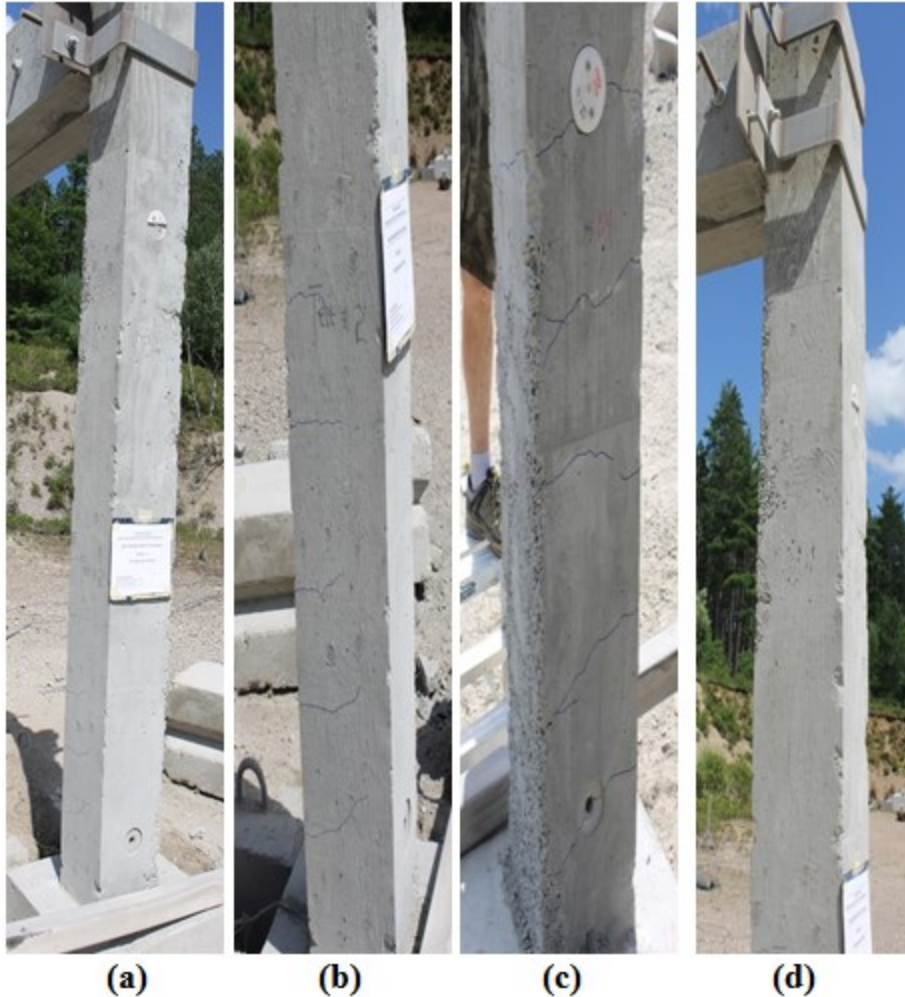
No data was recorded for SIES-14. Using CONWEP - A collection of conventional weapons effects calculations based on the Kingery-Bulmash polynomials with appropriate correction for incidence angle, the pressure at the bottom-front, mid-front and top-front gauges are 11,694 kPa, 12,743 kPa and 10,759 kPa respectively (Table 4-9). The maximum pressure calculated with a corrected incidence angle of 2° was at mid-front gauge with an arrival time of 1.6 ms. Table 4-9 presents reflected pressure data for the front face of SEIS-14. Figure 4-51 shows a pre-test photograph of SEIS-14 while Figure 4-52 shows a post-test photograph. The blast loading from the scaled distance of 0.86 $\text{m/kg}^{1/3}$ (150 kg of ANFO explosive charge at 4.3 m standoff) resulted in minimal

Figure 4-52: Post-test photograph of column SEIS-14 faces: (a) Front face, (b) Side face (right), (c) Back face, and (d) Side face (left)

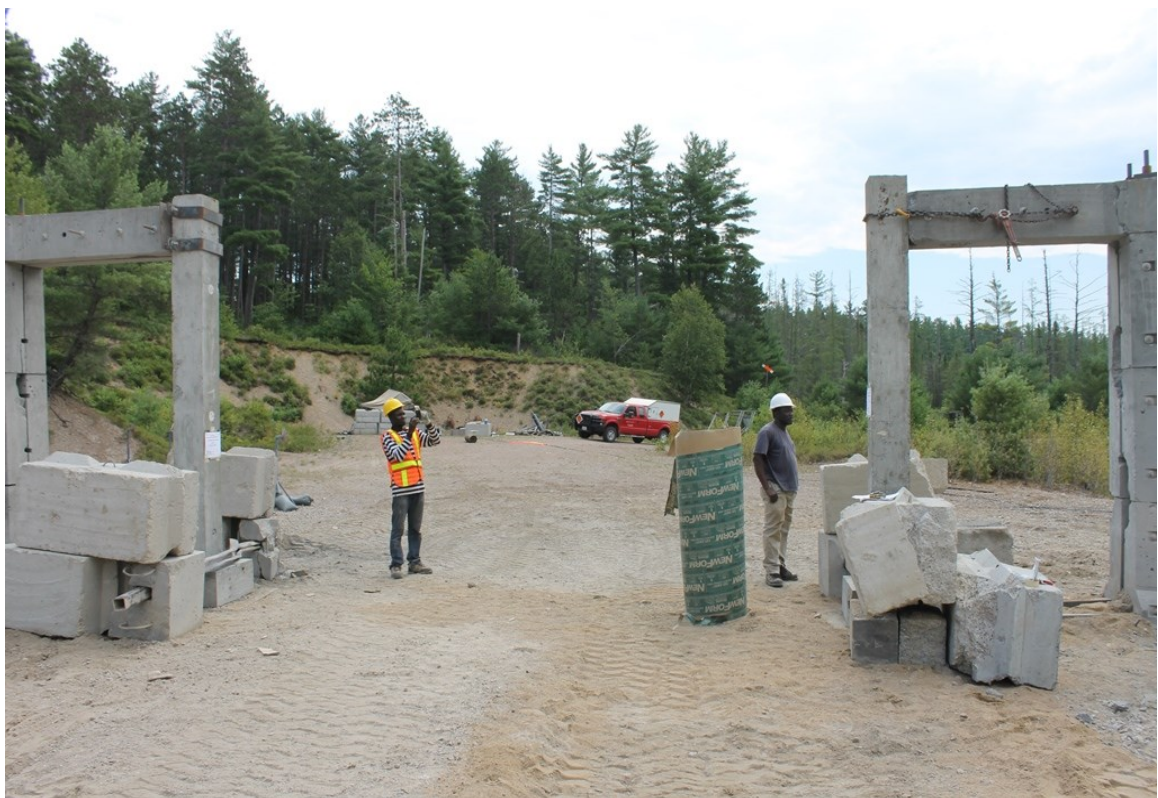
Figure 4-53 is a sketch of the experimental setup while Figure 4-54 is a photograph of the experimental setup prior to explosion test. The two columns (SEIS-3 and CONV-11) were instrumented with pressure gauges, string potentiometers and strain gauges. However, no data was recorded during the test.

Figure 4-54: Pre-test setup of test 6 (CONV-11 and SEIS-3)

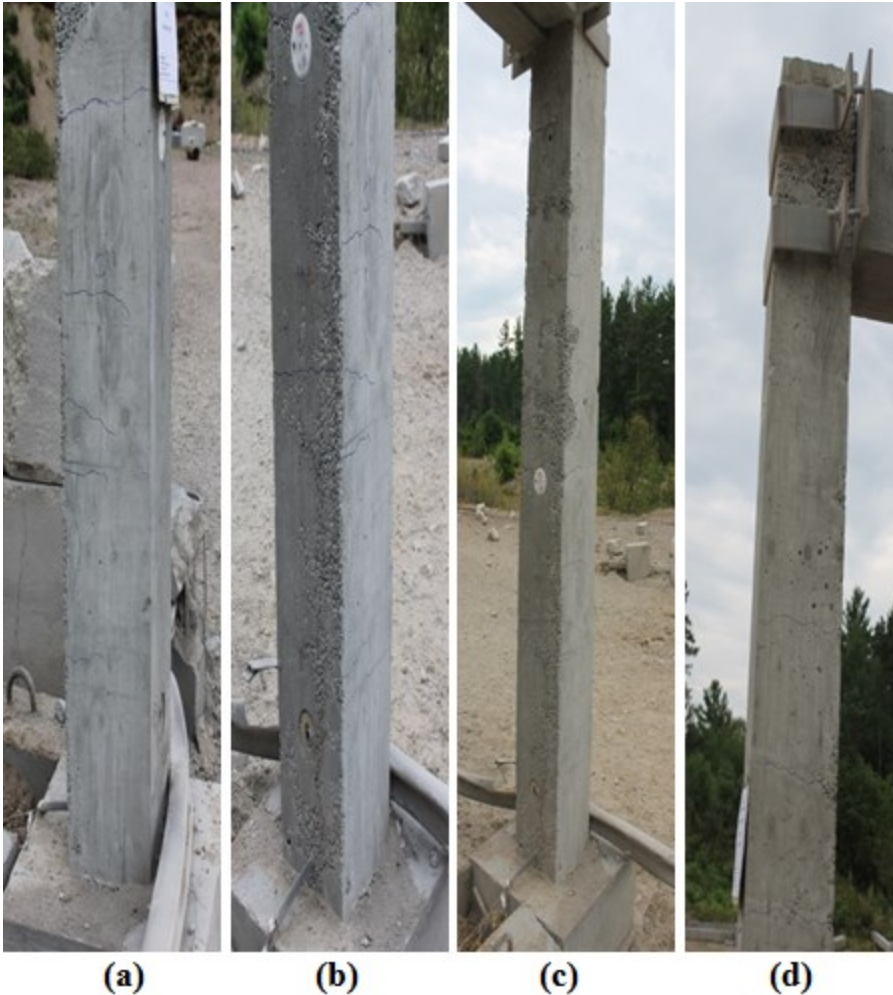
Minimal cracking was observed on the column after the explosion test. The cracks were predominantly flexural cracks developed on the sides and back of the column (Figure 4-58).

Figure 4-58: Post-test photograph of Column SEIS-11 face: (a) Side face (right), (b, c) Back face, and (d) Side face (left)

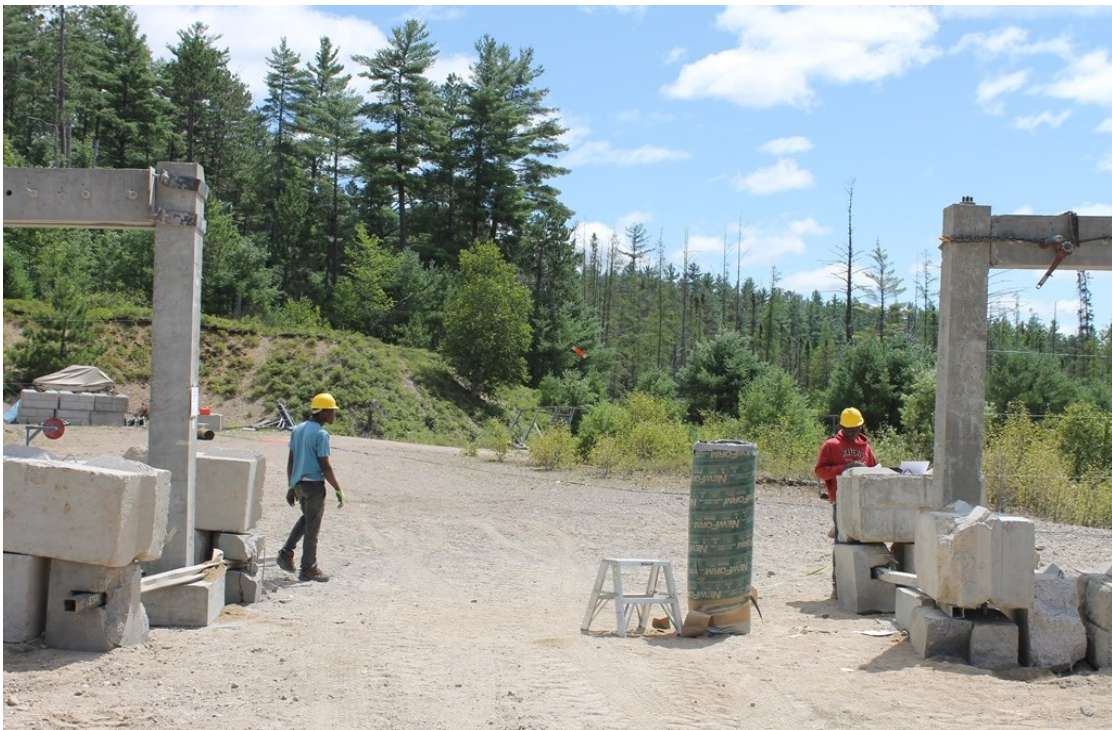
Figure 4-59 shows a sketch of the experimental setup, while Figure 4-60 shows a photograph of the experimental setup prior to explosion testing. The two columns (CONV-5 and CONV-12) were instrumented with pressure gauges, string potentiometers

Figure 4-60: Photograph of test 7 (CONV-12 and CONV-5) setup prior to detonation

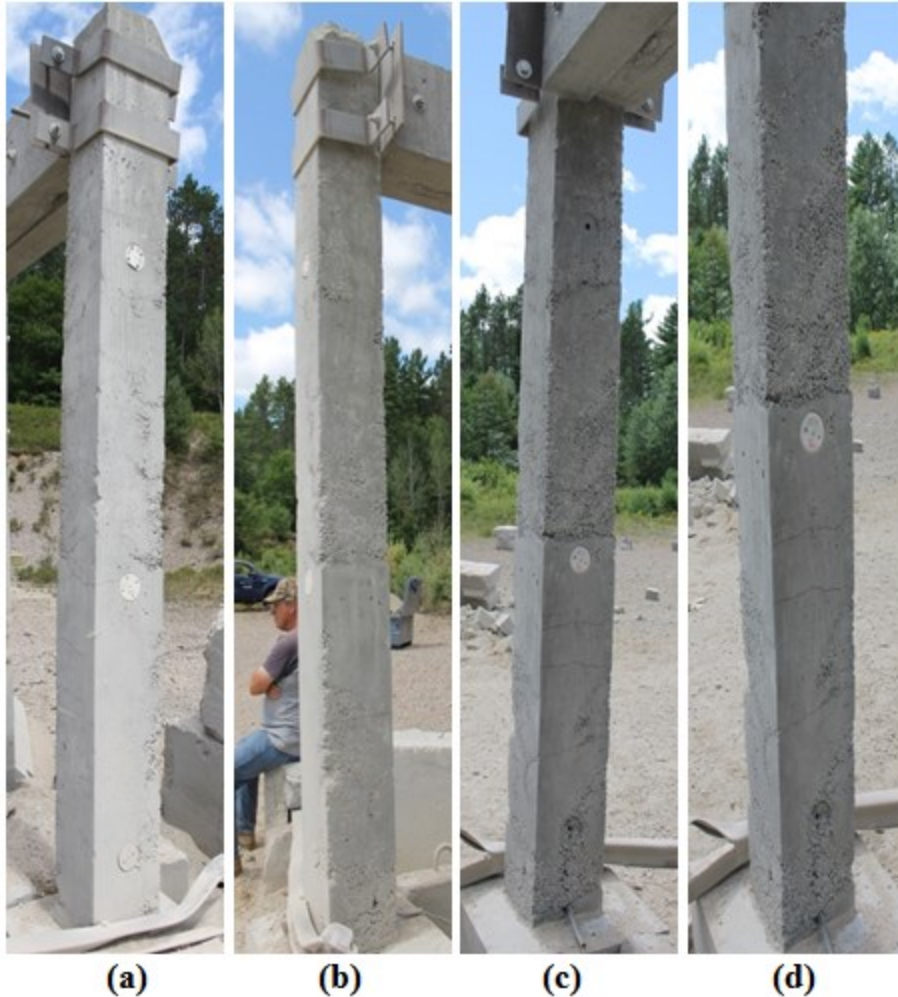
Figure 4-63 presents a pre-test photograph of CONV-12 while Figure 4-64 shows the post-test photograph. Minimal flexural cracking developed on the column (Figure 4-64).

Figure 4-64: Post-test photograph of Column CONV-12 faces: (a) Front face, (b) Side face (right), and (c, d) Back face

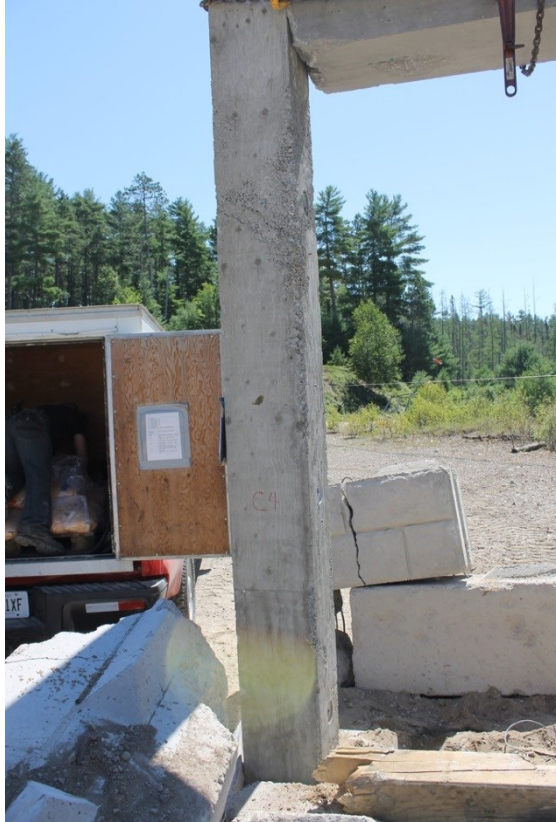
Figure 4-66: Photograph of Column SEIS-4 prior to test

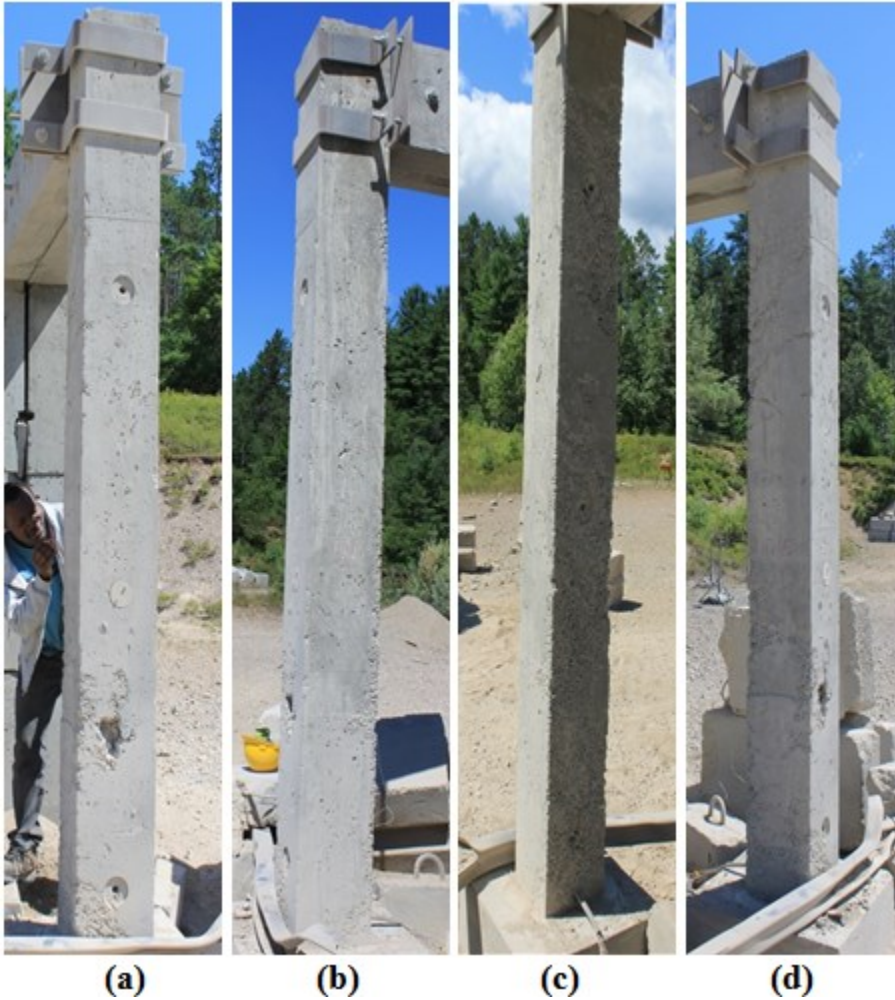
After the 150-kg ANFO was detonated, inspection of CONV15 showed that minimal cracks developed at the sides and back of the column (Figure 4-71).

Figure 4-69: Post-test photograph of Column CONV-15 faces: (a) Front face, (b) Side face (left), (c) Back face, and (d) Side face (right)

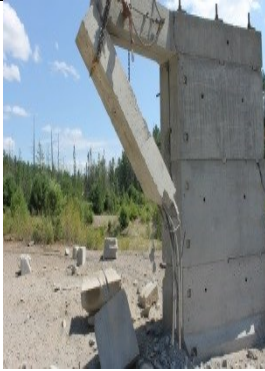
Total failure at column-footing joint
CONV-2	0.26	65,722*	95,049*	45,097 *	N/A	N/A	N/A

Total failure at column-footing joint

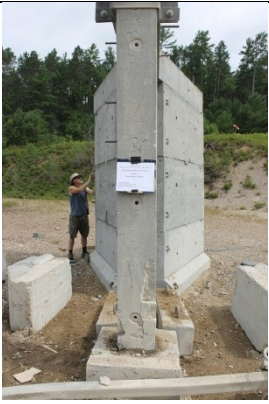
Cracking and spalling of concrete at lower height
CONV-7	0.58	33,133	Failed	8,791	24	17	41.1

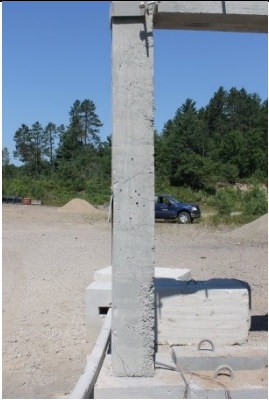
Minimal flexural and shear cracks

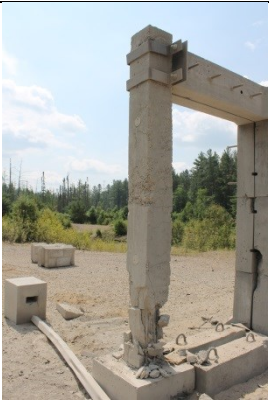
Flexural cracking at lower-height
CONV-11	0.88	10,212*	10,788*	9,193*	N/A	N/A	N/A

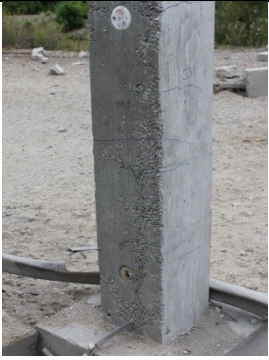
Minimal cracking observed on column

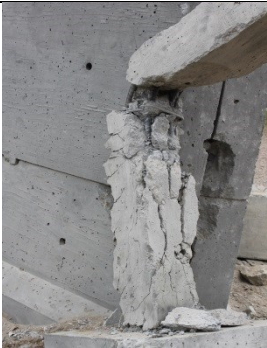
Crushing and spalling of concrete, concrete confinement precluded catastrophic failure
SEIS-4	0.34	59,128*	84,018*	37,808 *	N/A	N/A	N/A

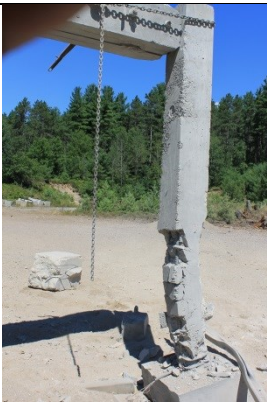
Lower 1.2 m severely cracked and spalled, though concrete core was well confined

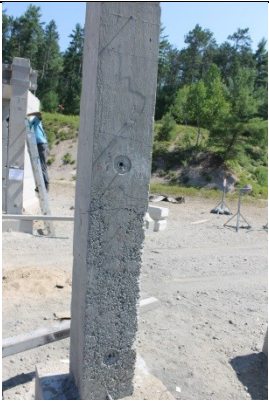
Minimal flexural and shear cracks
SEIS-9	0.52	35,555	26,531	2598	Failed	6.36	17.4

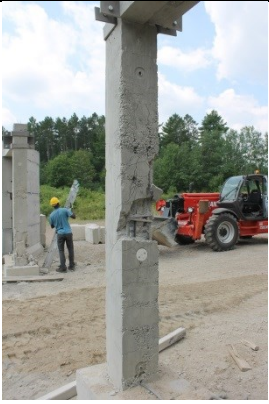
Flexural cracking at mid-height

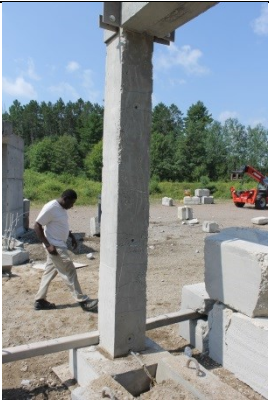
Minimal cracking on back face
SEIS-14	0.86	11,694*	12,743*	10,759*	N/A	N/A	N/A
