SEALED ENVIRONMENT

Climate Control of Historic House Museums

Golnaz Karimi

Master of Architecture

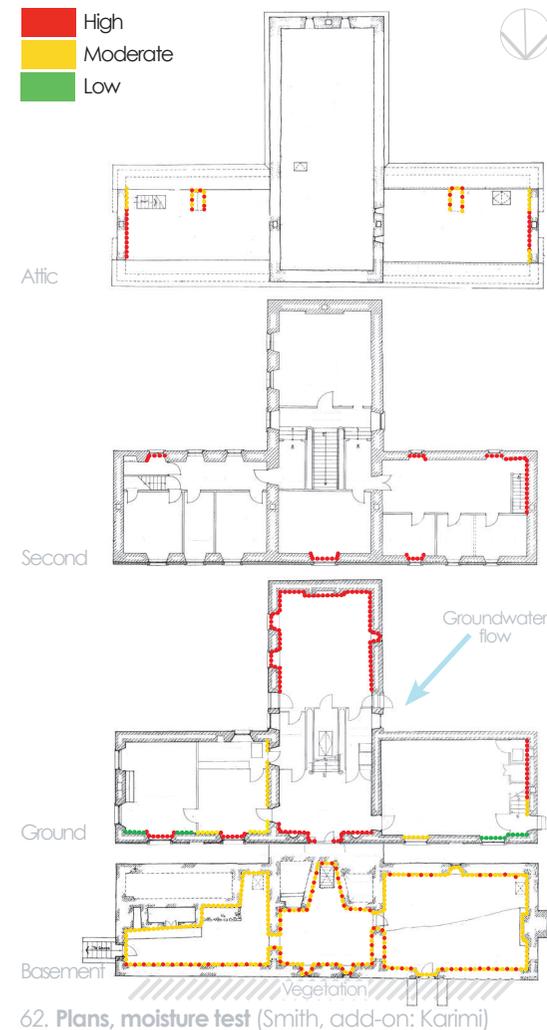
- 56. **Rising damp, ground** (Karimi, 2015)
- 57. **Rising damp, basement** (Karimi, 2015)
- 58. **Missing gutters** (Karimi, 2015)
- 59. **Water penetration** (Karimi, 2015)
- 60. **Exterior vegetation** (Karimi, 2015)
- 61. **Grade drainage toward the house** (Karimi, 2015)

and directs rain and groundwater toward the building, leading to damp masonry walls in the basement and the south wing's central kitchen at grade (fig. 57). Additionally, rising damp appears at the base of the foundation walls and up to about one-and-a-half metres above ground level in the south wing's kitchen walls. The visual evidence of the rising damp is a band of discolouration or physical damage on the surface of internal walls (Bagg, 2006).

Other factors affecting the damp problem are raised grade and exterior vegetation growing against the masonry walls (fig. 60). Raised ground levels outside the walls increase the moisture levels inside the walls and will not allow the moisture in the soil to evaporate beneath the ground floor. Also, overly raised flowerbeds and vegetation at the north side of the building keep excess moisture levels at the subsurface level, leading to deterioration of the walls and the ground floor log beams.

Deteriorated mortar joints were observed at the base of all exterior walls close to grade. Water and moisture penetrates through deteriorated mortar joints and saturates the masonry walls, leading to a reduction in the thermal performance of the walls. Also, sections of the walls have been repointed over the years with cement-based mortars, which restrict the breathability of the fabric. Traditionally, stone masonry buildings were constructed to breathe in order to accommodate moisture, using materials such as lime mortars and renders (Mitchell, 2007).

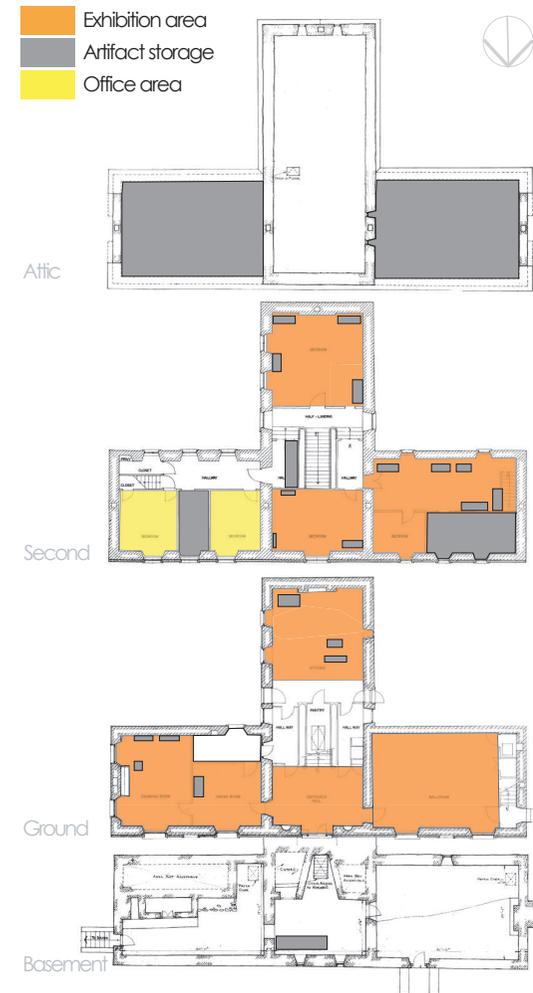
65. Plans, program study (Smith, add-on: Karimi)

Horaceville houses a collection of approximately 5000 artifacts. Currently, adequate space is not available for displaying and storing artifacts in the house. This has forced the Pinhey's Point Foundation to store a small number of fragile and valuable artifacts in a secure locker off-site. The diagram on the right (fig. 55) illustrates the arrangement of the exhibition and storage areas throughout the house museum. Three rooms on the second floor have been converted to store artifacts: one in the east wing for books and archival materials, and two in the west wing for small artifacts, framed works, and paintings. Additionally, numerous wardrobes and cupboards situated throughout the house are used as extra storage space. Previously, attic spaces in both the east and west wings were used to store a large number of furniture pieces of different materials (Lundholm Associates, 2015). As mentioned previously, storing artifacts in poorly ventilated attic spaces is inappropriate due to the damaging levels and rapid fluctuation of RH. The house's attic spaces are not heated during the heating season, and artifacts are kept in these areas due to the lack of winter storage. The low temperature of the attics is not detrimental to most artifacts, but sudden temperature changes can be (Kerschner, 2007). These changes can rapidly affect the RH level, leading to condensation on objects' surfaces and the inside layers of the exterior walls. A thermal investigation was conducted with a thermal camera to further assess the conditions of the historic fabric.

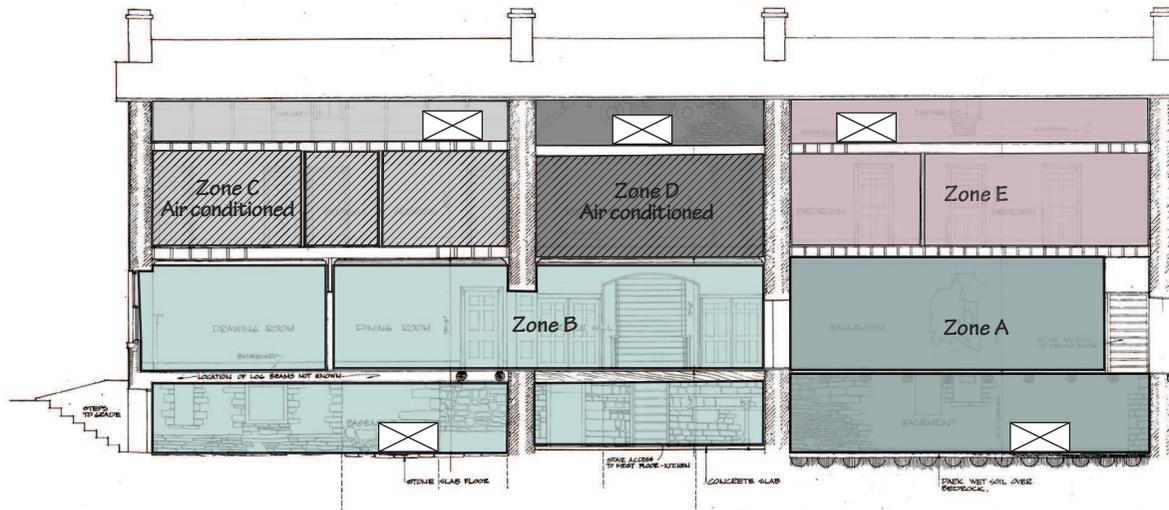
71. Section, 1999's ventilation system (Smith, add-on: Karimi)

The two section diagrams (fig. 70 and 71) show the estimated performance of the 1850's and 1990's ventilation systems. It is safe to say that the original ventilation system allowed free movement of air and moisture through the whole building, in comparison to the modern mechanical system that was designed to control partial areas of the house. Also, the air-conditioned spaces may draw moisture into assemblies from non air-conditioned spaces, which will cause periodic condensation and thermal stress in assemblies.
